# Upper Lillooet Hydro Project

## Weekly Environmental Monitoring Report #23

Reporting Period: May 25<sup>th</sup> – May 31<sup>st</sup>, 2014

Upper Lillooet River Hydroelectric Facility (Water File No. 2002561, Water licence No. C130613),  
Boulder Creek Hydroelectric Facility (Water File No. 2003049, Water licence No. C129969) &  
Transmission Line (TX Line)

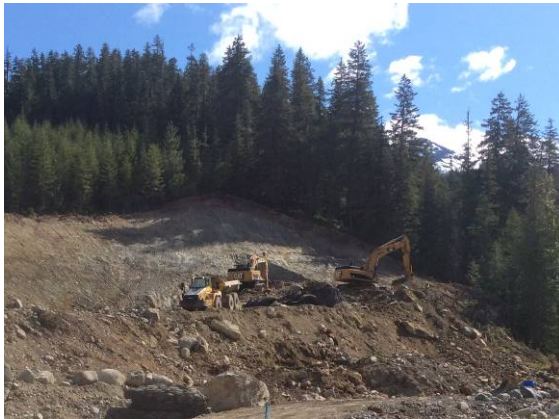
**Photo 1. Excavation of the BDRHEF downstream portal location (May 28, 2014).**

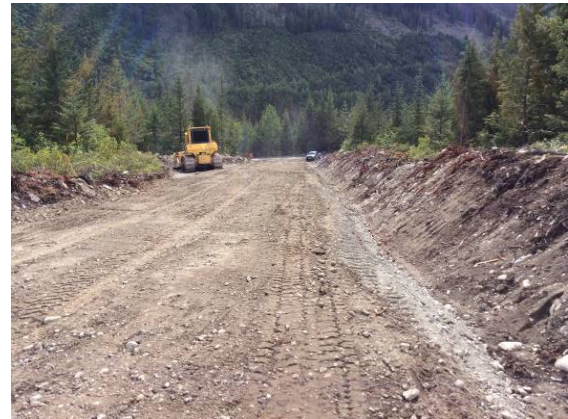
**Photo 2. Grade changes along Boulder Creek powerhouse access road. (May 27, 2014).**

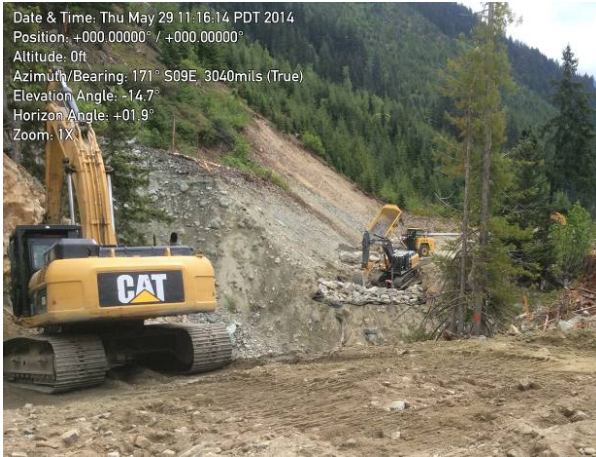
**Photo 4. Truckwash Creek bridge abutment works monitored on May 29, 2014.**

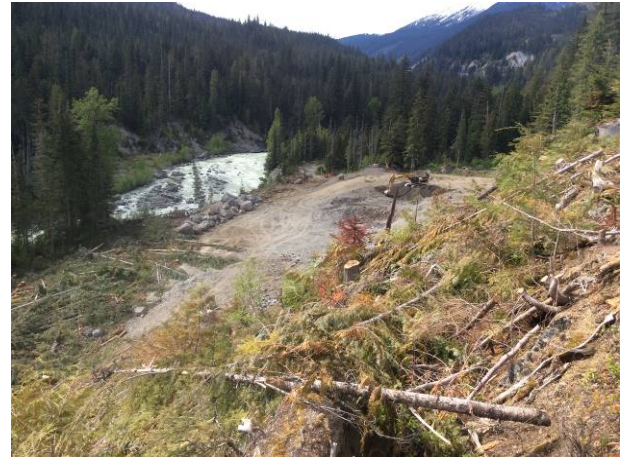
**Photo 5. Bench excavation at the ULRHEF powerhouse. (May 27, 2014).**

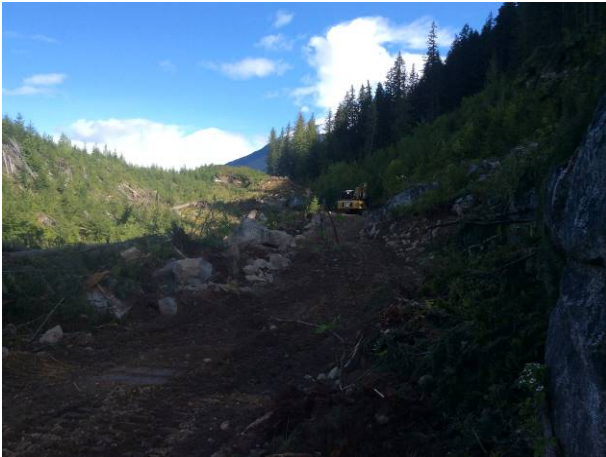
**Photo 6. Access road construction; Pebble D.1 Branch road (May 28, 2014).**

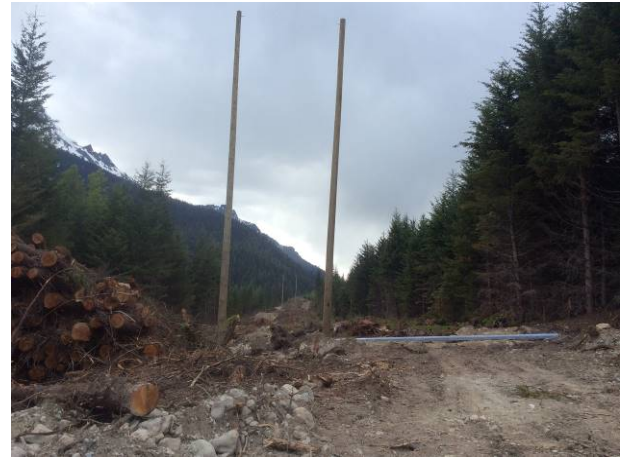
**Photo 7. Pole installation work in Segment 1 (May 28, 2014).**

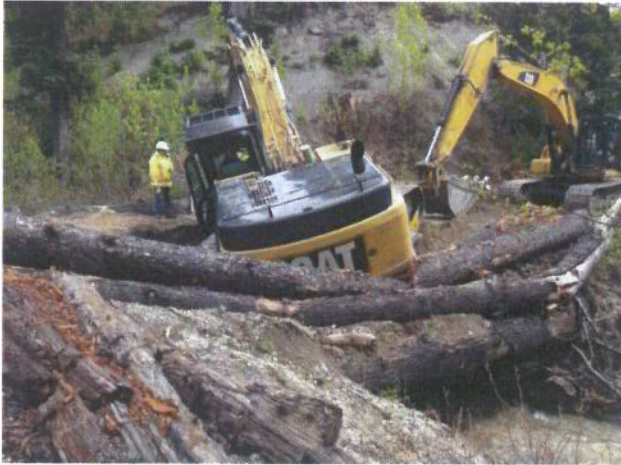
- At 1:30 PM, when travelling across the box culvert installed at km47, the box culvert failed and the excavator fell through the culvert. Normal hydraulic oil is used in this excavator, but no spills occurred in the watercourse and within the High Water Mark

Photo 1: The CRT-ebc 45 tons excavator, moments after the box culvert collapsed.

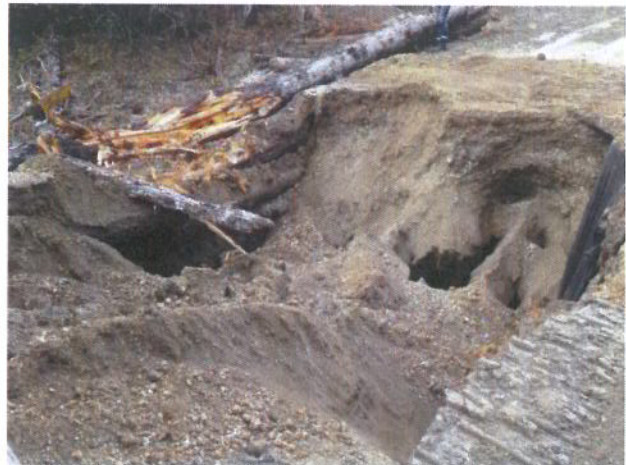
Photo 2: Box culvert post-excavator removal.

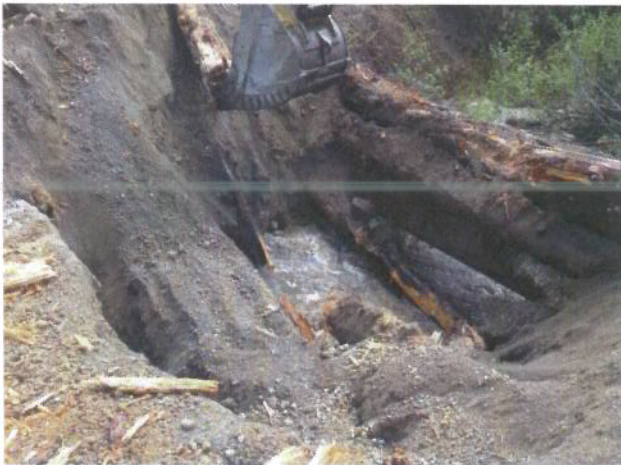
Photo 3: Condition of the creek bed following removal of the excavator and some material obstructing the flows. Debris and material was removed from the watercourse with an excavator equipped with biodegradable hydraulic oil.

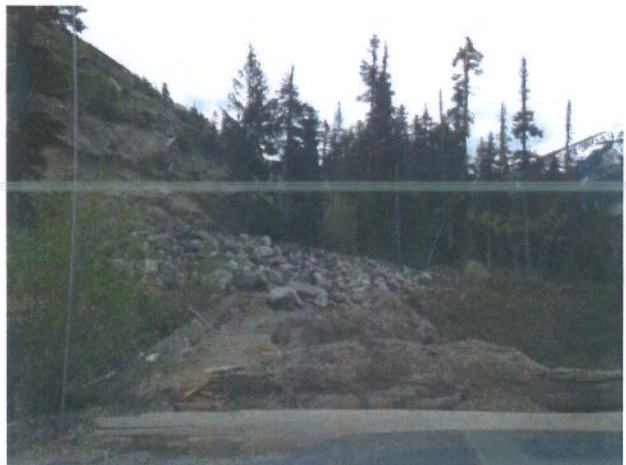
Photo 4: The slope above the creek was stabilized with boulders to avoid sediment from entering the watercourse.
