Upper Lillooet Hydro Project

Weekly Environmental Monitoring Report #24

Reporting Period: June 1st – June 7th, 2014

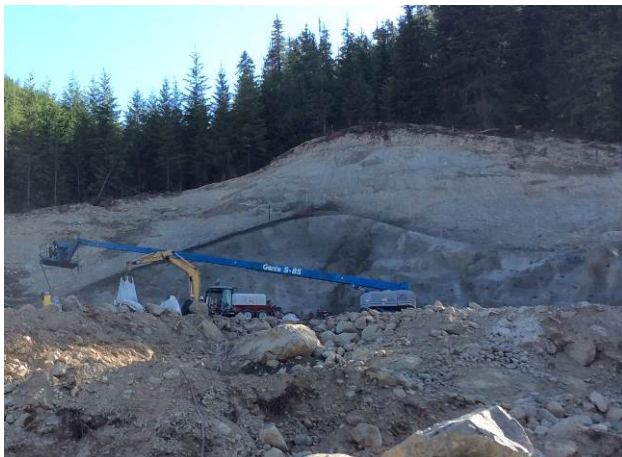
Photo 1. Shotcrete and rock bolt installation at the

BDRHEF downstream portal location (June 5, 2014). floor. (June 7, 2014).

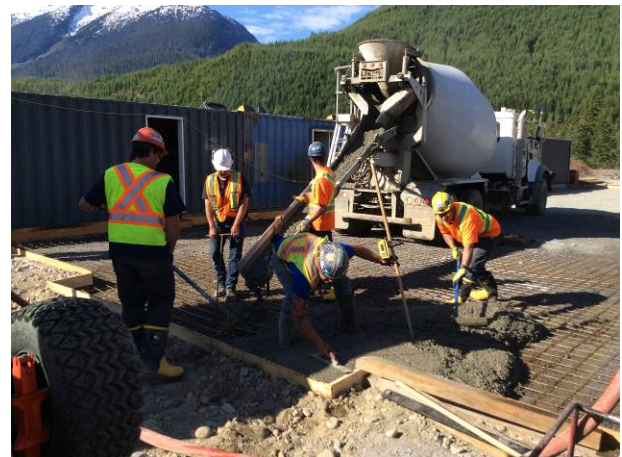
Photo 2. Concrete pour of the future mechanic shop

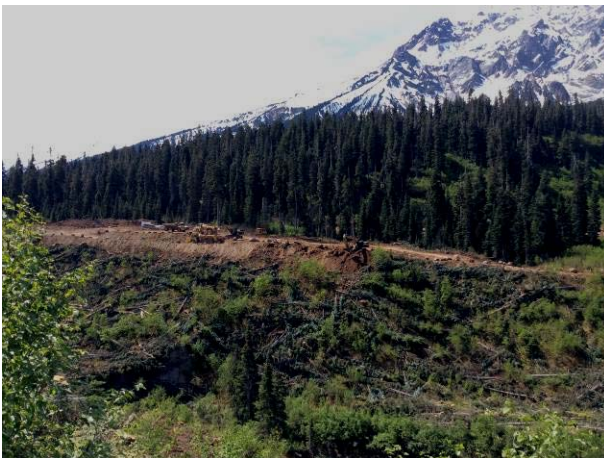
Photo 4. Conditions at the right bank diversion channel excavation on June 7, 2014.

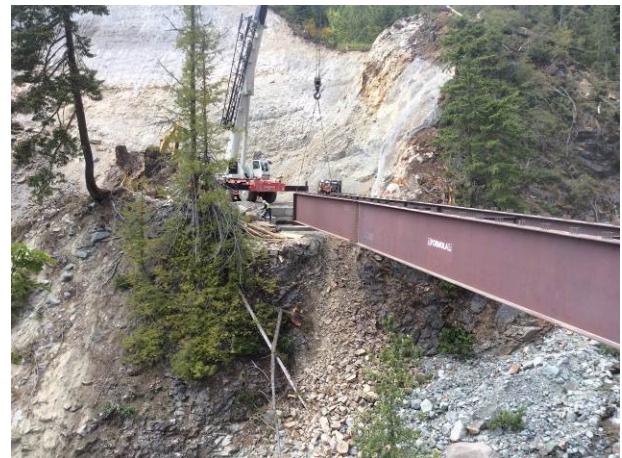
Photo 5. Launch of the Truckwash Creek bridge girders from the east abutment. (June 6, 2014).

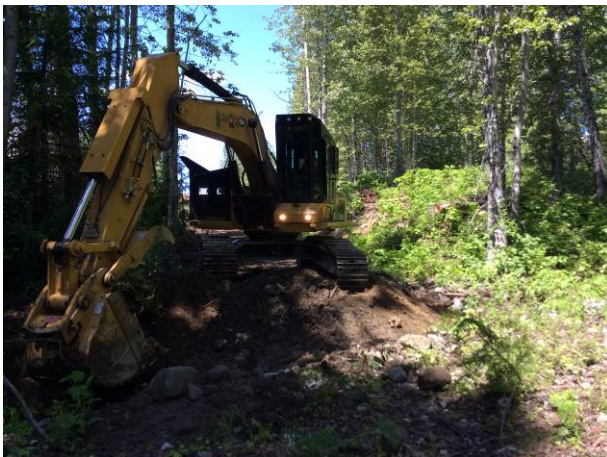
Photo 6. Culvert installation work proceeding in the dry; Pebble D.1 Branch road (June 5, 2014).

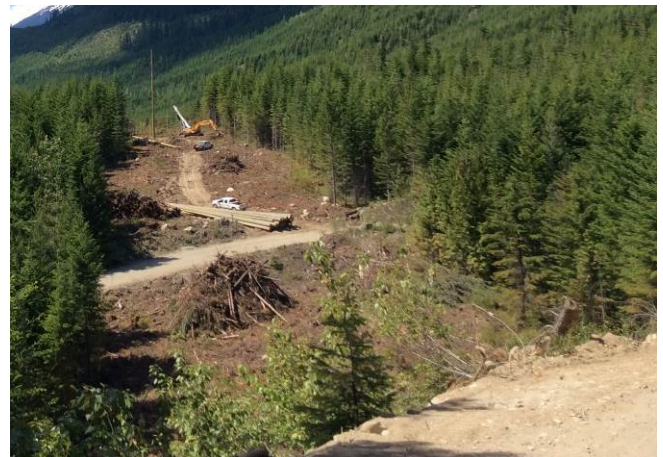
Photo 7. Pole installation work in Segment 2 (June 4, 2014).

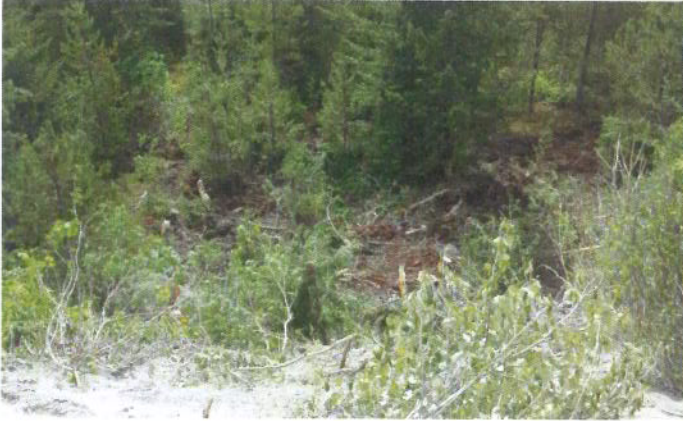
- The site superintendent (Roger Pelletier) made the decision to send an excavator from CRT-ebc in through an old access traverse below the FSR and bank to right the rock truck and remove it from the area in order to minimize the risk of fluid leaking from it. Minimal damage to vegetation occurred, and no surface water crossings.

Photo 1: Site where rock truck slid and rolled down slope at km39.9.

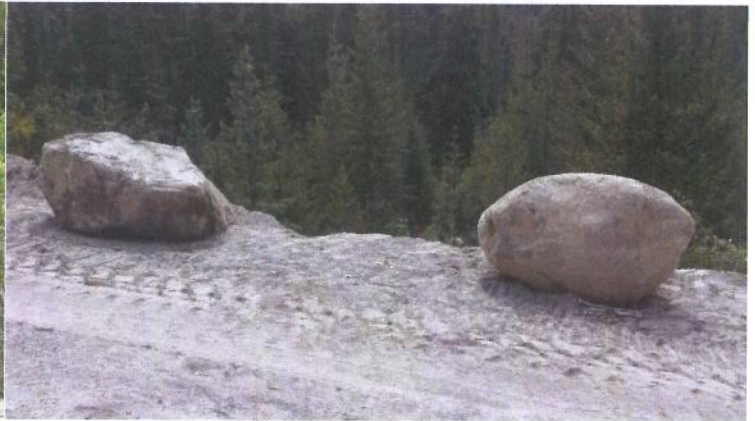
Photo 2: Boulders placed on soft shoulder to stop vehicles from driving there.

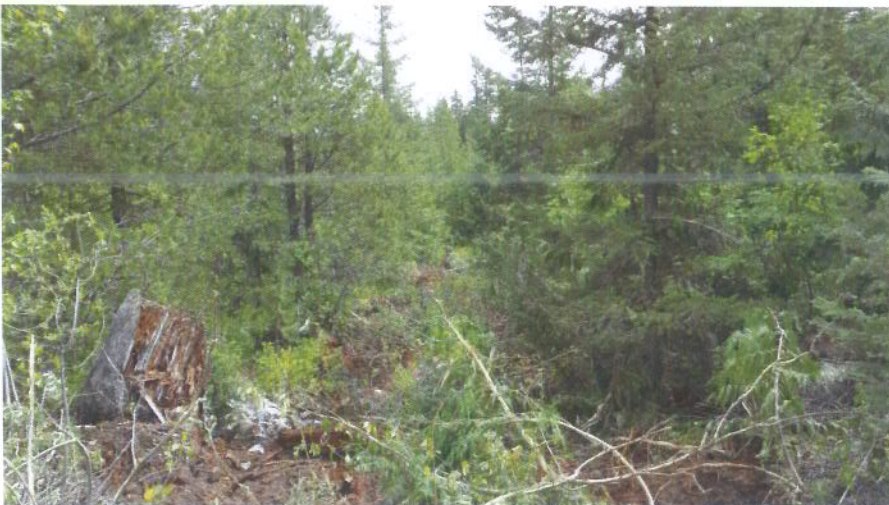
Photo 3: Access track where CRT-ebc excavator walked in to the site to remove rock truck.

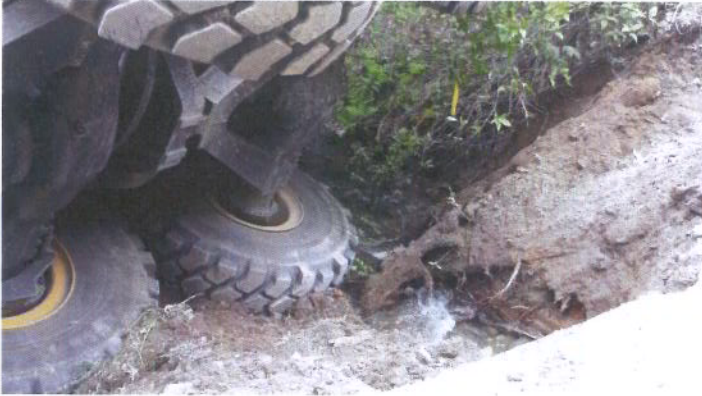
- The sand and gravel load spilled partially in the stream and a small amount of dirt from the collapsed culvert also entered the stream. During the incident, a plume of turbid water was observed from the dirt in the collapsed culvert. The turbidity dissipated very rapidly and was minimal. Ian McKeachie (Environmental Coordinator) was on site 15 minutes after the incident occurred and took pictures showing the stream running clear. No fish mortalities were observed.

Photo 1: Rock Truck and soil from culvert that entered the watercourse during the incident and clear running water in the stream (photo taken 15 mins after incident).

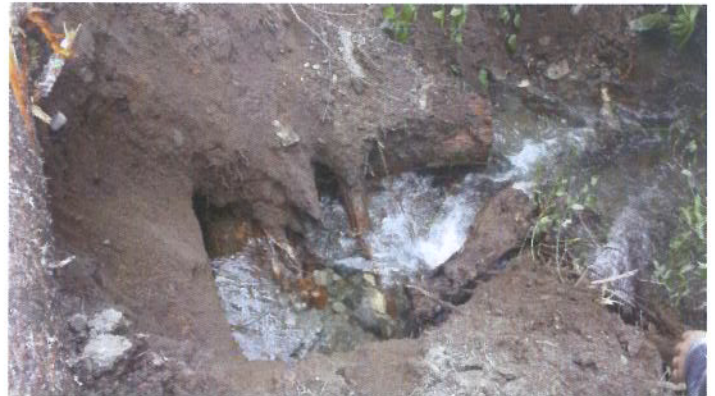
Photo 2: Material that entered the watercourse during the incident and clear running water in the stream after rock truck removal.

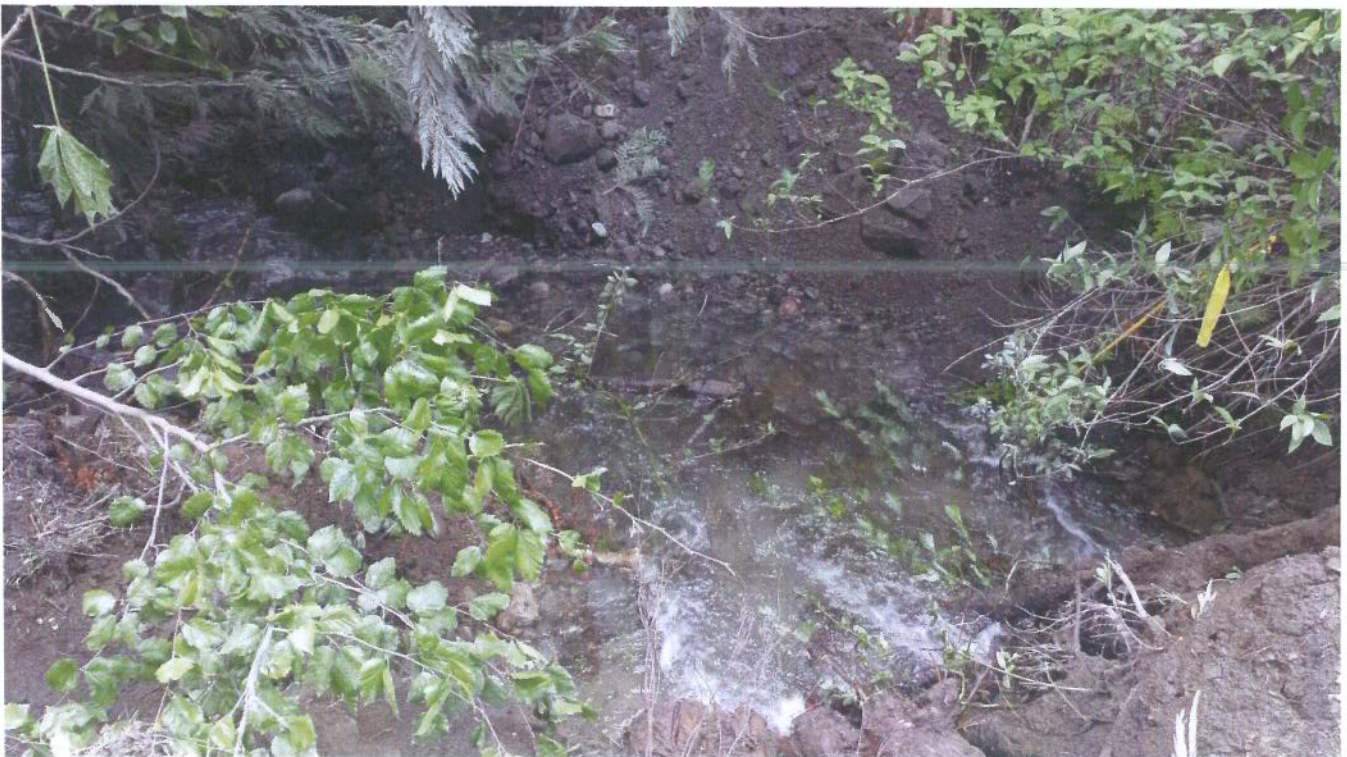
Photo 3: Sandy and gravelly material from load deposited in and next to stream.

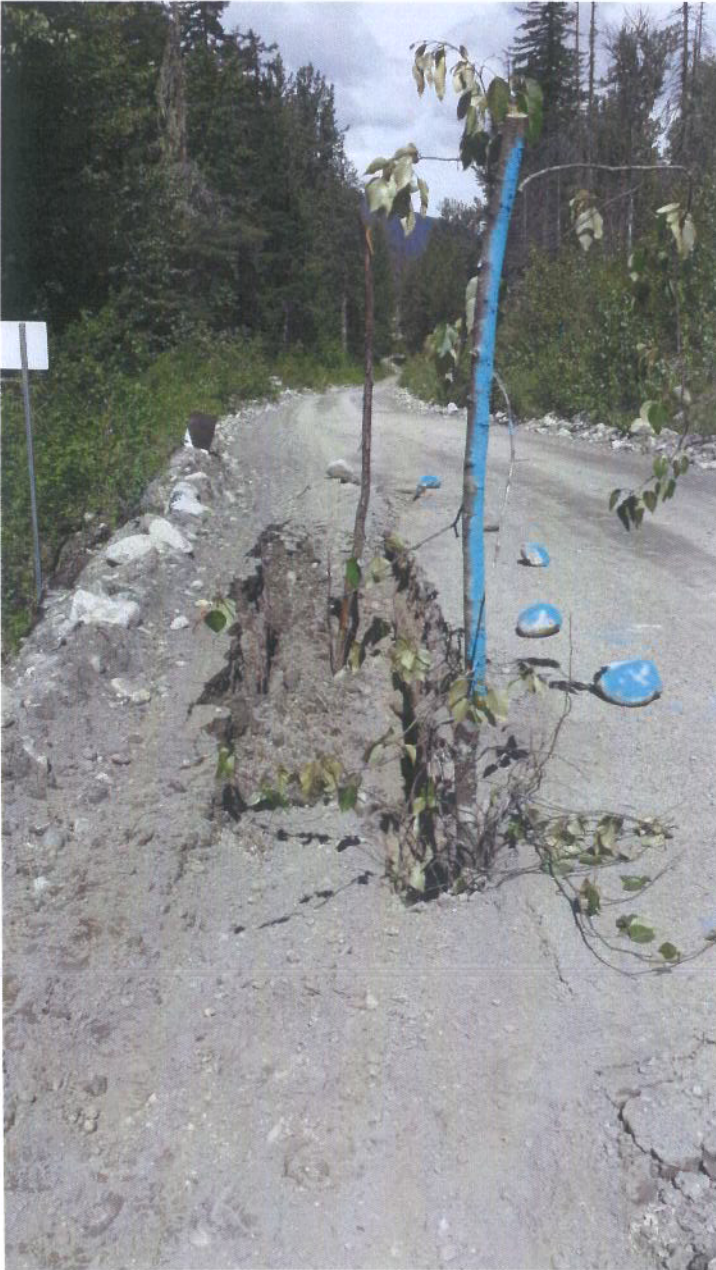
Photo 1: Photo showing failed box culvert with painted blue rocks and trees marking it.

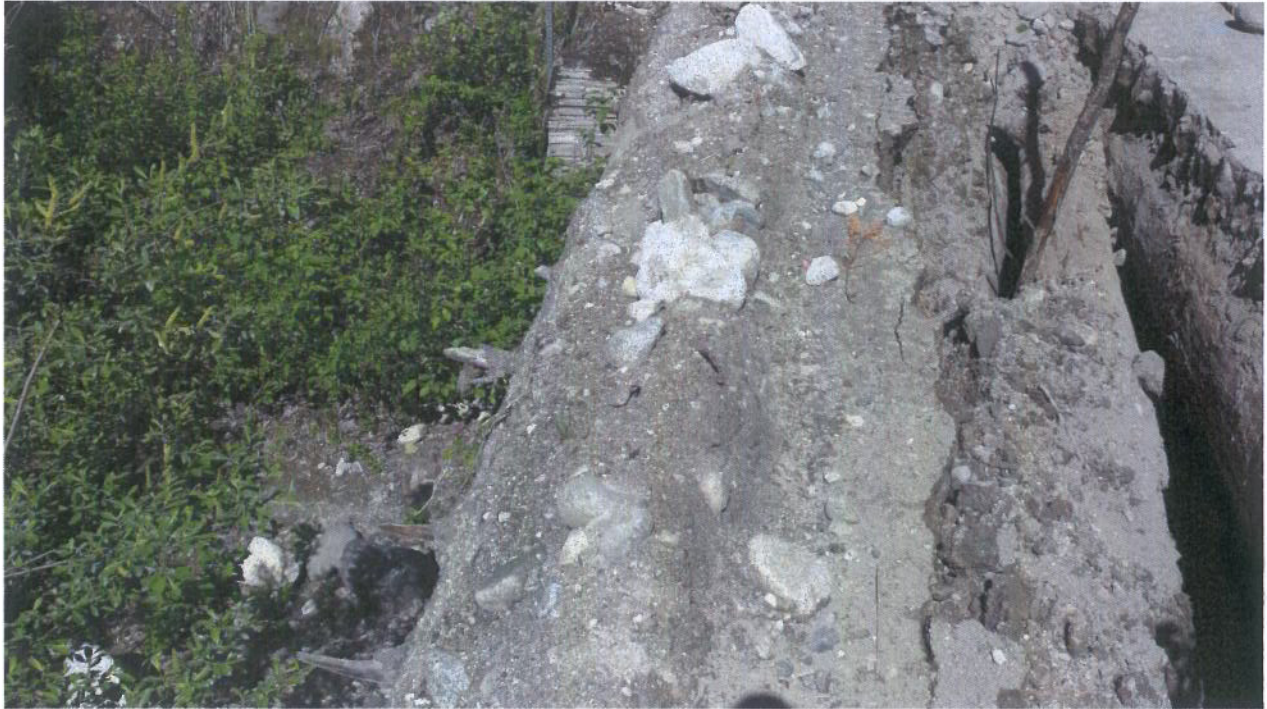
- The dirt from the collapsed box culvert entered the dry Silva Creek stream bed under the failed box culvert. Although this has historically been a potentially fish bearing stream, it has not had water in it this Spring.

Photo 2: Failed box culvert over the dry Silva
Creek bed.

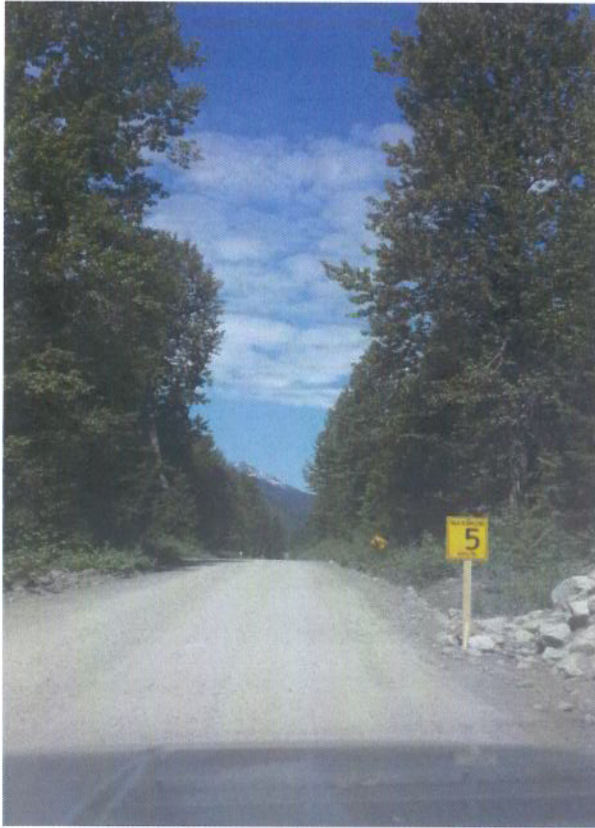
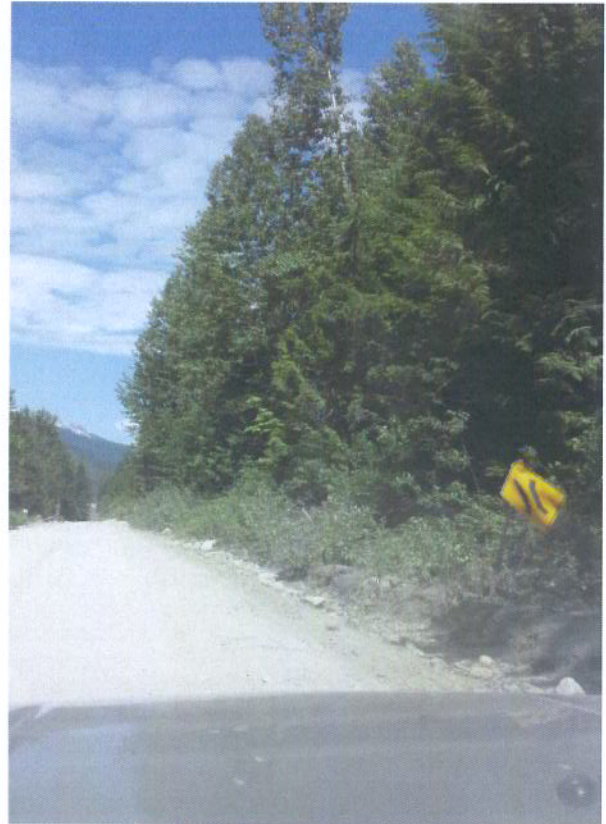
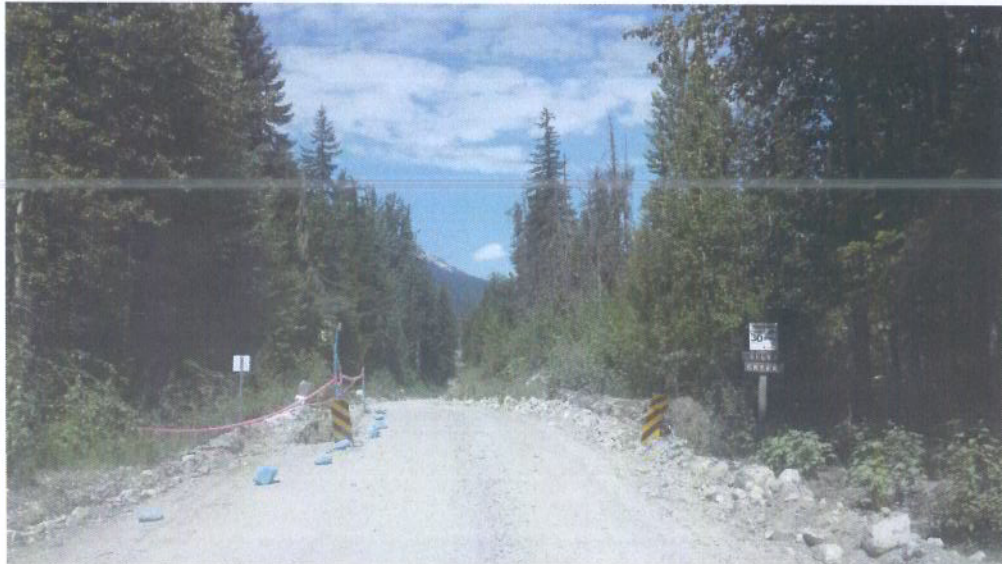
Photo 2, 3 & 4: New signage & flagging marking the area for safety.

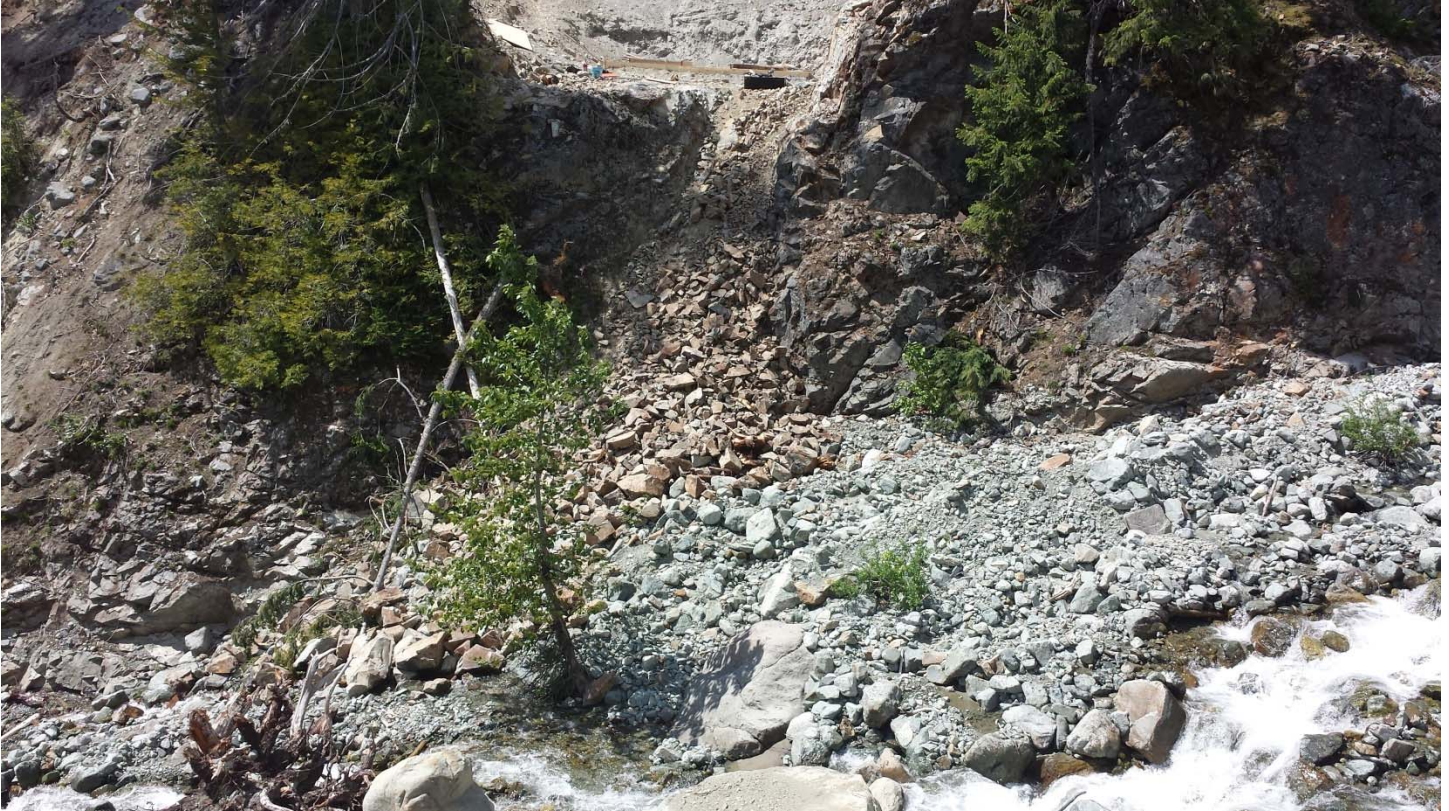
- The slope around the area of excavation was unstable, and as a result the material slid down the bank when the machine was performing scaling as part of bridge foundation excavation work.

Photo 1: Rock material that slid down
unstable bank from excavation works at the
top.

- Field Engineers and machine operators will have the IEM present prior to and during work near riparian areas.
- The IEM and CRT-ebc environmental team will advise operators of the need for extreme care while working near riparian areas, and make reference to site specific potential hazards.
- CRT-ebc employees will be reminded of spill response procedures and how to use the spill kits in a potential future event.
- Communication protocols for incident response have been strengthened and CRT-ebc employees will be reminded of them to ensure that the IEM and Innergex are informed in a timely manner.
- CRT-ebc will inform the IEM a minimum of 48 hours prior to working within 30 m of a watercourse.

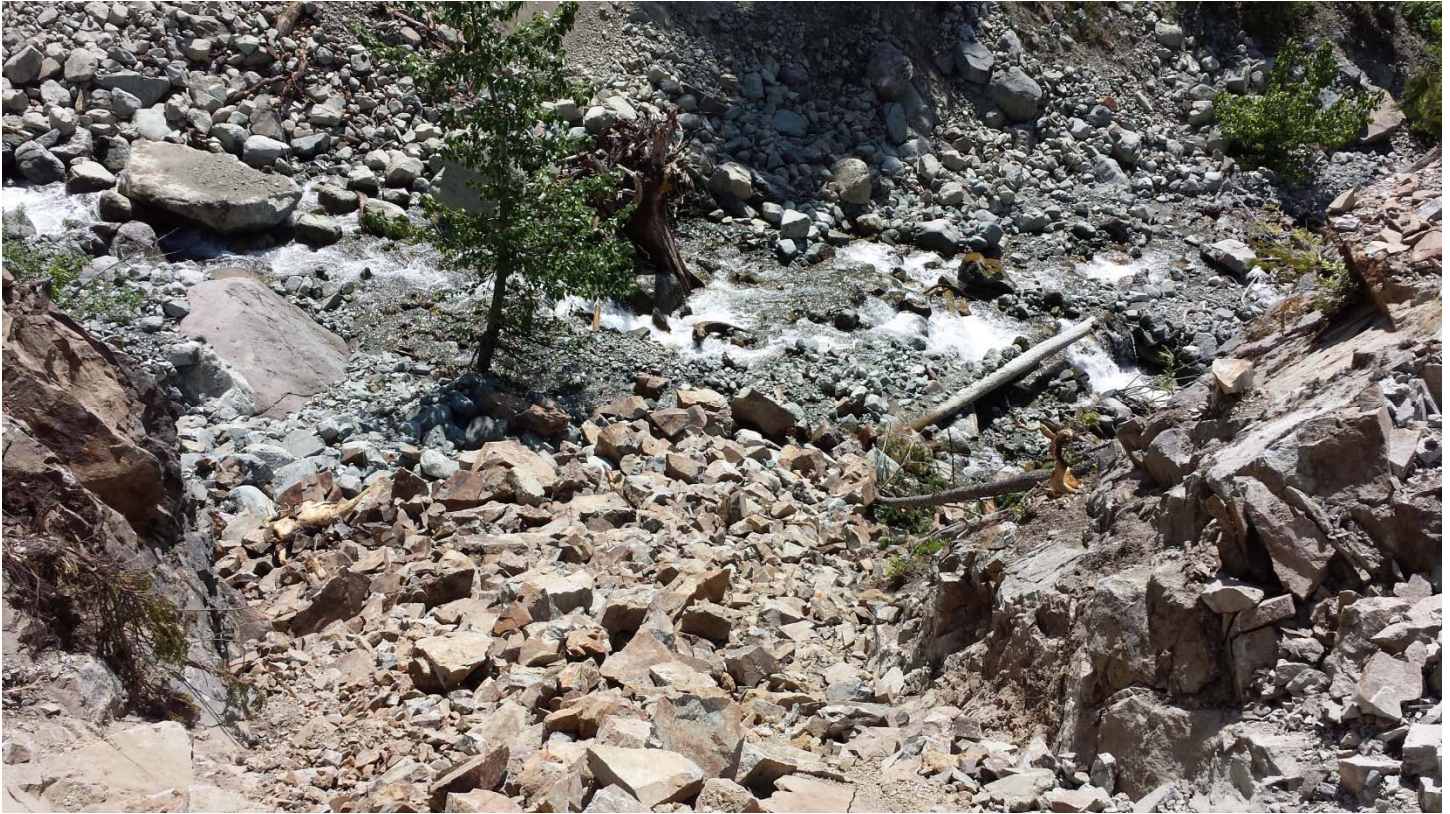
Photo 2: Rock pile shown from top of slope.

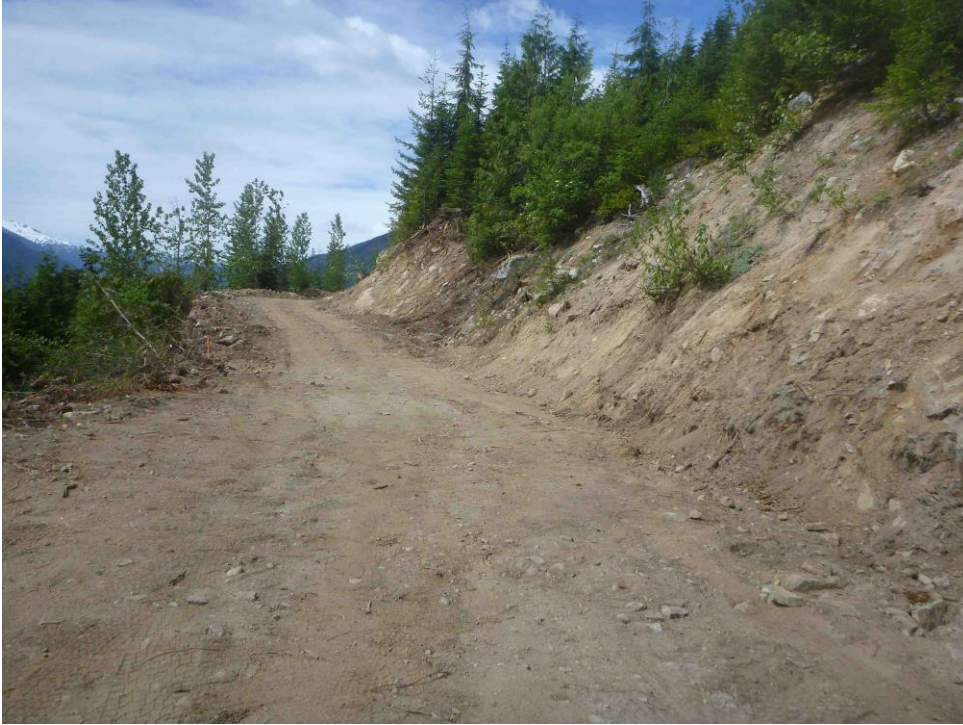
Figure 1: Area Cleared without AMBNS conducted before.

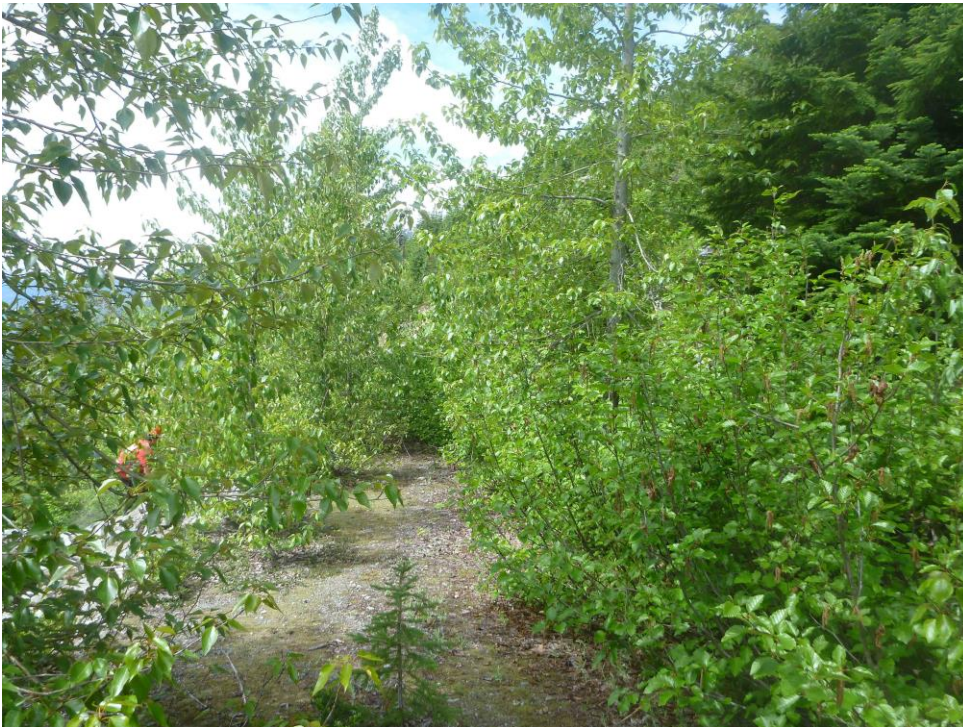
Figure 2: BDR HEF existing road just beyond clearing
