# Upper Lillooet Hydro Project

## Weekly Environmental Monitoring Report #38

Reporting Period: September 7 – September 13, 2014

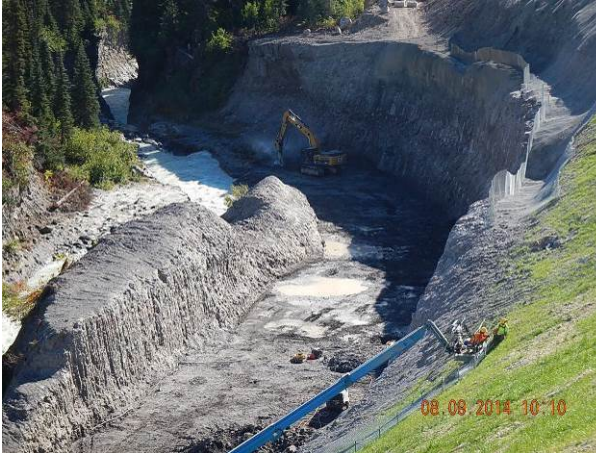
**Photo 1 – Continued excavation of ULRHEF intake diversion channel, river levels dropped (September 9, 2014).**

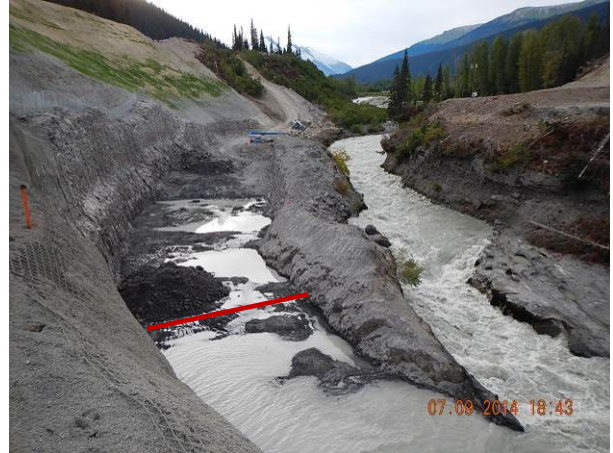
- On September 7, following subsequent days of warm weather and lower overnight temperatures typical of the fall season, river elevations at the downstream end the ULRHEF intake diversion channel were observed to be rising steadily throughout the day and peaking around midnight (Photo 2, 18:43). Due the backwatering effects into the works area, the contractor suspended works until such a time that river elevations dropped sufficiently to isolate the area. As marked on the redline in the photo, backwatering effect was isolated to the bottom quarter of the diversion channel and the pools observed above were a result of seepage from anchor drilling locations. On September 8, the IEM recommended that the seepage water be conveyed back to the river via a dewatering bag (Photo 3). As of September 10, water levels appeared to have stabilized below the downstream diversion channel elevation and works area remains adequately isolated. No environmental issues were observed. The IEM continued to be onsite full-time to monitor construction activities within 30m of the Lillooet River during day and night shifts.

**Photo 2 – ULRHEF intake diversion channel, backwatering due to elevated river flows (September 7, 2014)**

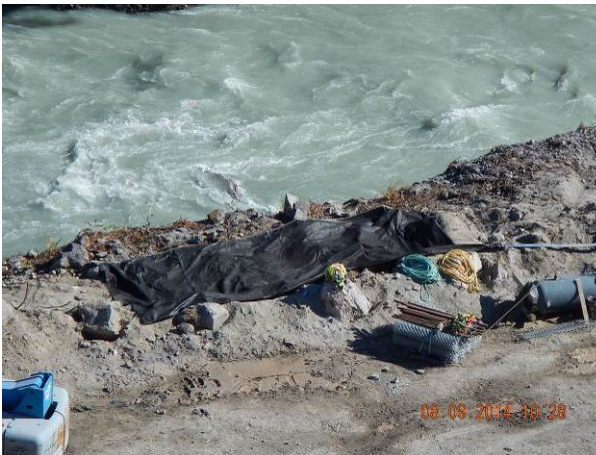
**Photo 3 – ULRHEF intake diversion channel, dewatering bag for seepage control (September 8, 2014).**

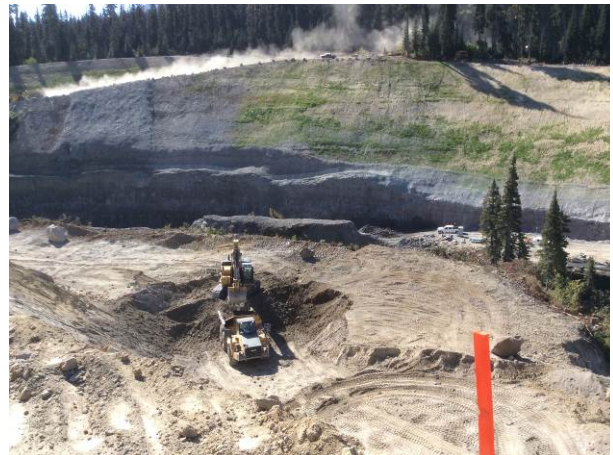
**Photo 4 – Continued bulk excavation at ULRHEF north side open cut (September 12, 2014).**

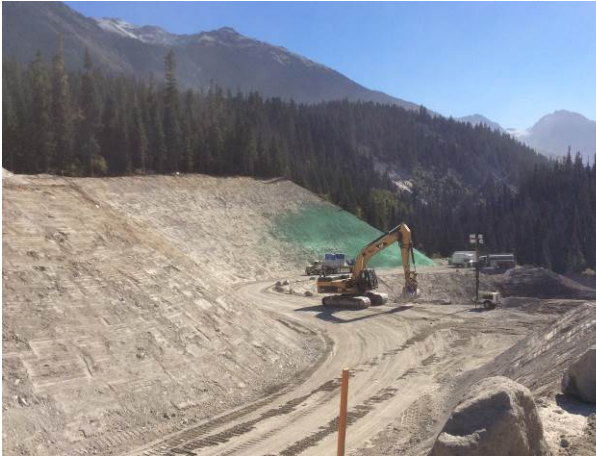
**Photo 5 – Hydroseeding on final slopes adjacent to ULRHEF intake north side open cut bulk excavation (September 12, 2014)**

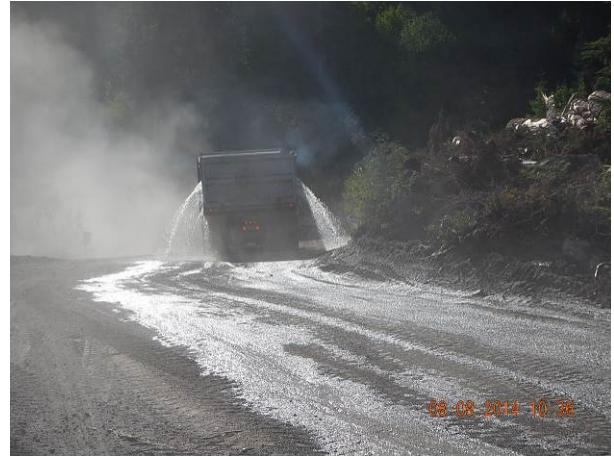
**Photo 6 – ULRHEF north side, dust control (September 8, 2014).**

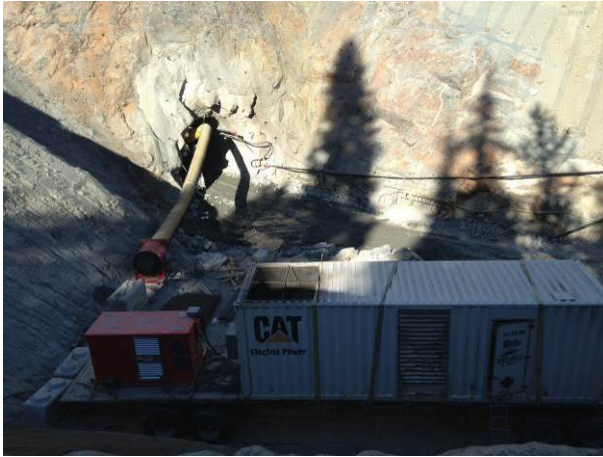
**Photo 7 – ULRHEF downstream tunnel portal (September 9, 2014).**

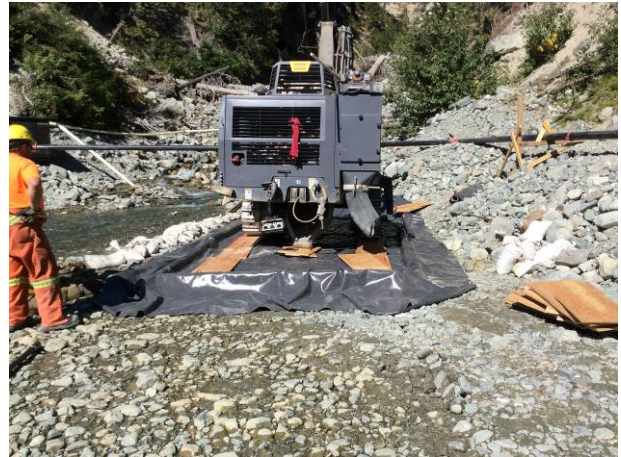
- No environmental issues were observed during geotechnical drilling adjacent to Truckwash Creek as adequate mitigation was in place. Sediment laden water created during drilling activities was isolated from the watercourse and conveyed to the settling ponds.
- Exposed cut slopes adjacent to the ULRHEF downstream tunnel portal were identified as requiring additional ESC protection (Photo 9).
- The settling ponds (Photo 10) installed adjacent to Truckwash Creek were used to treat the seepage and process water emanating from the tunnel. No surface discharge from the sediment ponds was observed this week; therefore no WQ measurements were taken by the IEM.
- Blast rock was hauled to the lower spoil area and managed according to the ULRHEF ARD/ML Monitoring and Control Plan.

**Photo 8 – Geotechnical drilling adjacent to Truckwash Creek, sandbag berm and secondary containment (September 12, 2014).**

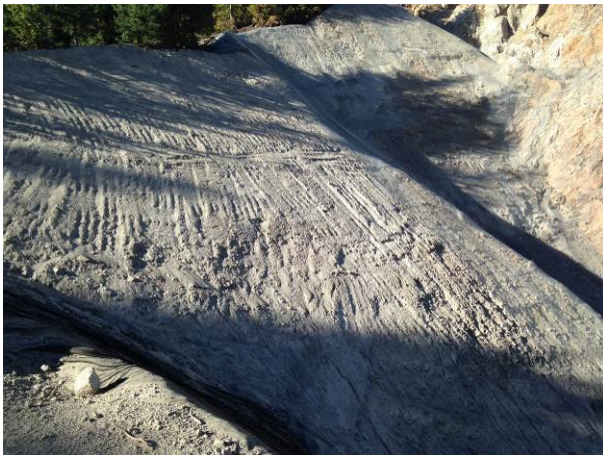
**Photo 9 – ULRHEF downstream tunnel portal cut slopes requiring hydroseeding or other erosion mitigation (September 9, 2014).**

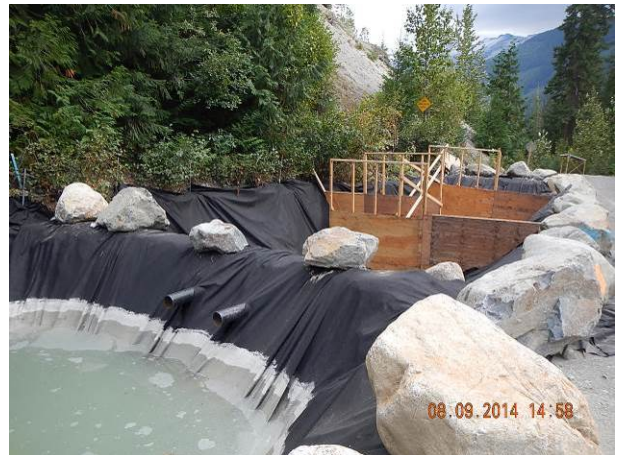
**Photo 10 – ULRHEF settling ponds, no discharge observed (September 8, 2014).**

- Settling ponds at the downstream portal should be continually monitored to ensure appropriate treatment of seepage from tunnelling activities is occurring. Although dry weather persists, rain events typical of the changing season may result in increased water volumes and current infiltration rates may result in discharge from the ponds. Further discussions were had with the contractor's Environmental Manager this week and it was agreed that pH treatment measures (in addition to those in place) would be explored in preparation for potential pond overflow conditions.
- Cut slopes directly adjacent to the ULRHEF intake have been identified by the IEM as requiring additional ESC protection. The contractor is aware and will be implementing measures in the coming reporting periods.

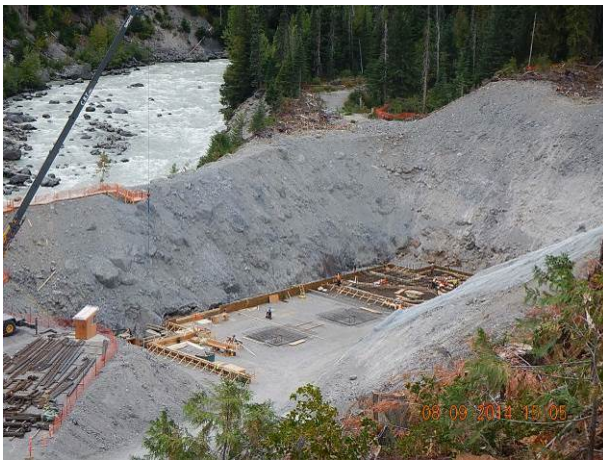
**Photo 11 – ULRHEF powerhouse rebar and formworks (September 8, 2014).**

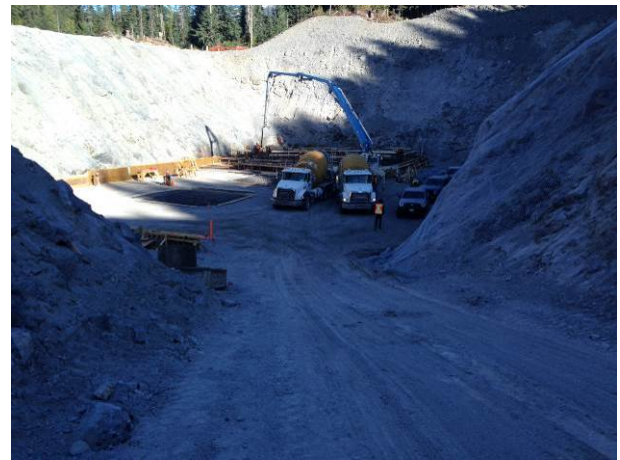
**Photo 12 – Concrete pour for ULRHEF powerhouse foundation (September 10, 2014)**

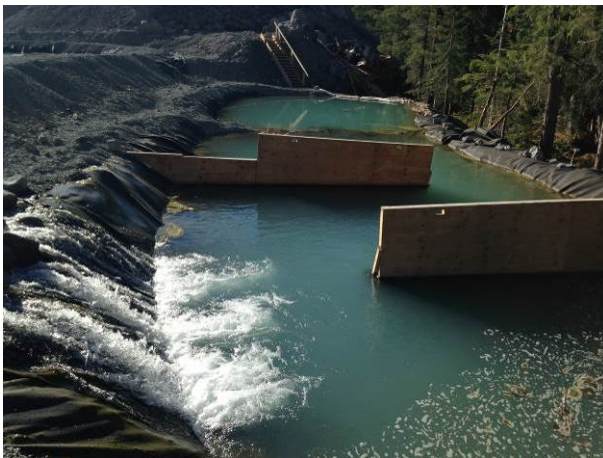
(Photo 13). No flowing surface water was observed within the excavation and pump capacity appears to be adequate to maintain isolation from active work areas.

**Photo 13 – Settling ponds at ULRHEF powerhouse, dewatering from excavation remains isolated from concrete works (September 10, 2014).**

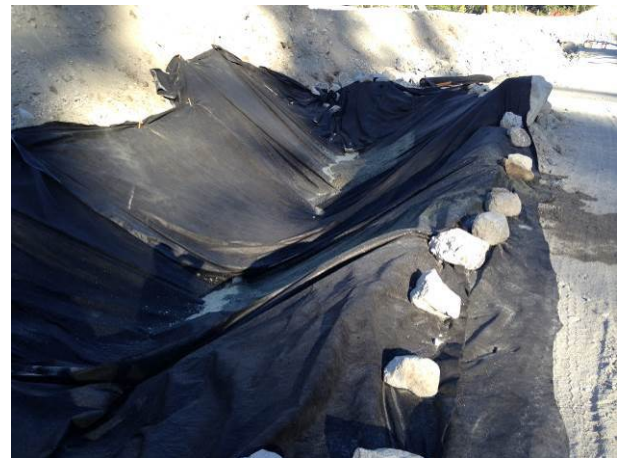
- A lined concrete wash out pit (Photo 14) was established along the ULRHEF powerhouse access road.
- No environmental issues were observed at the ULRHEF powerhouse during this reporting period.

**Photo 14 – Concrete washout pit along access road to ULRHEF powerhouse (September 10, 2014)**

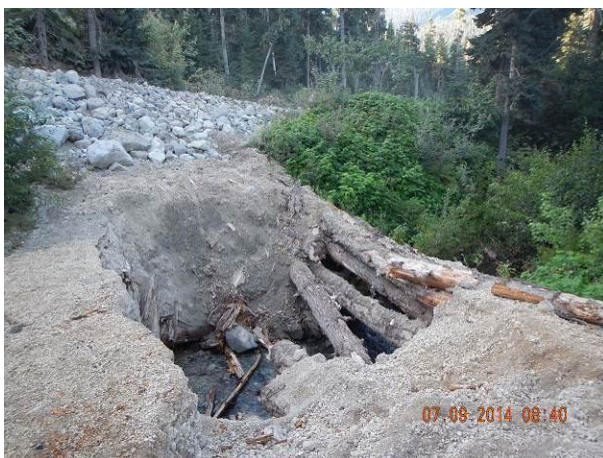
**Photo 15 – KM 47 log box culvert prior to repair works (September 7, 2014)**

Issue Tracking		Environmental Issue		Mitigation Measures			
ID No.	Status	Location	Issue Description	Action Taken/Recommended	Date of Identification	Targeted Date for Completion	Date Completed
ULR#4	Closed	47km – Lillooet River FSR	A log box structure failed while being crossed by an excavator (EIR002).	1. CE to prepare an EIR detailing the cause, description and actions items related to the incident.	May 23, 2014	May 26, 2014	September 11, 2014

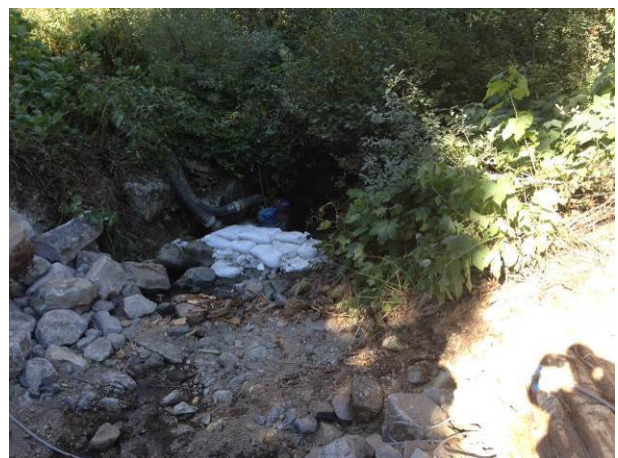
**Photo 16 – Sandbag diversion berm and two 6” pumps fitted with fish screens at KM 47 log box culvert repair (September 9, 2014).**

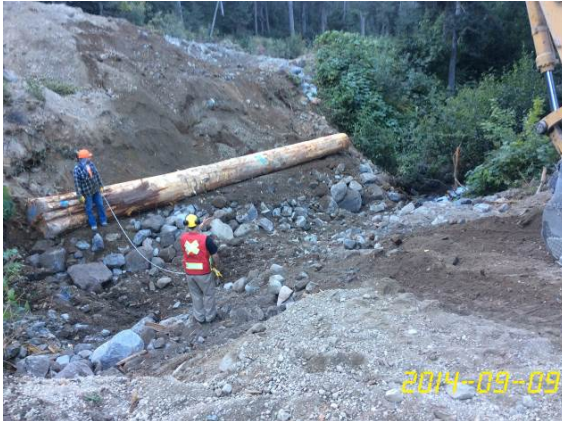
**Photo 17 – Lillooet River FSR KM 47 log box culvert repair, placement of abutment timbers in isolated works area (September 9, 2014).**

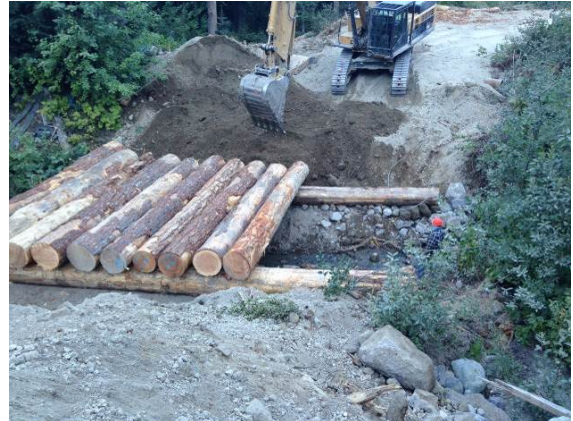
**Photo 18 – Lillooet River FSR KM 47 log box culvert repair, partial rewatering occurred once ISW were completed (September 10, 2014).**

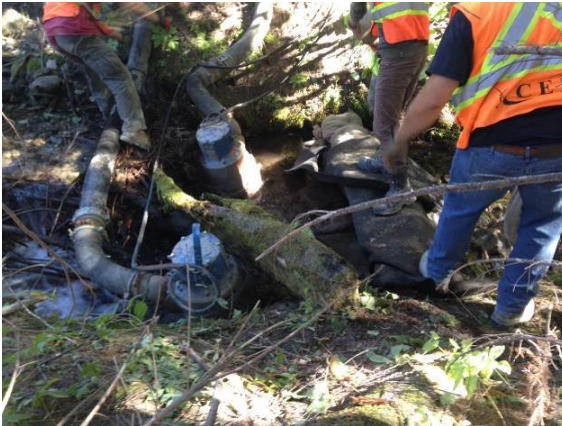
**Photo 19 – Lillooet River FSR KM 39.7 box culvert repair, sand bag diversion installation of two 6" pumps fitted with fish screens (September 11, 2014).**

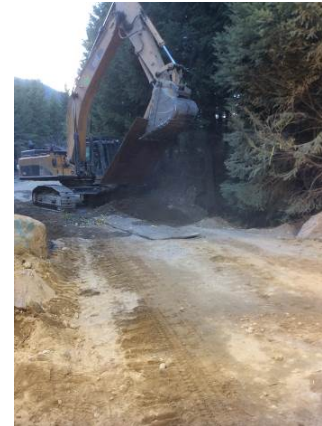
**Photo 20 – Lillooet River FSR KM 39.7 box culvert repair, removal temporary road plates (September 11, 2014).**

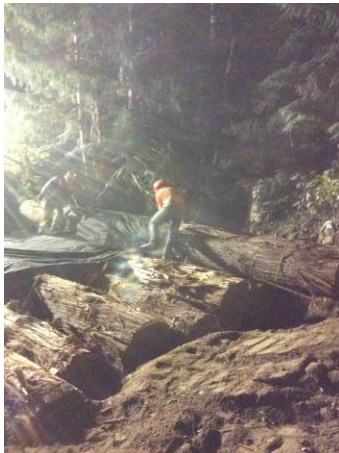
**Photo 21 – Lillooet River FSR KM 39.7 box culvert repair, abutment logs and stringer placement within isolated works area (September 12, 2014).**

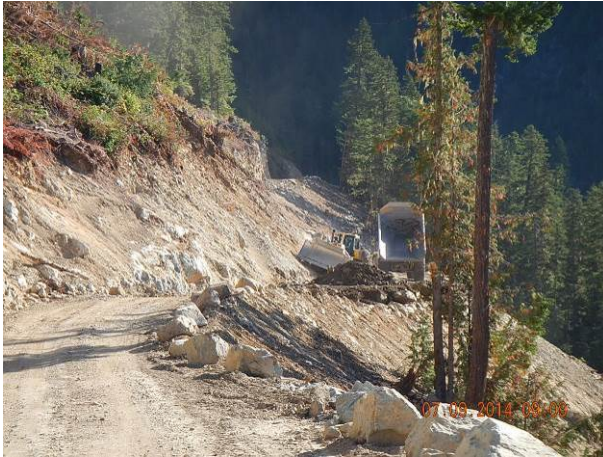
**Photo 22 – BDRHEF Intake access road construction (September 7, 2014)**

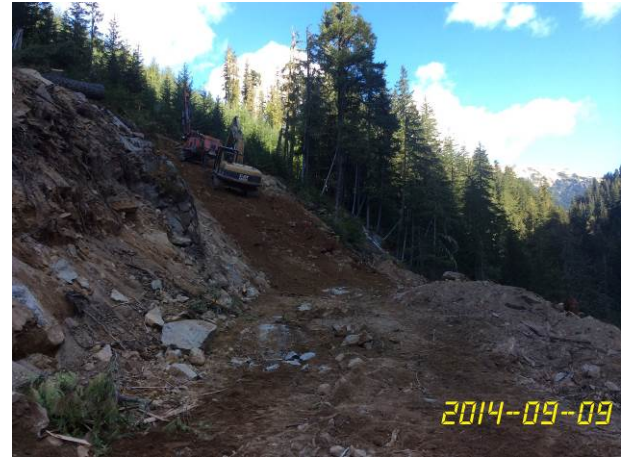
**Photo 23 – BDRHEF crane pad drilling and excavation at upper bench (September 9, 2014)**

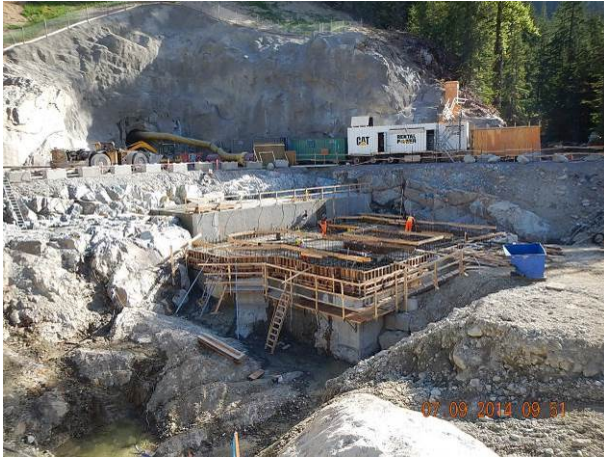
**Photo 24 – BDRHEF downstream tunnel portal and powerhouse rebar/formworks (September 7, 2014)**

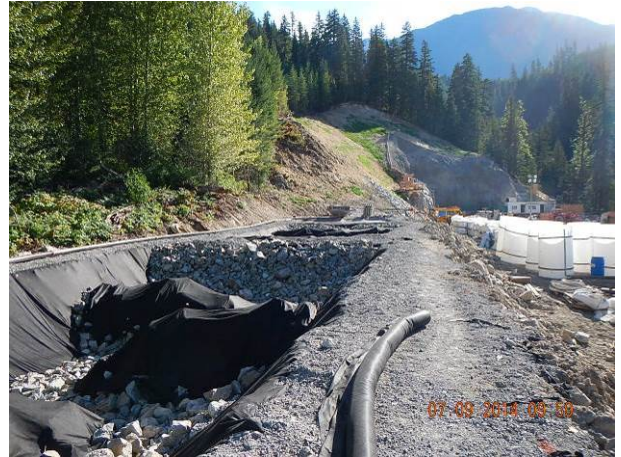
- Seepage flowing out of the tunnel continues to be collected at the portal tunnel entrance in a sump and this water is then pumped from the sump to the oil/water separator, pH adjustment holding tank, and settlement ponds for treatment. The pH was monitored daily by the contractor and a CO<sub>2</sub> diffuser was used as necessary to ensure pH was within acceptable surface water quality guidelines (pH 6.5 – 9). No discharge from the treatment ponds occurred during this reporting period (Photo 25); therefore, the IEM did not collect WQ results.

**Photo 25 – BDRHEF powerhouse settling pond, no discharge observed (September 7, 2014)**

Although dry weather persists, rain events typical of the changing season may result in increased water volumes and current infiltration rates may result in discharge from the ponds. Further discussions were had with the contractor's Environmental Manager on September 9 and it was agreed that pH treatment measures (in addition to those in place) would be explored in preparation for potential pond overflow conditions. Discussion also included a verbal commitment from the contractor's Environmental Manager to characterize the seepage slurry that is settling in the treatment ponds.

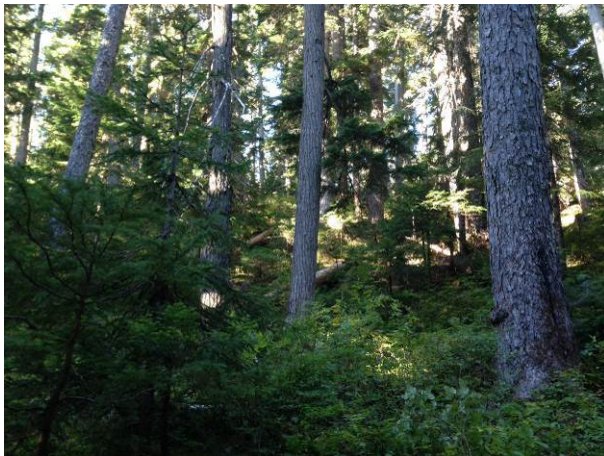
Photo 26 – Segment 14, hand falling within 100m CTF buffer near structure 340 (September 1, 2014).

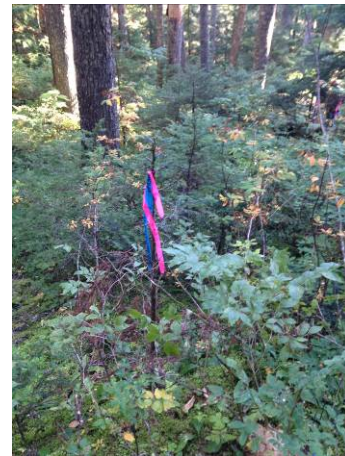
- The IEM was present as required when clearing activities occurred within 150m of wetlands, 15m RVMAs (30m for CTF streams, Photo 27), 100m of Coastal Tailed Frog Streams (Photo 26), Class 1 & 2 suitable Grizzly Bear WHA and/or suitable forage habitat, moose and deer UWR, and within legally designated Old Growth Management Areas (OGMAs). All flagged boundaries were respected during clearing activities. No environmental issues were observed.

Photo 27 – Segment 14, 30m RVMA flagging on CTF stream (September 11, 2014).
