Upper Lillooet Hydro Project

Weekly Environmental Monitoring Report #49

Reporting Period: November 23 – November 30, 2014

Cofferdam Construction Instream Works: Monitoring Report

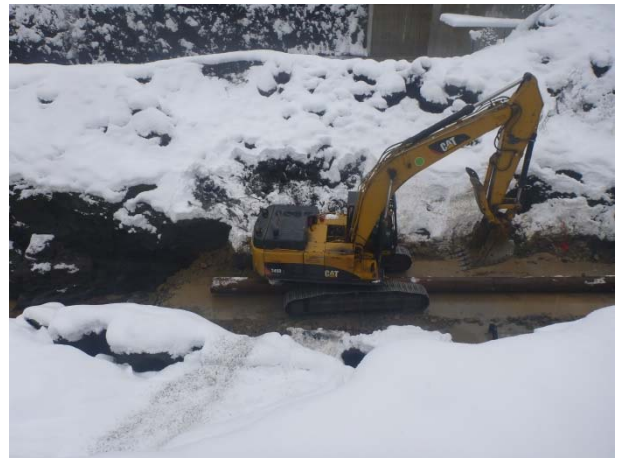
Photo 7 – ULRHEF upstream tunnel portion excavation filled with sediment laden water that was pumped during the cofferdam installation works. (November 25, 2014).

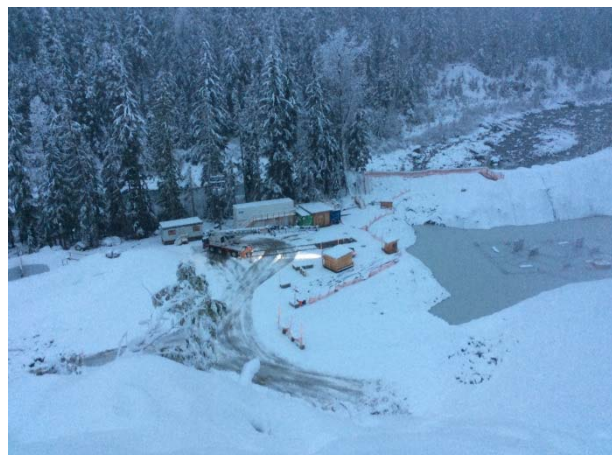
- The two pumps (6" and 10") previously installed in the sump draining seepage waters in the powerhouse excavation were removed once all equipment and materials were removed from the powerhouse foundation work area. Once the pumps were removed the area was naturally flooded by seepage water and ground water inputs. Winterization of the work area has been completed. Flooding of the powerhouse concrete structure presents no environmental concern.

Photo 13 – Final demobilization from the ULRHEF powerhouse site. Note the flooded powerhouse area. (November 26, 2014).

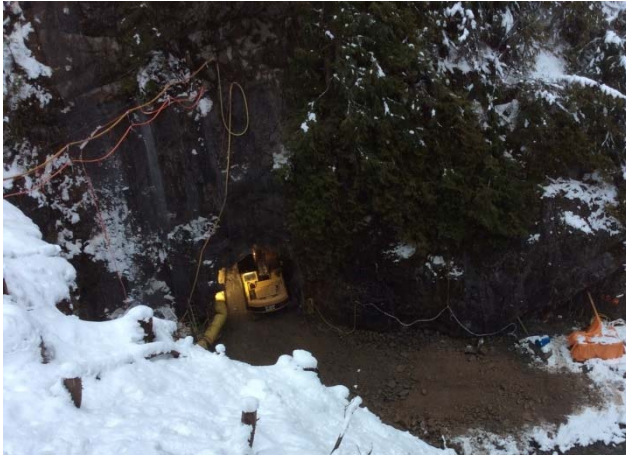
- Sequences of drilling, controlled blasts, and blast rock excavation continued on the top bench of the diversion tunnel until November 25 (Photo 14). The blast rock was placed in a crane bucket and hoisted to the crane pad for stockpiling. Care was taken to prevent material from entering Boulder Creek, and no environmental or water quality concerns were noted during this reporting period.
- All construction activities were suspended for the season on the morning of November 26, 2014.

Photo 14 – Excavator completing mucking activities inside the BDRHEF diversion tunnel excavation (November 25, 2014).

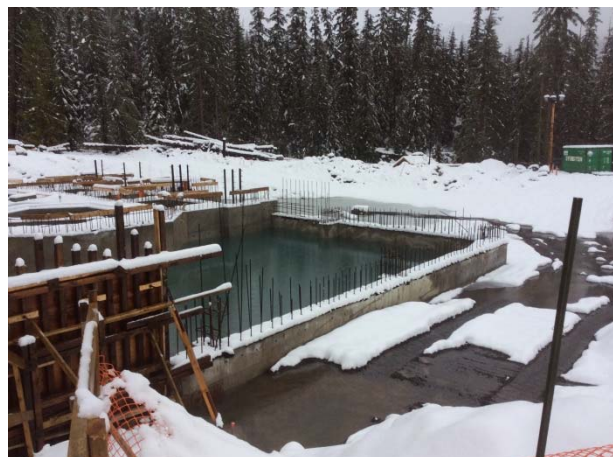
Photo 16 – Flooded BDRHEF powerhouse area following demobilization of dewatering equipment. (November 26, 2014).

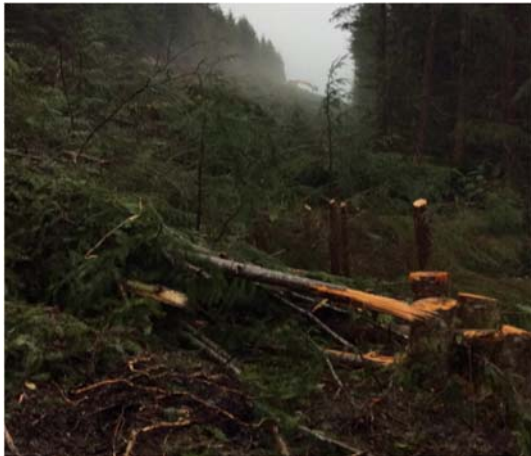
Photo 18 – Segment 8 RVMA clearing near structure 192 (November 24, 2014)

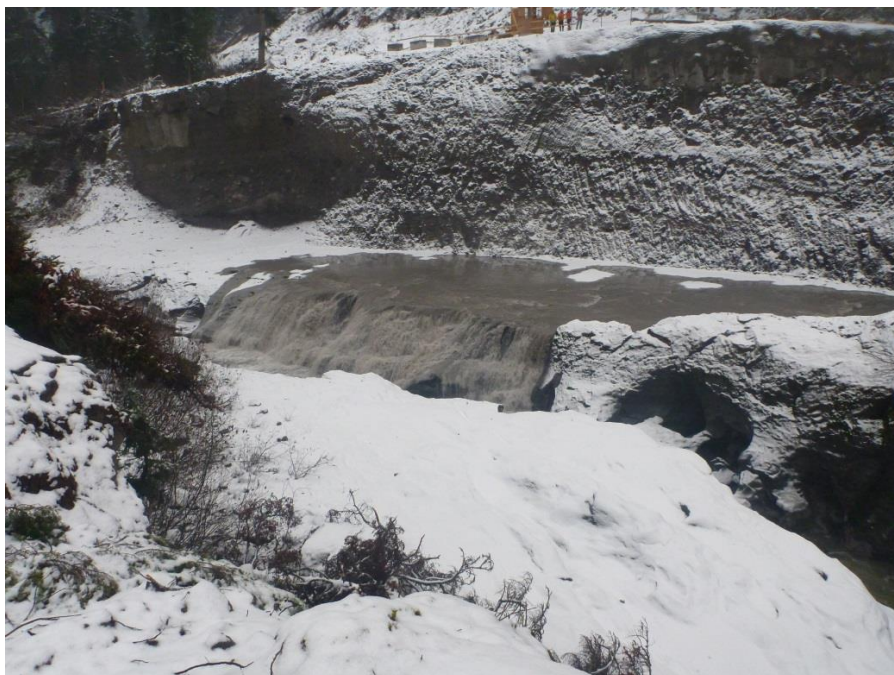
Figure 6. The initial flooding of the temporary diversion channel resulted in a significant flush of suspended sediment and turbidity which coincided with the flow stage change induced during the switch.

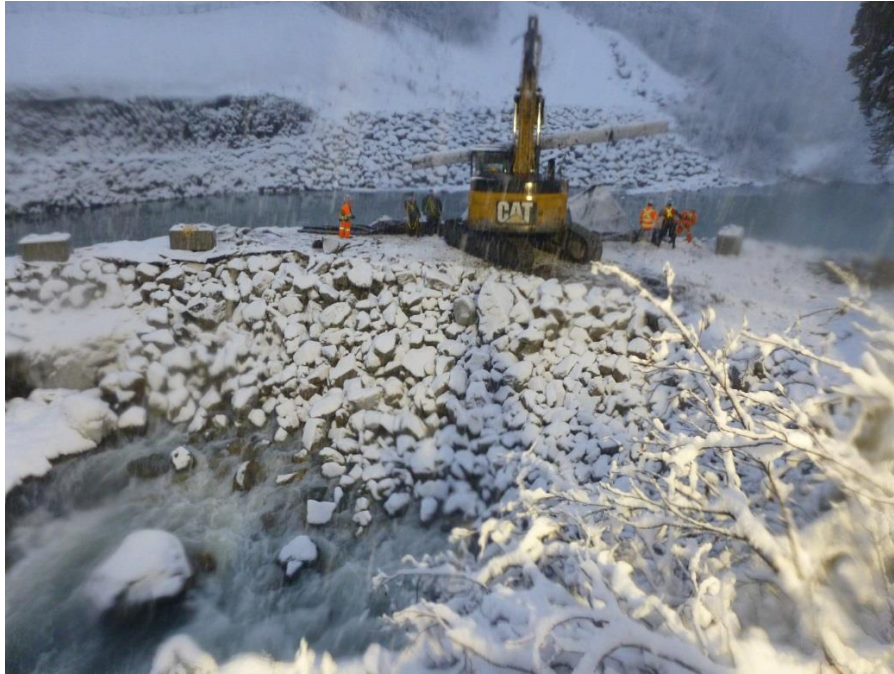
Figure 9. The first installation of the geomembrane did not reduce flows downstream of the cofferdam sufficiently, requiring an alternative methodology.

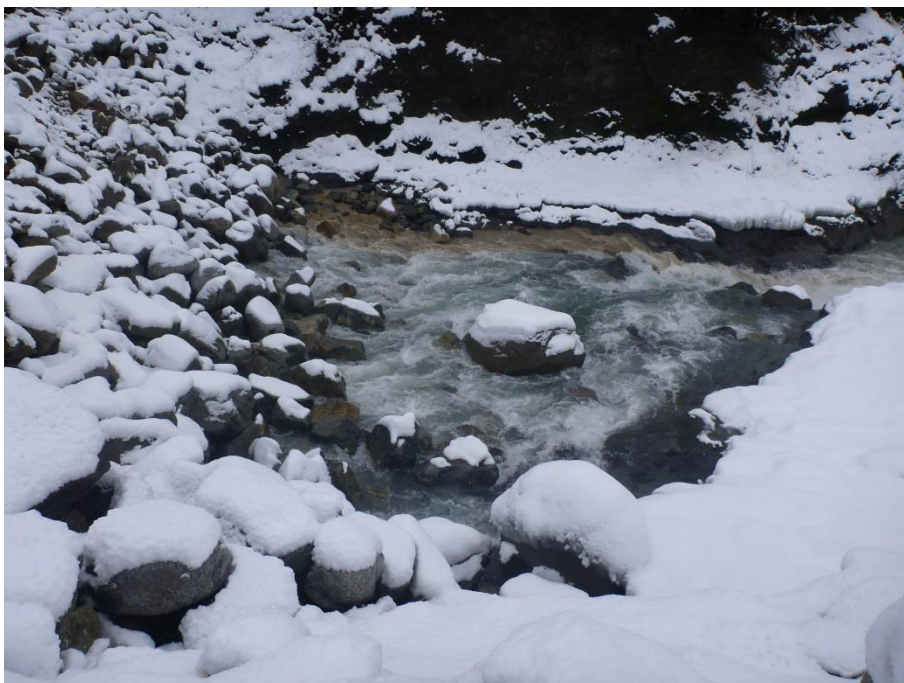
Figure 12. Placement of this material resulted in a short duration release of turbidity from river left.

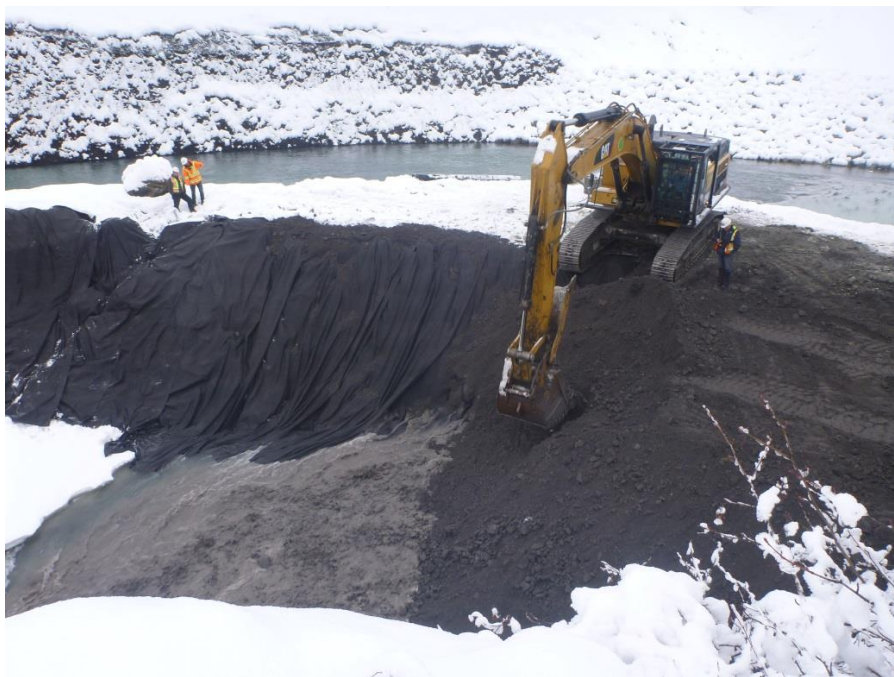
Figure 16. Installation of the fine material backfill began at river left and a full cofferdam width was packed in before proceeding section by section across the channel. The flows through the rock fill resulted in material washing out, elevating turbidity downstream.

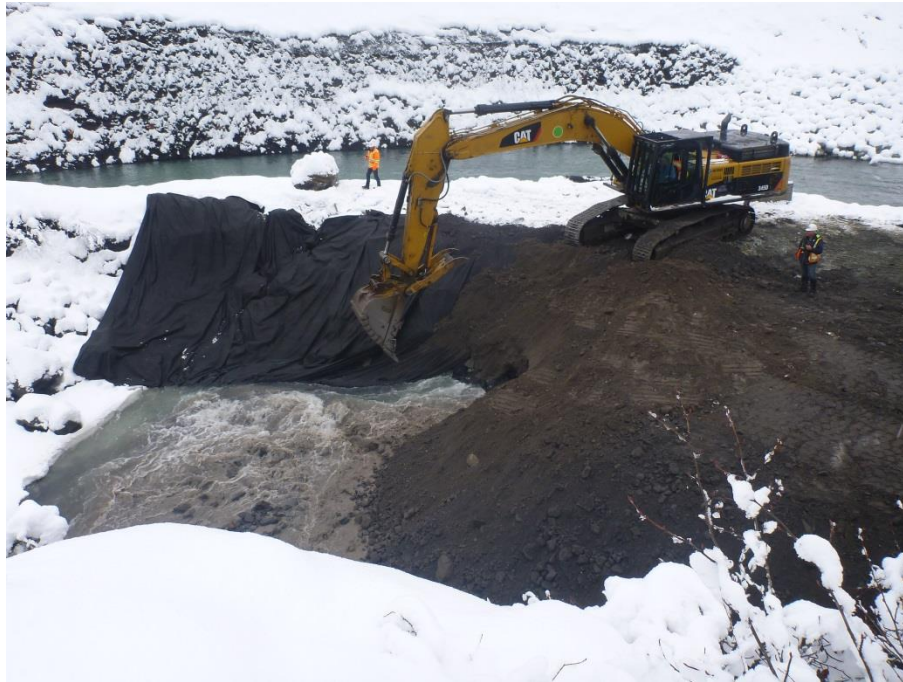
Figure 19. As works progressed across the channel fine material was sloughing out from the bottom of the cofferdam, requiring fast work and additional material.

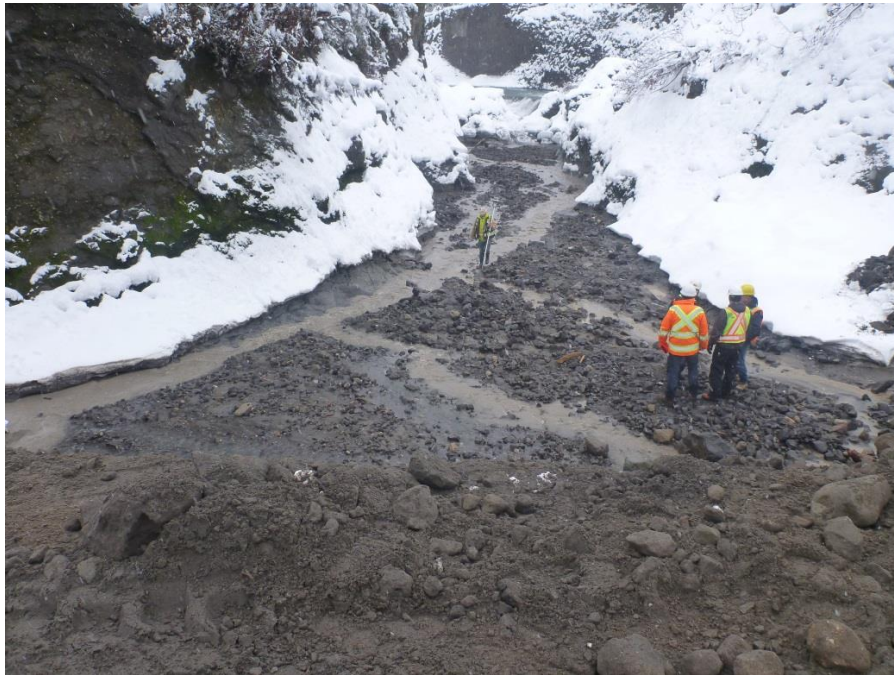
Figure 21. View downstream from the top of the cofferdam along the dewatered natural river channel. Small volumes of seepage are visible from the right and left corners of the cofferdam.

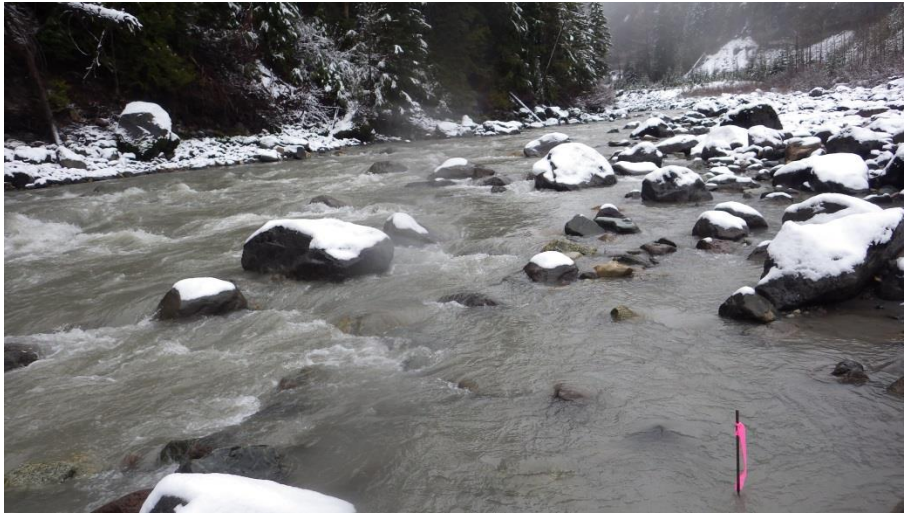
Figure 54. Elevated turbidity at site DSSD03 during infill of fine material at the cofferdam upstream.
