Upper Lillooet Hydro Project

Weekly Environmental Monitoring Report #94

Reporting Period: May 8 – May 21, 2016

Upper Lillooet River Hydroelectric Facility (Water File No. 2002561, Water licence No. C130613), Boulder Creek Hydroelectric Facility (Water File No. 2003049, Water licence No. C129969) & Transmission Line (TX Line)

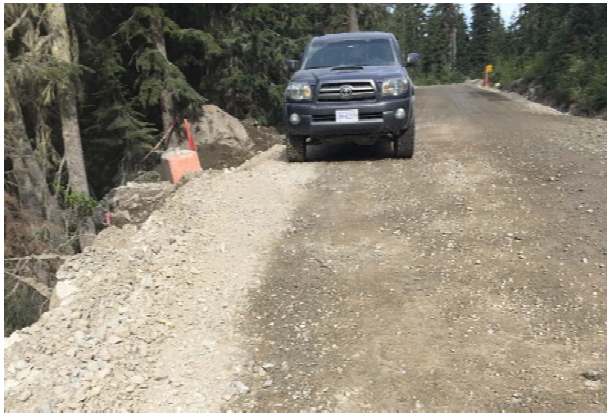
Photo 1– Dust suppression applied to control fugitive dust (May 15, 2016).

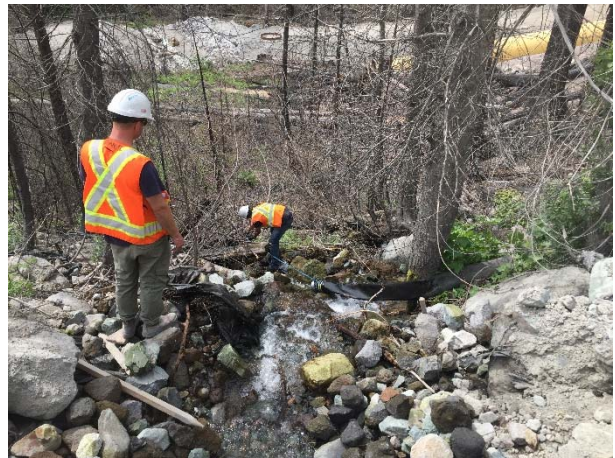
- Following a pre-work meeting on May 17, Ecofish installed CTF exclusion fencing and performed a CTF salvage in ASTR-04 in preparation for the removal of the compromised woodbox culvert (Photo 2; ULR#50). Bypass pumps were installed following the CTF salvage and were tested during the day shift. The culvert work area was dewatered in the presence of CE's QP (Ecofish). The work to remove and replace the culvert was completed on night shift to maintain access to the penstock alignment throughout the day shift. As the

Photo 2– Ecofish conducting a CTF salvage in ASTR-04 (May 17, 2016).

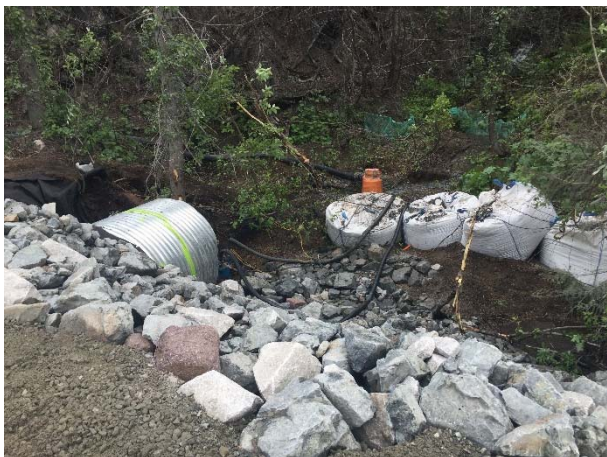
Photo 3 – ASTR-04 culvert installed outside of the natural channel alignment (May 18, 2016).

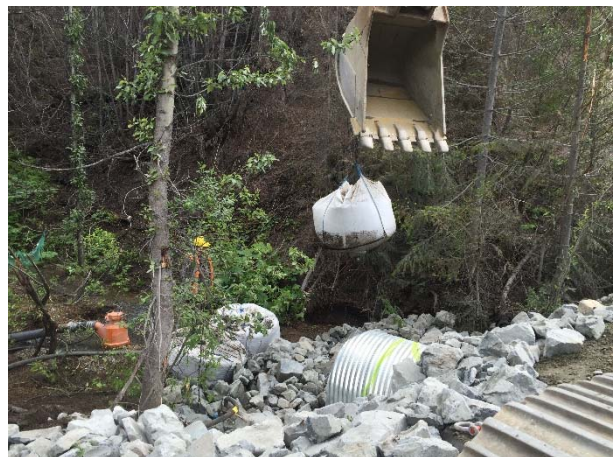
Photo 4– CE removing sand bags causing initial flush during commissioning of the new ASTR-04 culvert (May 20, 2016).

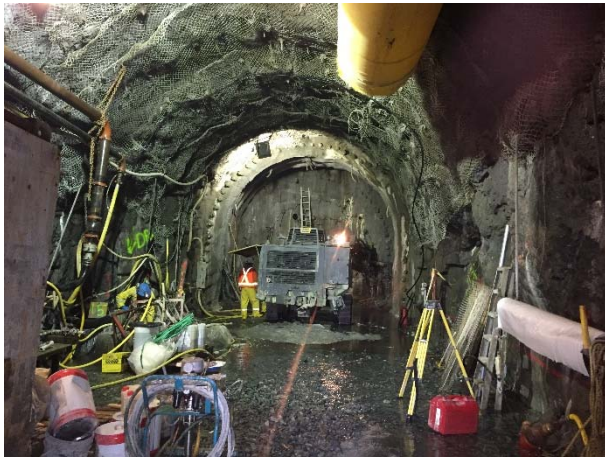
Photo 5 – Drilling probe holes into the grouting tunnel face prior to beginning mechanical excavation (May 10, 2016).

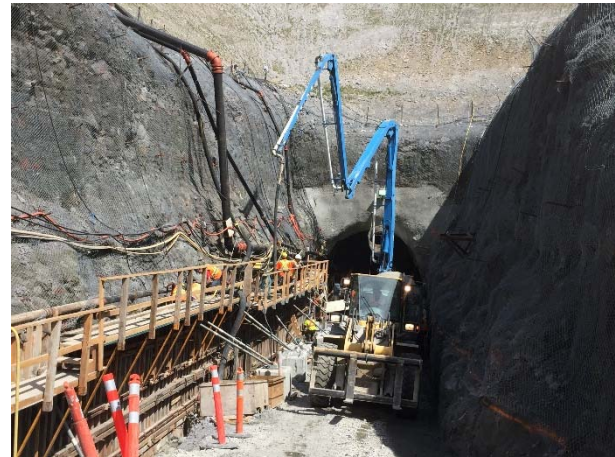
- On May 9 at the start of the concrete arch foundation wall pour, water discharged to the Lillooet River temporarily exceeded BCQWG for both turbidity and pH. The exceedance was caused when clean water flowing down the ramp, encountered concrete that was spilled from the first concrete mixer truck as it backed down the ramp. The water then flowed down the ramp and into the isolated clean water sump, which was discharging to the Lillooet River. CE immediately redirected this water to the water treatment system. Discharge of turbid and high pH water lasted approximately 10 minutes. Once water quality in the clean water sump was within BCQWG, the pumps were directed back to the Lillooet River and water quality was monitored by the IEM for the duration of the concrete pour. Due to the nature and short duration of this event, a mixing zone sample could not be taken until after the mitigation had been completed, at which time water quality at the mixing zone (Keyhole Bridge) was within BCQWG. However, it is unlikely that this discharge resulted in any instantaneous or long-term negative impacts.

Photo 6 – Concrete arch foundation wall (BEBO) concrete pour (May 11, 2016).

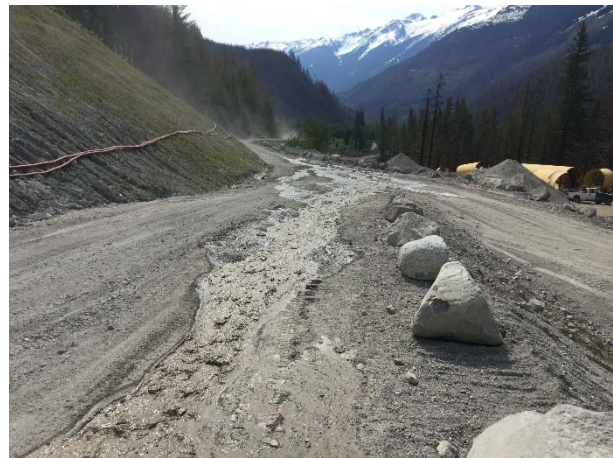
- On May 15, the active water treatment system failed twice when pumps lost power, causing the system to overflow onto the access road and transport of an unknown volume/quantity of sediment-laden water/material to ASTR-03 (Photo 10; EIR#022). Remedial actions items completed by CE included replacement of blown fuses, installation of a new and backup

generator to replace the original rental unit, and the assignment of a night watch person to provide continual monitoring of treatment system function. Due to the multiple failures that occurred in the first week of operation of the active water treatment system, the IE requested that CE update their protocols surrounding shut-off procedures for all water treatment systems onsite in the event of a future problem or should water being treated exceed BCWQGs at the outlet. The IE's request will be tracked in the ITM list as ULR#54. In addition the IEM requested that CE prepare an environmental incident report (EIR) for both events for submission to agencies once complete. The completed report is appended to this environmental monitoring report. Additional water quality sampling results are available upon request.

Photo 10 – Erosion and overland flow resulting from a power failure that caused the water treatment system to overflow and contribute elevated pH and turbid water to ASTR-03. The incident was reported as EIR#22 (May 15, 2016).

- CE should regularly monitor the new water treatment system installed to treat water emanating from the downstream tunnel to ensure the system is functioning as intended and that discharge into ASTR-03 continues to meet BCWQGs. The water treatment system capacity should be regularly assessed to ensure the system can handle the necessary volumes of water and to prevent discharging process water above BCWQGs offsite. An assessment of the Lillooet River Trail should be performed to determine the extent of erosion caused by water discharging offsite once the snow melts from the area.

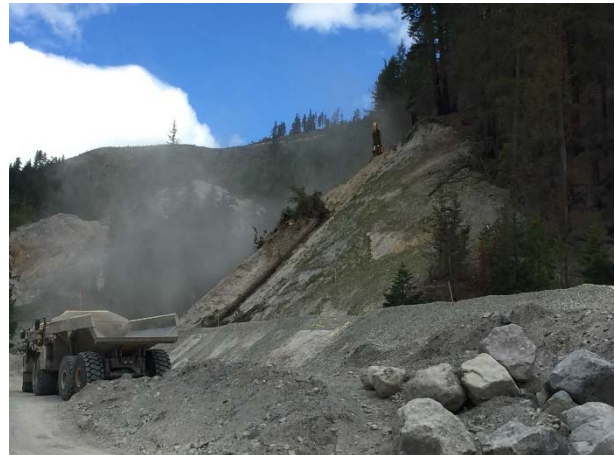
Photo 12 – Removing trees at the top of the cut slope above
the penstock alignment on the left bank of Truckwash Creek
(May 12, 2016).

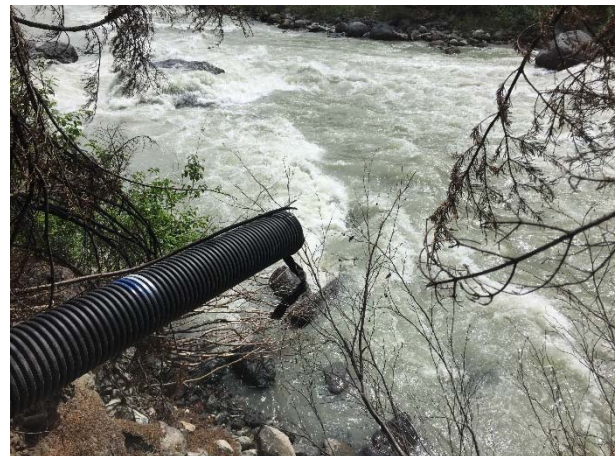
Photo 16 – Discharge to the Lillooet River from the water treatment system (May 15, 2016).

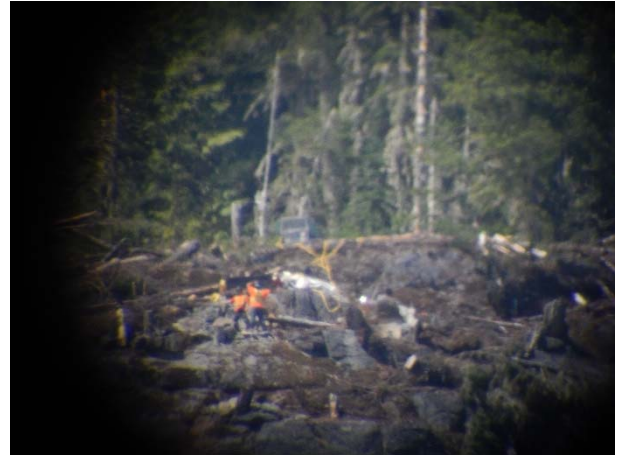
Photo 24 – Worker observed thru the spotting scope and within 500m of UWR (Segment 15; May 13, 2016).

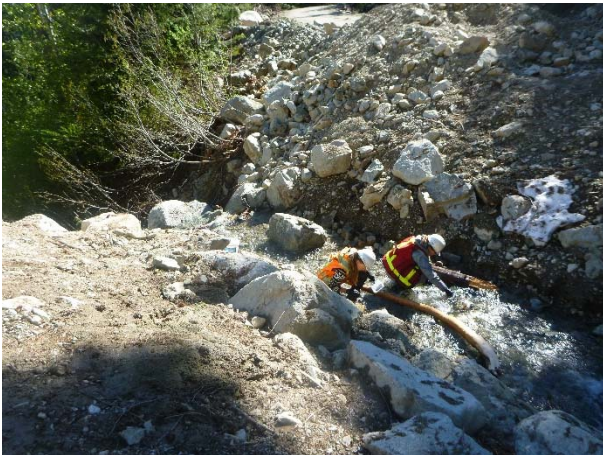
Photo 25 – Precautionary CTF salvage in stream 272a prior to performing a one-time crossing with an excavator equipped with bio-oil (Segment 11; May 10, 2016).

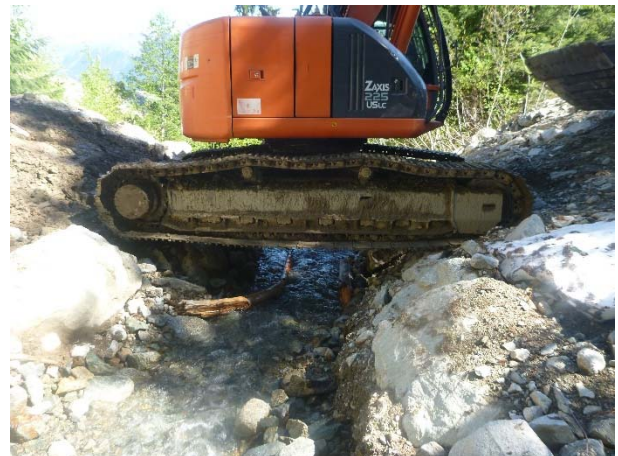
- Instream works associated with the bridge installation was limited to a one-time wetted crossing of the watercourse to permit the construction of the woodside approach, footing, and placement of riprap armouring up to the wetted perimeter. Water quality sampling was performed during these works and two brief turbidity pulses were generated. The first pulse was generated when a bit of the bank collapsed under the excavator track during the crossing. The maximum turbidity generated was 1905 AU but it attenuated quickly and water quality returned to 8.62 NTU within 15 minutes. The second pulse occurred during riprap placement used to shore this section of the bank. A brief pulse with a maximum turbidity of 13.9 NTU was generated and returned to 5.80 NTU within five minutes.

Photo 26 – Excavator performing one-time crossing of stream 272a (Segment 11; May 10, 2016).

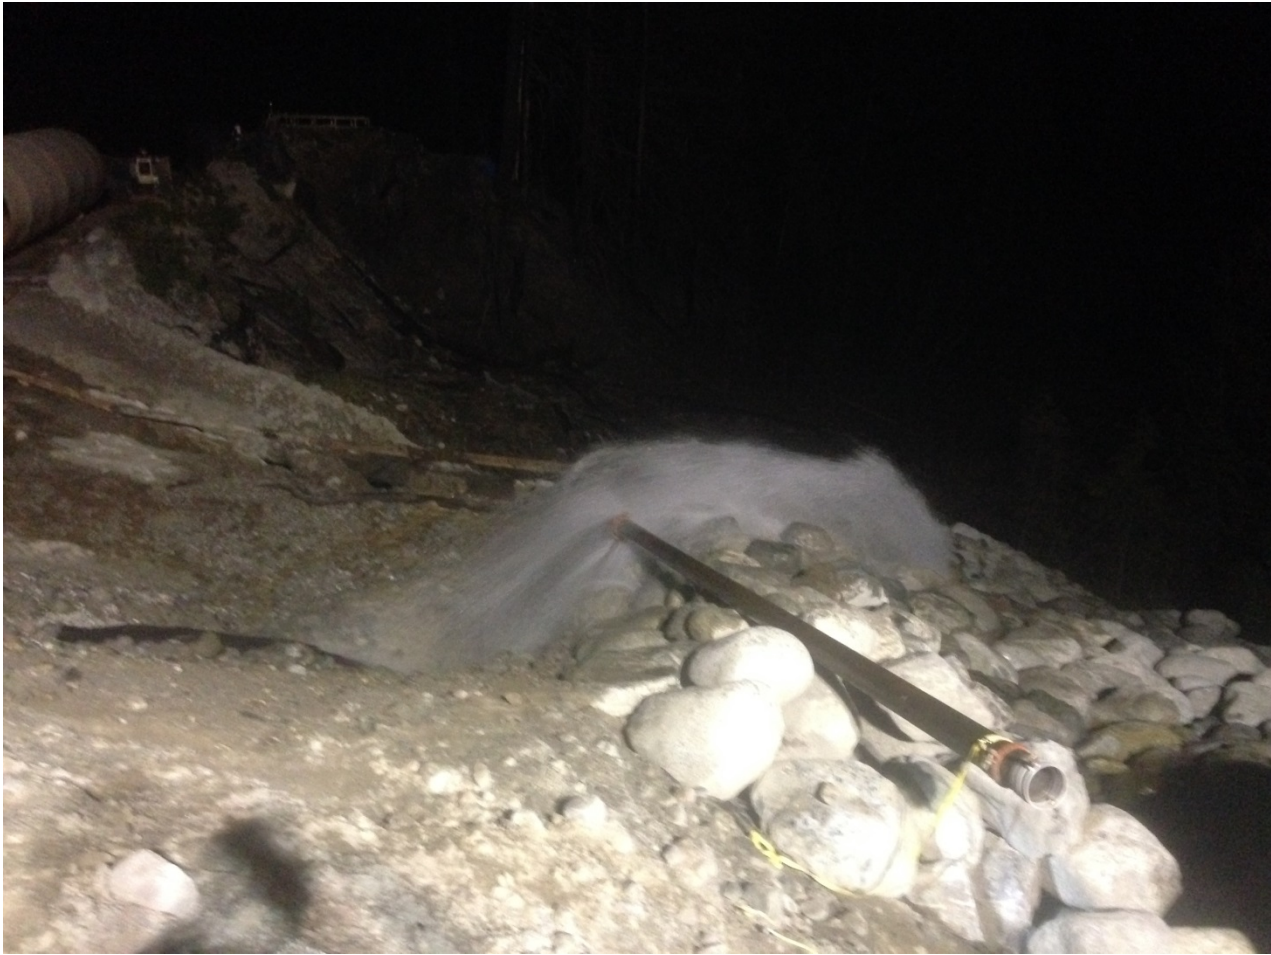
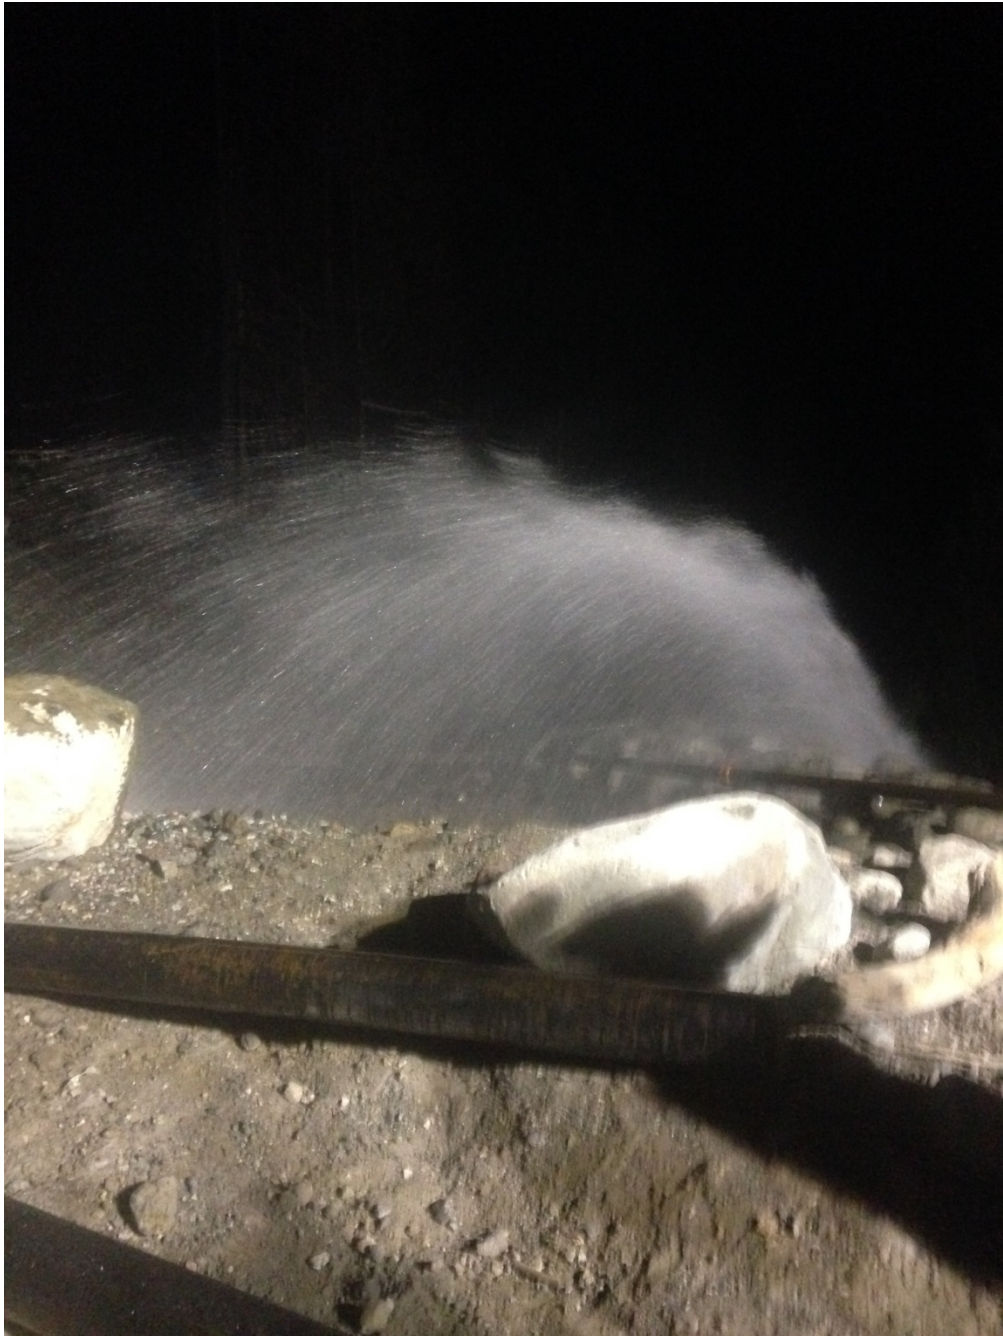
<input type="checkbox"/> Snow
Specific Location: On the penstock, near Astr-03			
Description and Cause of Incident:			
<p><u>Description:</u> A large rock was initially used to anchor the discharge hose in the riprap. After multiple pumping cycles the anchoring rock was dislodged and the hose pulled out of the riprap and redirected to the road and penstock fill. Discharging water eroded the penstock fill and conveyed large quantities of sediment to ASTRO3. A large volume of sediment was directly conveyed to Astr-03 and washed down stream. It is unknown if turbid water was discharged to the Lillooet.</p> <p>The incident was identified by the Stormtec technician who immediately called for assistance. This was around 10:00 PM. Joshua Zandbergen, from Innergex, heard the call and went on site. He asked our CSO Angel Orejas to get someone from the environment team on site asap. Jean M. Pelletier, Sr Env. Manager was on site at 10:45 PM. The night foreman assisted by 2 labors managed to re anchor the hose. J. Pelletier and J. Zandbergen watched the pump being turned on again and the situation was resolved. It was about midnight. Alex, from Stormtec, confirmed that the water being discharged was very clean, turbidity reading at 1.4 NTU</p> <p><u>Cause:</u> The root cause of the incident was that the discharge hose was not properly anchored.</p>

spraying on the night of the incident

2. Water spraying on the night of the incident

1. Response by CRT-EBC was rapid: workers and supervisor were on site within 45 minutes
2. This rapid response helped mitigate further damage.

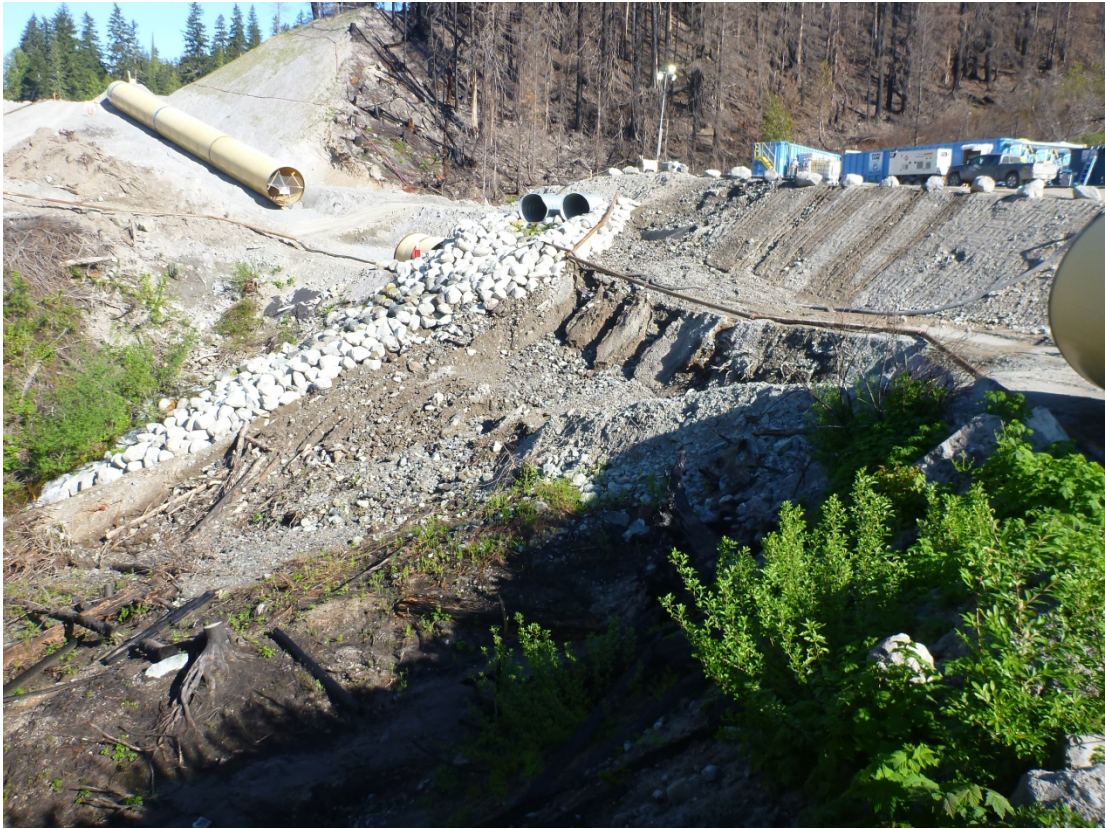
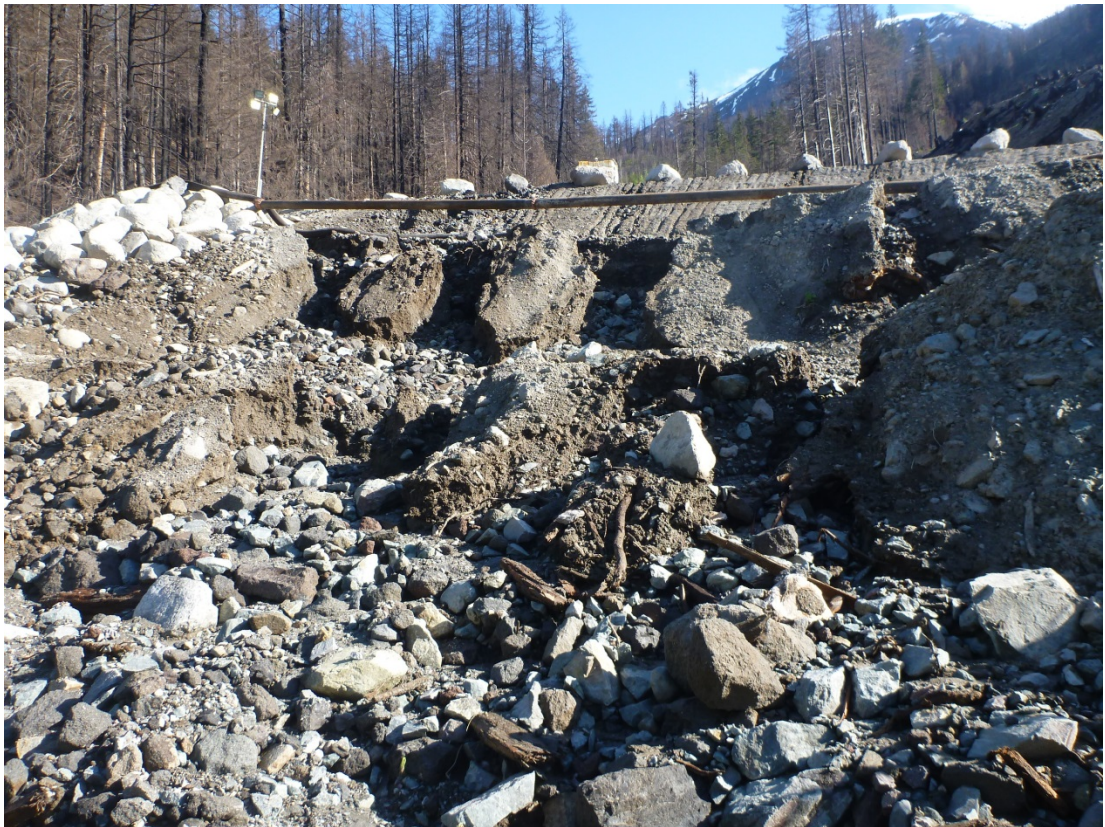
3. Extend of the erosion as seen daytime the next day.

4. Another view of the erosion on site.

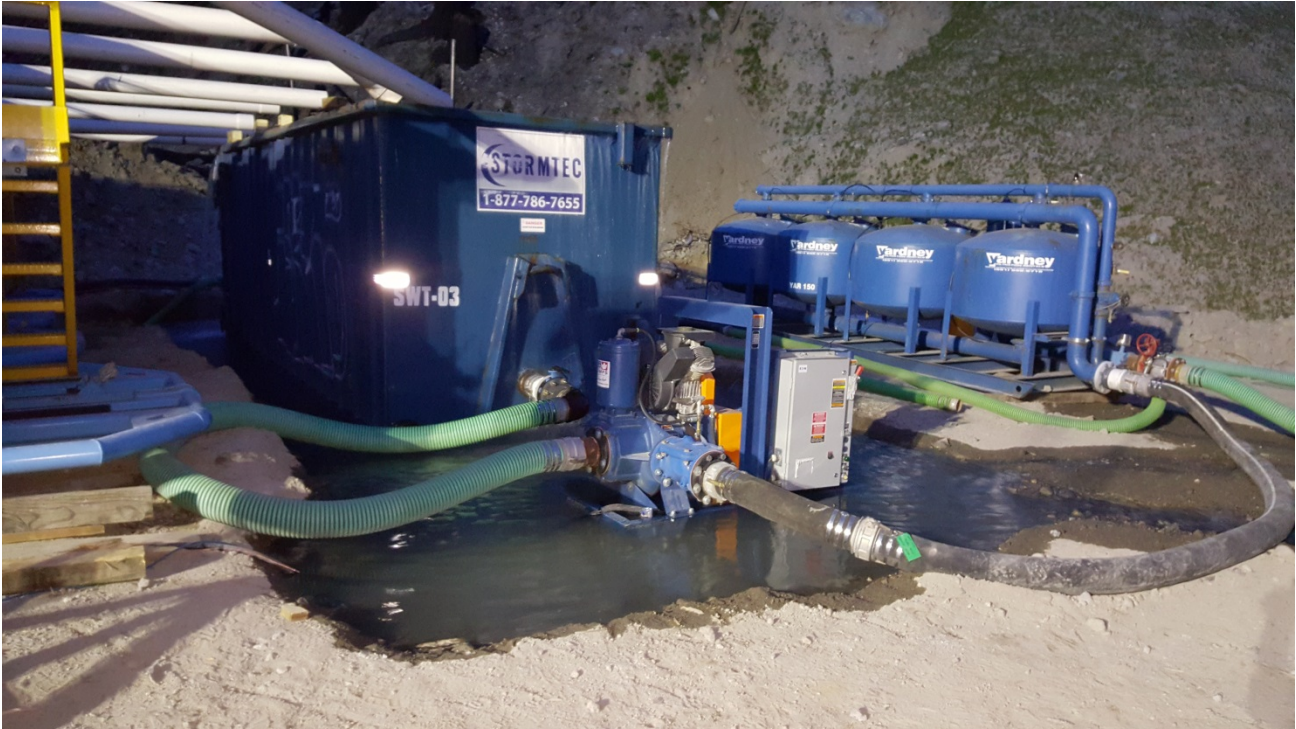
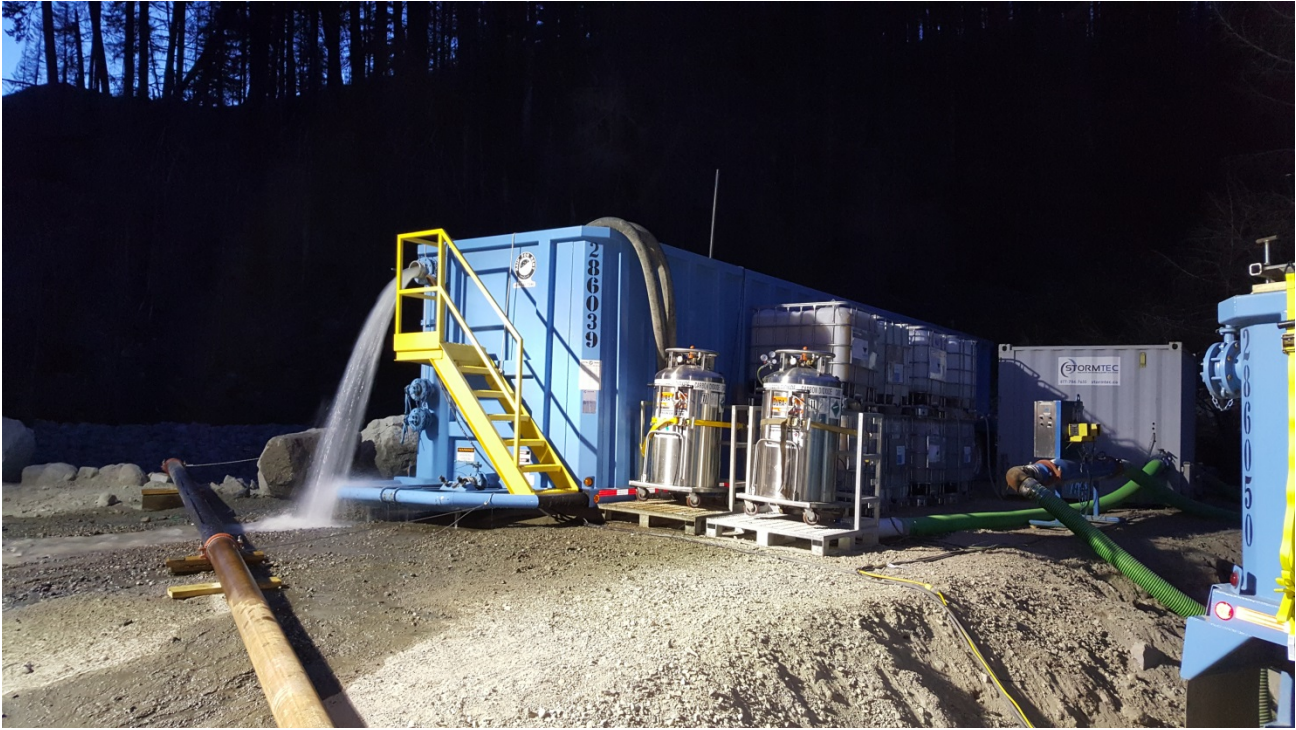
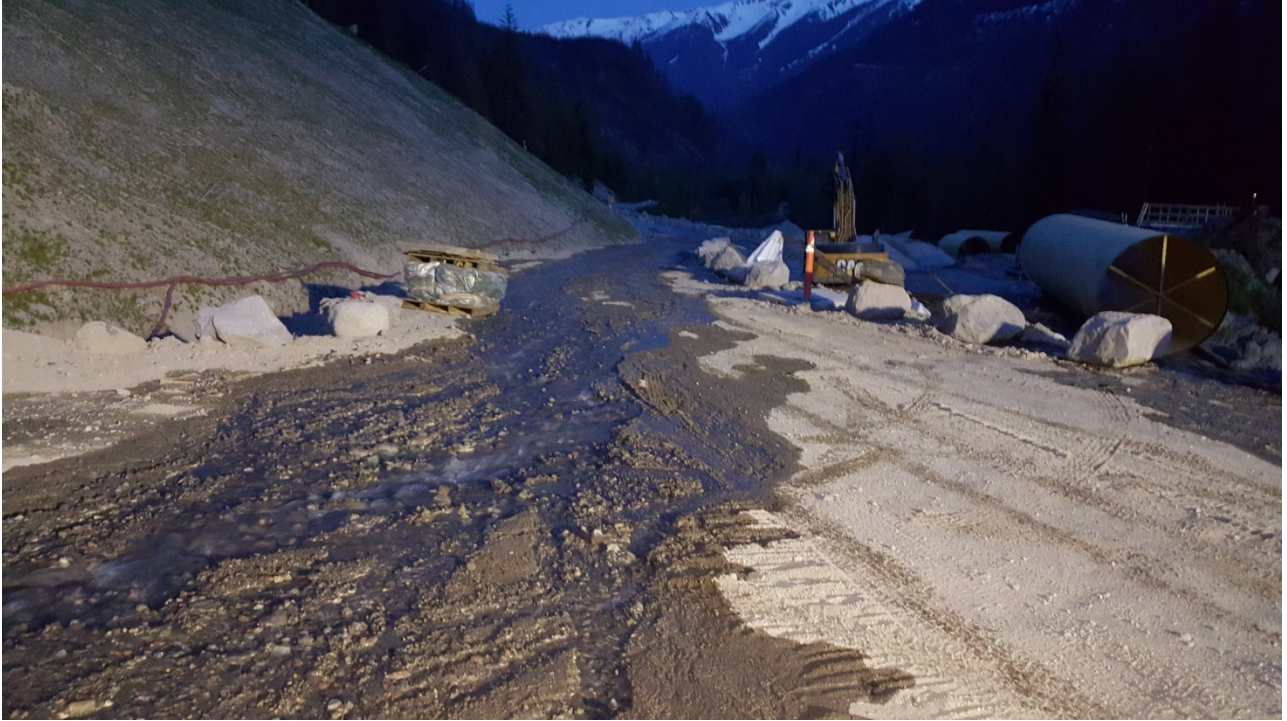
<input type="checkbox"/> Snow
Specific Location: On the penstock, near Astr-03			
Description and Cause of Incident:			
<p><u>Description:</u> Around 9:20 PM on the night of May 6th, one of our workers noted that water was overflowing from the Stormtec Water Treatment System (SWTS) near 42.5 km. The generator for the WTS had stopped. He immediately called for a mechanic and an electrician. The generator was started again and the situation was resolved within the hour.</p> <p><u>Cause:</u> The root cause of the incident was that the generator stopped working. However, we do not know why the generator stopped working. A service call has been made to the manufacturer.</p>

1. Flooded area near the sand filters

2. Water treatment tank overflowing

3. Water flowing down Truckwash access road

1. The generator is now closely watched.
2. Actually, 2 solutions are been analysed: The first solution is to connect the WTS to BC Hydro grid with a generator back up in case of power outage. The second solution is to connect the WTS to a new generator with a second generator ready to start if the first one fails. Both solutions require transformers. The transformers should be delivered shortly. The set-up will be done as soon as we get the generator.

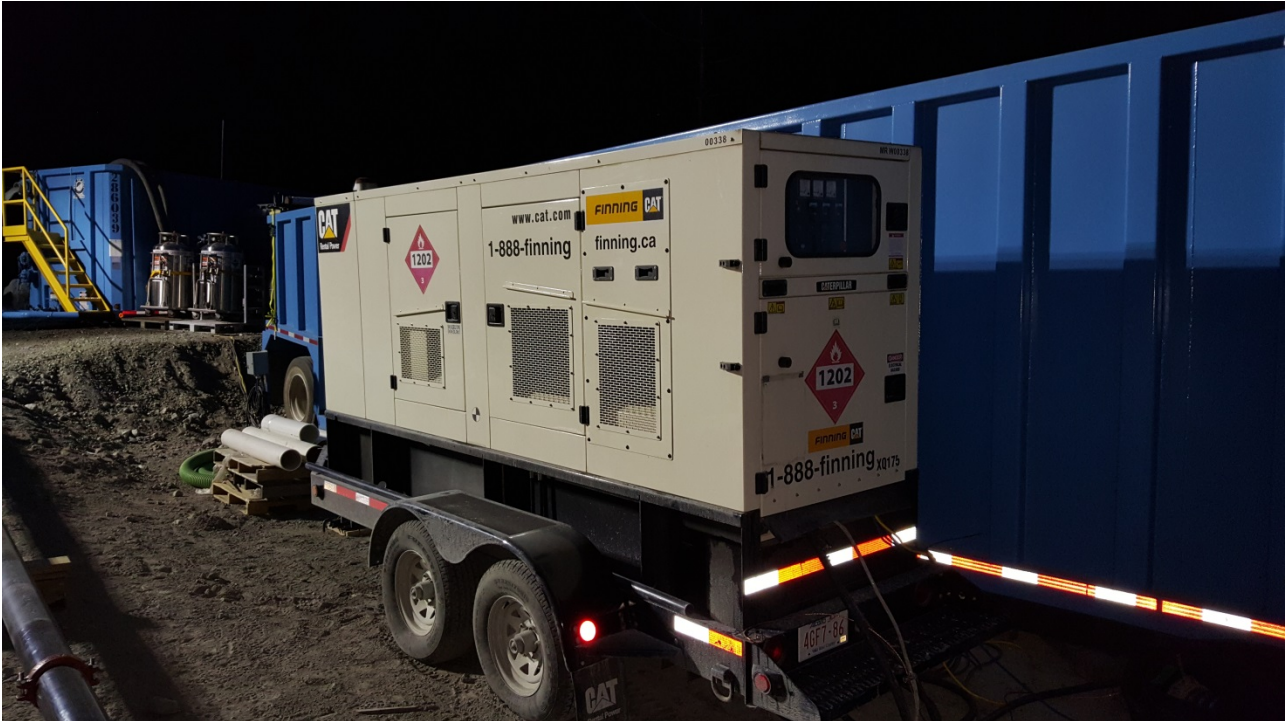
4. The generator at fault
