Upper Lillooet Hydro Project

Weekly Environmental Monitoring Report #98

Reporting Period: July 03 – July 16, 2016

Upper Lillooet River Hydroelectric Facility (Water File No. 2002561, Water licence No. C130613), Boulder Creek Hydroelectric Facility (Water File No. 2003049, Water licence No. C129969) & Transmission Line (TX Line)

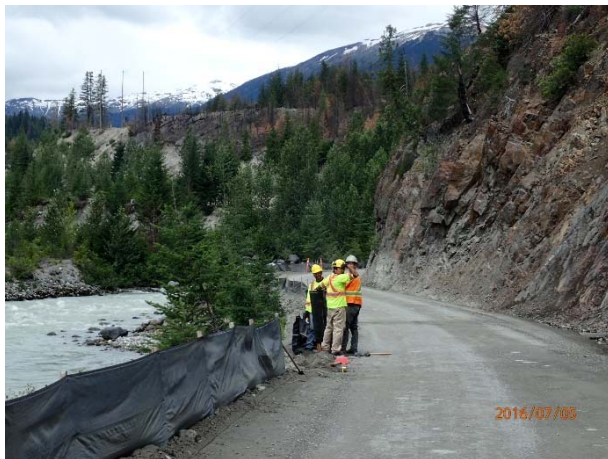
Photo 1 – Silt fence repairs at KM41.2 Lillooet River FSR (July 5, 2016).

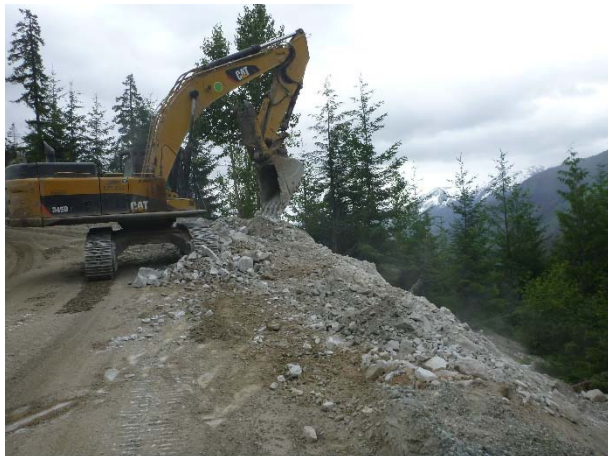
<i>Email</i>	CE, SES, INX	RE: Lillooet River FSR, KM45.2 works – The IEM identified the placement of material along the downslope side of KM45.2 of the Lillooet River FSR, which resulted in some material sloughing into the mountain goat migration corridor. The IEM was not notified of these works and requested that CE provide the following information: <ol style="list-style-type: none"> 1. What work was completed? 2. What work is left? 3. When will CE complete the works? CE placed the material at the request of one of the pumice mining companies in the valley to create a safety berm on the downslope side of the road. Based on the IEM’s email and potential impacts to the mountain goat migration corridor, CE removed the material from the side of the road.	-
July 5	<i>Site Inspection</i>	JEM (IE), IEM, INX, CE	IE Monthly Site Inspection – The IE delegate conducted a monthly site inspection with INX, the IEM delegate and CE environmental staff.	-

Photo 3 – Clean-up of material dumped at KM45.3 of the Lillooet River FSR (July 4, 2016).

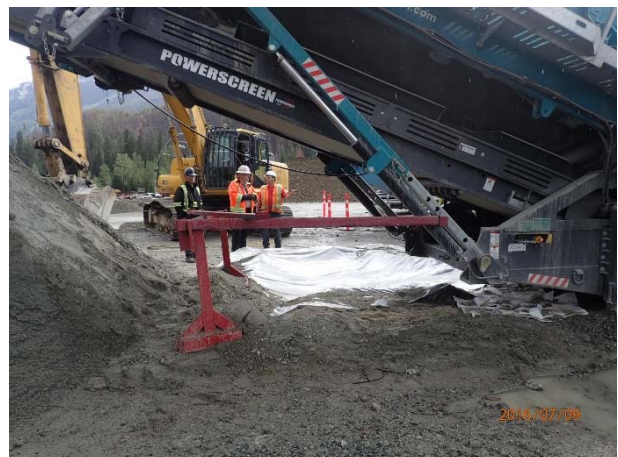
- On July 9, a spill occurred (83L) at the crusher pad when a hydraulic hose ruptured on the crusher. The operator immediately stopped the machine and contained the spill with spill pads. He then built a berm around the crusher to prevent the spill from migrating off site (Photo 4). The IEM monitored CE's crews while excavating the contaminated soil surrounding the crusher. CE sent soil samples to a lab for confirmation of complete remediation. CE temporarily stored the contaminated soil in 55-gallon drums prior to its removal by an approved contaminated soils vendor.
- On July 12, CE fixed the gaps between the construction camp fence and the electric entrance mats, as requested by the BC EAO during their site audit on July 6, 2016 (Photo 2, ITM ULR #58).

Photo 4 – Hydraulic leak on the crusher (July 9, 2016).

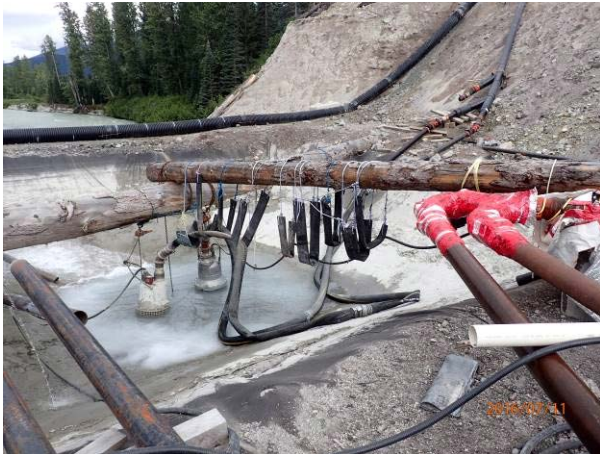
- CE installed an additional 12" hard discharge water line from the concrete lined sump to the setting ponds and water treatment system (Photo 9). This new water line will increase pumping capacity and ensure that CE can pump all construction wastewater from the tunnel, BEBO wall, and the sluiceway to the treatment system simultaneously. CE will continue to monitor the capacity of this system and stage works in a manner that prevent the concrete lined sump from overflowing. The IEM is satisfied with CE's new pumping system, *ULR#54* is now closed.

Photo 9 – New discharge water line from the concrete lined sump at ULRHEF (July 11, 2016).

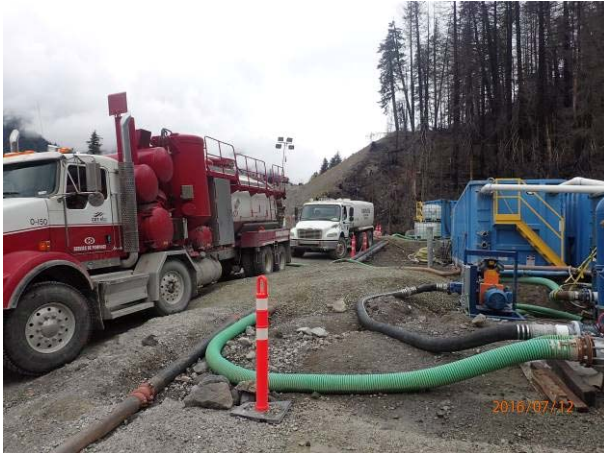
Photo 10 – Sediment removal from the active water treatment system at ASTR-03 (July 13, 2016).

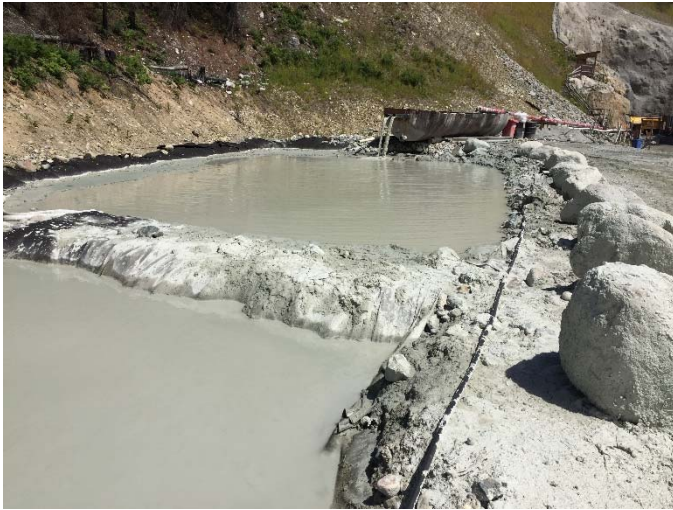
Photo 21 – BDRHEF downstream portal settling ponds (July 6, 2016).

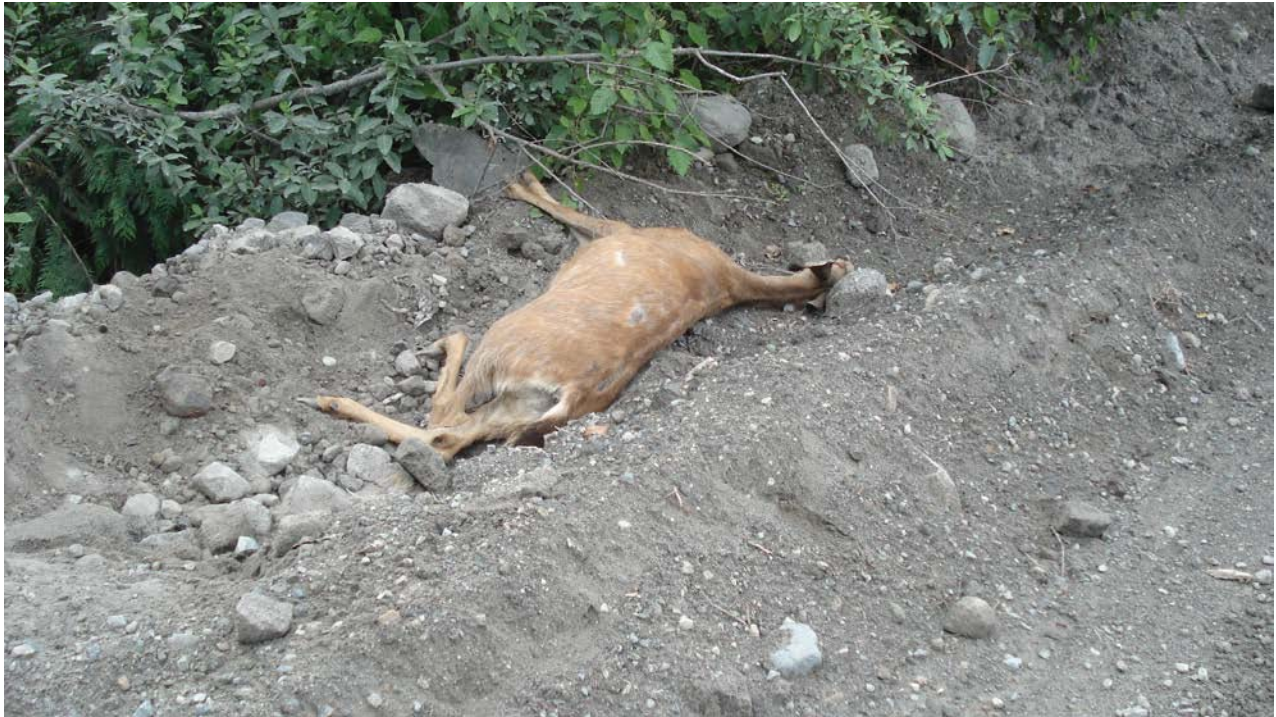
<input type="checkbox"/> Snow
Specific Location: Upper Lillooet Downstream Portal – Lunchroom (near 44.7 on the FSR)								
Description and Cause of Incident:								
<p><u>Description:</u> At 10:00 PM, a deer struck the truck driven by an engineer driving down the Lillooet River FSR near KM42.4. The driver was not injured and there was no passenger in the vehicle. The doe died later of the injuries sustained in the collision. According to the driver, the doe jumped in front of his pick-up from the right bank of the FSR. The left front portion of the pick-up is where the doe's rear collided with the truck as it attempted to cross the road. The driver then called Safety to report the incident. A few minutes later, the night shift Environment Manager was informed of the accident. She followed the protocol outlined in the Accident, Malfunction and Emergency Response Plan (EPP) and notified a conservation officer through the RAPP line. The Sr Environment Manager was informed of the accident at 5:05 am this morning. He also called the RAPP line to get instruction how to dispose of the deer carcass. Mike, the CO on duty required that it be buried. So, around 8:30 am this morning, the deer was buried close to the accident location. The burial site is in a spoil, on the other side of the road. The deer is buried at more than 3 meter deep, far enough from the road to allow the digging of a ditch for the road when reclamation work will be completed. The location was approved by the IEM on site, who supervised the burial with the Sr Environment manager. It was also documented with pictures. (See attached).</p> <p><u>Cause:</u> There is plenty of deer on site and they often jump right in front of pick-ups. In this particular situation, the doe might have jumped to close to the pick-up for the driver to react quick enough. Unfortunately, this occurrence resulted in the death of the deer.</p>

1. Doe in the ditch near km 42.4 of the FSR.

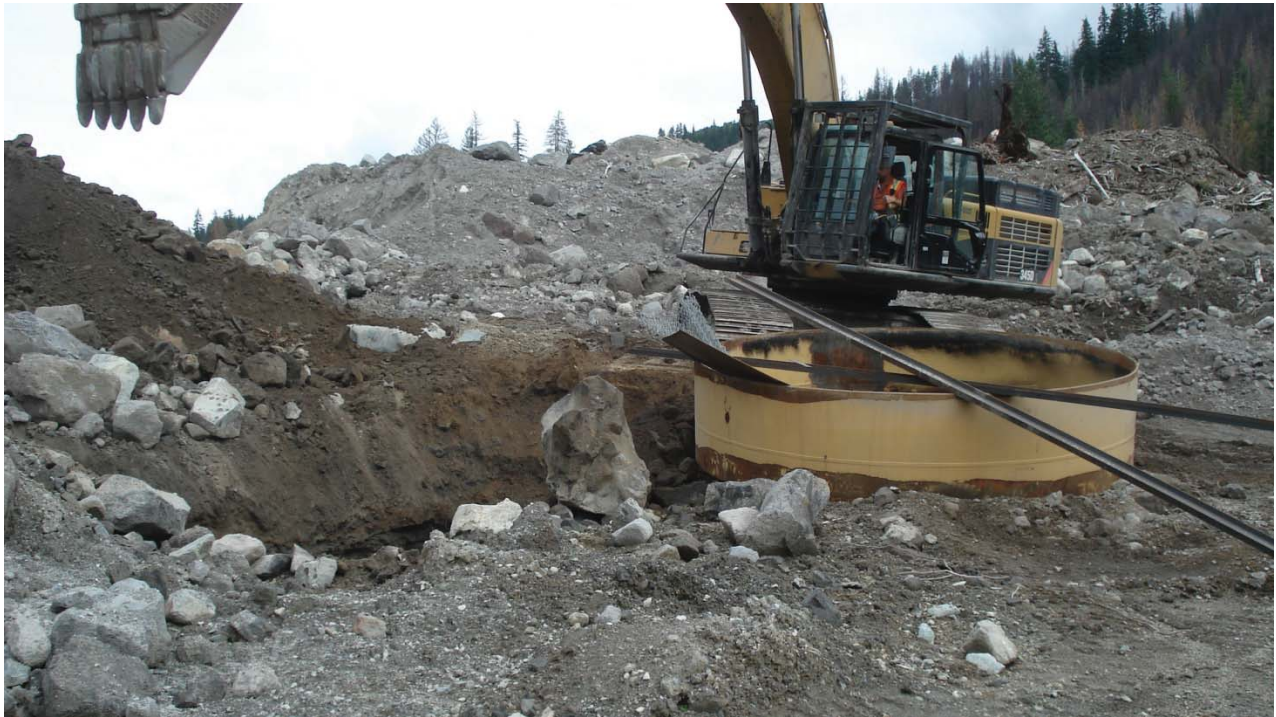
3. Excavator digging the hole to bury the animal.
