Upper Lillooet Hydro Project

Weekly Environmental Monitoring Report #105

Reporting Period: October 9 – 22, 2016

Upper Lillooet River Hydroelectric Facility (Water File No. 2002561, Water Licence No. C130613), Boulder Creek Hydroelectric Facility (Water File No. 2003049, Water Licence No. C129969) & Transmission Line (TX Line)

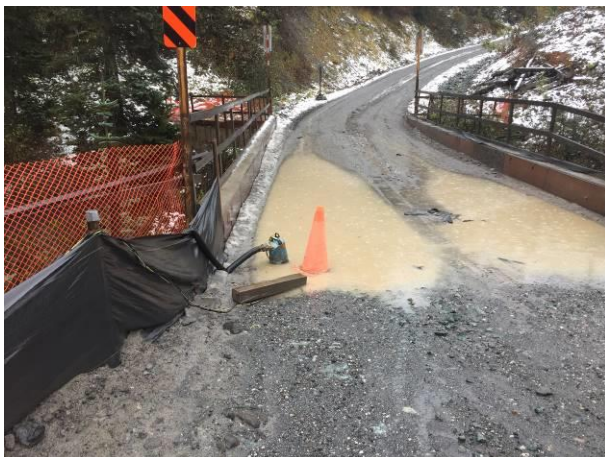
- On October 13, the IEM identified sediment laden road run-off discharging to the Lillooet River at the KM49 bridge (Photo 1). CE had previously installed two 2-inch pumps to temporarily divert sediment laden road run-off into nearby vegetation, but neither were turned on at the time of the inspection (Photo 2). The IEM reported this issue to CE's environmental staff, reminding them that it was their responsibility to manage road run-off and to implement temporary measures that prevent erosion, control sediment, and protect surface water quality as outlined in the project CEMP and EPPs. Additionally, the IEM had been advising CE to address ESC measures at this site for two months during site

visits, the bi-weekly environmental coordination meeting, and in FAM # 13. However, CE failed to implement the necessary ESC mitigation measures to prevent the issue from reoccurring. Once notified, CE crews turned on the two 2-inch pump and temporarily discharged sediment laden road run-off to vegetation. On October 15, crews began cleaning out the road side ditch and infiltration ponds from KM48.5 to the KM49 bridge (Photo 3). CE also committed to ensuring that all sediment and erosion control measures would be maintained to prevent a reoccurrence of this issue.

Photo 1 – Non-functioning pump installed on KM49 Bridge (October 13, 2016).

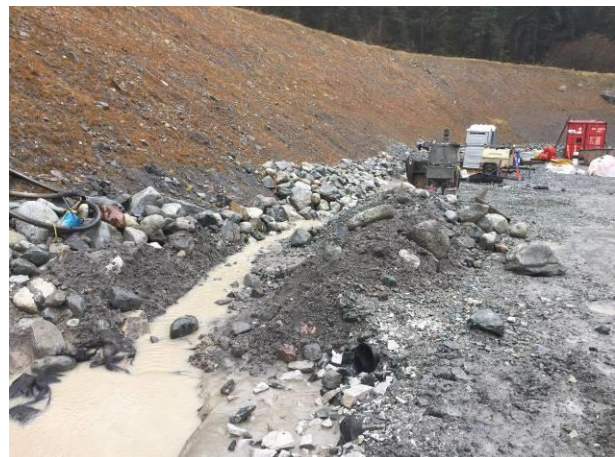
Photo 2 – Sediment laden water flowing towards KM49 bridge and pump sitting idle on slope (October 13, 2016).

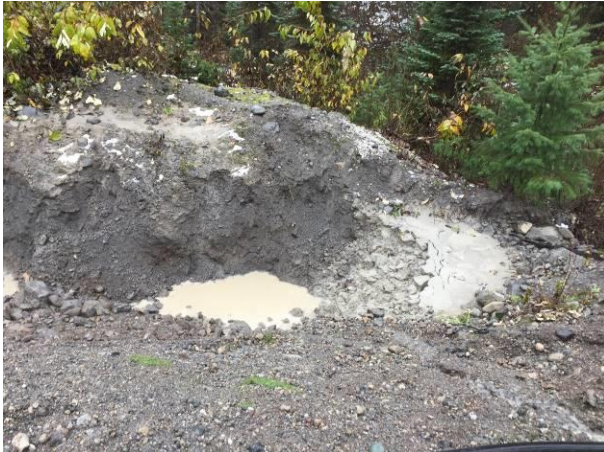
Photo 3 – Infiltration pond re-excavated on river left of KM49 bridge (October 15, 2016).

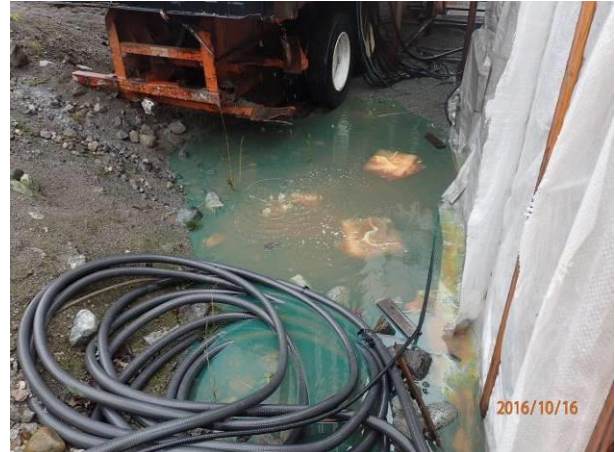
- On October 16, a large spill occurred when a mechanic left a fuel pump running unattended while fueling a generator at KM48.5 of the Lillooet River FSR (Photo 4). The generator overflowed for approximately 5-minutes, spilling an estimated 300 – 500L of diesel to the road surface. Due to the volume of the spill, and heavy rainfall the fuel migrated down the FSR towards the KM49 bridge. Once identified, crews quickly deployed spill pads and booms to intercept the fuel before it reached the bridge. A vacuum truck was used to remove all contaminated water and soil (Photo 5). All contaminated soil was deposited and stored at the mechanic shop at KM38 prior to offsite disposal at an accredited facility. No fuel migrated offsite or entered the Lillooet River. On October 19, CE retained Cascade Environmental to collect soil samples from the site of the large spill to ensure that crews had removed all contaminated materials. Due to the size of the spill (>100L) the Provincial Environmental Emergency Program was notified of the spill.

Photo 4 – Diesel spill from overflowing the generator at KM48.5 (October 16, 2016).

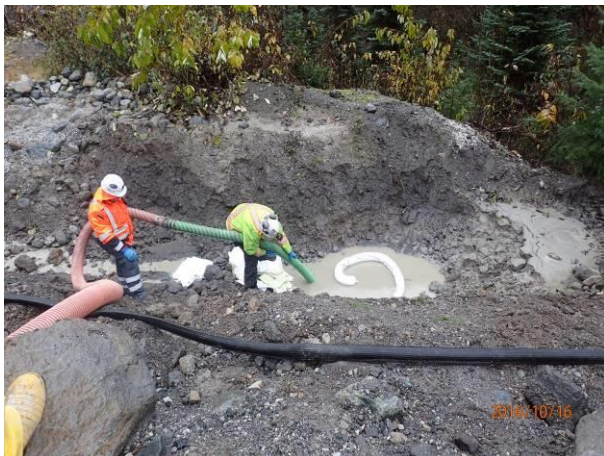
Photo 5 – Vacuum truck removing water and soil contaminated from diesel spill at KM48.5 (October 16, 2016).

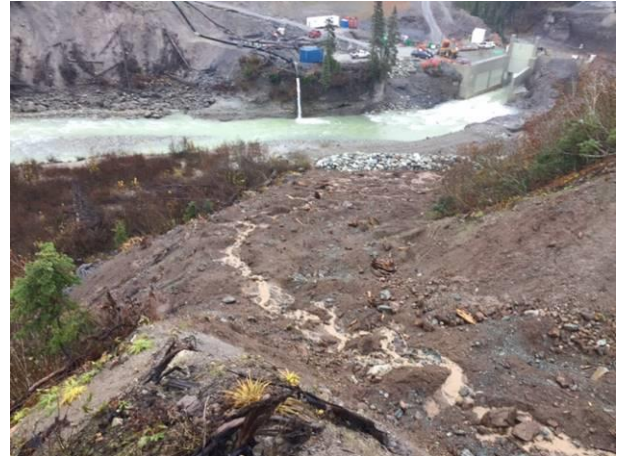
- CE continued to excavate and re-contour the slope on the right bank of the ULRHEF intake structure and to reclaim the old Obermeyer access road. On October 21, the IEM and IE observed erosion along a portion of the reclaimed old Obermeyer access road (Photo 10). CE had already begun implementing corrective measures to prevent further erosion to the slope at the time the issue was identified.

Photo 10 – Erosion on the old Obermeyer diversion channel access road (October 20, 2016).

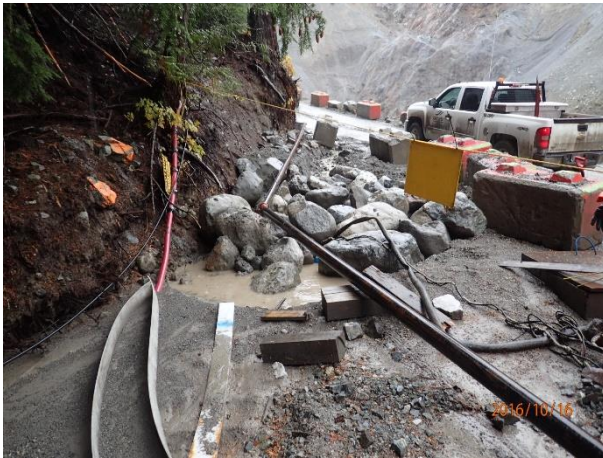
- On October 13, the IEM observed sediment laden road run-off entering Truckwash Creek from the access road to the lower tunnel portal. The IEM had been advising CE to implement ESC mitigation measures on the lower portal access road for two months, outlining the expected mitigation measures during site visits, the bi-weekly environmental coordination meeting, and in FAM # 13. On October 16, CE began repairing the ditch line, excavated an infiltration pond in the small laydown area, and installed a pump to convey water into the oil-water separator during heavy rainfall events (Photo 13).

Photo 13 - Newly excavated infiltration pond and 2-inch pump at the small lower-tunnel portal lay down area (October 16, 2016).

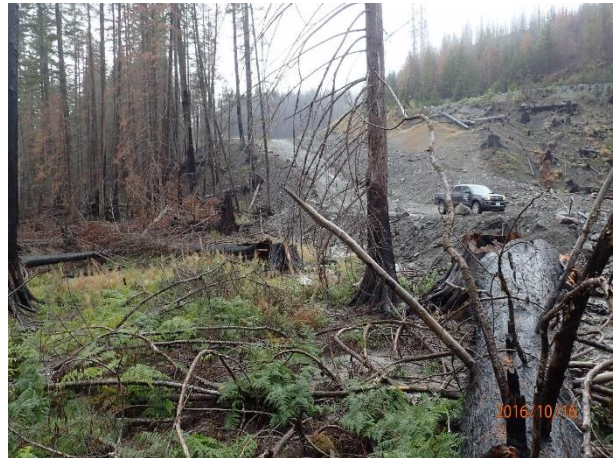
- On October 18 and 19, the IEM observed the surge tank, on the lower tunnel portal active water treatment system, overflowing due to a pump failure. Water flowing out of the tank was clean and was contained in the access road ditch line. The water flowed along the penstock and into vegetation before reaching ASTR-04 (Photo 14). Stormtec technicians repaired the pump on October 19 and the IEM did not observe any additional environmental issues at this site during the monitoring period. Additional water quality sampling results are available upon request.

Photo 14 - Overflow, from the lower portal active water treatment system, entering vegetation before ASTR-04 (October 18, 2016).

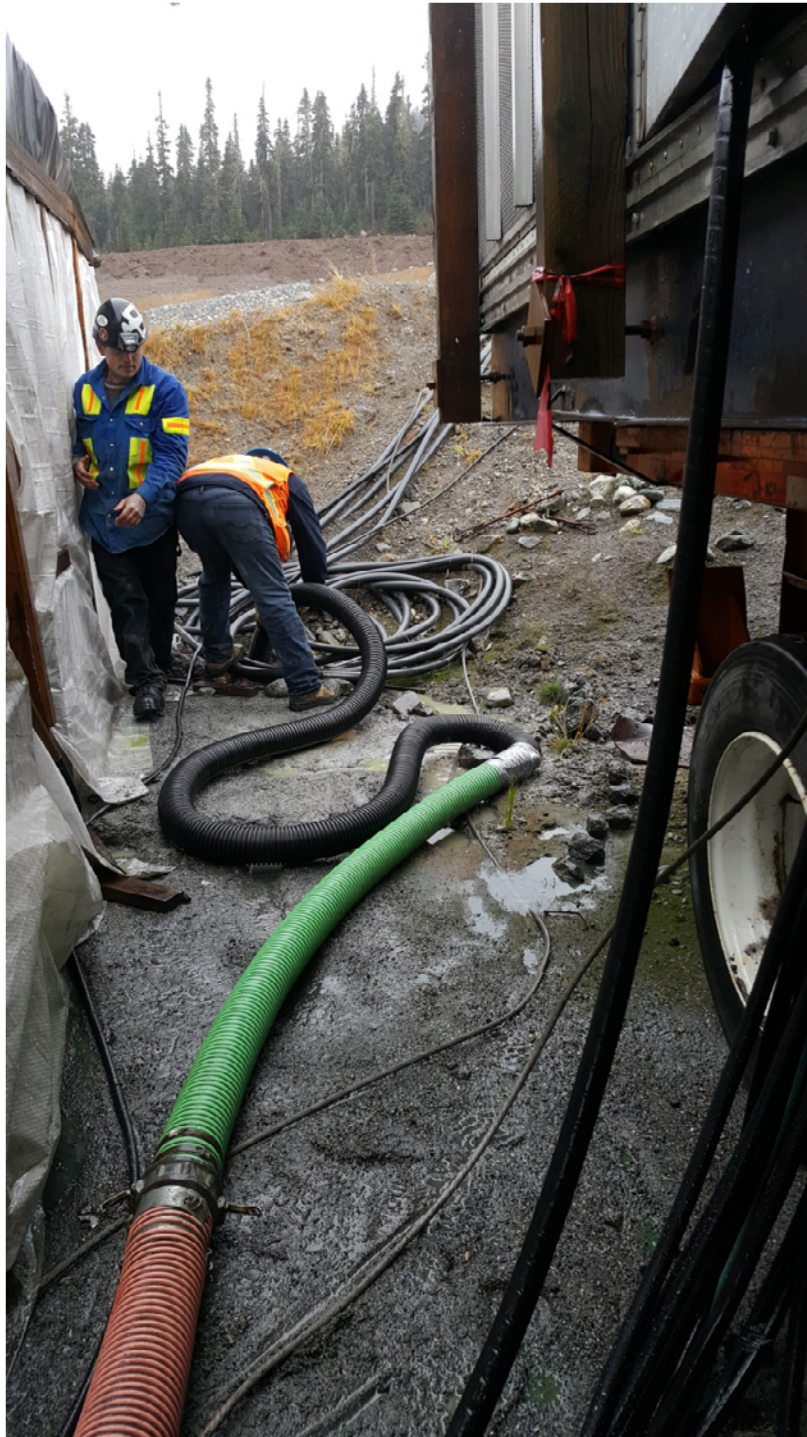
Figure 1: Vacuum truck removing contaminated water and sediment under generator tank

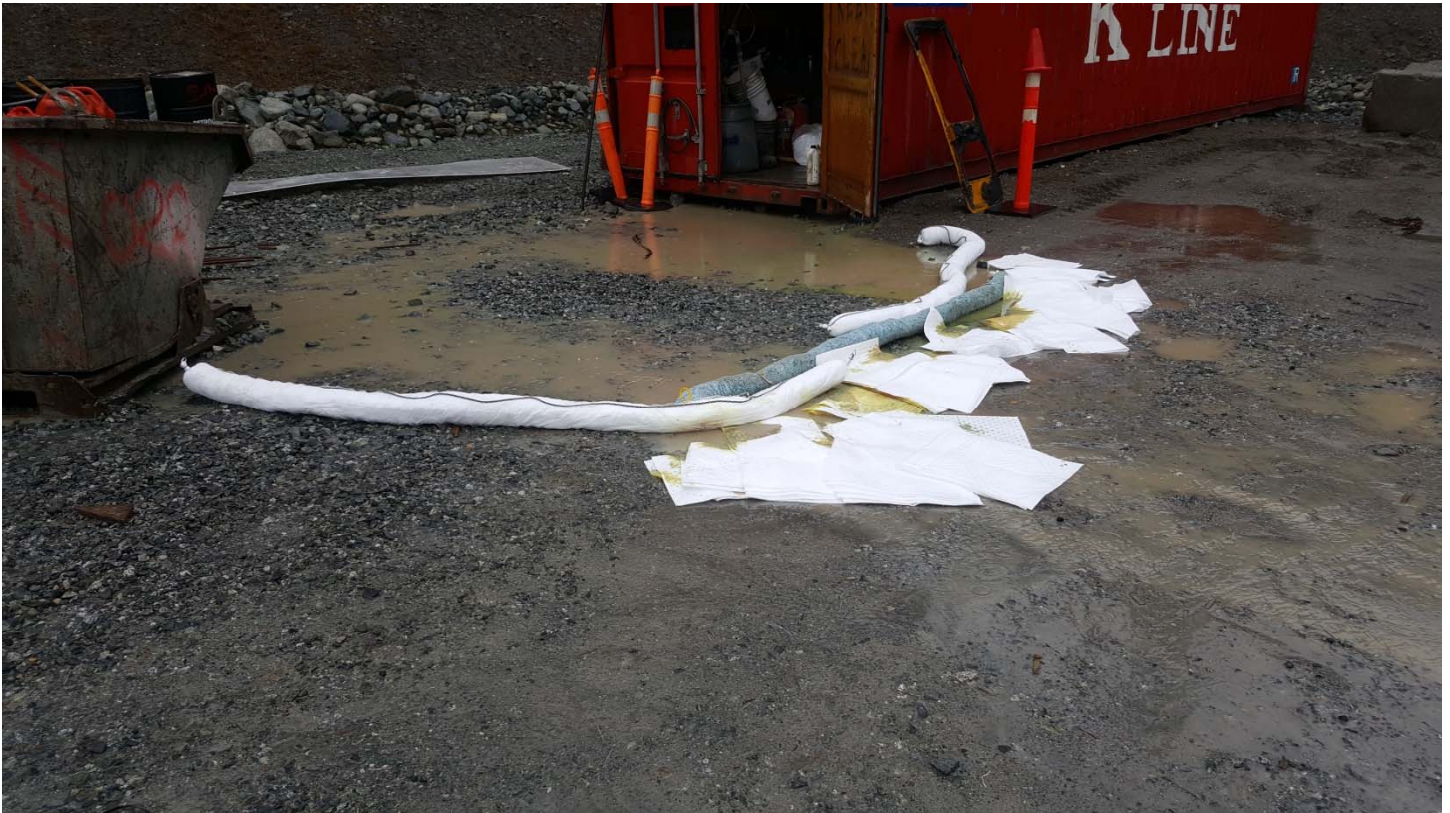
Figure 2: Spill booms and absorbent pads to stop migration of spill

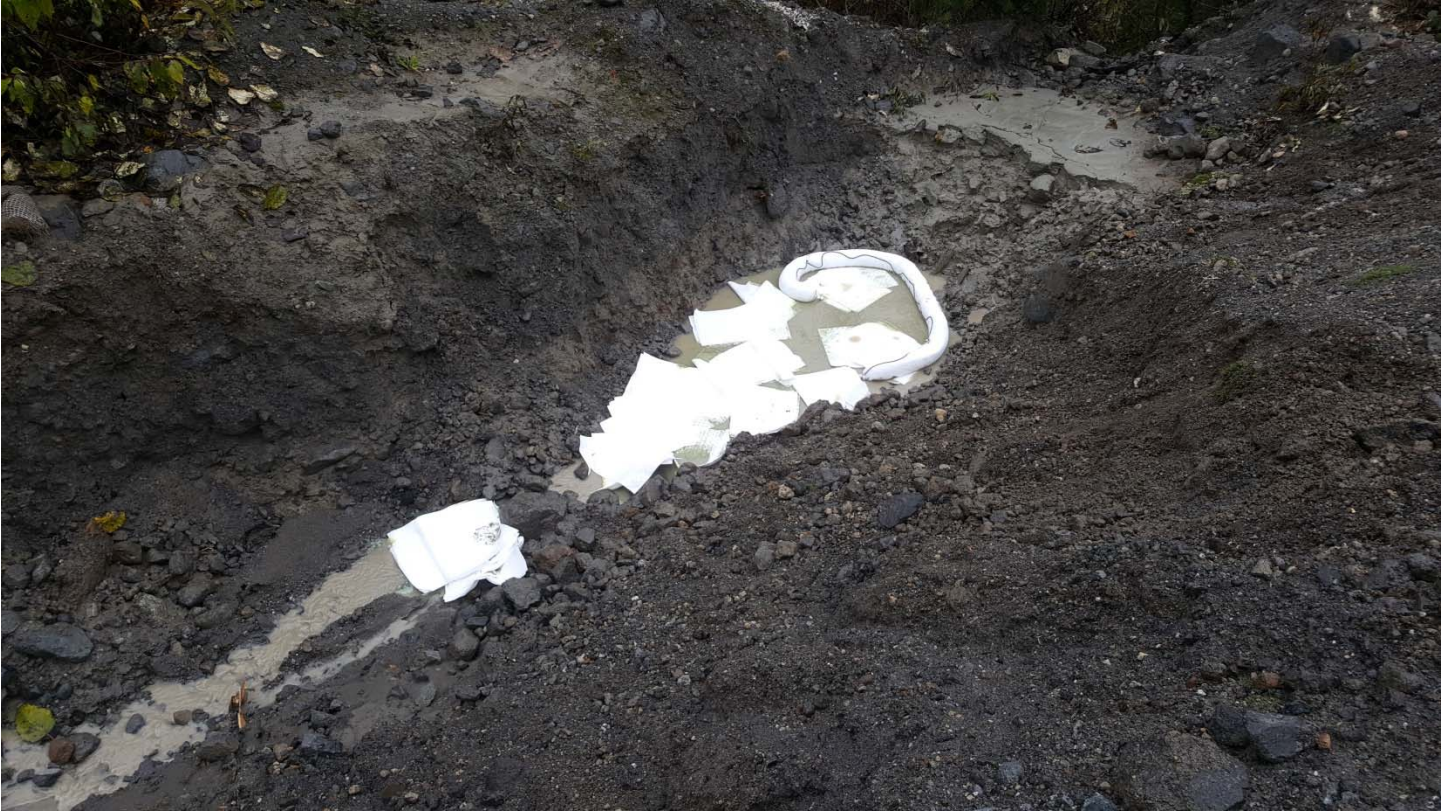
Figure 3: Spill booms and absorbent pads in sump

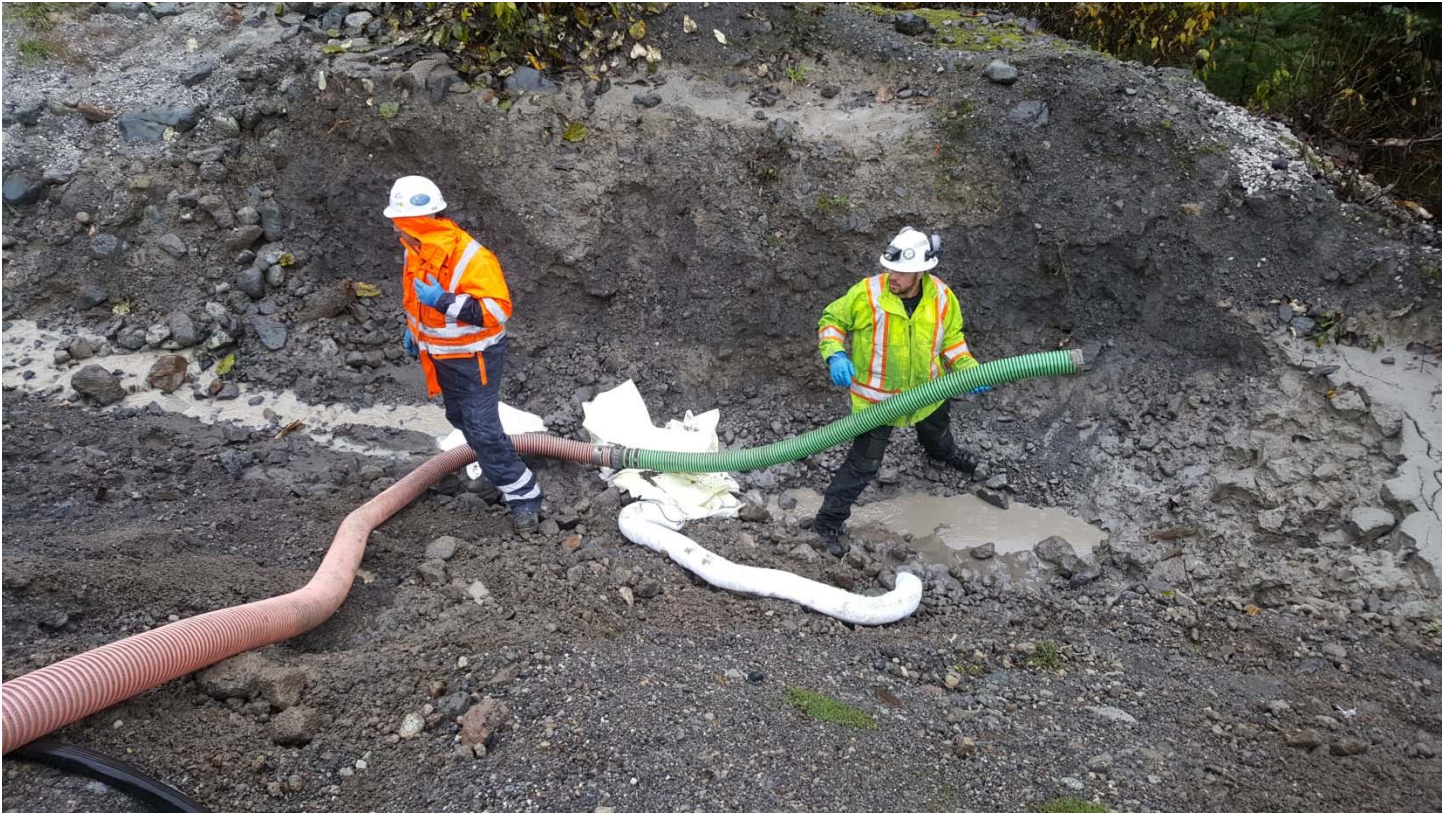
Figure 4: Vacuum truck removing contaminated water and sediment from sump

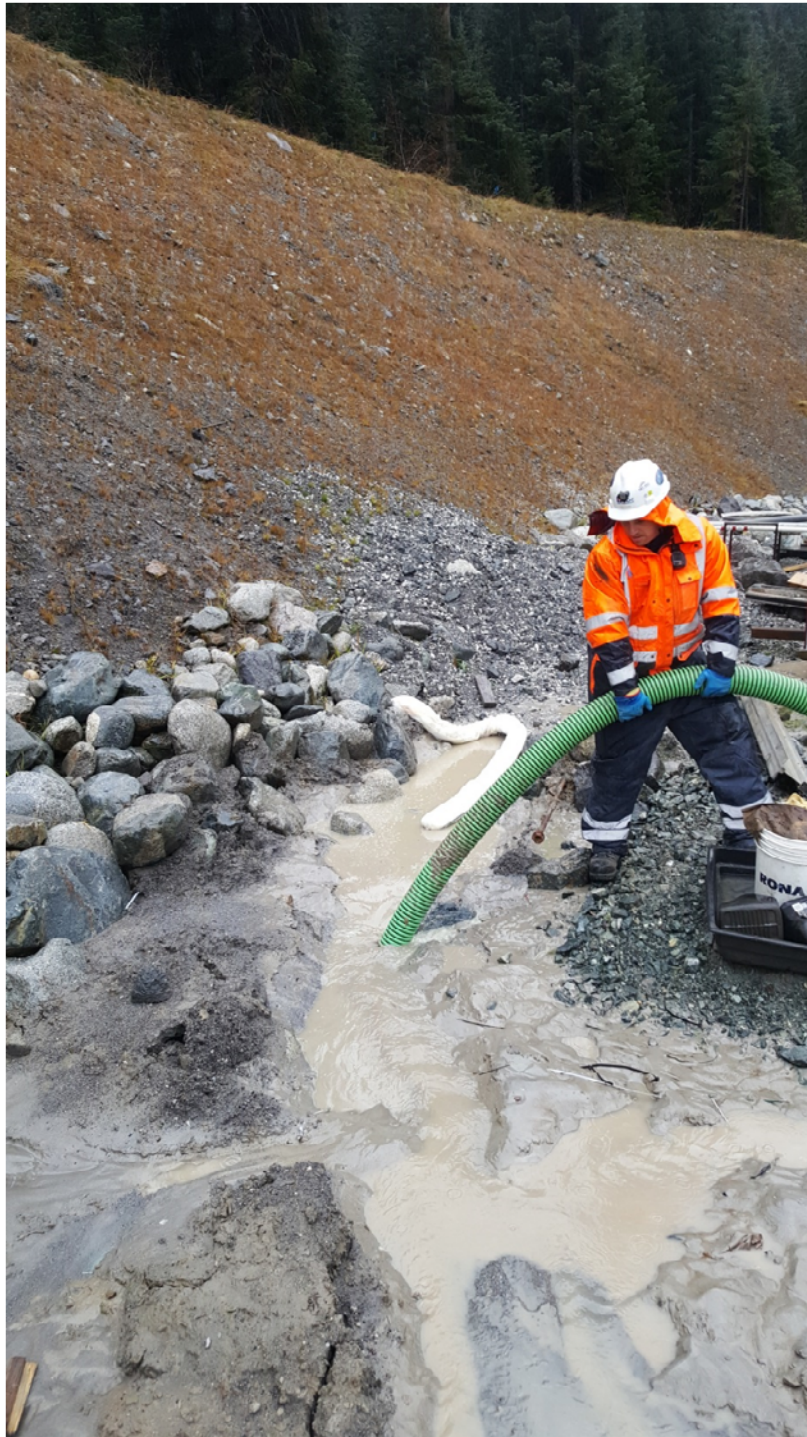
Figure 5: Vacuum truck removing contaminated water and sediment from ditch-line
