Upper Lillooet Hydro Project

Operational Environmental Monitoring Year 5

April 24, 2024

Ecofish Research Ltd.

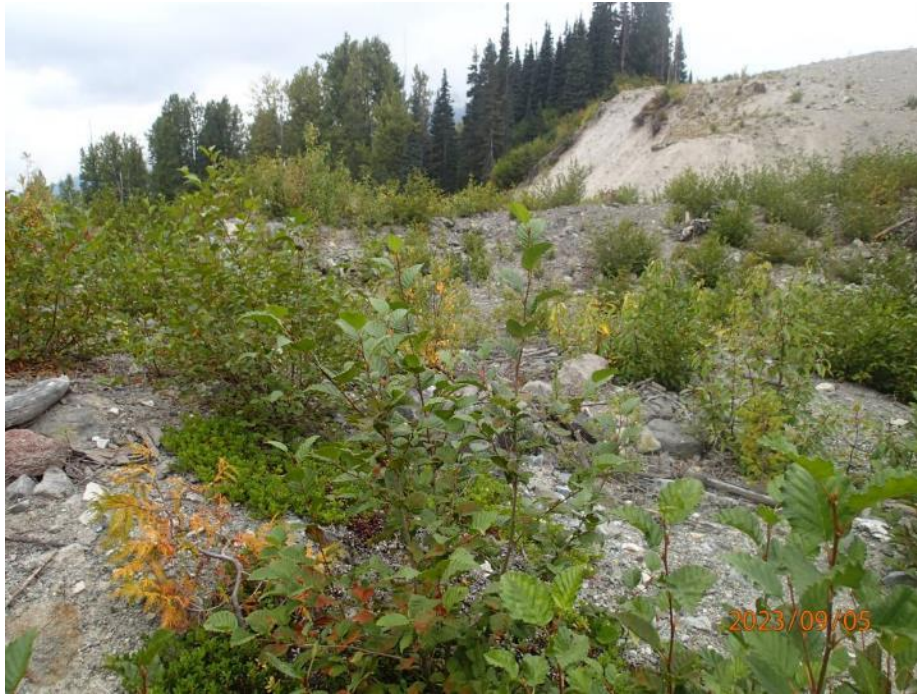
Figure 1. Woody vegetation at ULL-PRM03 on September 5, 2023. Shrub stem densities are below target but have increased from Year 3.

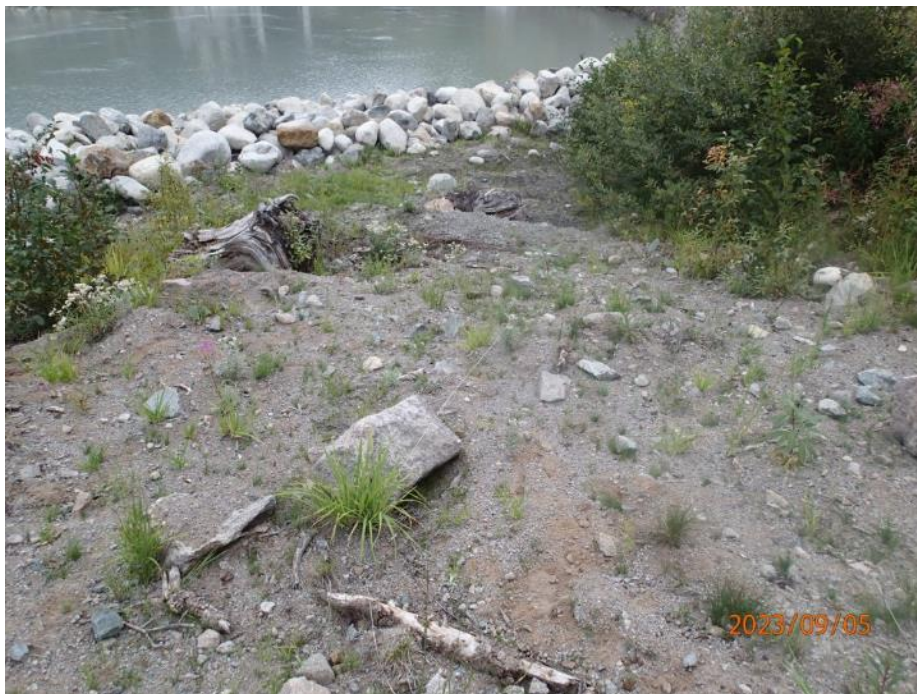
Figure 2. Area with signs of possible mechanical disturbance near ULL-PRM01 on August 30, 2023. Woody stem density and herbaceous cover are sufficient.

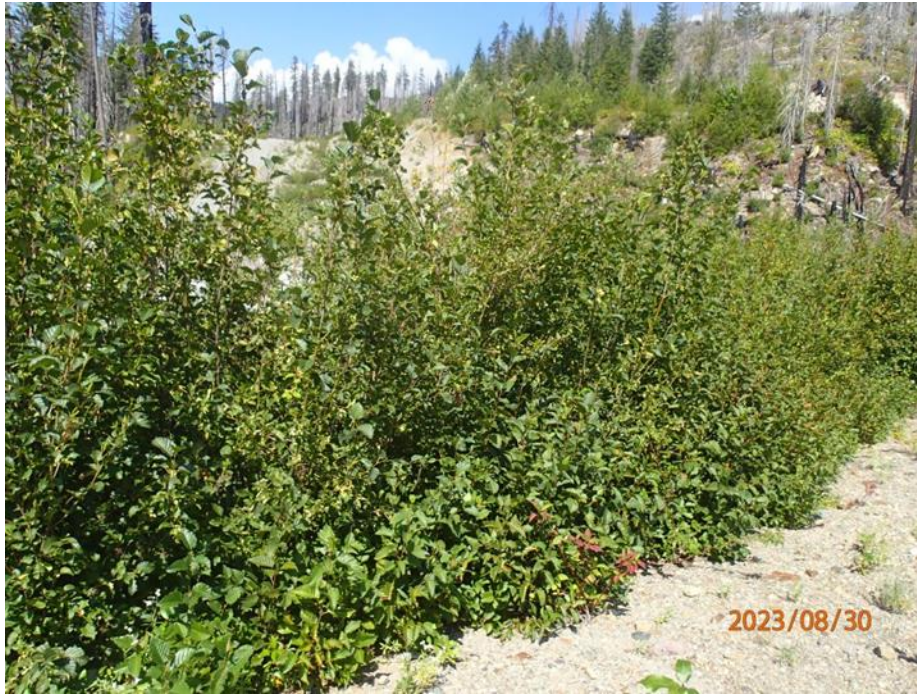
Figure 3. Abundant red alder and black cottonwood growth along the stream edge, with sparse herbaceous cover, at ULL-PRM09 on August 30, 2023.

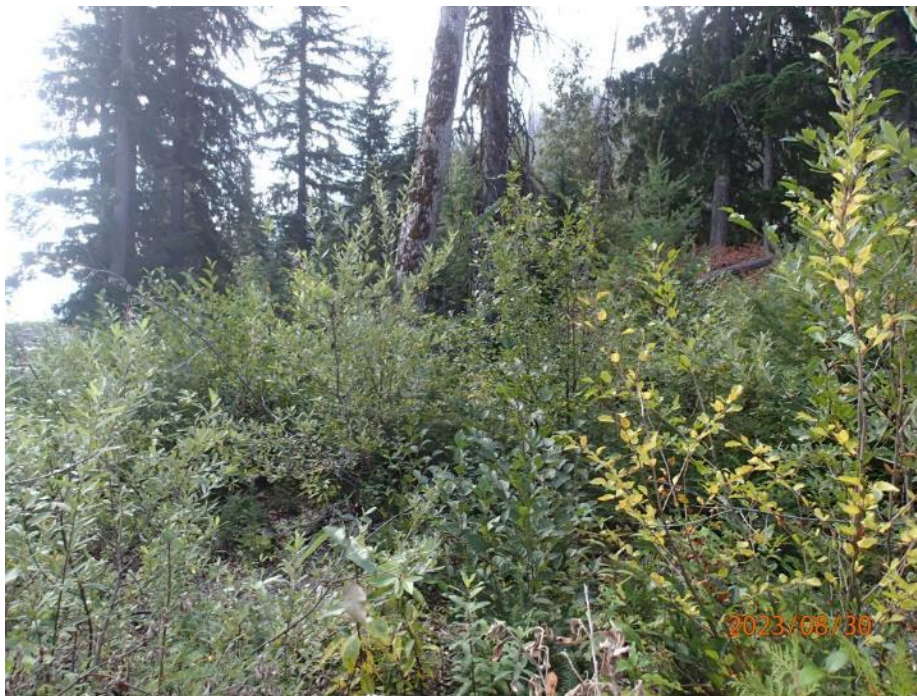
Figure 4. Dense tree and woody shrub regeneration at ULL-PRM10 on August 30, 2023.

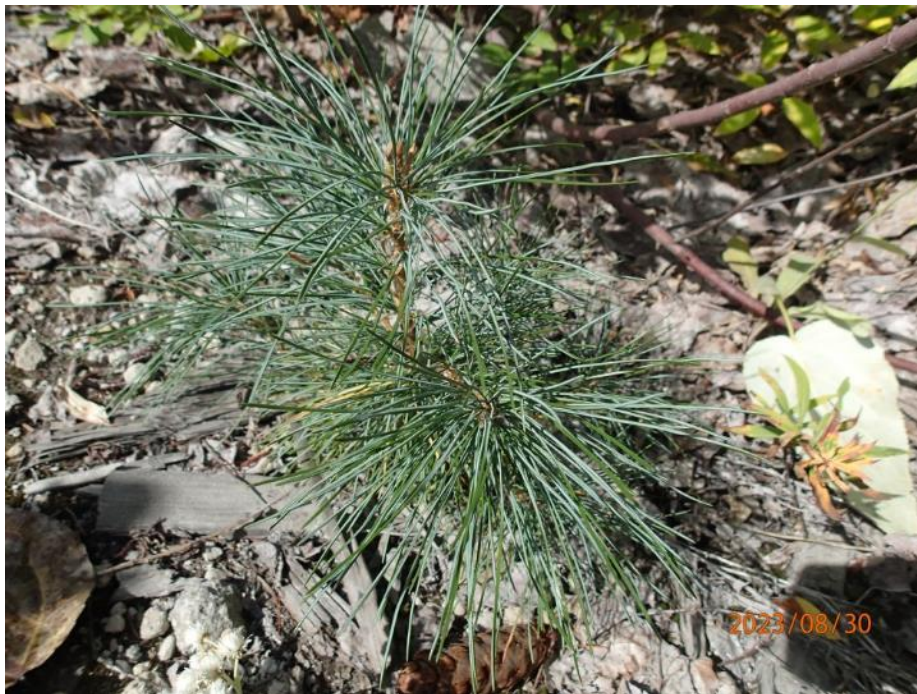
Figure 5. Western white pine seedling at ULL-PRM05 on August 30, 2023.

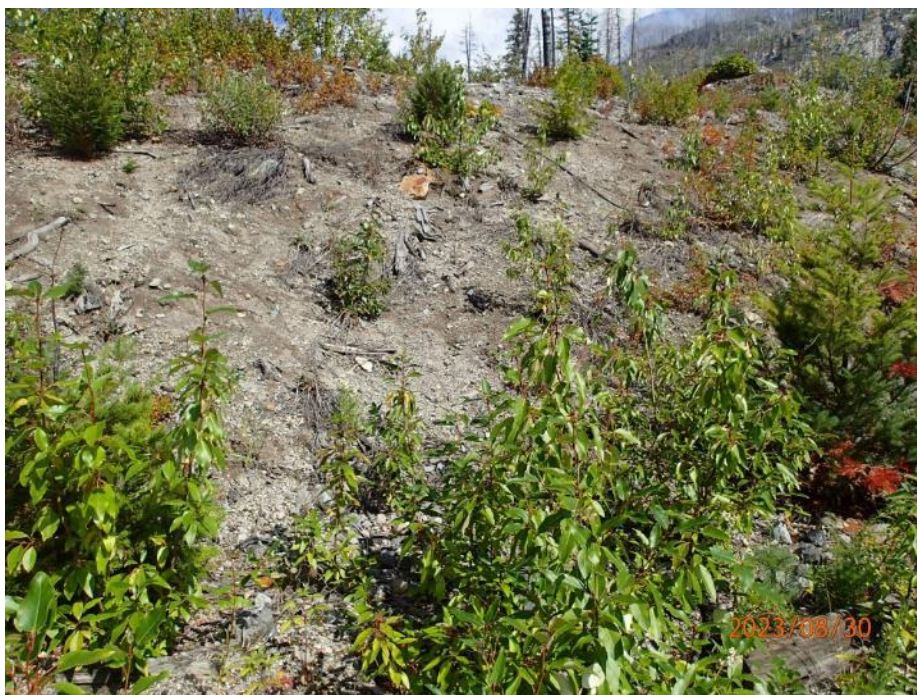
Figure 6. Dry, rocky substrate but healthy black cottonwood regeneration and no observed erosion at ULL-PRM11 on August 30, 2023.

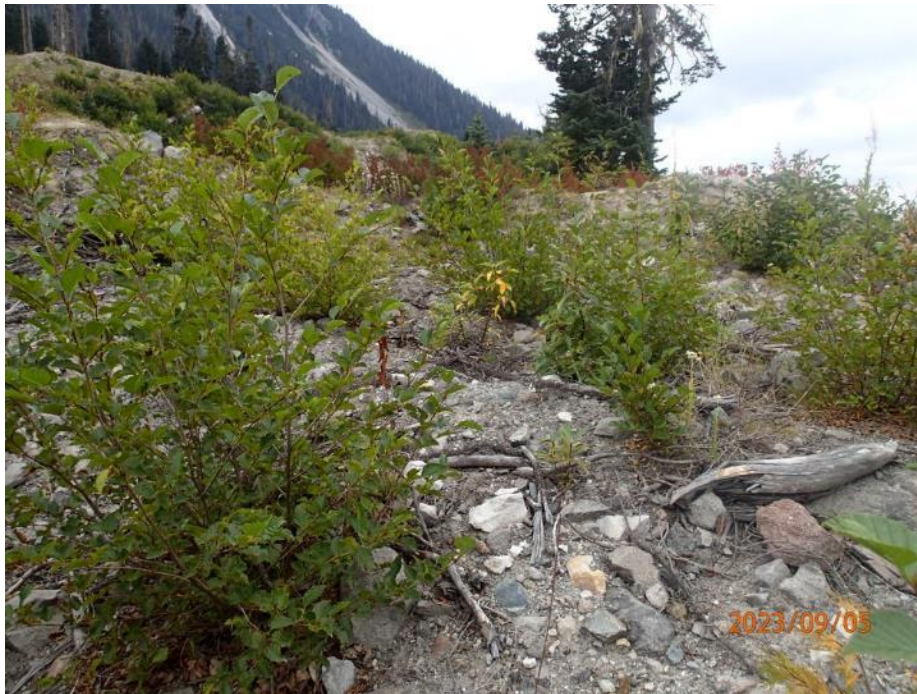
Figure 7. Dry, rocky substrate and healthy red alder and black cottonwood at ULL-PRM03, on September 5, 2023.

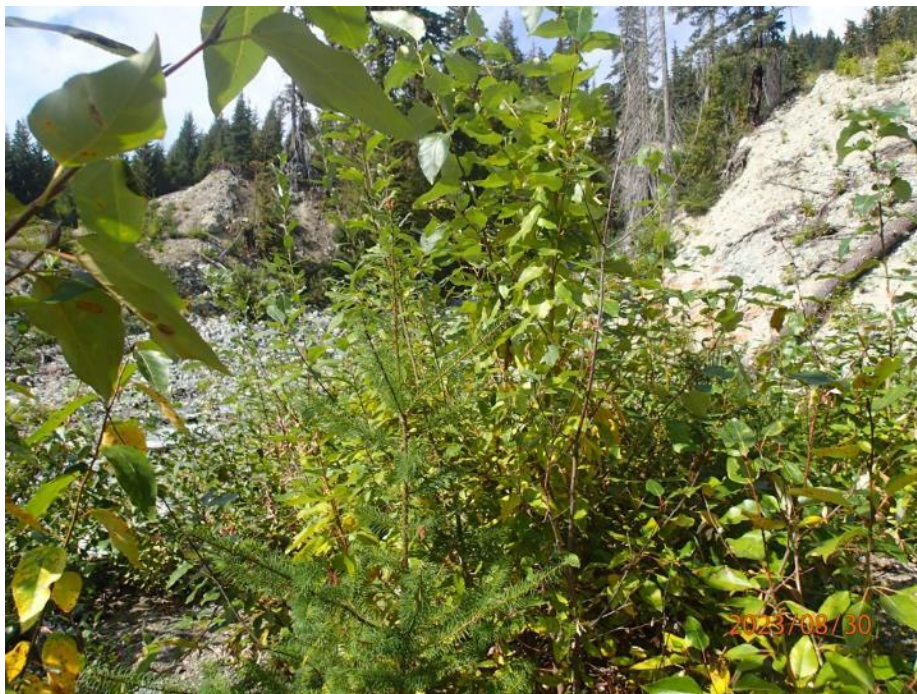
Figure 8. Tall black cottonwood and Douglas-fir regeneration at ULL-PRM05 on August 30, 2023.

A comparison of photographs taken in Year 3 generally supports the results of the two quantitative assessment methods. In particular, the comparison demonstrates that 1) established woody vegetation continues to grow (Figure 8) and appears healthy (which is not apparent from stem density counts) and 2) vegetation cover is increasing in the majority of plots. It is also apparent that there are still areas of exposed soil in most plots. However, the overall trends of high stem density, increasing herbaceous cover, and increasing size of established woody vegetation suggest that revegetation is progressing successfully.

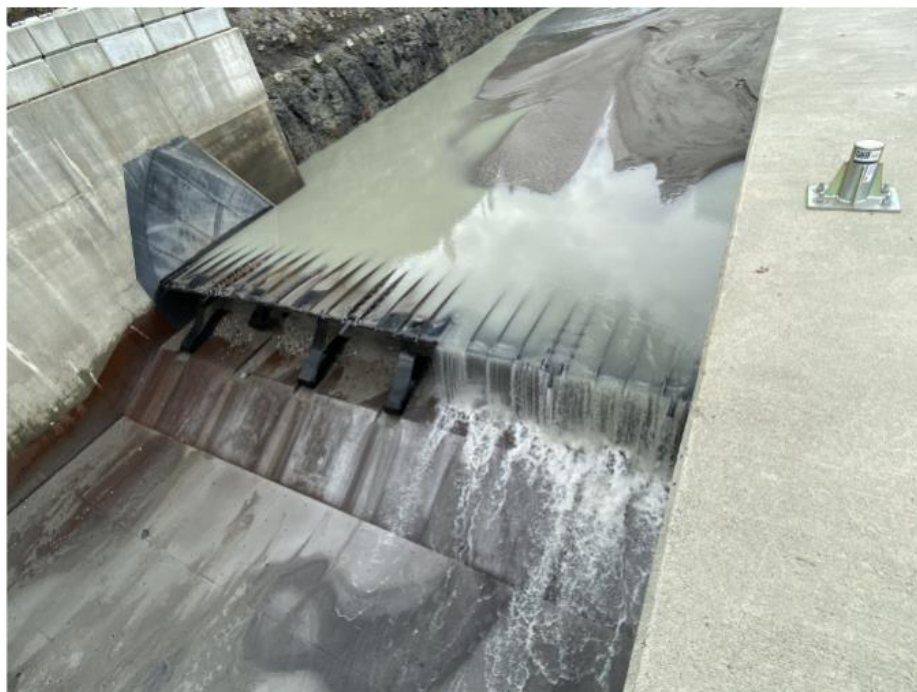
Figure 18. Obermeyer weir fully lowered during peak flow event to convey accumulated headpond sediment to be flushed downstream on June 29, 2023.

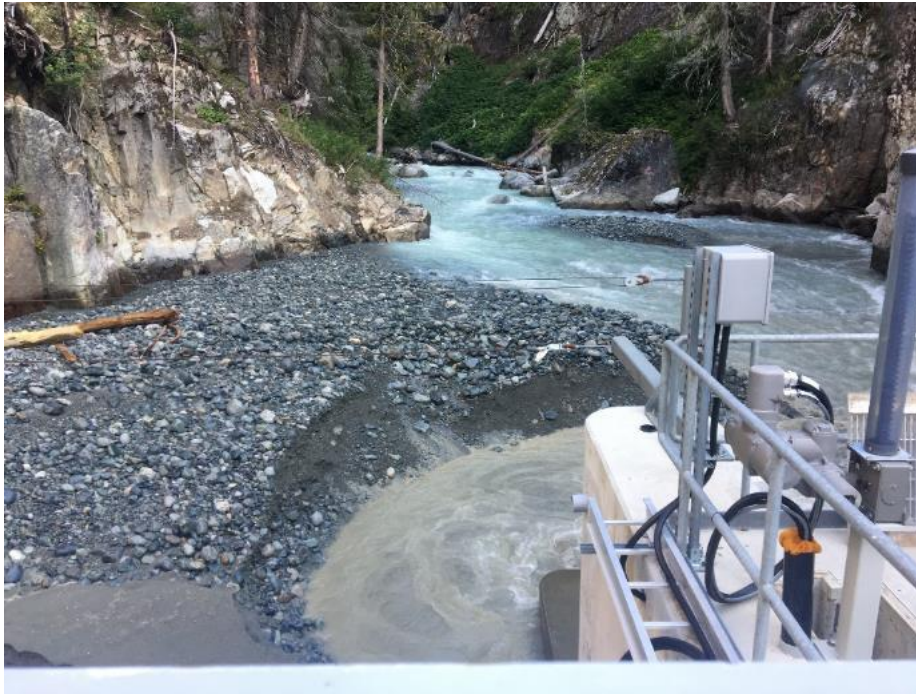
Figure 19. Boulder intake displaying naturally-accumulated bedload in the headpond prior to routine sediment management on August 9, 2019.

The Boulder Creek intake is composed of a Coanda screen-type water intake structure. Sediment load in Boulder Creek is naturally very high, requiring frequent headpond flushing during peak flows. Sluicing is used as a mechanism to allow sediment, substrate, and large wood passage through the headpond (i.e., headpond flushing). However, additional sediment mobilization (referred to as sediment management) has been required using an excavator (Sims 2019). The additional sediment management requires the opening of the sluice gate, and the shutdown of the generating plant and flows through the facilities infrastructure. An excavator is used to move accumulated bedload in the headpond into the thalweg to allow the flow to transport the sediment load downstream. Sluicing was conducted routinely during the operational period, while additional sediment management was conducted 8 times from December 2017 to October 2019, once in 2021 and once in 2022. These combined methods successfully transport bedload from the headpond to the lower reaches of Boulder Creek (Figure 19, Figure 20).

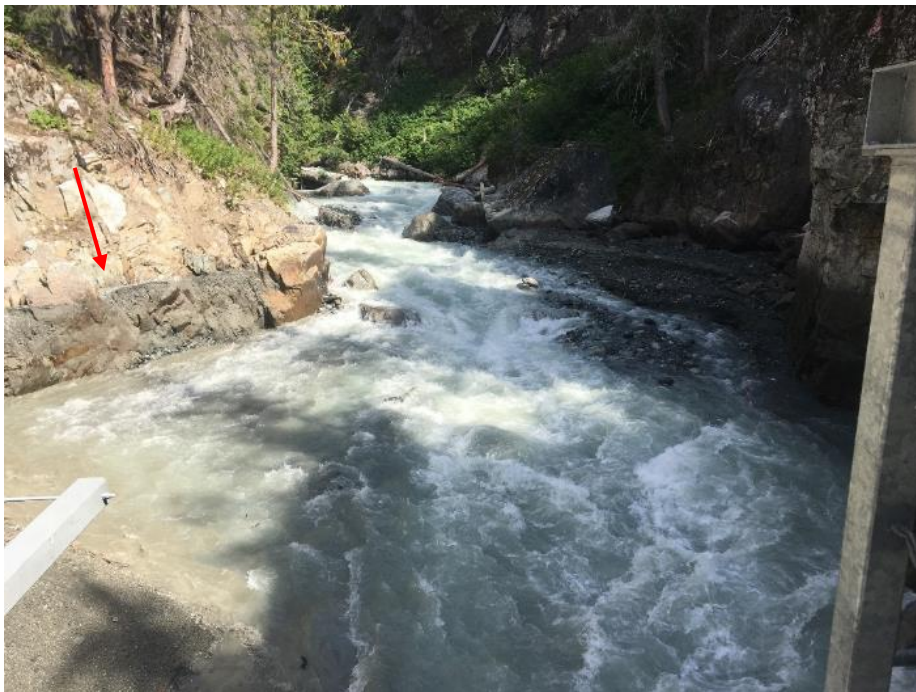
Figure 20. Boulder intake displaying the successful removal of bedload from the headpond post sediment management on August 9, 2019. Red arrow is a visual representation of the height of sediment pre-sediment management activities.

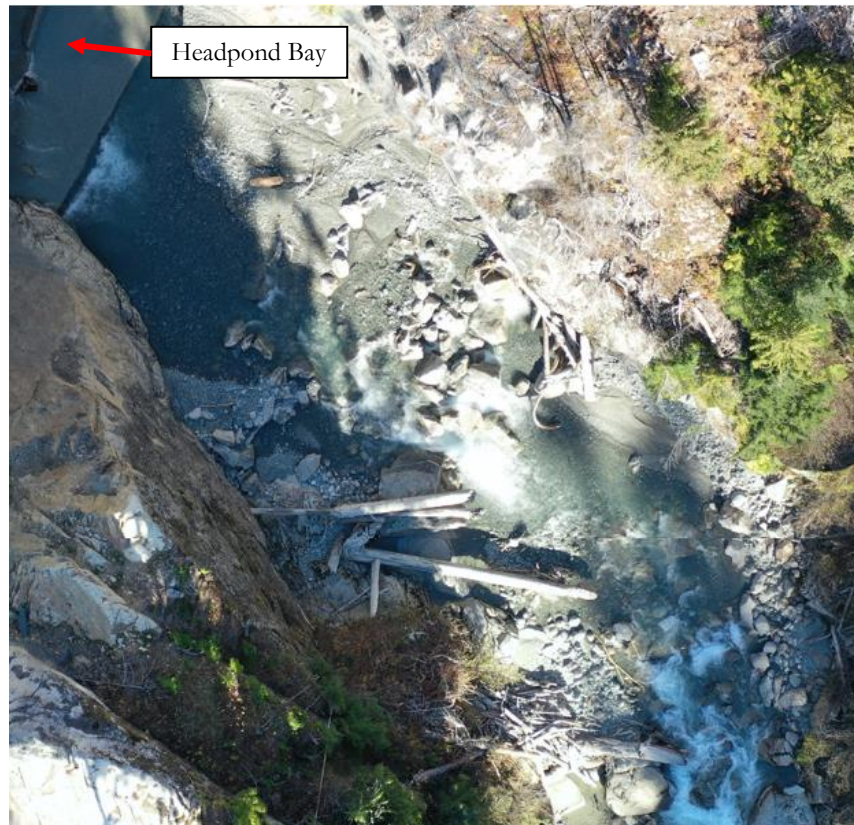
Figure 21. Evidence of large wood and spawning gravel being transported below the Boulder Creek headpond bay on October 28, 2023.

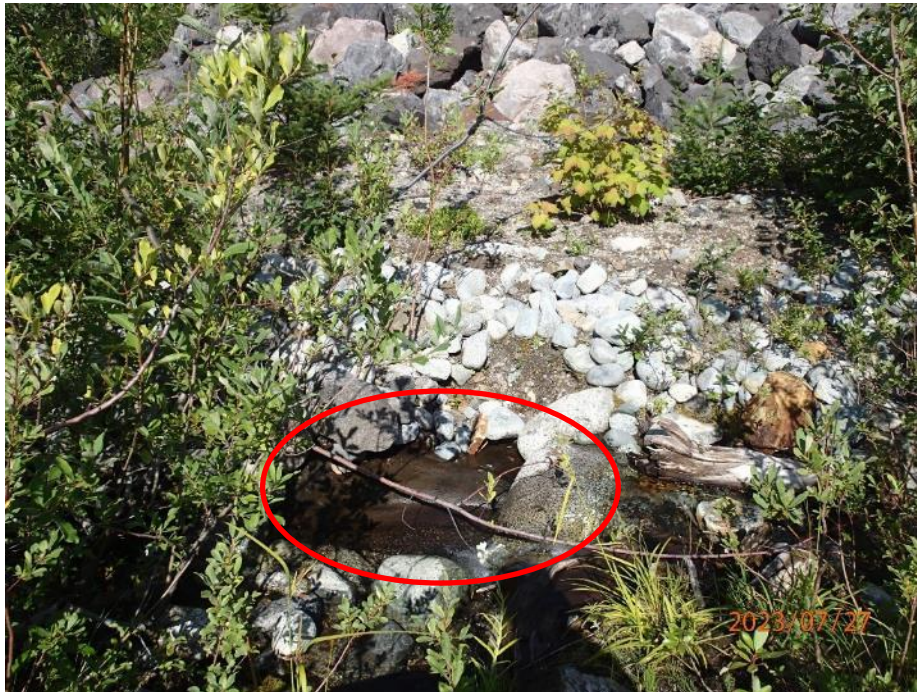
Figure 38. Exposed geotextile within the stream channel at ULL-ASTR04 on July 27, 2023.

During the Year 5 (2023) spot check, the same small portion (~ 0.7 m long) of geotextile that was uncovered in 2020 had again become exposed at the edge of river right, which was re-covered by hand. Given that repeated exposure of covered geotextile has been observed in a specific problem area, it is recommended that inspections, with maintenance implemented as needed, be conducted on a regular basis at ULL-ASTR04 (e.g., every three years).

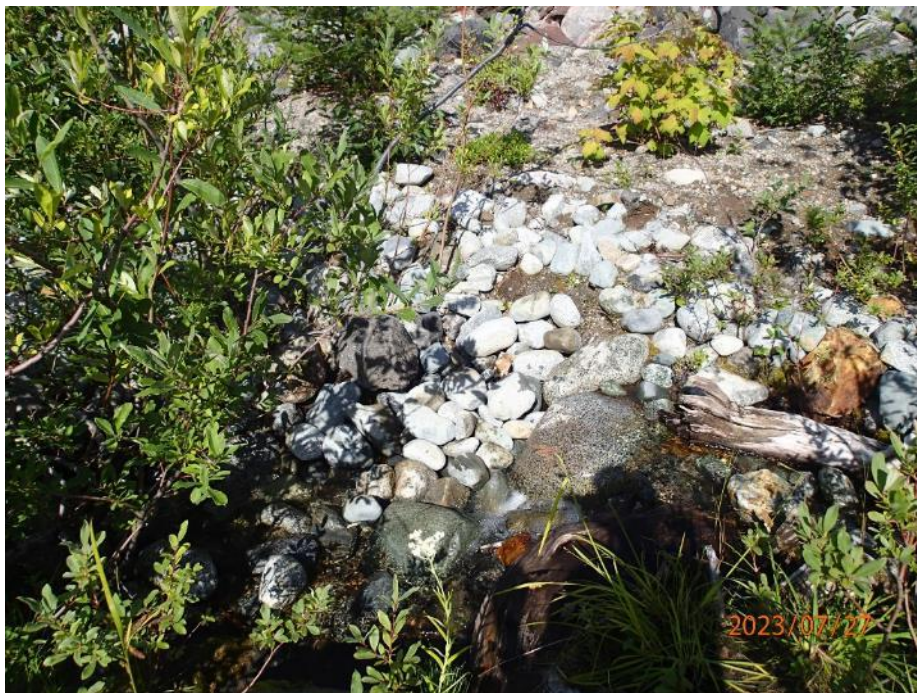
The spot check conducted on July 27, 2023, at ULL-ASTR04, where geotextile had been found exposed in Year 1 and Year 3, indicated that a small portion (~ 0.75 m long) of geotextile had once again become exposed at the edge of river right (Figure 38), in the same location where it had become exposed in 2020. This small section was again re-covered (with cobble found on site) on the day of the spot check (Figure 39). As also noted in Year 3, it was apparent that the extra cobble that had been added to the substrate in 2019 to cover the geotextile found exposed in Year 1 continued to be functional, since most of the geotextile that had been exposed in 2018 (see Figures 33 and 34 in Regehr *et al.* (2019)), and that had been covered in fall of 2019, remained covered. Abundant regeneration of riparian vegetation in this location, consisting of alder, willow, and cottonwood, was noted.

Figure 39. Location where geotextile had been exposed adjacent to the stream channel, after covering exposed section with cobble by hand, on July 27, 2023.

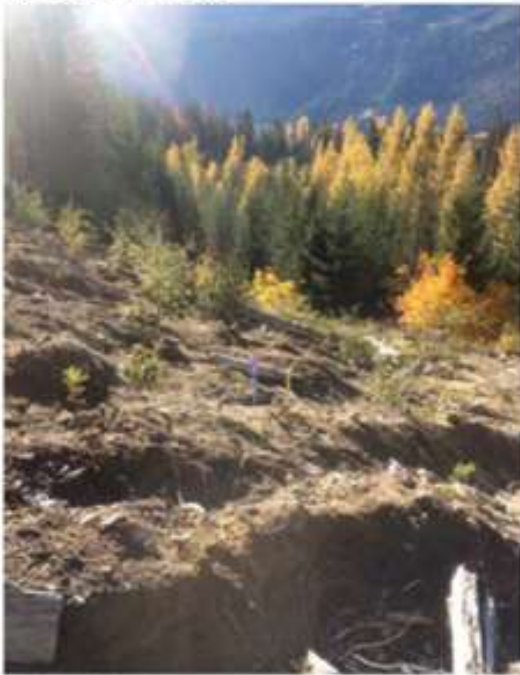
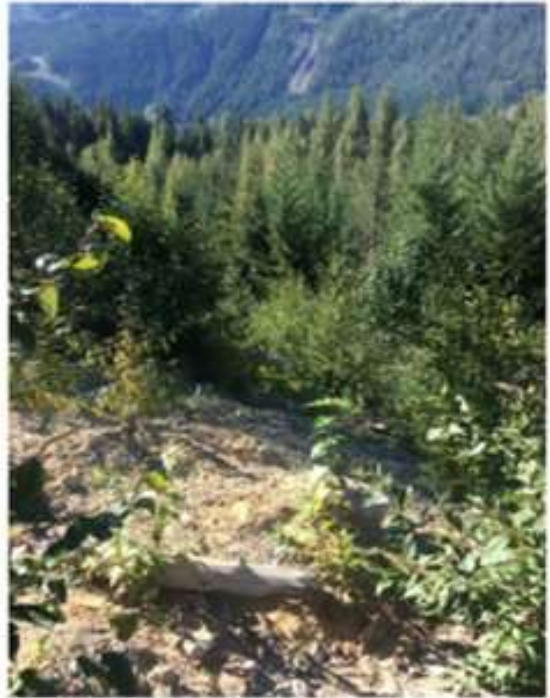
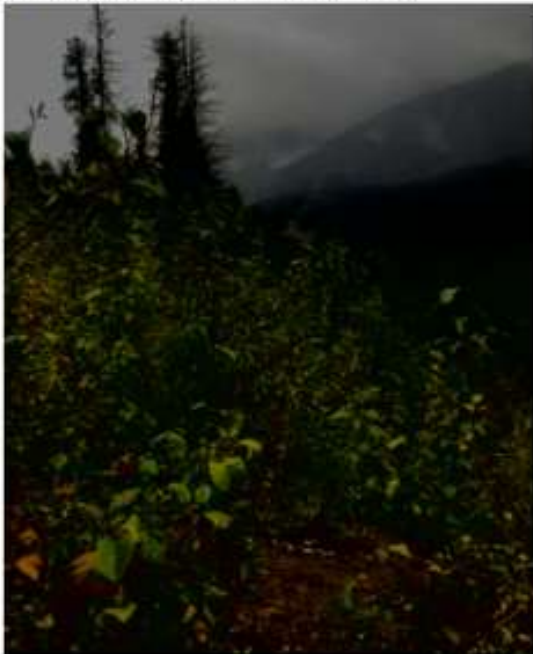
Figure 1A. Zone 1: 36 Km Borrow Pit Plot S Photos from 2018, 2020 and 2023

Stratum: 2018 36Km Borrow Pit/Plot: S/Comments
Overview photo looks South towards plot center. Oct 16, 2018 11.58.04 AM.jpg

Stratum: 2020 36 Km Borrow Pit/Plot: S/Comments
Overview photo looks South from plot S.jpg

Stratum: 36 Km Borrow Pit/Plot: S/Plot Name
Overview photo looks South from plot S.jpeg

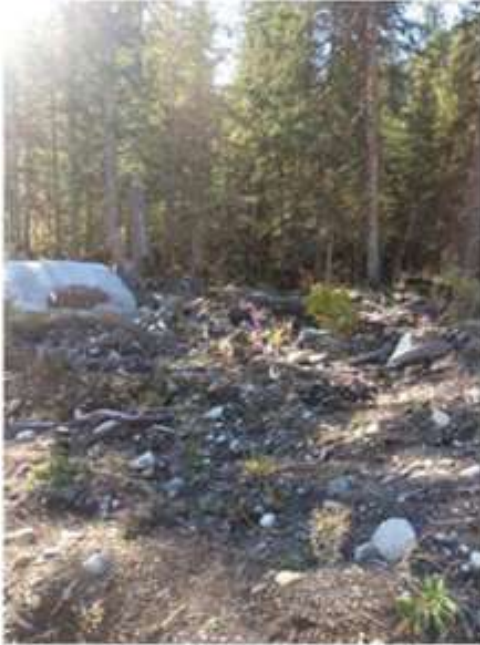
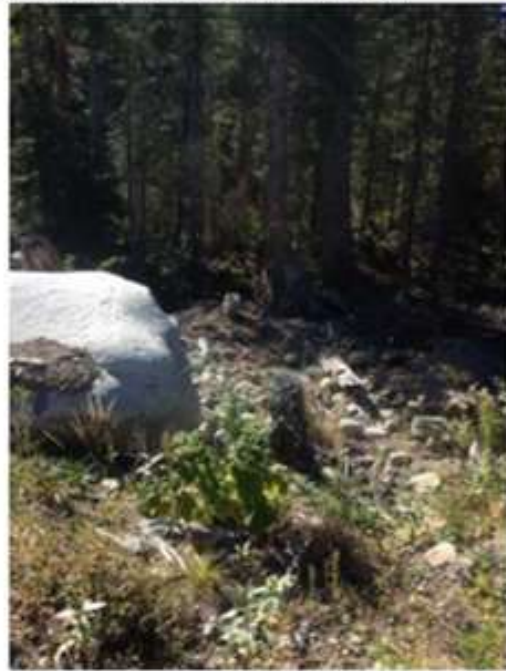
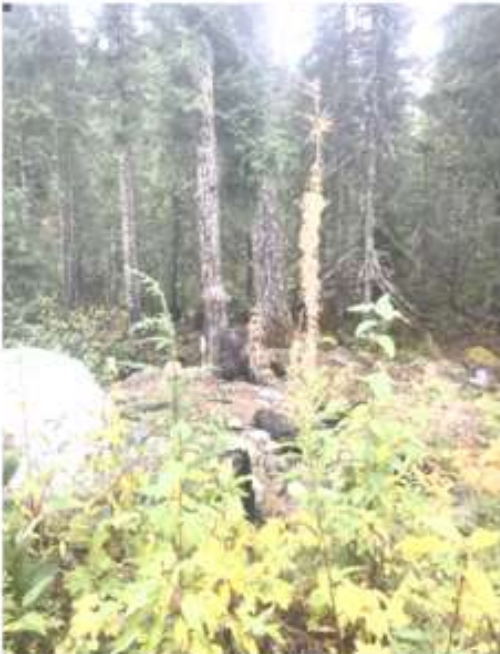
Figure 2B. Zone 1: Boulder Powerhouse and Spoil Plot Q Photos from 2018, 2020 and 2023

Stratum: 2018 Boulder Powerhouse and Spoil/Plot:
Q/Comments
Overview photo looks South towards plot center. Oct
15, 2018 12.07.35 PM.jpg

Stratum: 2020 Boulder Powerhouse and Spoil/Plot:
Q/Comments
Overview photo looks South from plot Q.jpg

Stratum: 2023 Boulder Powerhouse and Spoil/Plot:
Q/Plot Name
Overview photo looks South from plot Q.jpeg

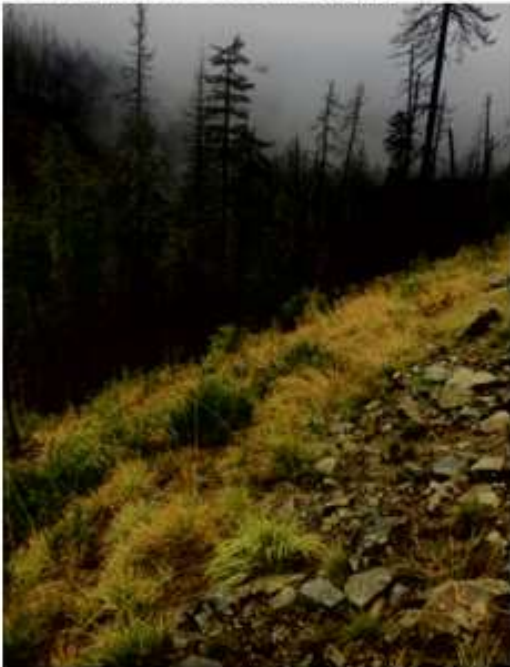
Figure 3A. Zone 2 Boulder Spoil #2 Plot K Photos from 2018, 2020 and 2023

Stratum: 2023 Boulder Spoil #2/Plot: K/Plot Name
Overview photo looks South from plot K.jpeg

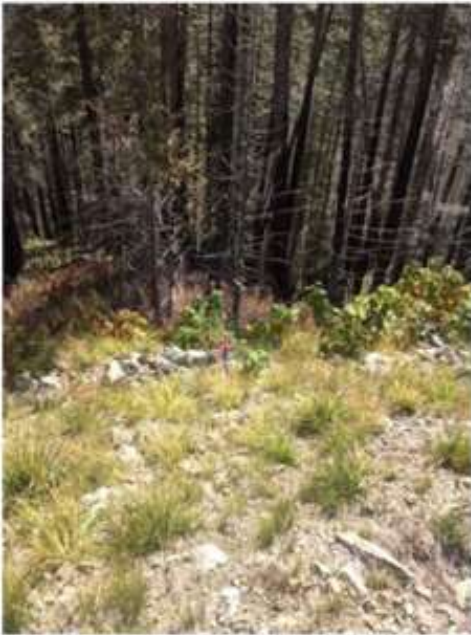
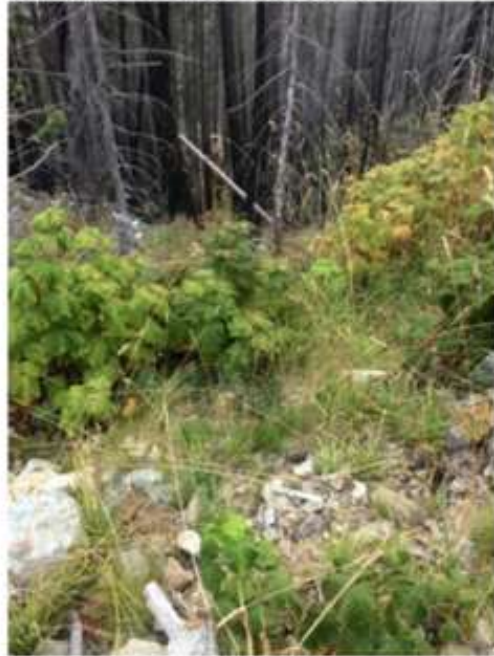
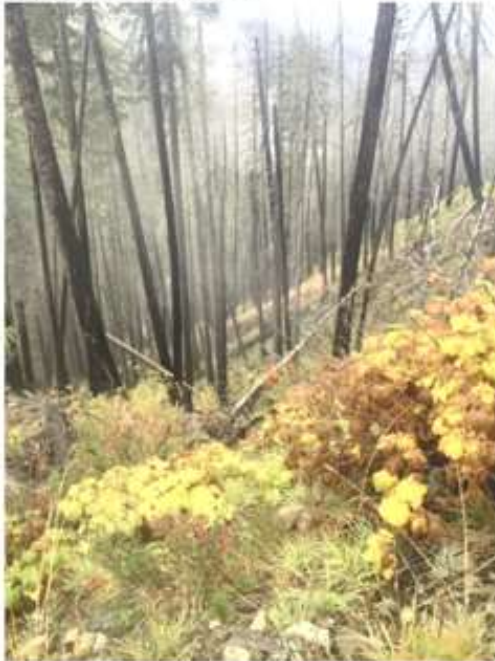
Figure 4B. Zone 2 Boulder Spoil #2 Plot L Photos from 2018, 2020 and 2023

Stratum: 2018 Boulder Spoil #2/Plot: L/Comments
Overview photo looks South towards plot center. Sep 26, 2018 01.10.41 PM.jpg

Stratum: 2020 Boulder Spoil #2/Plot: L/Comments
Overview photo looks South from plot L.jpg

Stratum: 2023 Boulder Spoil #2/Plot: L/Plot Name
Overview looks S from L.jpeg

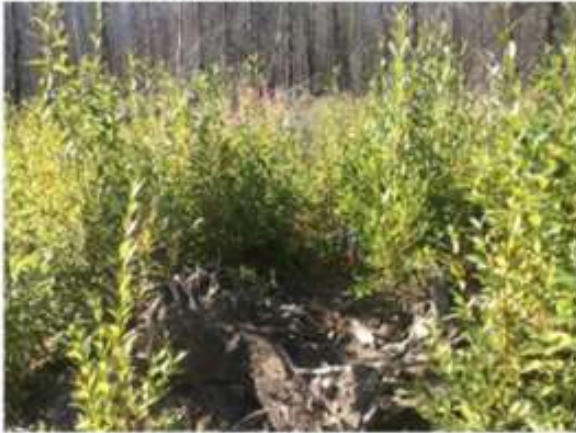
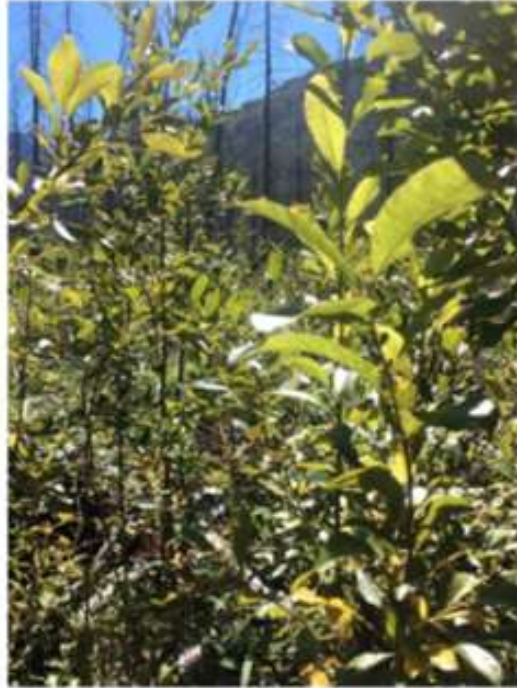
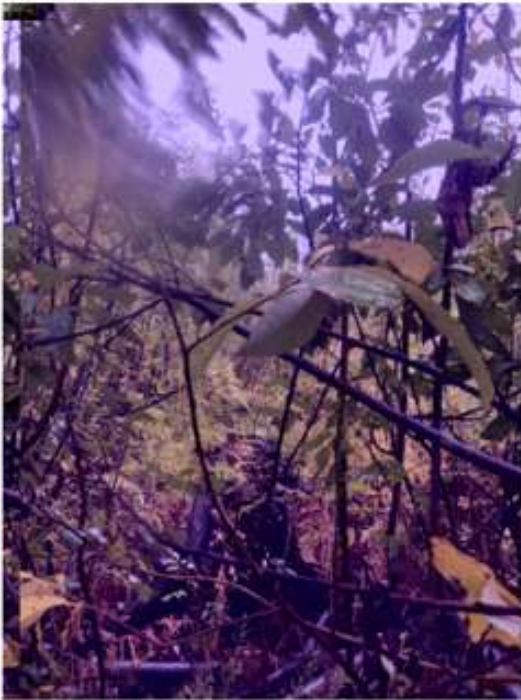
Figure 5C. Zone 2 Explosive Magazine Plot 001 Photos from 2018, 2020 and 2023

Stratum: 2018 Explosive Magazine/Plot: 001/Comments
Overview photo looks North towards plot center. Sep
05, 2018 11.22.20 AM.jpg

Stratum: 2020 Explosive Magazine/Plot: 001/Comments
Overview photo looks South from plot 001.jpg

Stratum: 2023 Explosive Magazine/Plot: 001/Plot Name
Overview photo looks S from 001.jpeg

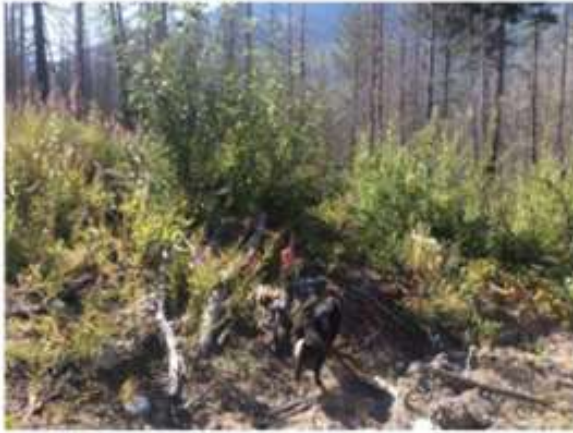
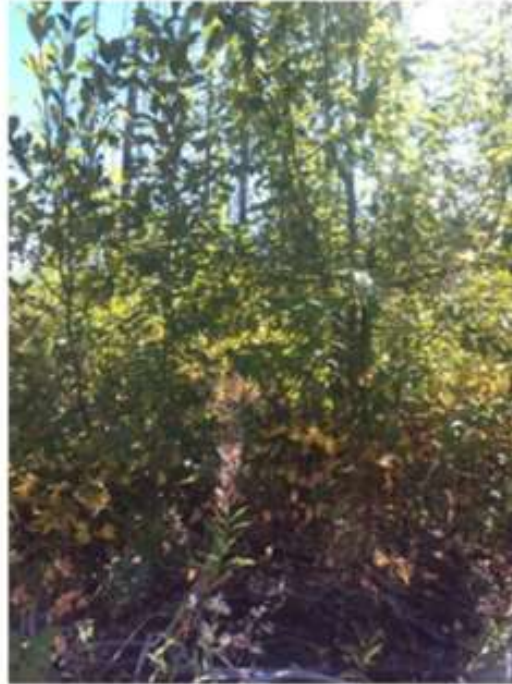
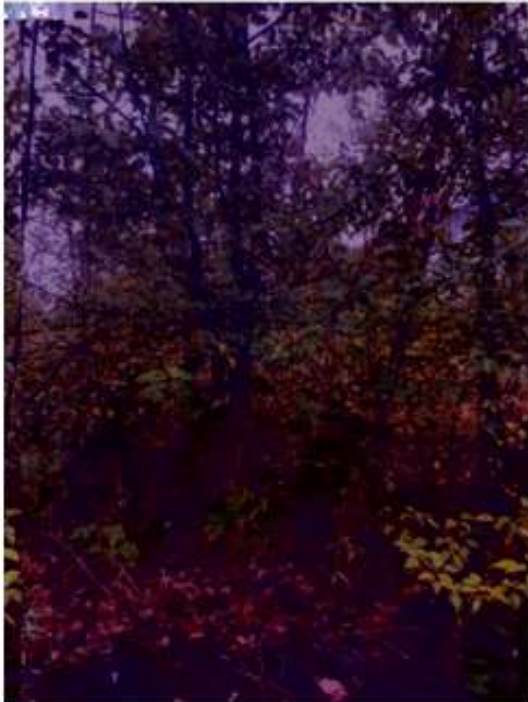
Figure 6D. Zone 2 Plot Explosive Magazine Plot 002 Photos from 2018, 2020 and 2023

Stratum: 2018 Explosive Magazine/Plot: 002/Comments
Overview photo looks North towards plot center. Sep
05, 2018 12.20.55 PM.jpg

Stratum: 2020 Explosive Magazine/Plot: 002/Comments
Overview photo looks South from plot 002.jpg

Stratum: 2023 Explosive Magazine/Plot: 002/Plot Name
Overview photo looks South from plot 002.jpeg

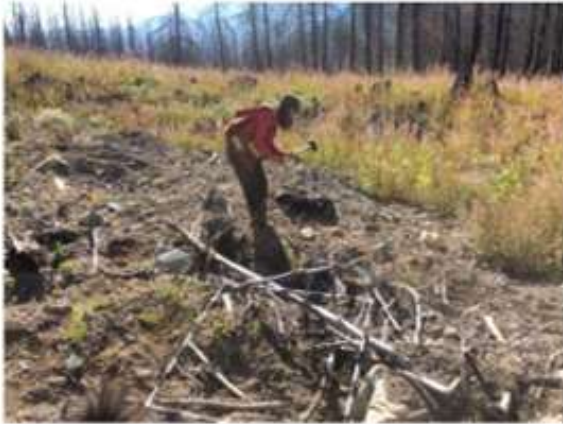
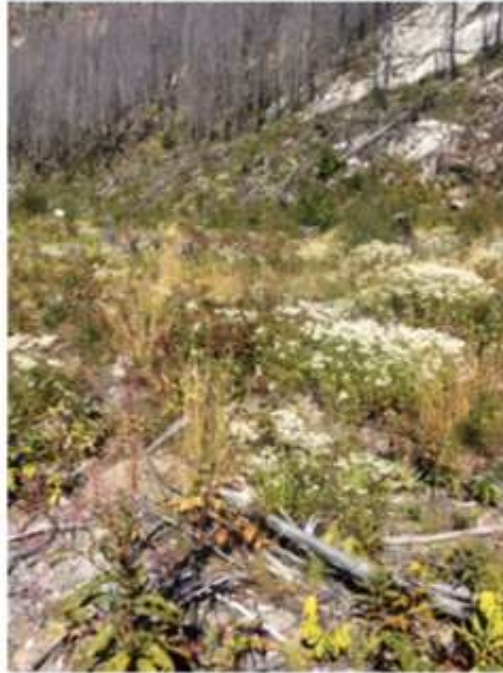
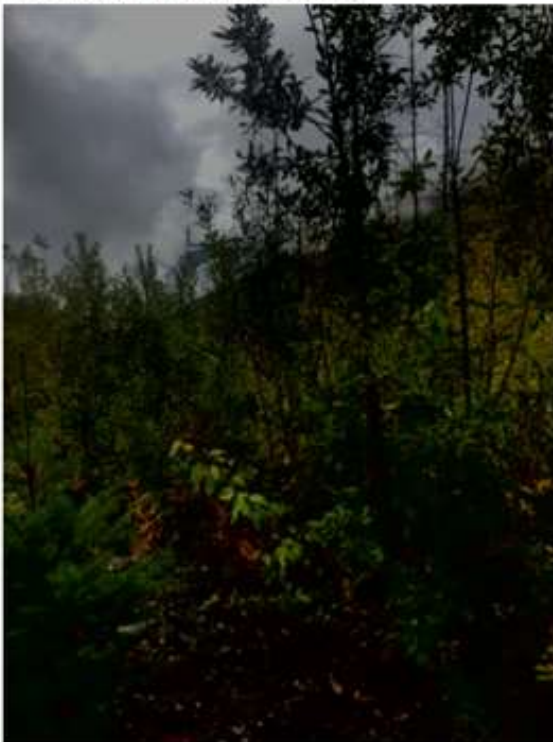
Figure 7E. Zone 2 Plot Explosive Magazine Plot 003 Photos from 2018, 2020 and 2023

Stratum: 2018 Explosive Magazine/Plot: 003/Comments
Overview photo looks North toward plot center. Sep
05, 2018 11.47.35 AM.jpg

Stratum: 2020 Explosive Magazine/Plot: 003/Comments
Overview photo looks South from plot 003.jpg

Stratum: 2023 Explosive Magazine/Plot: 003/Plot Name
Overview photo looks S from 001.jpeg

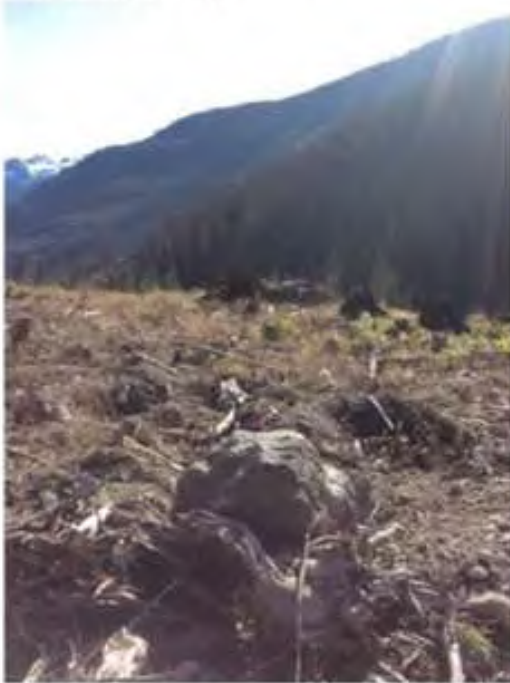
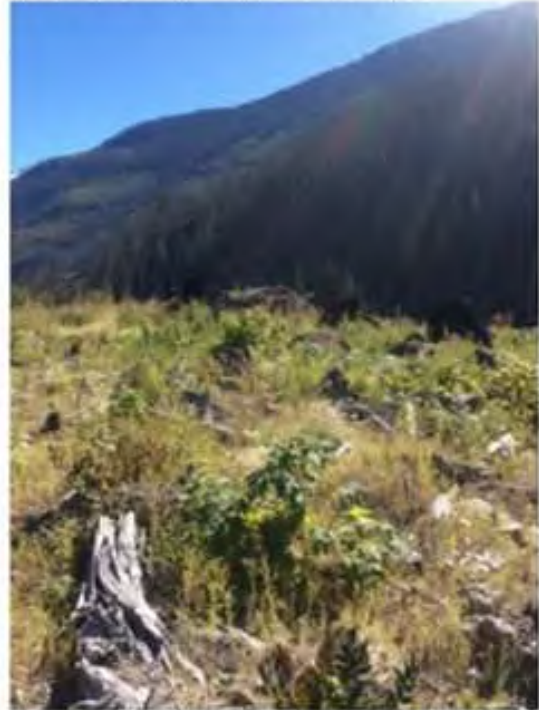
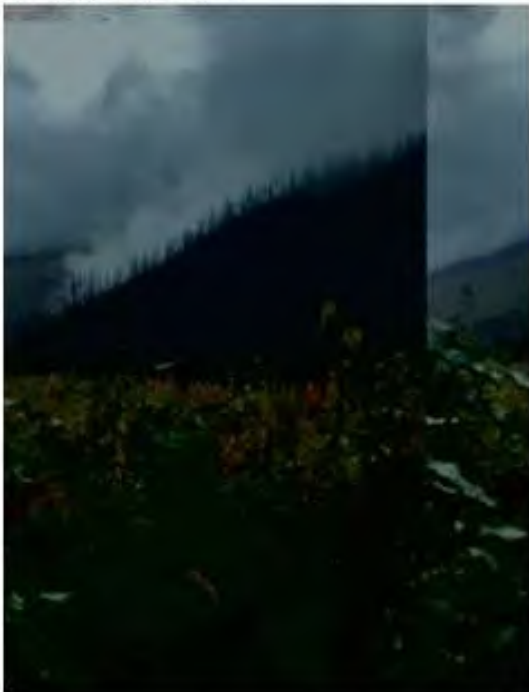
Figure 10B. Zone 3. 41.7 Km Borrow Pit Plot Photos from 2018, 2020 and 2023

Zone 3 includes two sites - the 41.7 Km Laydown and the Upper Lillooet Penstock. The portion of the laydown located on the West side of the Lillooet River Forest Service Road (FSR) was planted in 2017 with berry shrubs to meet the requirements of the grizzly bear management strategy and was subsequently planted in 2018 with a mix of conifer species. This site had two plots established in 2018, only one of these plots could be found in 2023. A portion of the laydown site located on the East side of the FSR was planted in 2019, in 2020 there was only one year of data collected so this area was discussed in section 6.2 of the 2020 report. The plot data for the East side of the FSR has been included with this dataset to offset the loss of the missing plot. The terrain in this site is mainly flat and was mounded when the site was reclaimed. Soils contain a good mix of mineral and organics. The area currently exceeds the conifer density target of 1,000 sph with a total of 1,650 sph. The planted conifers are of good form and vigour with strong leader growth. Natural ingress of Douglas fir, Western hemlock and yellow cedar continues to establish with heights ranging from 25 to 120cm. Cottonwood numbers continue to increase and add to the biomass and are not out competing the conifers. The diversity of shrub species and corresponding sph has decreased but overall cover of trees and berry shrubs has increased. Moss cover continues to increase and is dependent on microtopography. Moss cover is expected to increase as more shading is created by the growing herbs, shrubs, and trees. This site continues to meet the revegetation targets and no further planting is required. No soil erosion or siltation was noted at the time of the survey. For reference a photo was taken near where plot N should have been located.

Stratum: 2018 41.7km Laydown/Plot: N/Comments
Overview photo looks South towards plot center. Sep
26, 2018 02.15.33 PM.jpg

Stratum: 2020 41.7 Km Borrow Pit/Plot: N/Comments
Overview photo looks South from plot N.jpg

Stratum: 2023 41.7 Km Borrow Pit/Plot: N/Plot Name:
Plot N looking south .jpeg

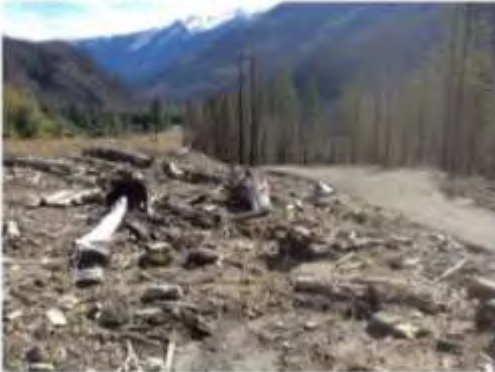
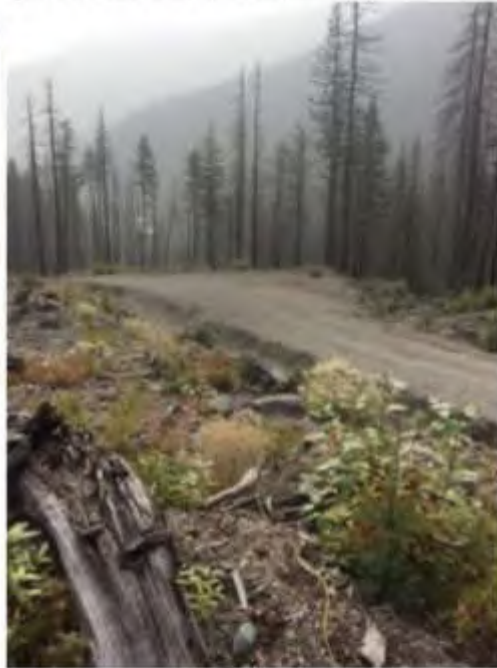
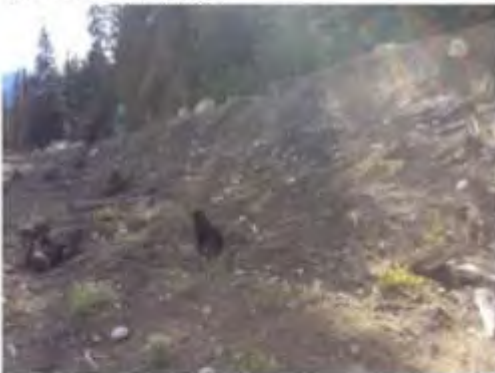
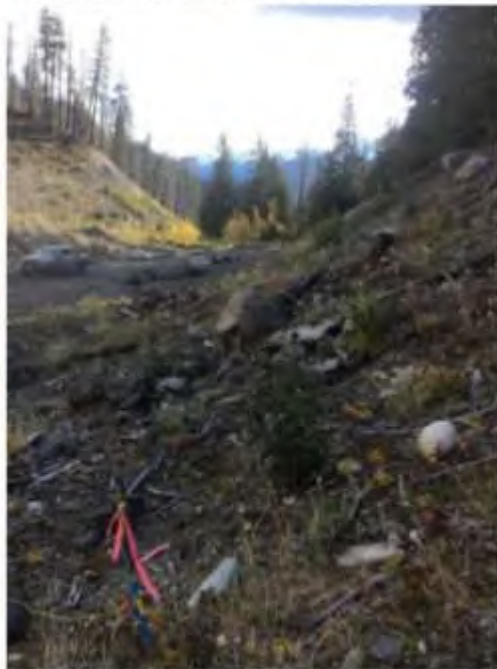
Figure 12D. Zone 3. Upper Lillooet Penstock Plot I and H Photos from 2018, 2020 and 2023

The Upper Lillooet Penstock is a long linear site that follows the buried penstock. This area was not planted with trees, however it was planted with shrubs and has no wildlife specific planting requirements. The penstock has good distribution of coarse woody debris and soils are not compacted. Four plots were established in 2018. The plot at the north end of the penstock was partially disturbed since plot data was collected in 2018 (Year 1). The disturbance was caused by machine blading as it is along a right-of-way for the adjacent transmission line, this affected approximately one quarter of the plot. The disturbed area has started to recover, and it was determined that the disturbance was not significant enough to drop the plot from the data set. In 2023 two of the four plots could not be located as the area was used for helicopter staging and wildfire (V31300) fighting efforts, and may have been removed. The number of conifers and species diversity has decreased since 2020 and is likely due to the reduction in plot numbers, decreasing sample size. The number of deciduous stems is less than half of what was counted in 2020. The conifer and deciduous species will eventually need to be manually brushed to protect the integrity of the penstock, which will not be required for another 3 to 6 years. Shrub diversity has remained constant from 2020 to 2023 and the number of sph has increased significantly from 8,850 in 2020 up to 22,900 in 2023 with red raspberry having the largest increase in sph. No erosion or siltation issues were noted during the survey. The moss cover is increasing slowly and is dependent on microtopography. No forest health issues were noted to be affecting any of the species. No further revegetation treatments are required for this site. No soil erosion or siltation was noted at the time of the survey.

Stratum: 2018 Upper Lillooet Penstock/Plot:
I/Comments
Overview photo looks South towards plot center. Sep
18, 2018 02.11.15 PM.jpg

Stratum: 2020 Upper Lillooet Penstock/Plot:
I/Comments
Overview photo looks South from plot I.jpg

Stratum: 2018 Upper Lillooet Penstock/Plot:
H/Comments
Overview photo looks South towards plot center. Sep
18, 2018 01.15.06 PM.jpg

Stratum: 2020 Upper Lillooet Penstock/Plot:
H/Comments
Overview photo looks South from plot H.jpg

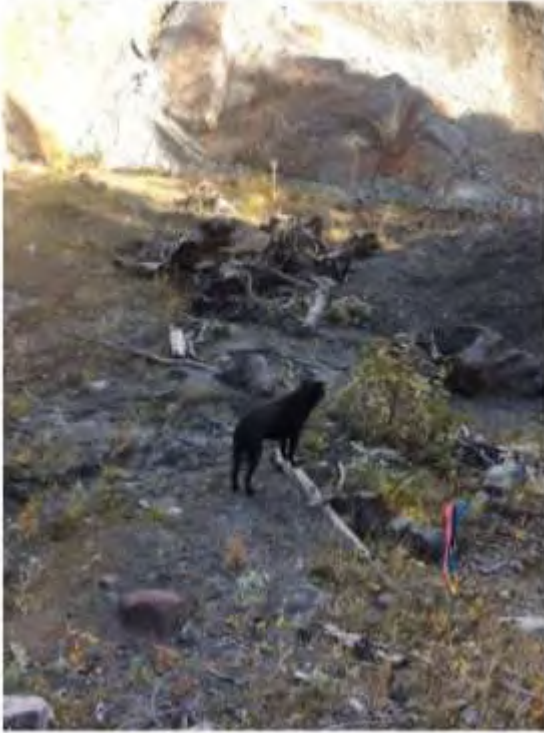
Figure 13E. Zone 3. Upper Lillooet Penstock Plot H Photos from 2018, 2020 and 2023

Site has been partially disturbed since 2018, jpg

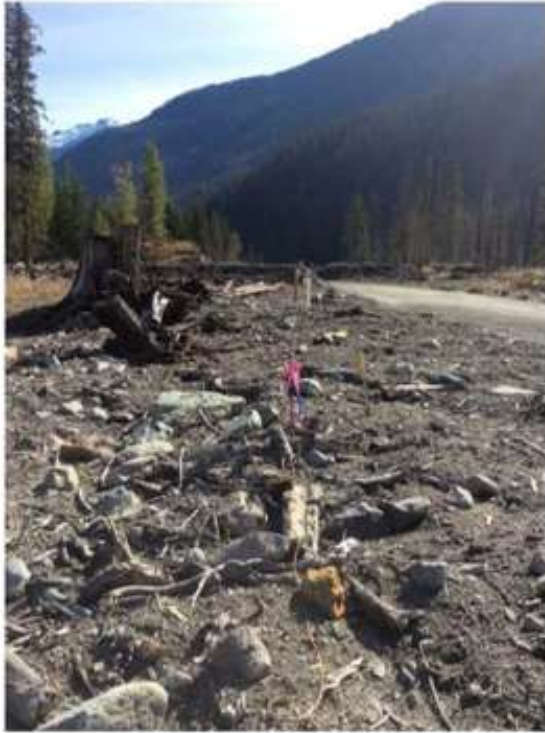
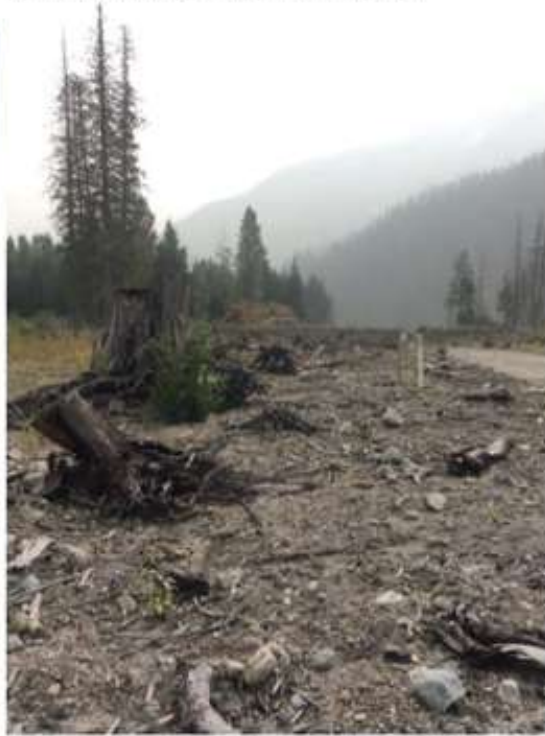
Figure 14F. Zone 3 . Upper Lillooer Penstock Plot P Photos from 2018, 2020 and 2023

Stratum: 2018 Upper Lillooet Penstock/Plot:
P/Comments
Overview photo looks South towards plot center. Sep.
26, 2018 02:59:52 PM.jpg

Stratum: 2020 Upper Lillooet Penstock/Plot:
P/Comments
Overview photo looks South from plot P.jpg
