Upper Lillooet Hydro Project

Operational Environmental Monitoring Year 5

April 24, 2024

Ecofish Research Ltd.

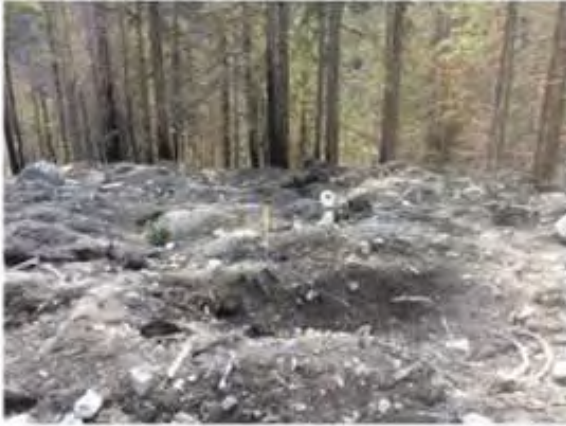
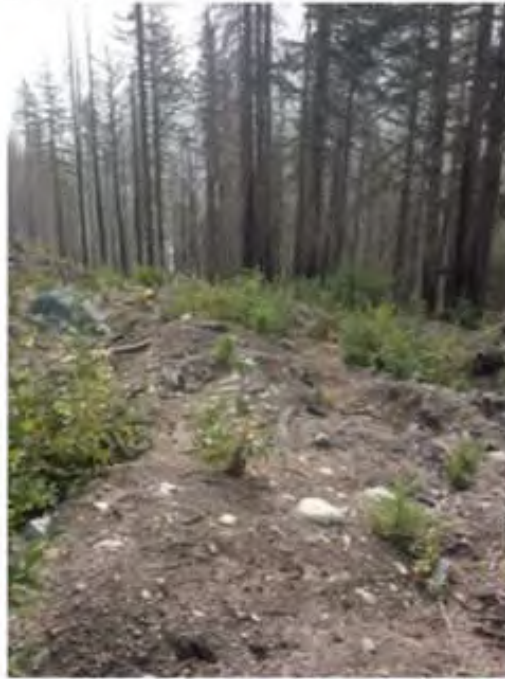
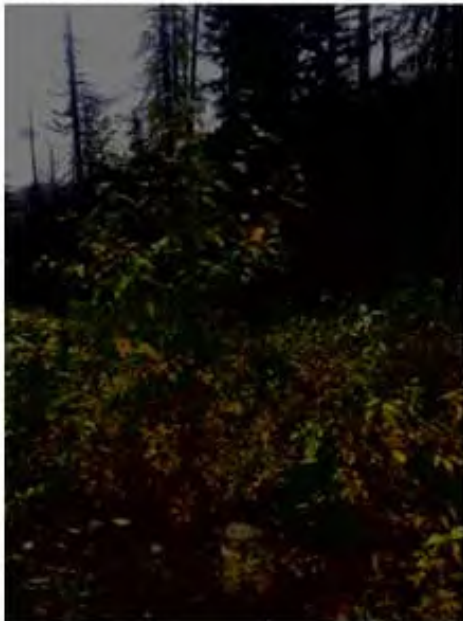
Figure 15.A Zone 4. Upper Spoil #6 Plot J Photos from 2018, 2020 and 2023

Stratum: 2018 Upper Spoil #6/Plot: J/Comments
Overview photo looks South towards plot center. Sep
18, 2018 02.23.18 PM.jpg

Stratum: 2020 Upper Spoil #6/Plot: J/Comments
Overview photo looks South from plot J.jpg

Stratum: 2023 Upper Spoil #6/Plot: J/Plot Name
Overview photo looks South from plot J.jpeg

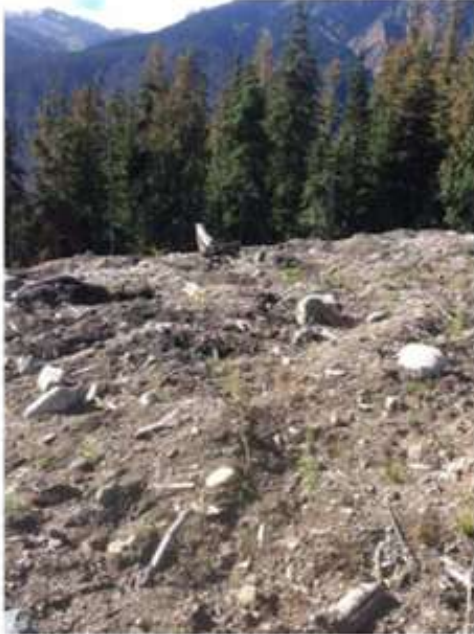
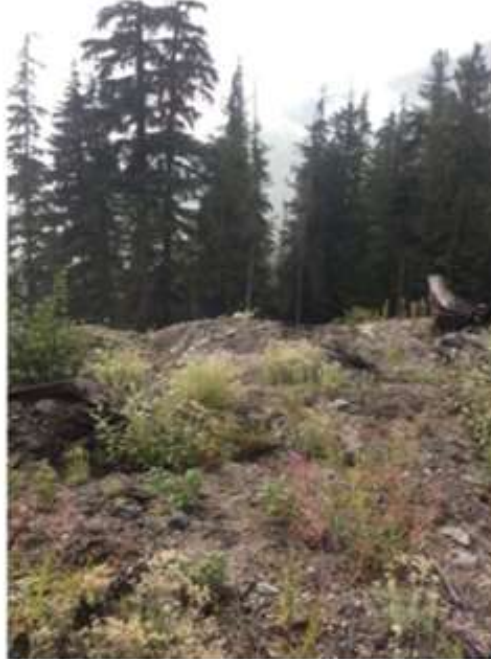
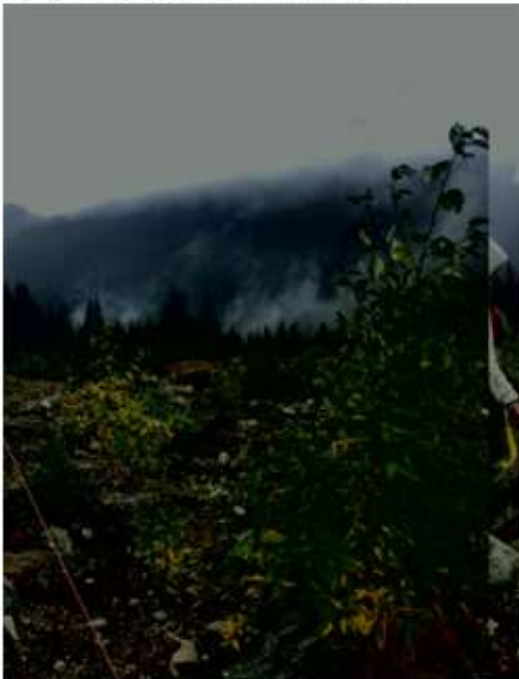
Figure 17B. Zone 5. Upper Spoil #3 Plot E Photos from 2018, 2020 and 2023

Stratum: 2018 Upper Spoil #3/Plot: E/Comments
Overview photo looks South towards plot center. Sep
18, 2018 11.08.44 AM.jpg

Stratum: 2020 Upper Spoil #3/Plot: E/Comments
Overview photo looks South from plot E.jpg

Stratum: 2023 Upper Spoil #3/Plot: E/Plot Name
Overview photo looks South from plot E.jpeg

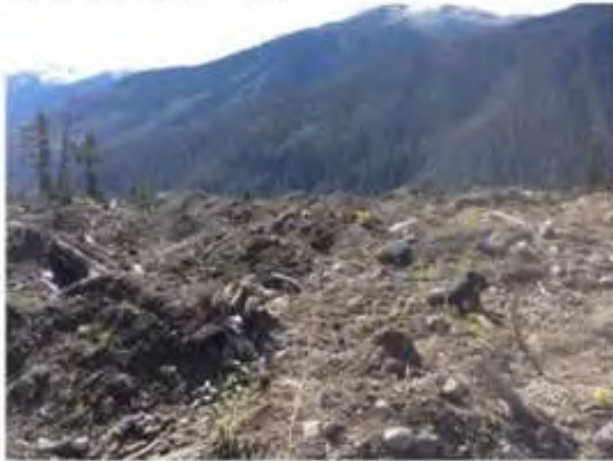
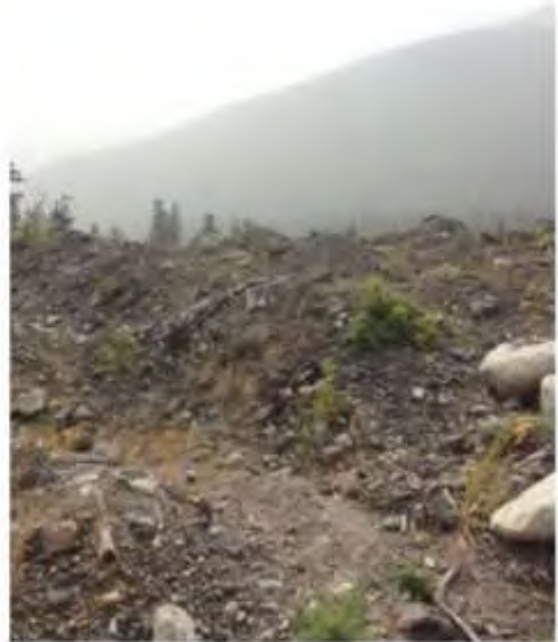
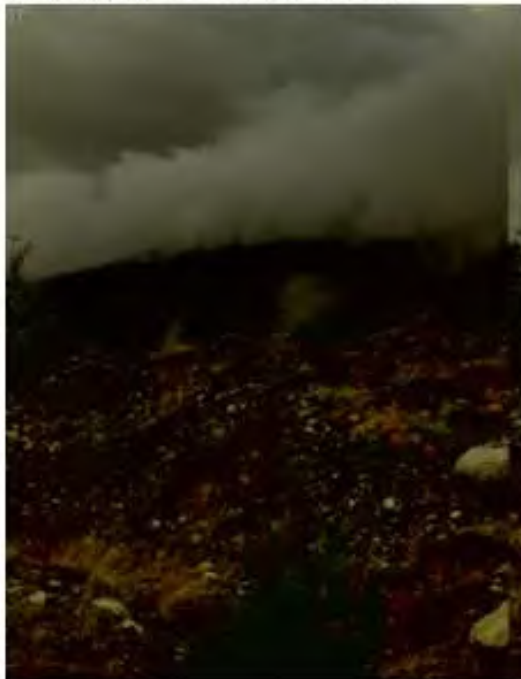
Figure 18C. Zone 5. Upper Spoil #4 Plot F Photos from 2018, 2020 and 2023

Spoil #4 has moderate to gentle slopes and was mounded prior to planting. Soils are mostly gravelly with some organics and sand mixed in. This site had good survival of the planted trees with Douglas-fir and Western white pine continuing to infill. The number of spruce stems have decreased due to drought conditions. The planted and natural conifers are of good form and vigour with moderate to strong leader growth. The conifers range from 30 to 145 cm in height. This site exceeds the target of 1,000 sph with 3,200 sph of conifers. The number of cottonwoods is also continuing to increase from 500 sph to 1,000 sph. The planted and natural berry shrubs are also growing well and species diversity has increased from three to five with Sitka alder and willow now present on the site. The number of sph has increased from 4,100 sph to 6,300 sph. The increase in the number of sph ensures biomass will be added to the soils annually, thus increasing the organic component of the soils over time. Moss cover is increasing slowly but cover is still quite minimal. No further treatments are required on this site. No erosion or siltation was noted during the survey.

Stratum: 2018 Upper Spoil #4/Plot: F/Comments
Overview photo looks South towards plot center. Sep
18, 2018 12.00.57 PM.jpg

Stratum: 2020 Upper Spoil #4/Plot: F/Comments
Overview photo looks South from plot F.jpg

Stratum: 2023 Upper Spoil #4/Plot: F/Plot Name
Overview photo looks South from plot F.jpeg

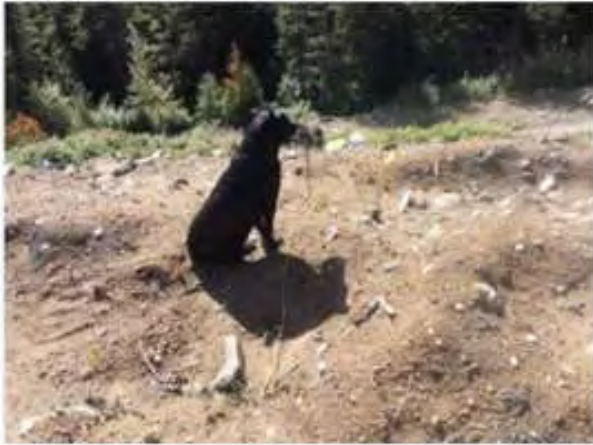
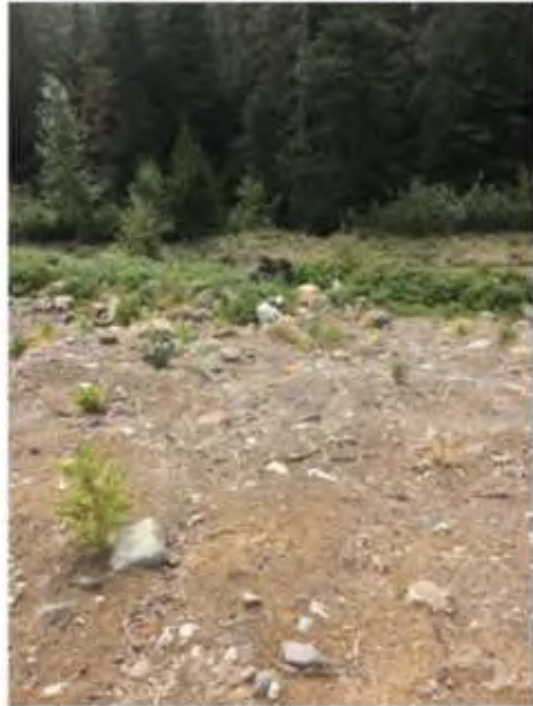
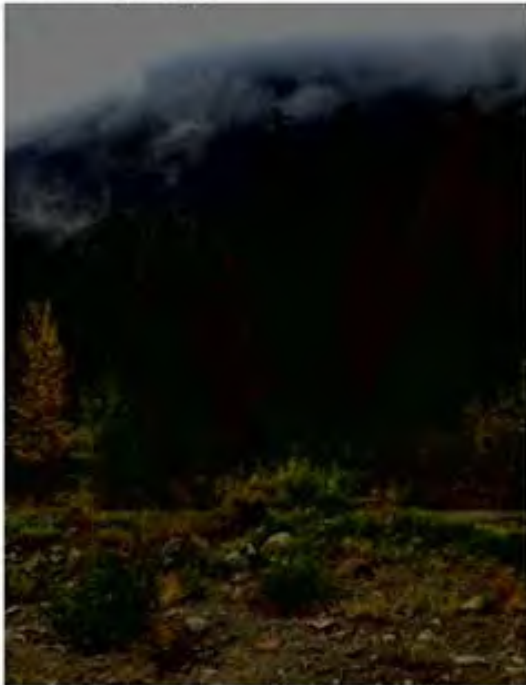
Figure 19D. Zone 5. Upper Spoil #4 Plot G Photos from 2018, 2020 and 2023

Stratum: 2018 Upper Spoil #4/Plot: G/Comments
Overview photo looks South towards plot center. Sep
18, 2018 12.20.59 PM.jpg

Stratum: 2020 Upper Spoil #4/Plot: G/Comments
Overview photo looks South from plot G.jpg

Stratum: 2023 Upper Spoil #4/Plot: G/Plot Name
South from plot G.jpeg

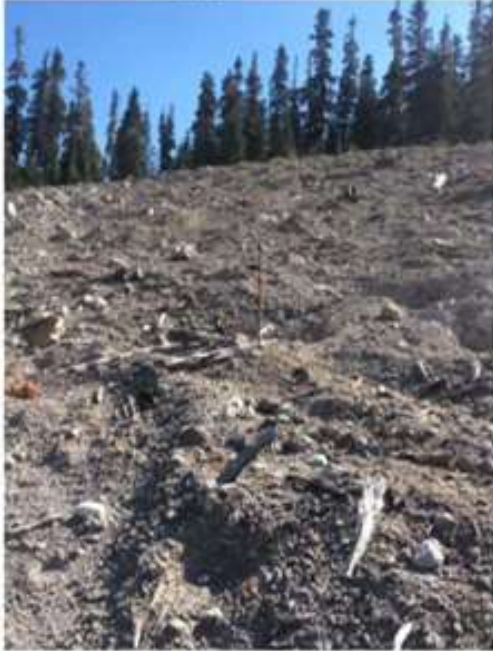
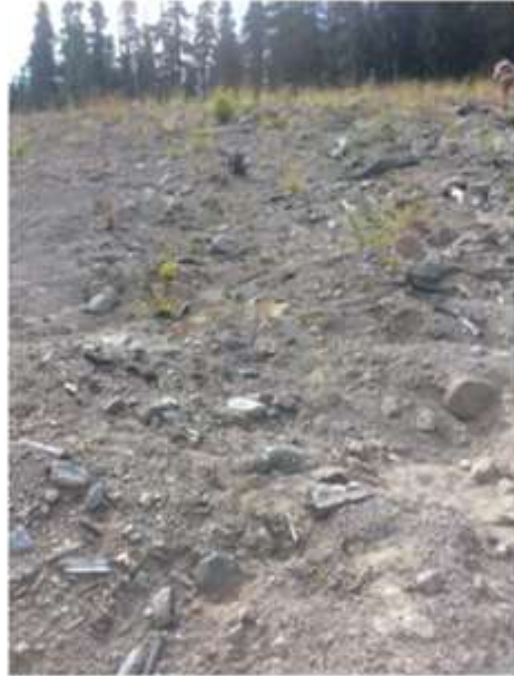
Figure 23B. Zone 6. Diversion Channel Slopes Plot 009 Photos from 2018, 2020 and 2023

Stratum: 2018 Diversion Channel Slopes/Plot:
009/Comments
Overview photo looks at plot from the North side. Sep
06, 2018 03.00.48 PM.jpg

Stratum: 2020 Diversion Channel and Slopes/Plot:
009/Comments
Overview photo looking South from plot 009.jpg

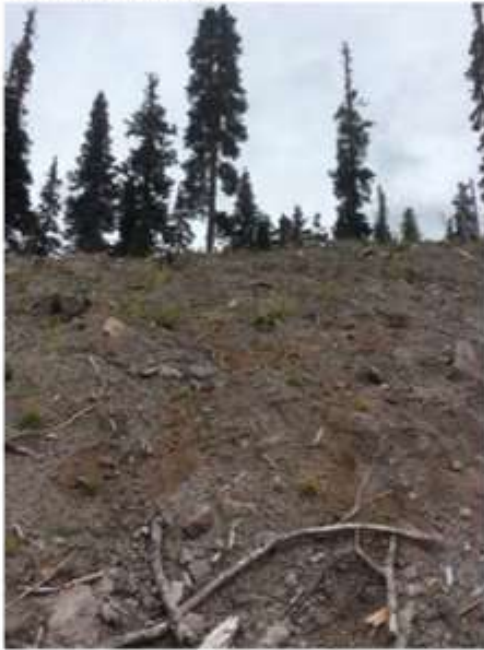
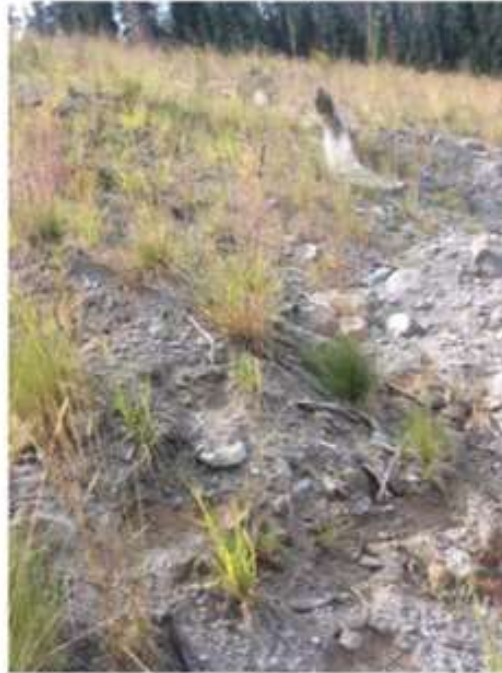
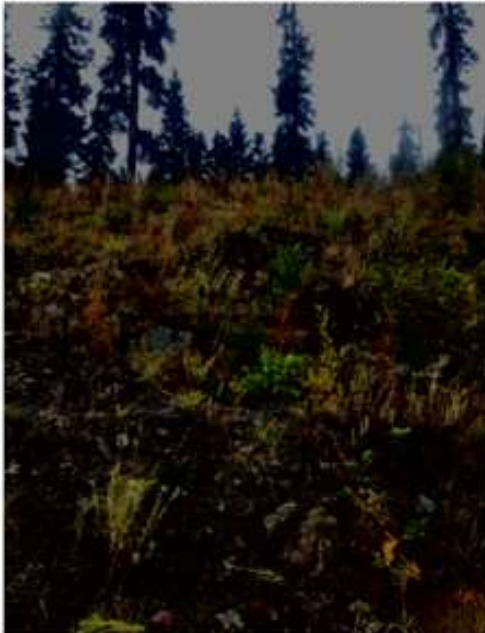
Figure 24C. Zone 6. Diversion Channel and Slopes Plot 013 Photos from 2018, 2020 and 2023

Stratum: 2018 Diversion Channel Slopes/Plot: 013/Comments
Overview photo looks South towards plot center. Sep 07, 2018 12.01.34 PM.jpg

Stratum: 2020 Diversion Channel and Slopes/Plot: 013/Comments
Overview looking South plot 013.jpg

Stratum: 2023 Diversion Channel and Slopes/Plot: 013/Plot Name
Overview photo looks South from plot 013.jpeg

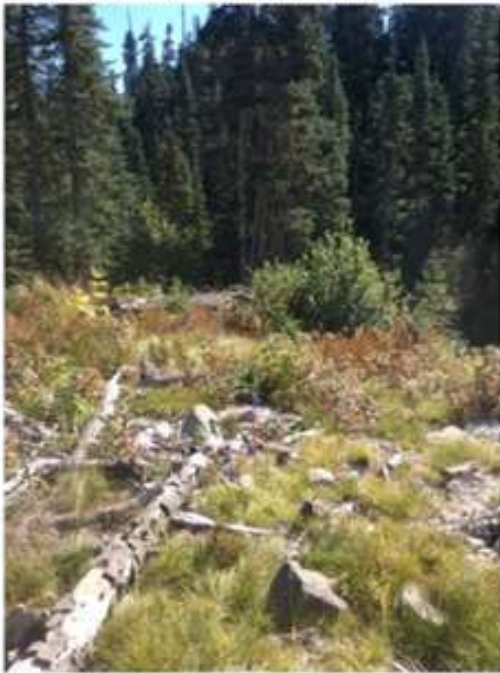
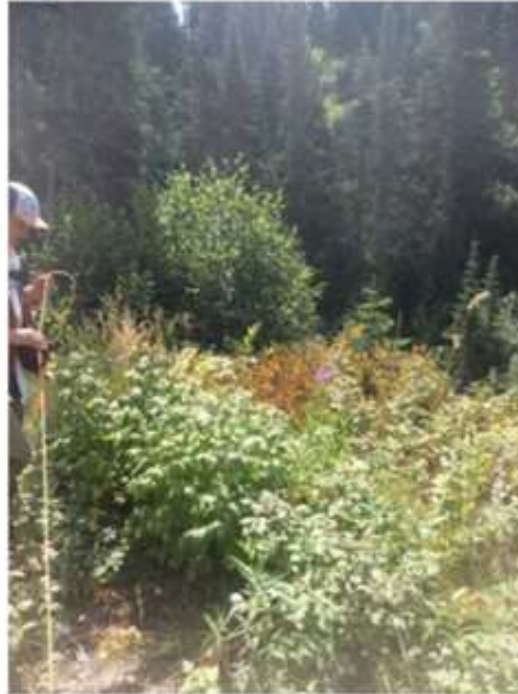
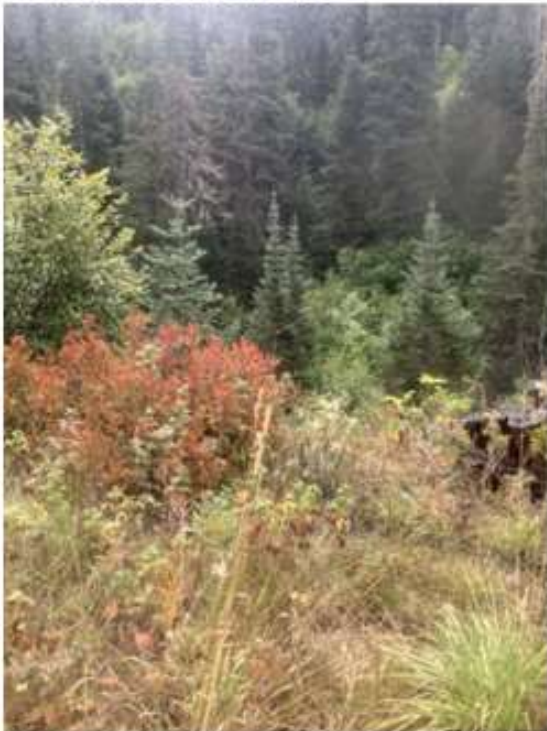
Figure 25D. Zone 6. Keyhole Laydown Plot 007 Photos from 2018, 2020 and 2023

Stratum: 2018 Keyhole Laydown/Plot: 00/Comments
Overview photo looks towards plot center from North
side of plot. Sep 06, 2018 02.13.30 PM.jpg

Stratum: 2020 Keyhole Laydown/Plot: 007/Comments
Looking South plot center 007.jpg

Stratum: 2023 Keyhole Laydown/Plot: 007/Plot Name
Overview looks South from 07.jpeg

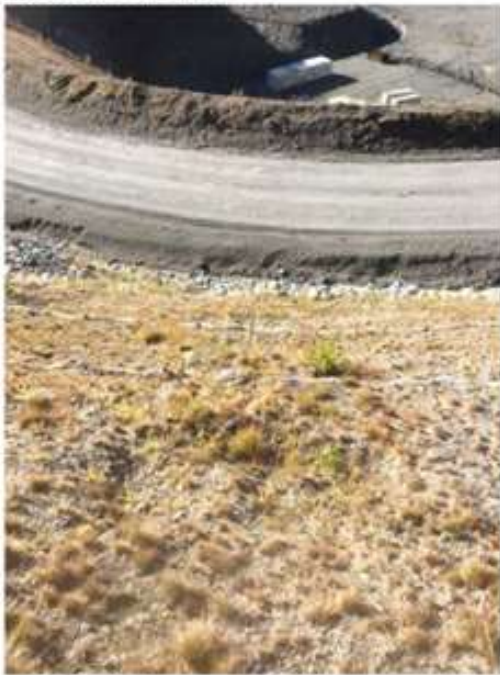
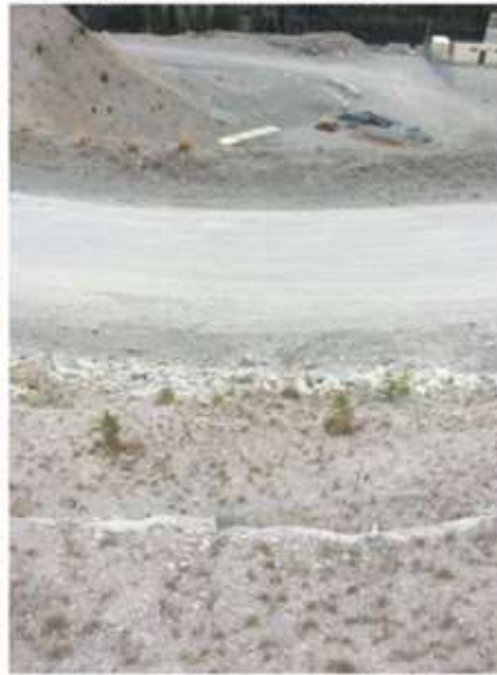
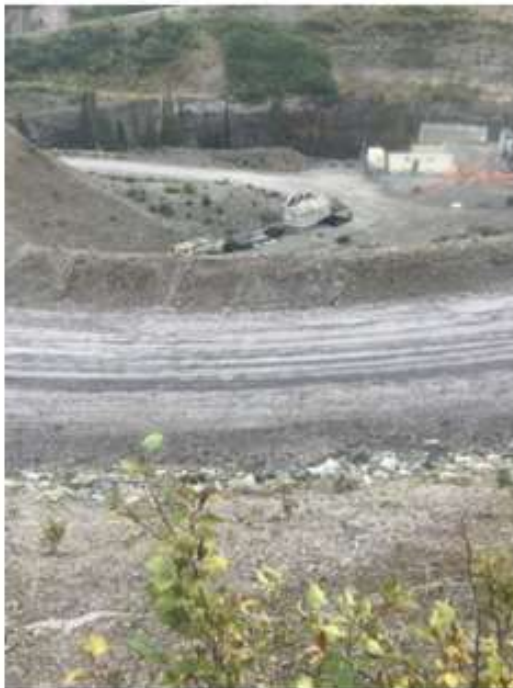
Figure 26E. Zone 6. Upper Intake and Laydown Plot B Photos from 2018, 2020 and 2023

Stratum: 2018 Upper Intake and Laydown/Plot:
B/Comments
Overview photo looks South towards plot center. Sep
18, 2018 09:12:42 AM.jpg

Stratum: 2020 Upper Intake and Laydown/Plot:
B/Comments
Overview photo looks South from plot B.jpg

Stratum: 2023 Upper Intake and Laydown/Plot: B/Plot
Name
Overview photo looks South from plot B.jpeg

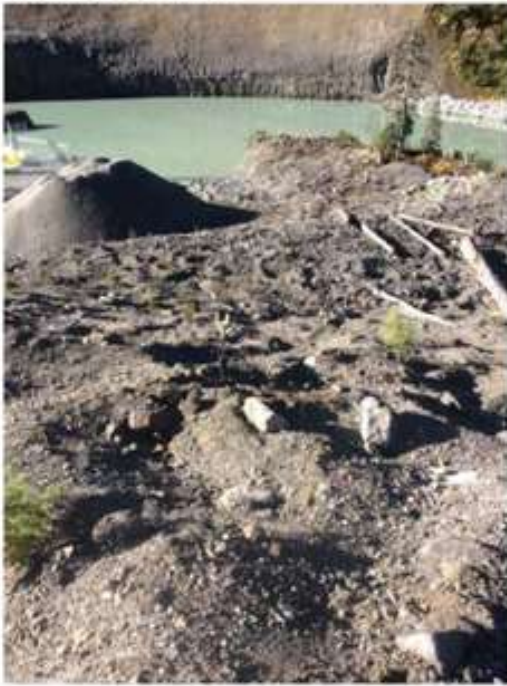
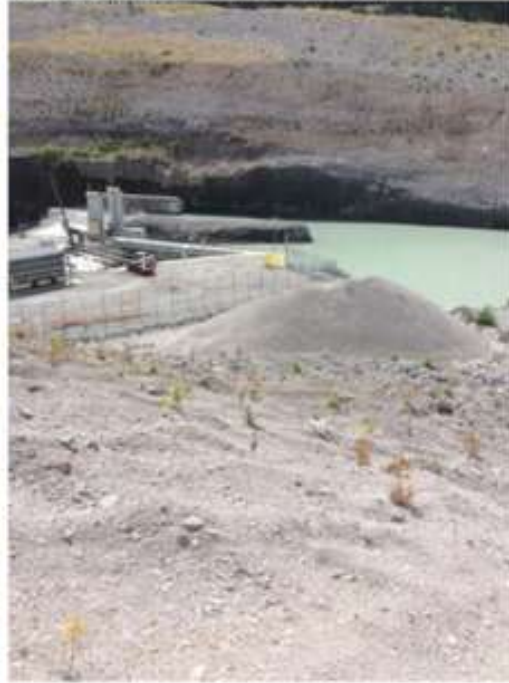
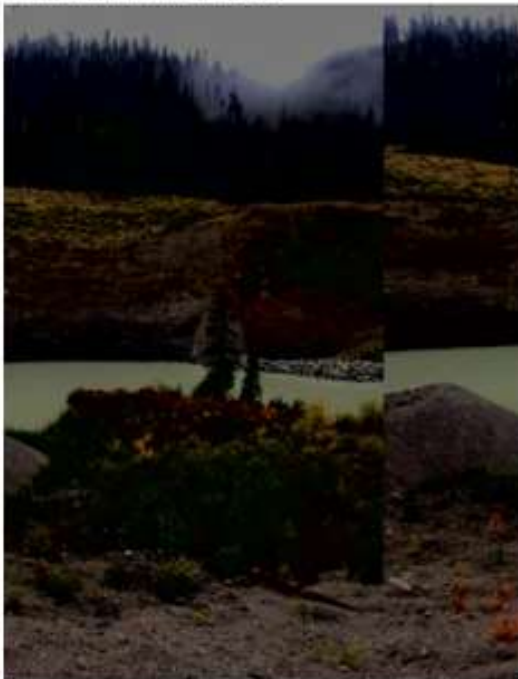
Figure 27F. Zone 6. Upper Intake and Laydown Plot C Photos from 2018, 2020 and 2023

Stratum: 2018 Upper Intake and Laydown/Plot:
C/Comments
Overview photo looks South towards plot center. Sep
18, 2018 09:24:35 AM .jpg

Stratum: 2020 Upper Intake and Laydown/Plot:
C/Comments
Overview photo looks South from plot C. .jpg

Stratum: 2023 Upper Intake and Laydown/Plot: C/Plot
Name
Looking south from plot C. .jpeg

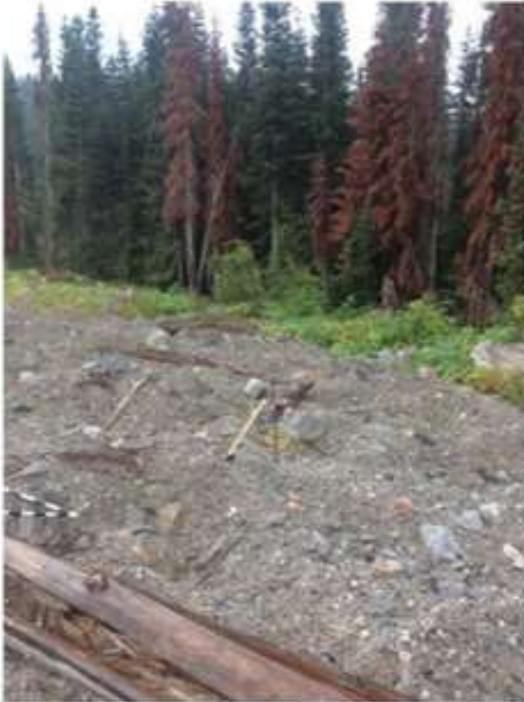
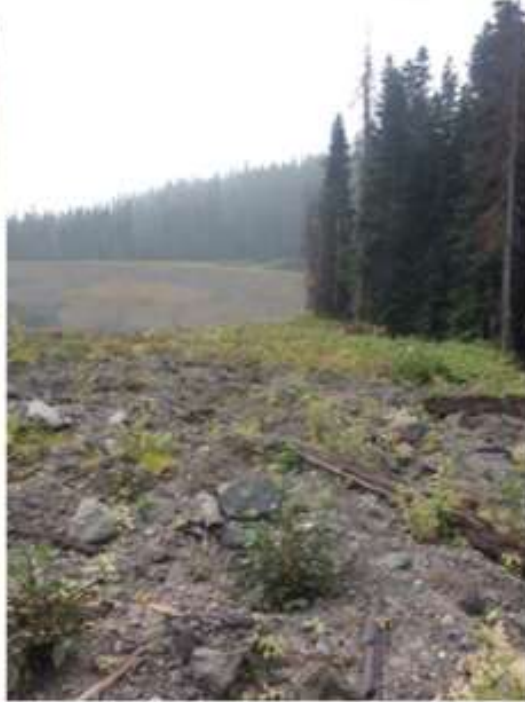
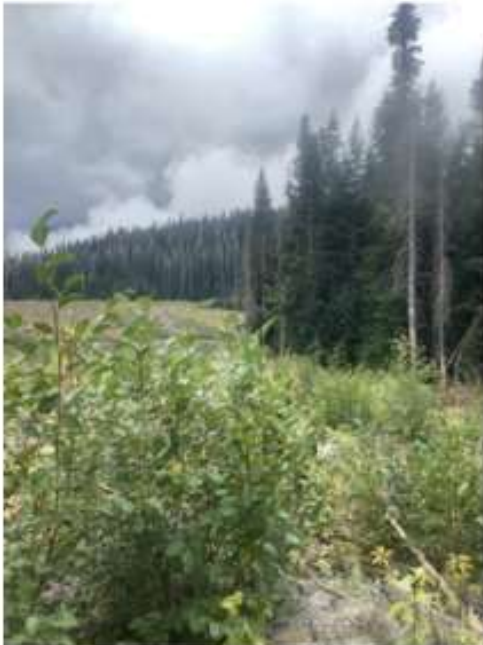
Figure 28G. Zone 6. Upper Intake and Laydown Plot 014 Photos from 2018, 2020 and 2023

Stratum: 2018 Upper Intake and Laydown/Plot:
014/Comments
Overview photo looks South towards plot center: Sep
07, 2018 02:43:28 PM.jpg

Stratum: 2020 Upper Intake and Laydown/Plot:
014/Comments
Overview photo looks South from plot 014.jpg

Stratum: 2023 Upper Intake and Laydown/Plot:
014/Plot Name
Overview photo looks South from plot 014.jpeg

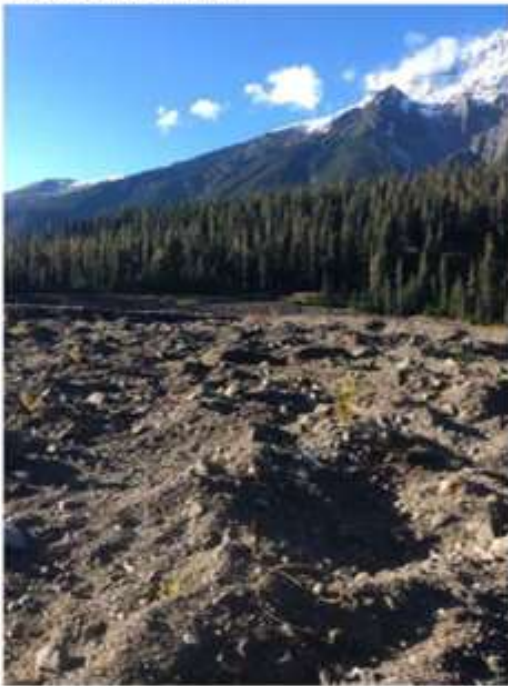
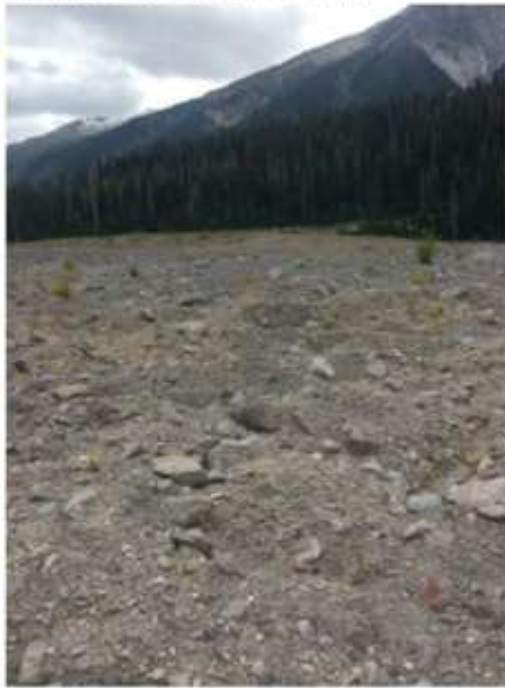
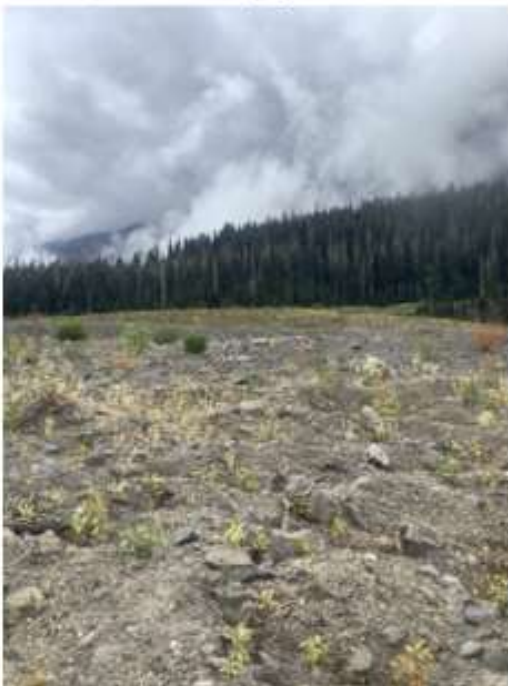
Figure 29H. Zone 6. Upper Intake and Laydown Plot A Photos from 2018, 2020 and 2023

Stratum: 2018 Upper Intake and Laydown/Plot:
A/Comments
Overview photo looks South towards plot center: Sep
18, 2018 09:00:54 AM.jpg

Stratum: 2020 Upper Intake and Laydown/Plot:
A/Comments
Overview looking South from c plot b.jpg

Stratum: 2023 Upper Intake and Laydown/Plot: A/Plot
Name:
Overview photo looks South.jpeg

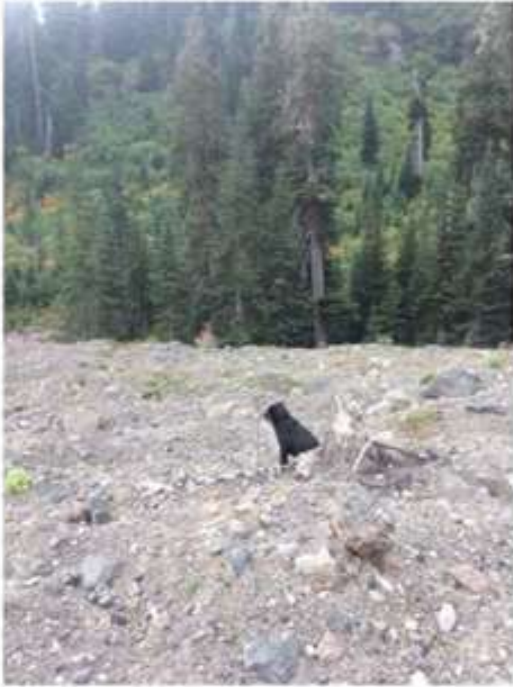
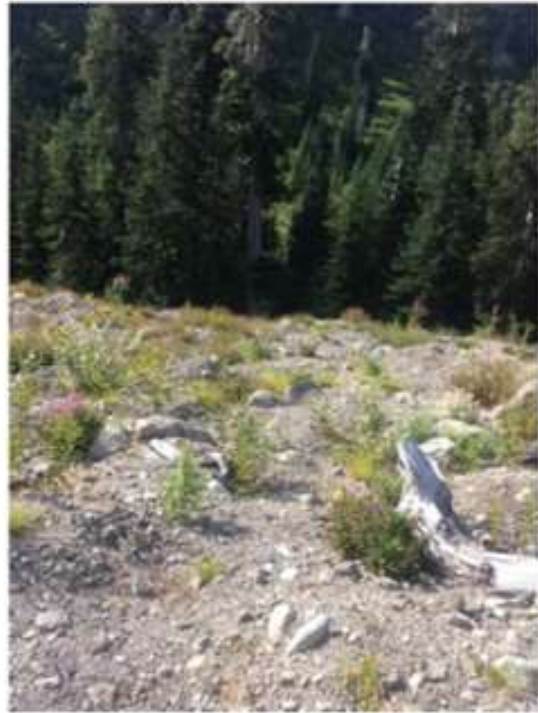
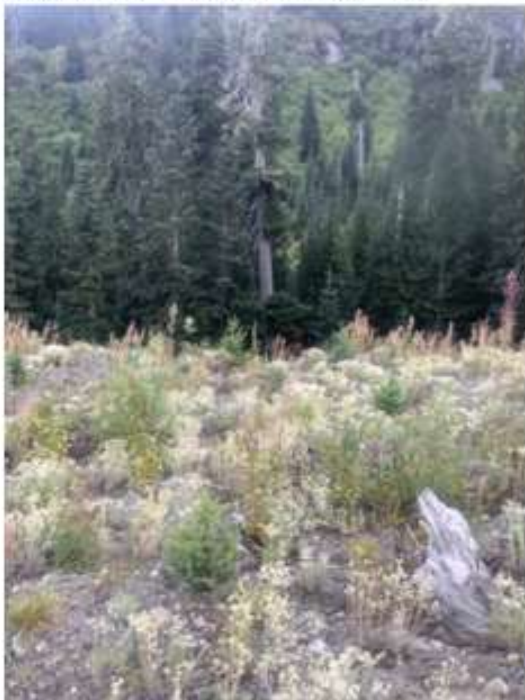
Figure 30I. Zone 6. Upper Spoil 1 Plot 010 Photos from 2018, 2020 and 2023

Stratum: 2018 Upper Spoil #1/Plot: 010/Comments
Overview photo looks South towards plot center. Sep
07, 2018 09.44.26 AM.jpg

Stratum: 2020 Upper Spoil #1/Plot: 010/Comments
OV looking South.jpg

Stratum: 2023 Upper Spoil #1/Plot: 010/Plot Name
Overview photo looks South from plot 010.jpeg

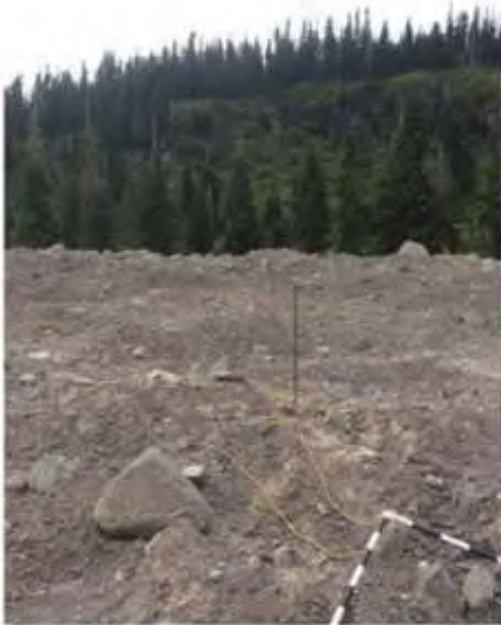
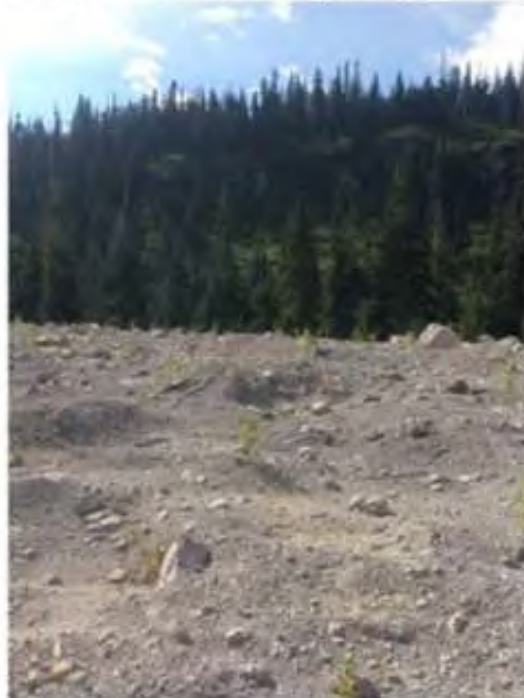
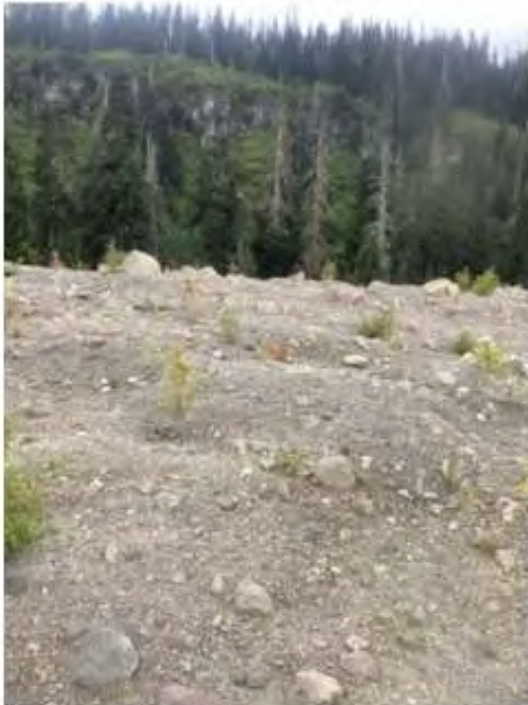
Figure 31J. Zone 6. Upper Spoil 1 Plot 011 Photos from 2018, 2020 and 2023

Stratum: 2018 Upper Spoil #1/Plot: 011/Comments
Overview photo looks South towards plot center. Sep
07, 2018 09.55.49 AM.jpg

Stratum: 2020 Upper Spoil #1/Plot: 011/Comments
Overview photo looks South from plot 011.jpg

Stratum: 2023 Upper Spoil #1/Plot: 011/Plot Name
Overview photo looks South from plot 011.jpeg

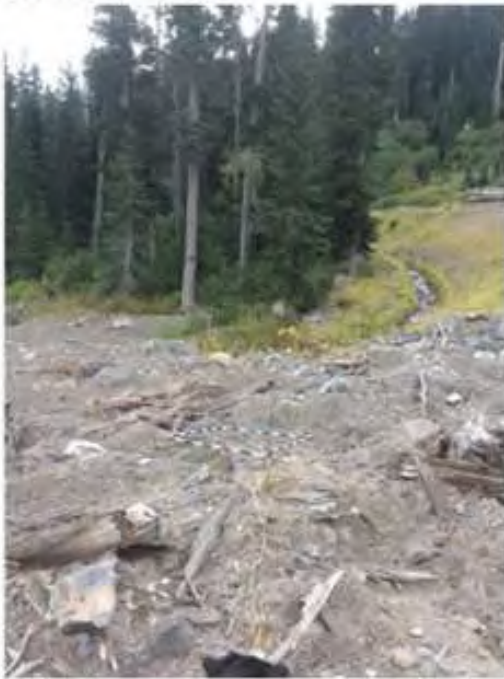
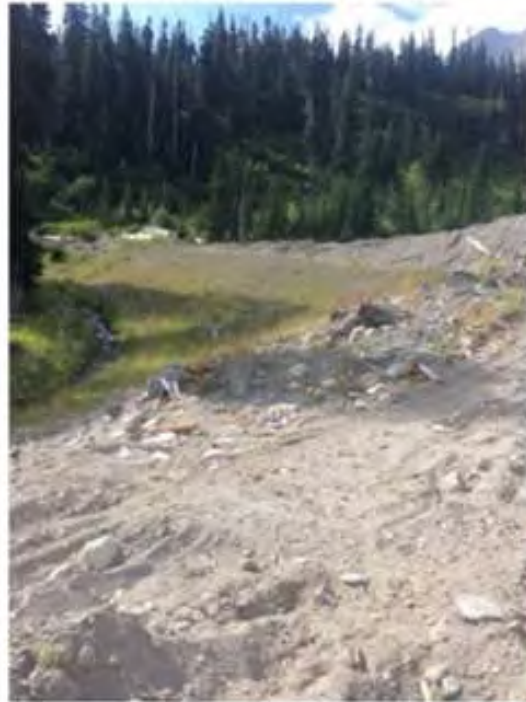
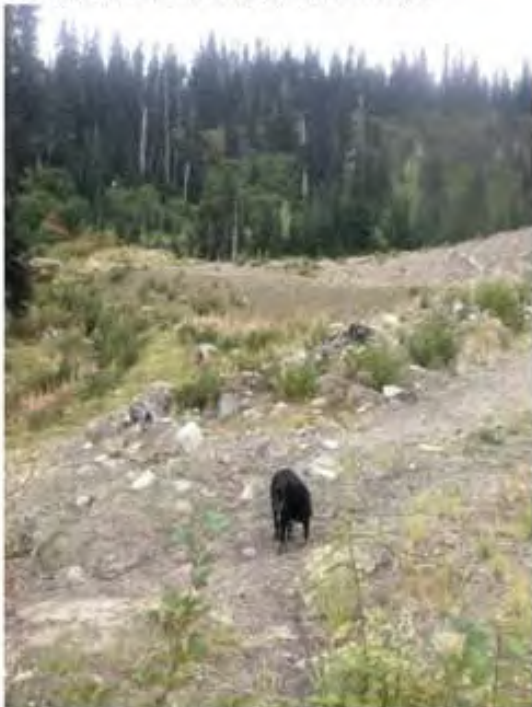
Figure 32k. Zone 6. Upper Spoil #1 Plot 012 Photos from 2018, 2020 and 2023

Stratum: 2018 Upper Spoil #1/Plot: 012/Comments
Overview photo looks South towards plot center. Sep
07, 2018 10:17:17 AM.jpg

Stratum: 2020 Upper Spoil #1/Plot: 012/Comments
Overview photo looks South from plot 012.jpg

Stratum: 2023 Upper Spoil #1/Plot: 012/Plot Name
Overview photo looks South from plot 012.jpeg

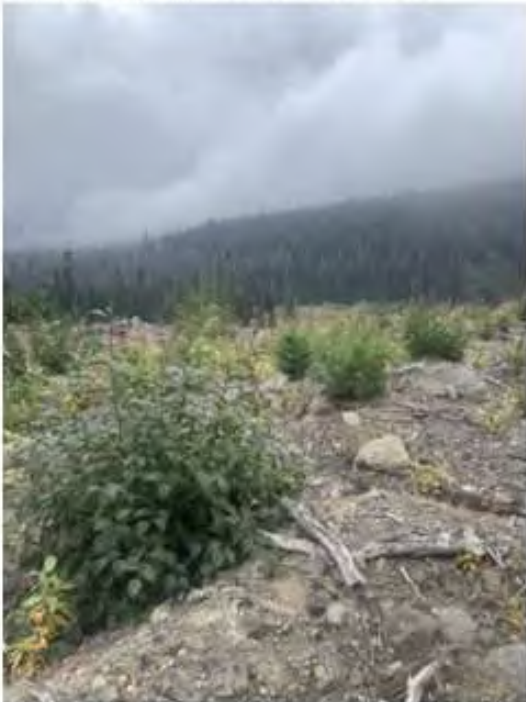
Figure 33L. Zone 6. Upper Spoil #2 Plot 017 Photos from 2018, 2020 and 2023

Stratum: 2023 Upper Spoil #2 and Settling Basin/Plot: 017/Plot Name
Overview photo looks South from plot 017.jpeg

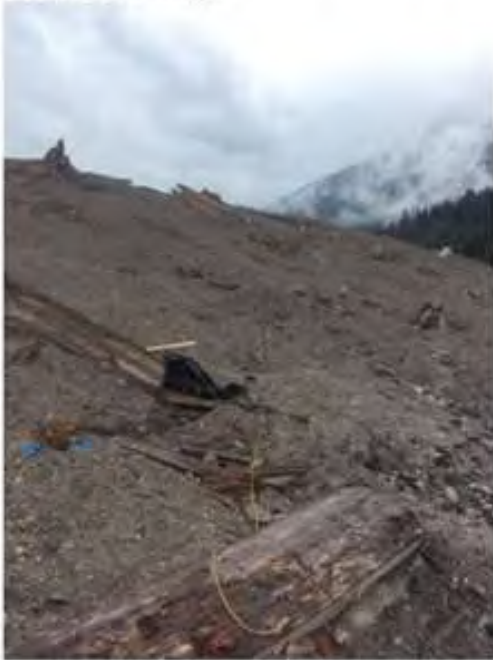
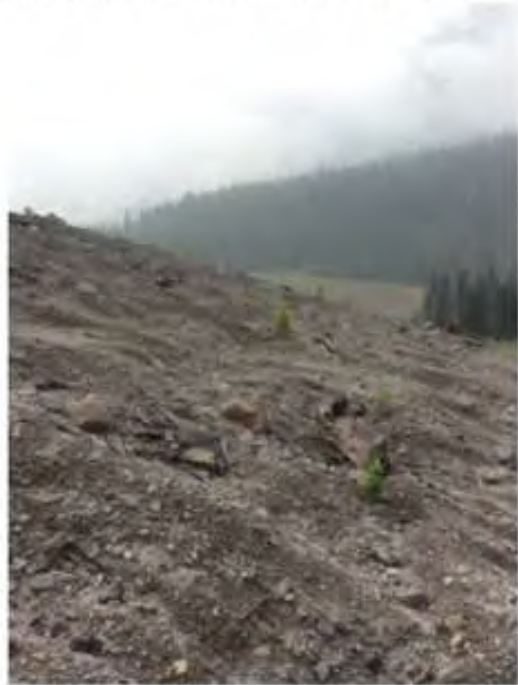
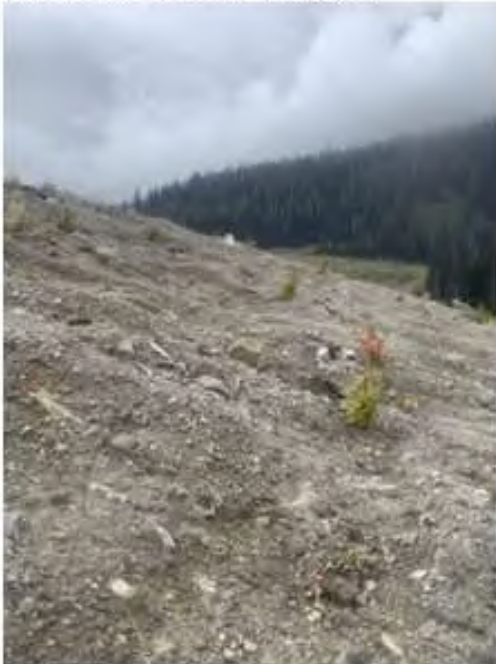
Figure 34M. Zone 6. Upper Spoil #2 Plot 018 Photos from 2018, 2020 and 2023

Stratum: 2018 Upper Spoil #2 & Settling Basin/Plot: 018/Comments
Overview photo looks South towards plot center. Sep 07, 2018 03.37.08 PM.jpg

Stratum: 2020 Upper Spoil #2 and Settling Basin/Plot: 018/Comments
Overview photo looks South from plot 018.jpg

Stratum: 2023 Upper Spoil #2 and Settling Basin/Plot: 018/Plot Name
Overview photo looks South from 018.jpeg

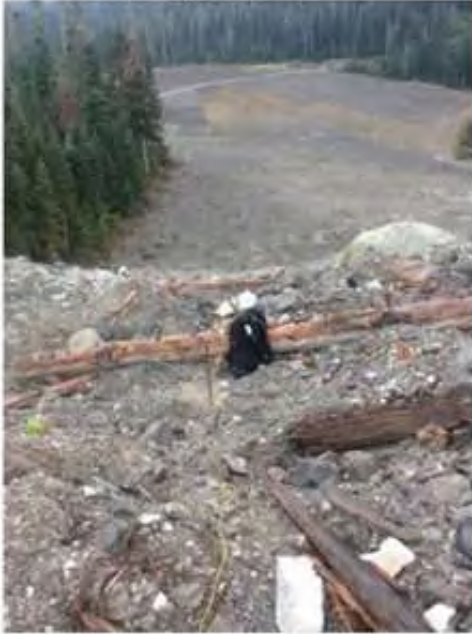
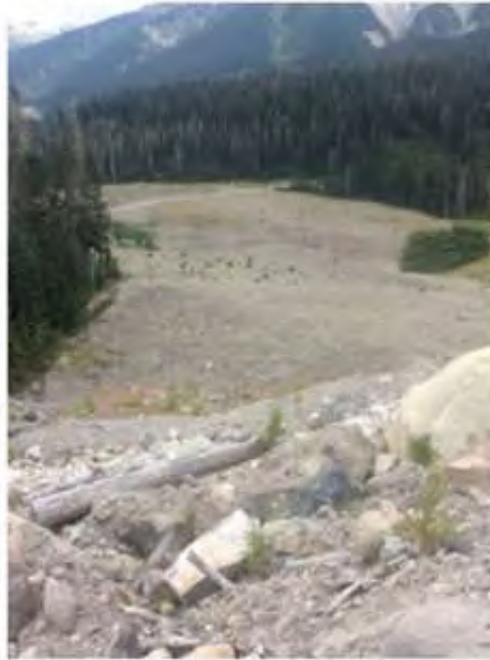
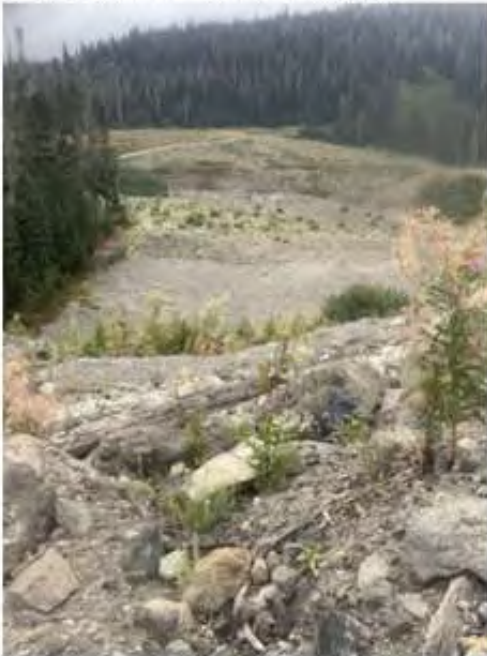
Figure 35N. Zone 6. Upper Spoil #2 Plot 016 Photos from 2018, 2020 and 2023

Stratum: 2018 Upper Spoil #2 & Settling Basin/Plot: 016/Comments
Overview photo looks South towards plot center. Sep 07, 2018 03:18:21 PM.jpg

Stratum: 2020 Upper Spoil #2 and Settling Basin/Plot: 016/Comments
Overview photo looks South from plot 016.jpg

Stratum: 2023 Upper Spoil #2 and Settling Basin/Plot: 016/Plot Name
Overview photo looks South from plot 016.jpeg

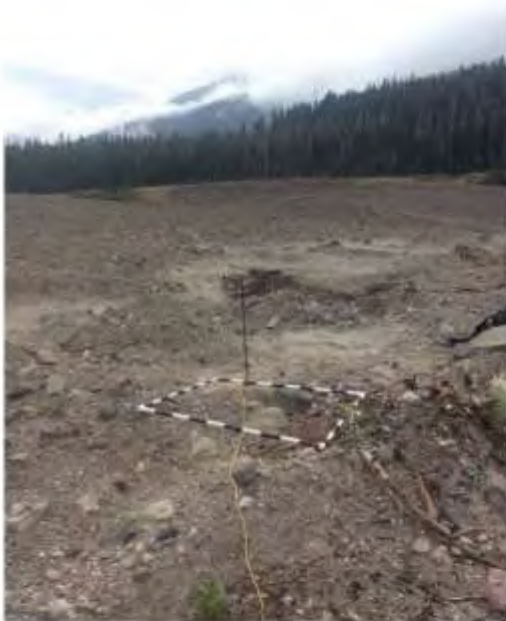
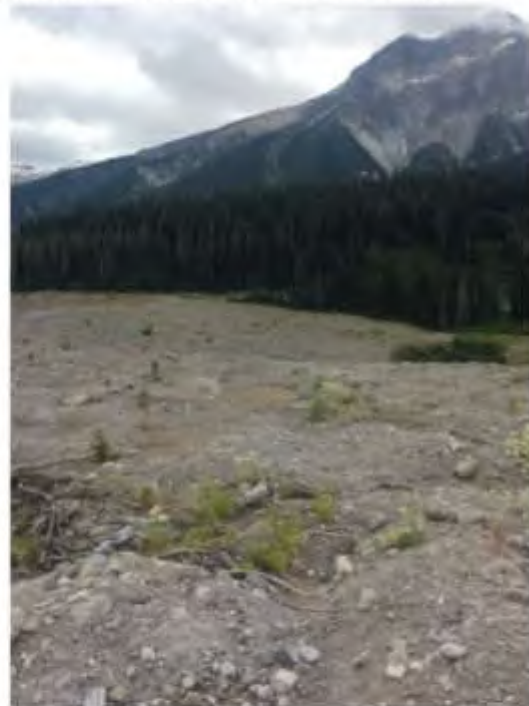
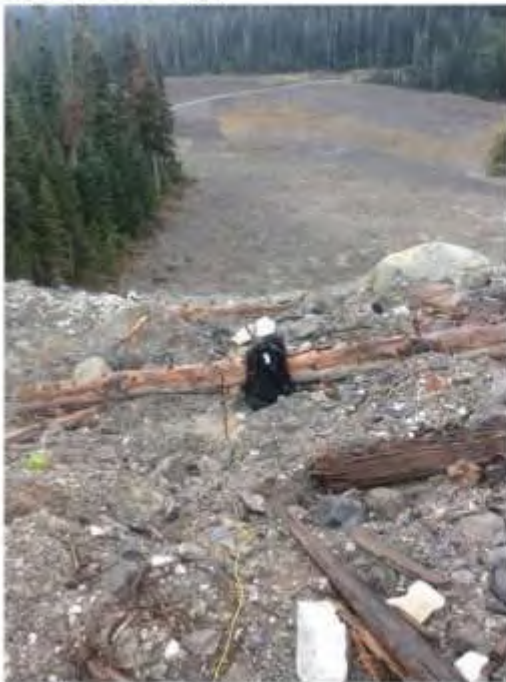
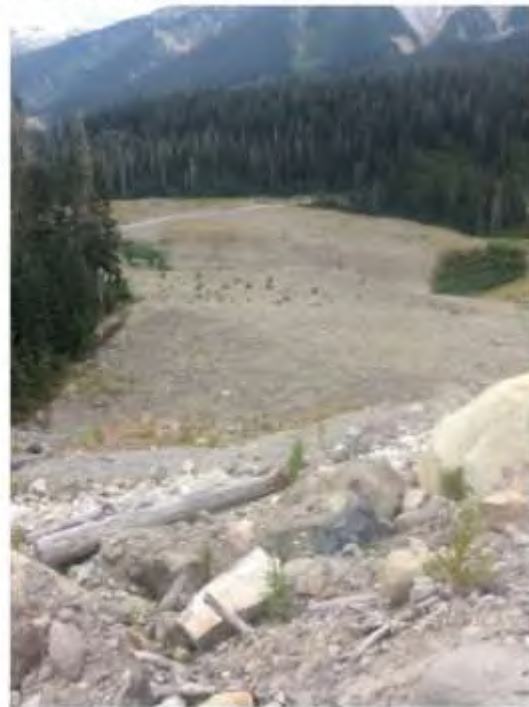
Figure 360. Zone 6. Upper Spoil #2 & Settling Basin Plot 016 Photos from 2018, 2020 and 2023

Overview photo looks South towards plot center. Sep 07, 2018 03.03.11 PM.jpg

Overview photo looks South from plot 015.jpg

Overview photo looks South towards plot center. Sep 07, 2018 03.18.21 PM.jpg

Overview photo looks South from plot 016.jpg

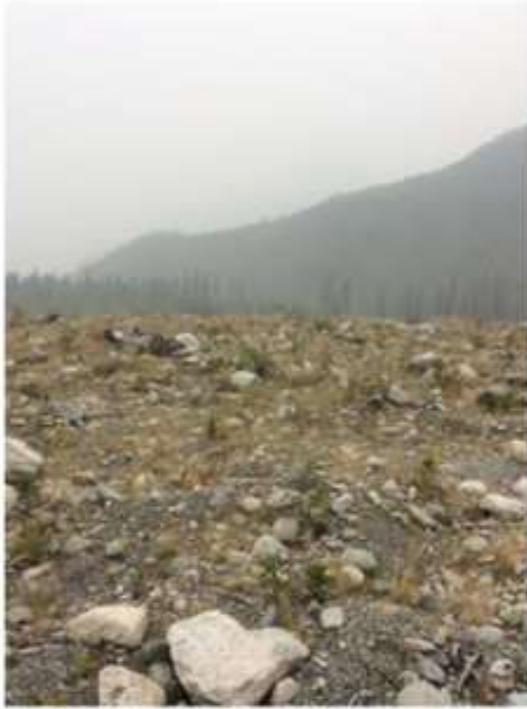
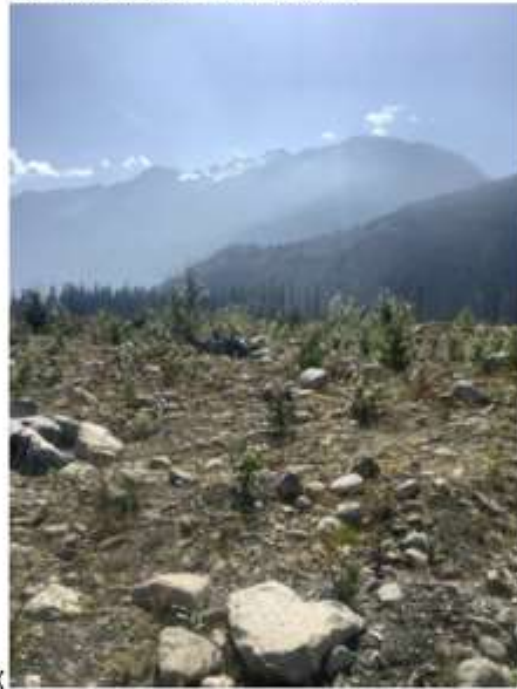
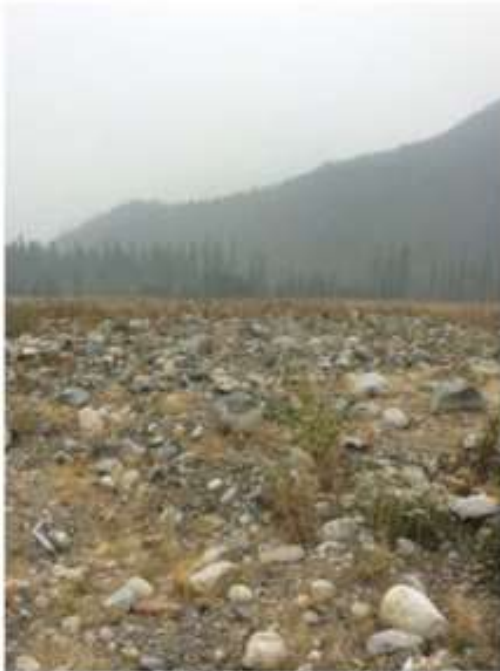
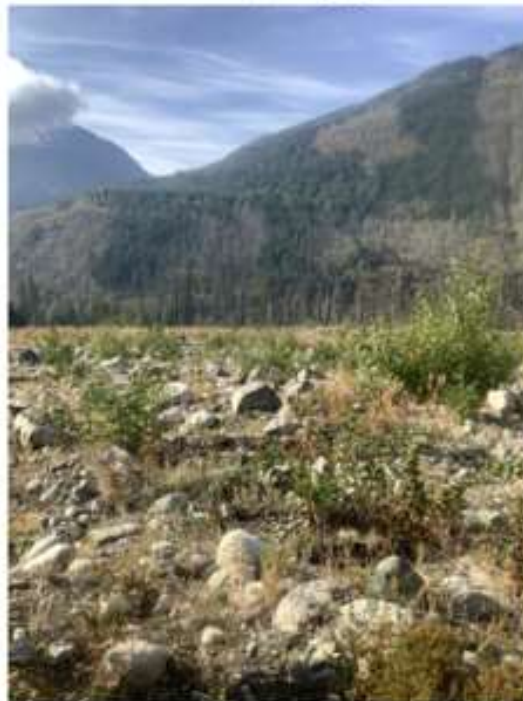
Figure 37A. 38 km Laydown Plot W1/W2 photos from 2020 and 2023

Stratum: 2020 38 km Laydown/Plot: W1/Comments
Overview photo looks South from plot W1.jpg

Stratum: 2023 38km Laydown/Plot: W1/Plot Name
Overview photo looks S from W1.jpeg

Stratum: 2020 38 km Laydown/Plot: W2/Comments
Overview photo looks South from plot W2.jpg

Stratum: 2023 38km Laydown/Plot: W2/Plot Name
Overview looks South from plot W2.jpeg

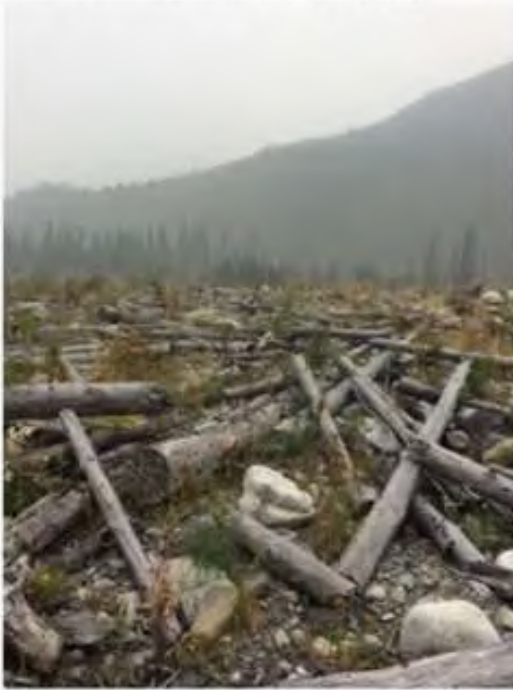
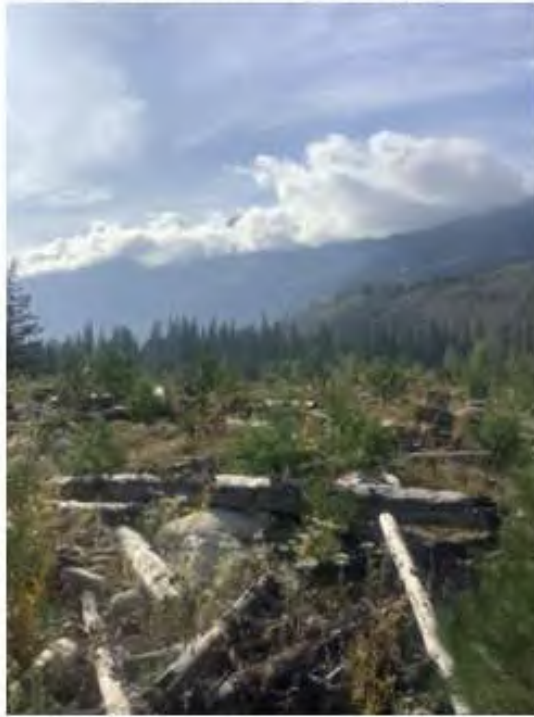
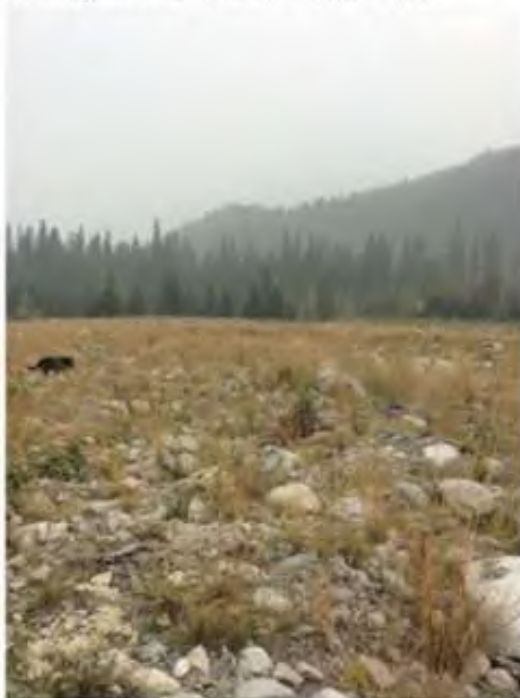
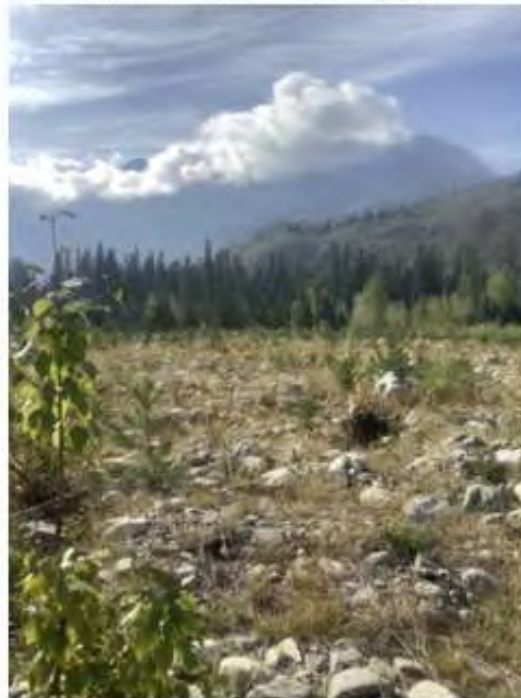
Figure 38B. 38 km Laydown Plot W3/W4 photos from 2020 and 2023

Stratum: 2020 38 km Laydown/Plot: W3/Plot Name
Overview photo looks South from plot W3.jpg

Stratum: 2023 38km Laydown/Plot: W3/Plot Name
Overview photo looks South from plot W3.jpeg

Stratum: 2020 38 km Laydown/Plot: W4/Comments
Overview photo looks South from plot W4.jpg

Stratum: 2023 38km Laydown/Plot: W4/Plot Name
Overview photo looks South from plot SD1.jpeg
