Upper Lillooet Hydro Project

Operational Environmental Monitoring Year 5

April 24, 2024

Ecofish Research Ltd.

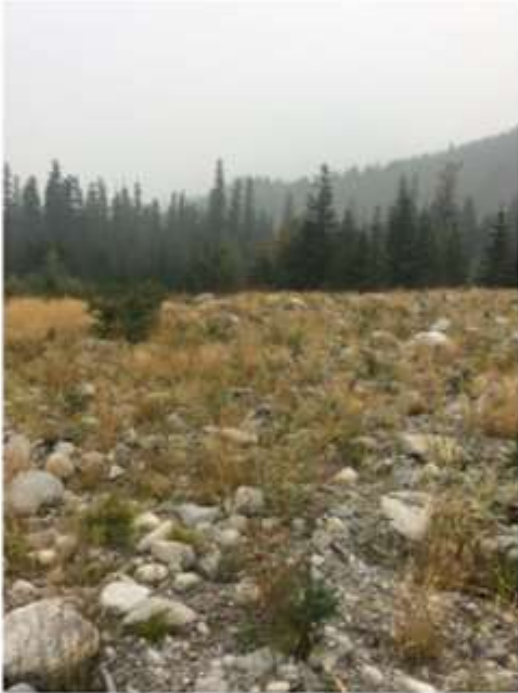
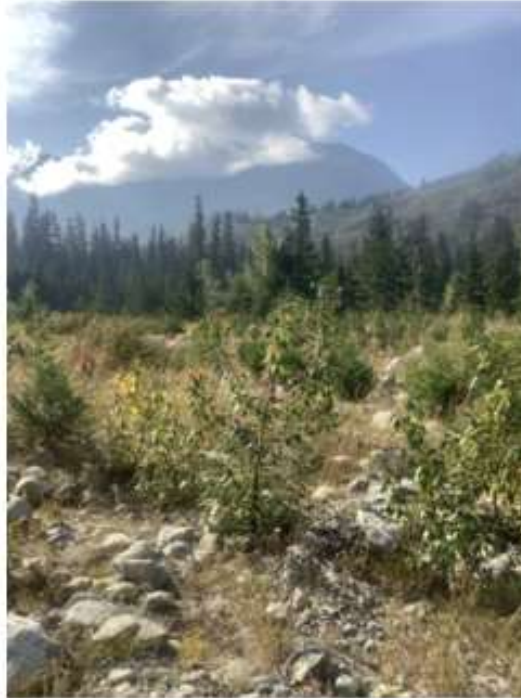
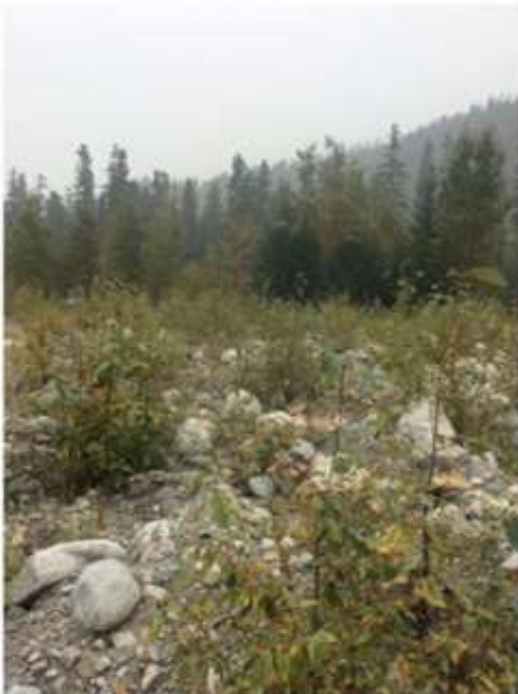
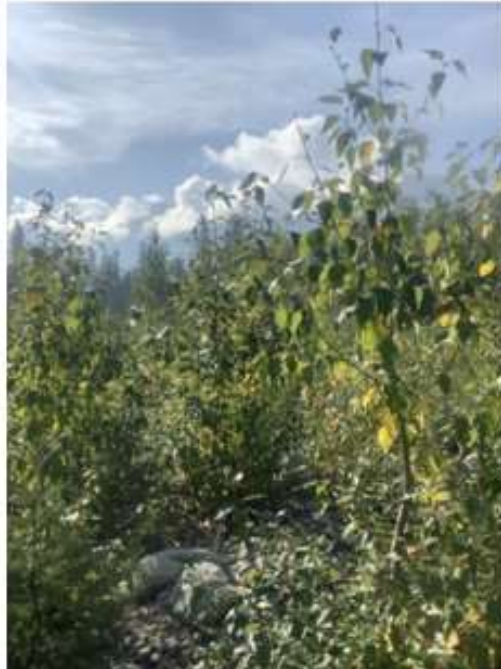
Figure 39C. 38 km Laydown Plot W5/W6 photos from 2020 and 2023

Stratum: 2020 38 km Laydown/Plot: W5/Comments
Overview photo looks South from W5.jpg

Stratum: 2023 38km Laydown/Plot: W5/Plot Name
Overview photo looks South from plot W4.jpeg

Stratum: 2020 38 km Laydown/Plot: W6/Comments
Overview photo looks South from plot W6.jpg

Stratum: 2023 38km Laydown/Plot: W6/Plot Name
Overview photo looks South from W6.jpeg

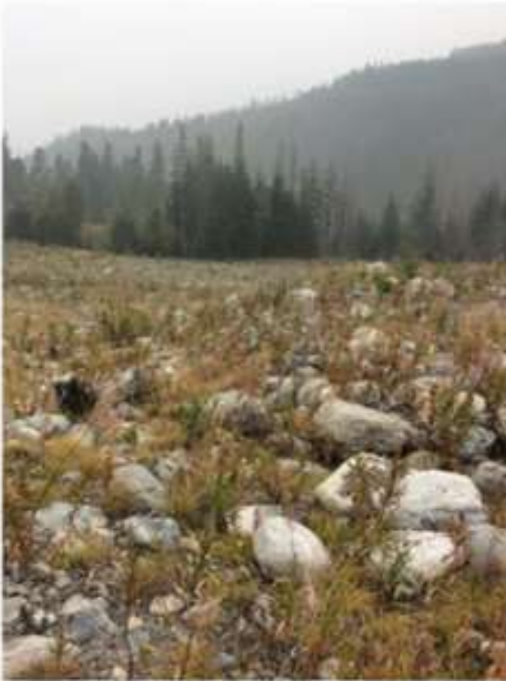
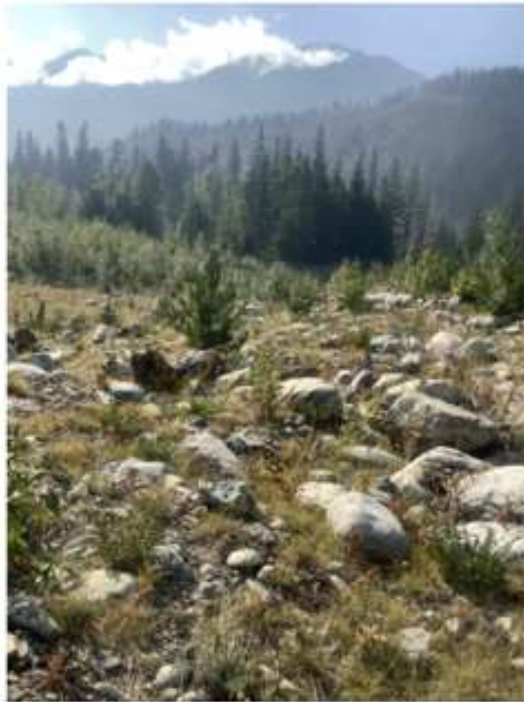
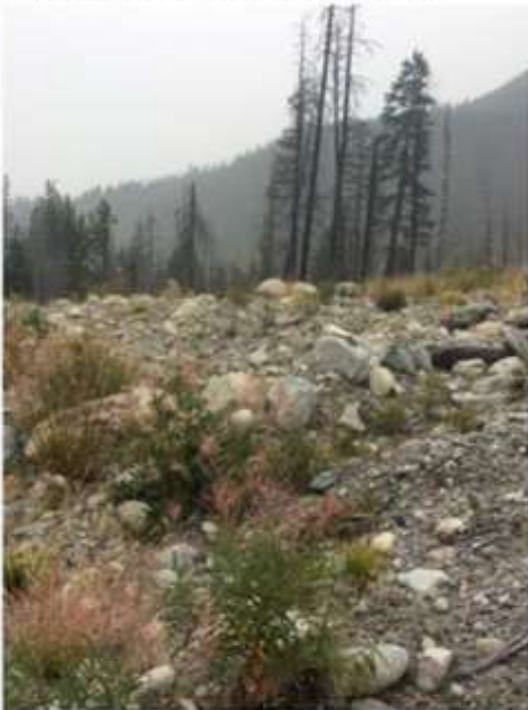
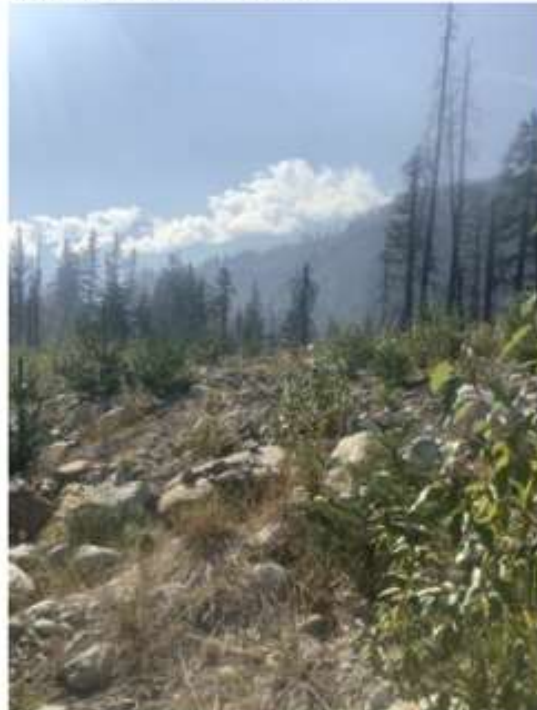
Figure 40D. 38 km Laydown Plot W7/W8 photos from 2020 and 2023

Stratum: 2020 38 km Laydown/Plot: W7/Comments
Overview photo looks South from plot W7.jpg

Stratum: 2023 38km Laydown/Plot: W7/Plot Name
Overview photo looks South from plot W7.jpeg

Stratum: 2020 38 km Laydown/Plot: W8/Comments
Overview photo looks South from plot W8.jpg

Stratum: 2023 38km Laydown/Plot: W8/Plot Name
Overview looks South from W8.jpeg

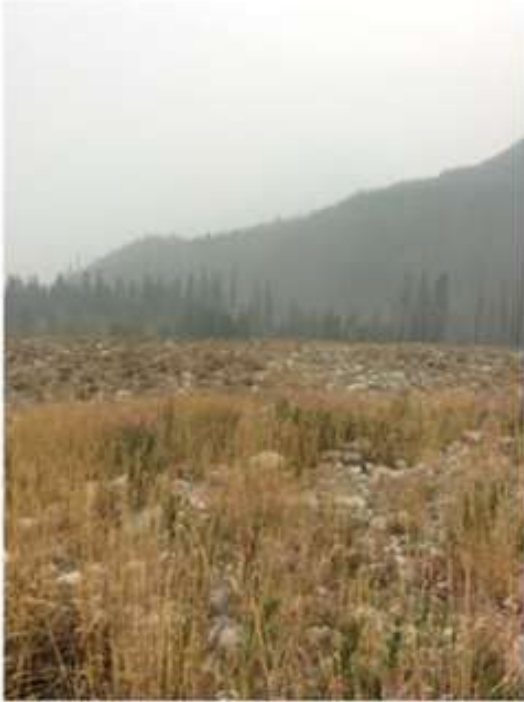
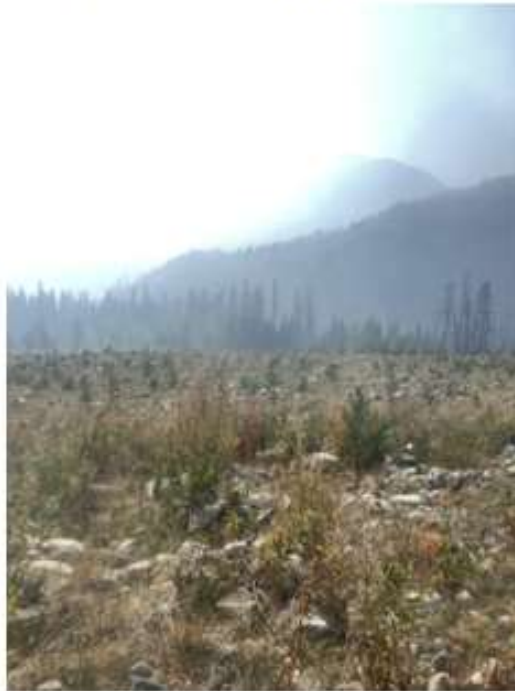
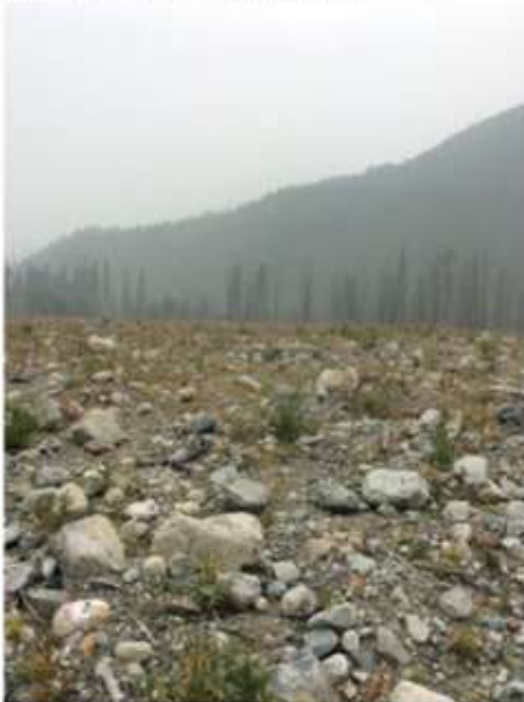
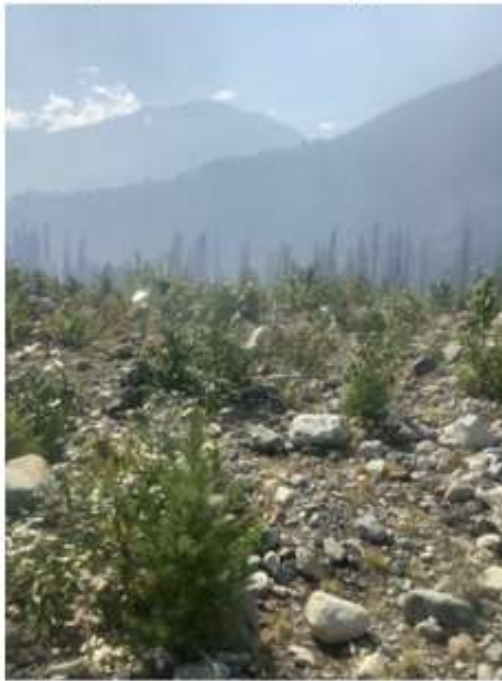
Figure 42F. 38 km Laydown Plot W11/W12 photos from 2020 and 2023

Stratum: 2020 38 km Laydown/Plot: W11/Comments
Overview photo looks South from plot W11.jpg

Stratum: 2023 38km Laydown/Plot: W11/Plot Name
Overview photo looks South from plot W11.jpeg

Stratum: 2020 38 km Laydown/Plot: W12/Comments
Overview photo looks South from plot W12.jpg

Stratum: 2023 38km Laydown/Plot: W12/Plot Name
Overview photo looks South from W12.jpeg

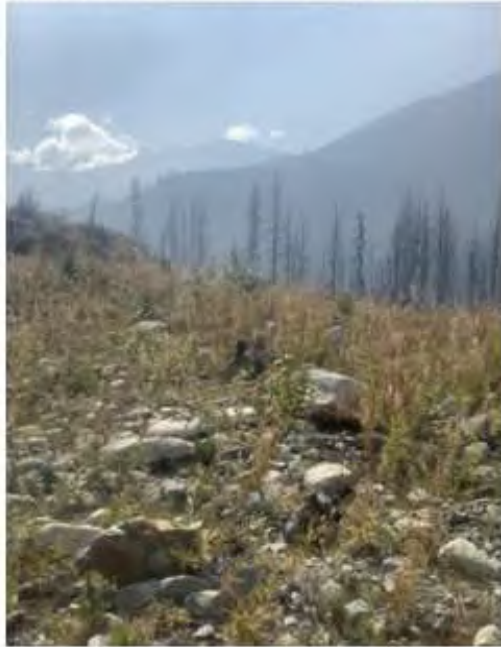
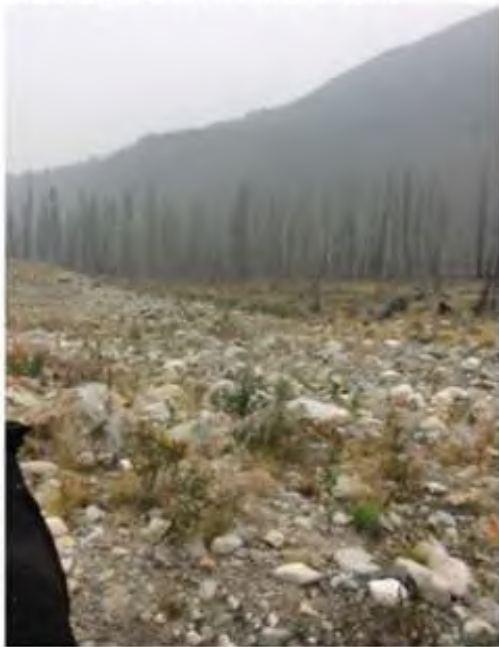
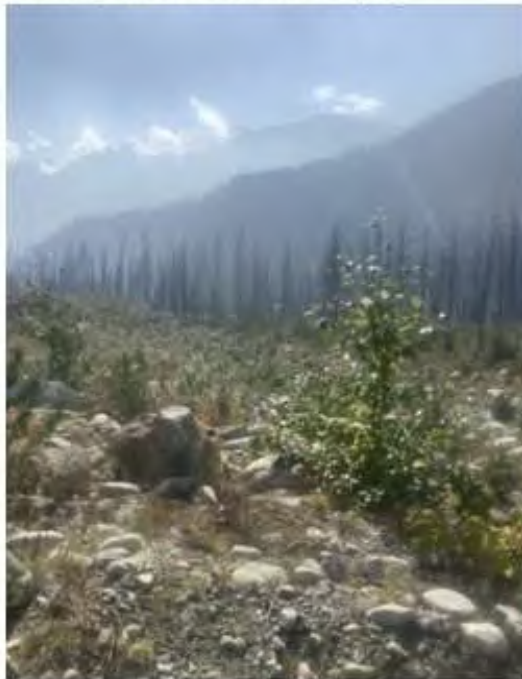
Figure 43G. 38 km Laydown Plot W13/W14 photos from 2020 and 2023

Stratum: 2023 38km Laydown/Plot: W13/Plot Name
Overview photo looks South from plot W13.jpeg

Stratum: 2020 38 km Laydown/Plot: W14/Comments
Overview photo looks South from W14.jpg

Stratum: 2023 38km Laydown/Plot: W14/Plot Name
Overview photo looks South from W14.jpeg

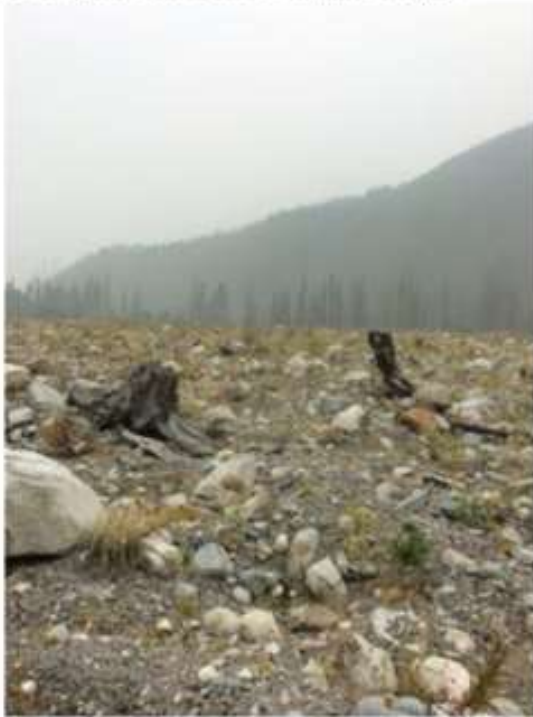
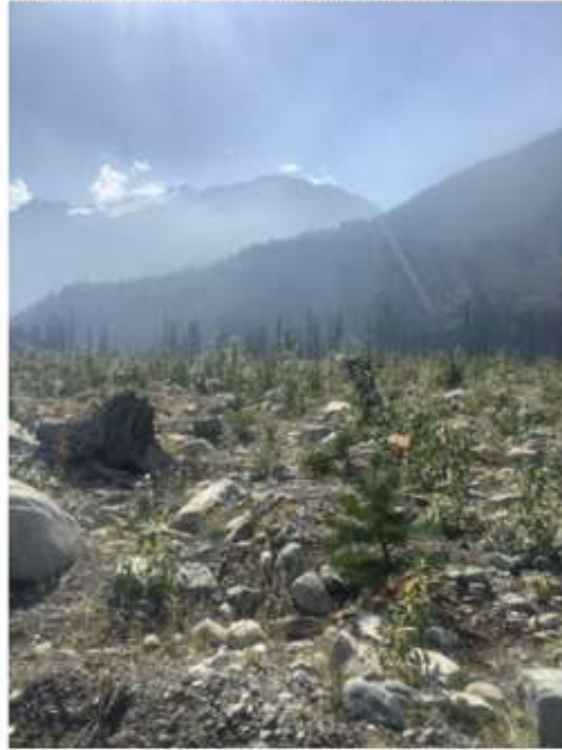
Figure 44H. 38 km Laydown Plot W15 photos from 2020 and 2023

Stratum: 2020 38 km Laydown/Plot: W15/Comments
Overview photo looks South from plot W15.jpg

Stratum: 2023 38km Laydown/Plot: W15/Plot Name
Overview photo looks South from plot W15.jpeg

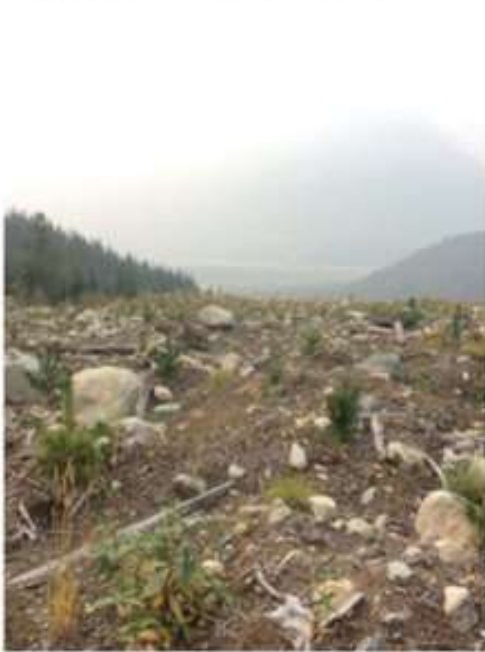
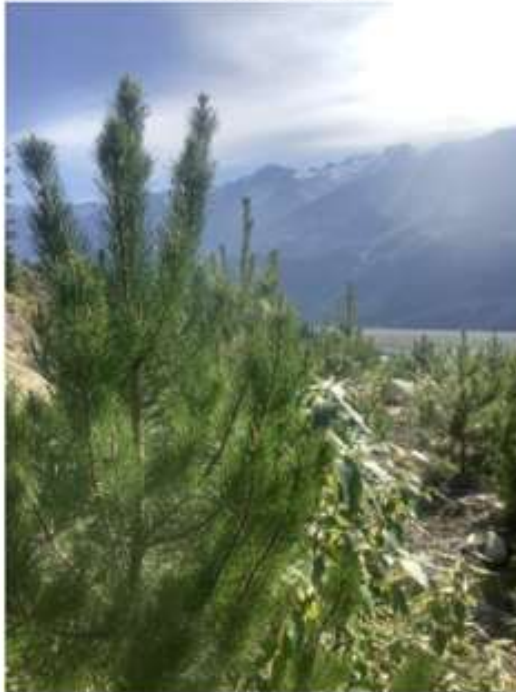
Figure 45A. Camp plot B1 and V photos from 2020 and 2023

Stratum: 2023 Camp/Plot: B1/Plot Name
Overview photo looks South from plot B1.jpeg

Stratum: 2020 Camp/Plot: V/Comments
Overview photo looks South from plot V.jpg

Stratum: 2023 Camp/Plot: V/Plot Name
Overview looks South from plot V.jpeg

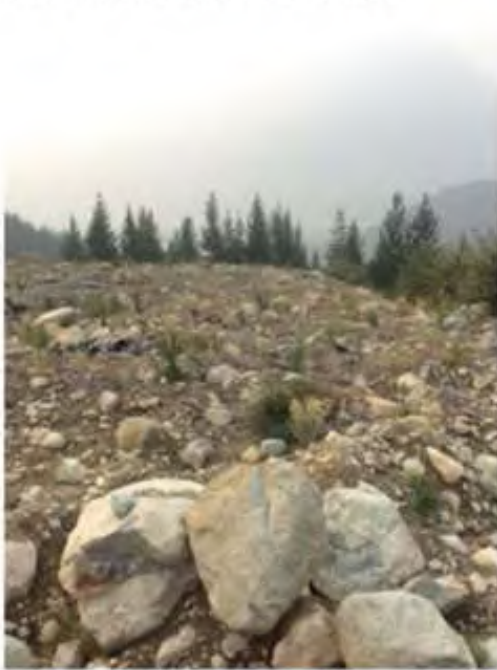
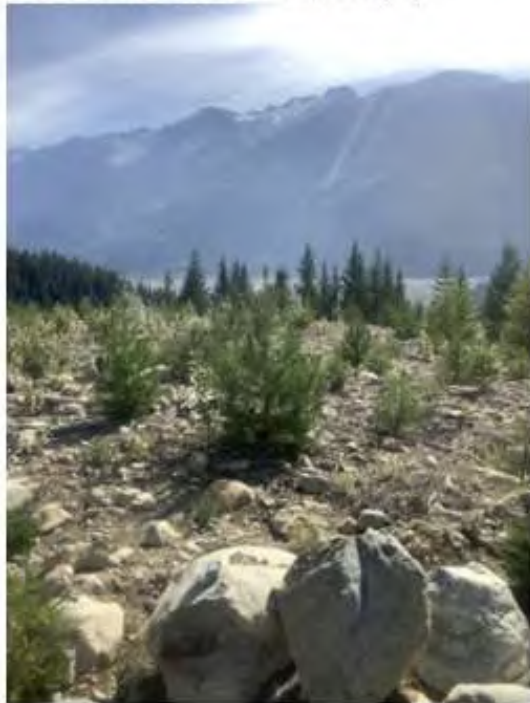
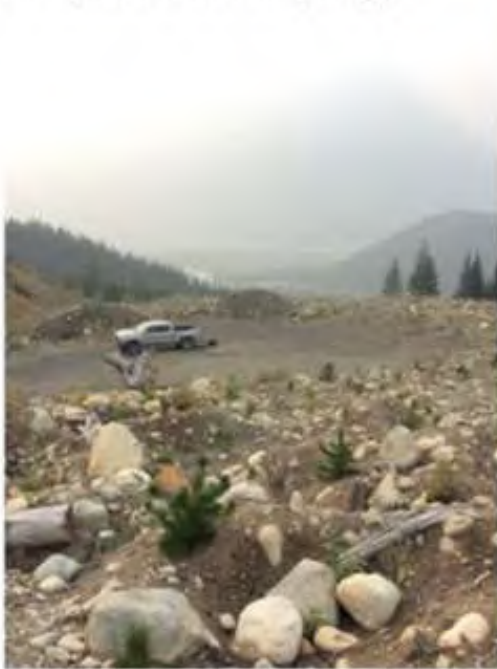
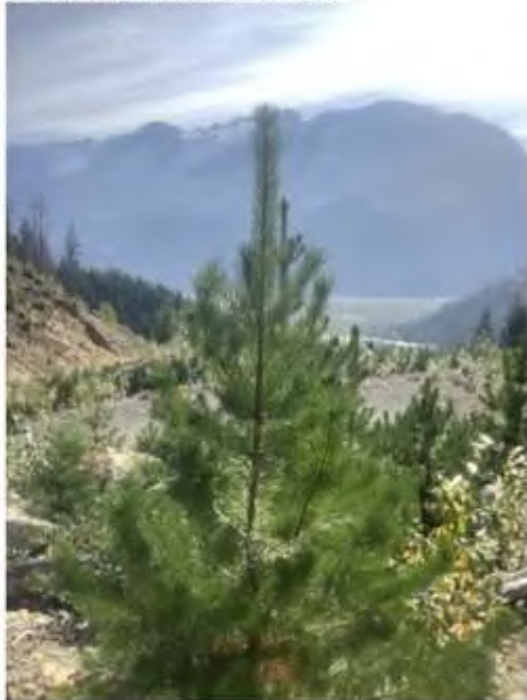
Figure 46B. Camp plot W/X photos from 2020 and 2023

Stratum: 2020 Camp/Plot: W/Comments
Overview photo looks South from plot W.jpg

Stratum: 2023 Camp/Plot: W/Plot Name
Overview photo looks South from plot W.jpeg

Stratum: 2020 Camp/Plot: X/Comments
Overview photo looks South from plot X.jpg

Stratum: 2023 Camp/Plot: X/Plot Name
Overview photo looks South from X.jpeg

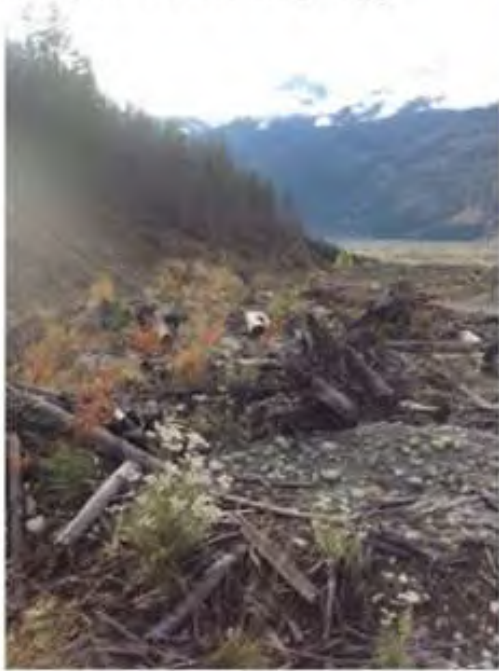
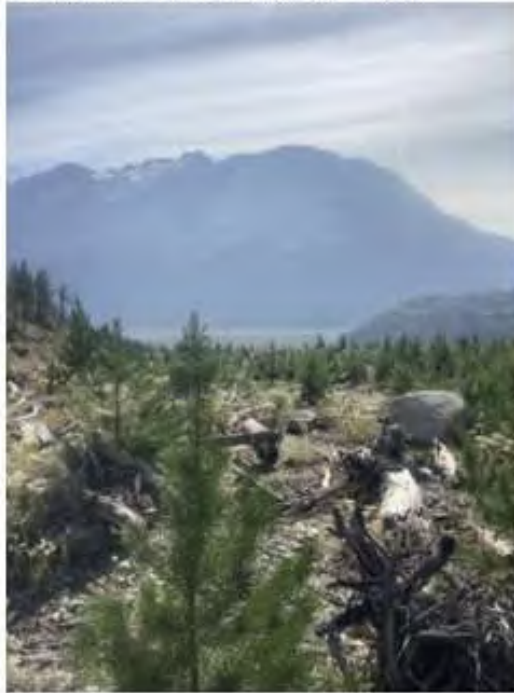
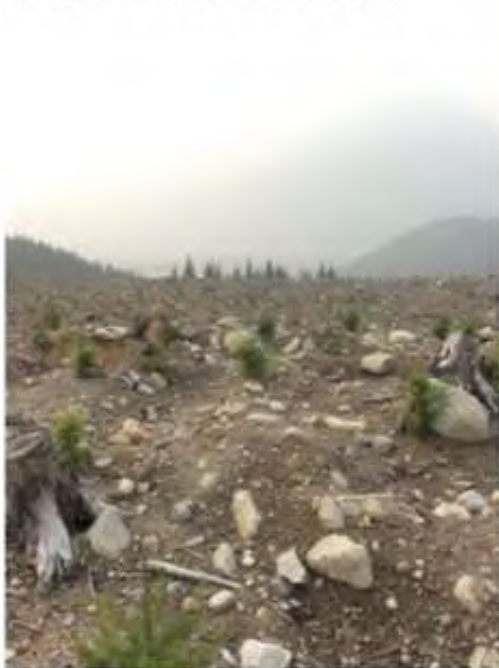
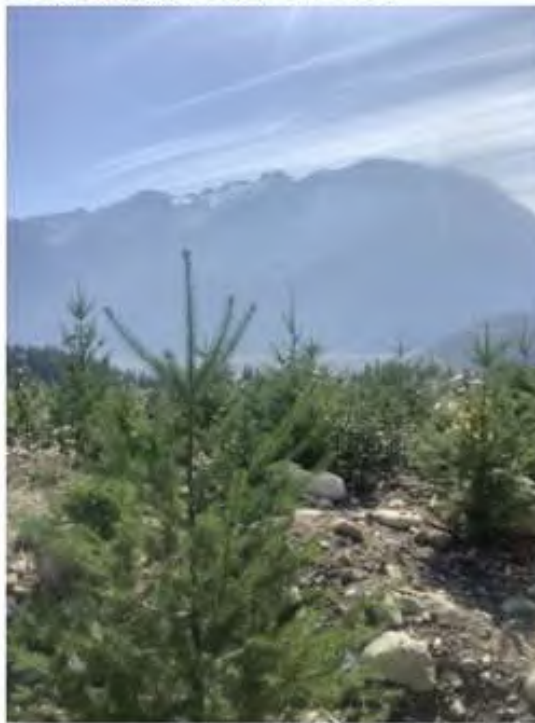
Figure 47C. Camp plot Y/Z photos from 2020 and 2023

Stratum: 2020 Camp/Plot: Y/Plot Name
Overview photo looks South from plot Y.jpg

Stratum: 2023 Camp/Plot: Y/Plot Name
Overview photo looks South from plot Y1.jpeg

Stratum: 2020 Camp/Plot: Z/Comments
Overview photo looks South from plot Z.jpg

Stratum: 2023 Camp/Plot: Z/Plot Name
Overview photo looks South from Z1.jpeg

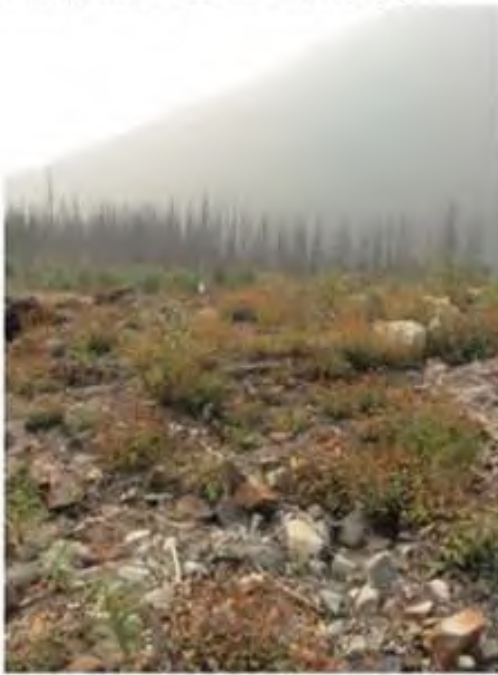
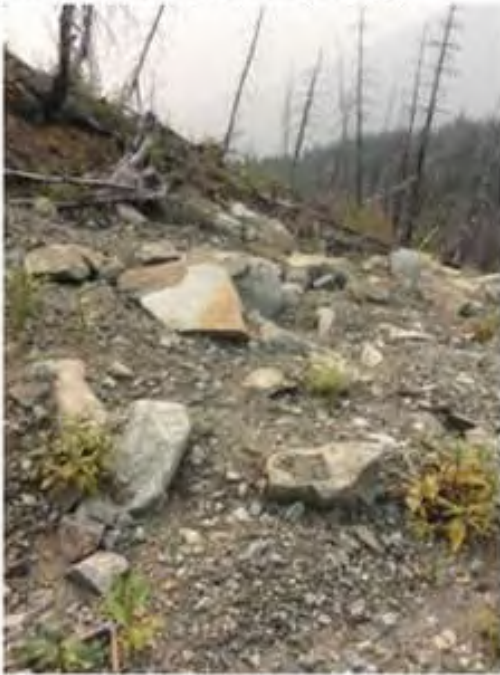
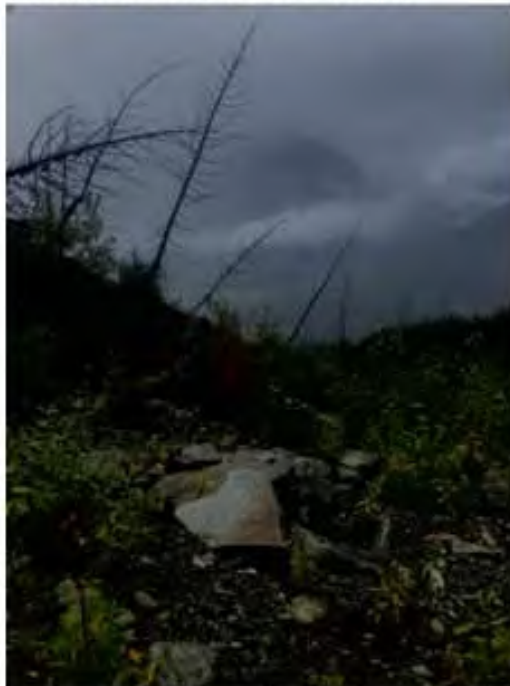
Figure 48A. Boulder Spoil #4 and #7 Plot D1/E1 Photos from 2020 and 2023

Stratum: 2020 Boulder Spoil #4/Plot: D1/Comments
Overview photo looks South from plot D1.jpg

Stratum: 2020 Boulder Spoil #7/Plot: E1/Comments
Overview photo looks South from plot E1.jpg

Stratum: 2023 Boulder Spoil #7/Plot: E1/Plot Name
Overview photo looks South from plot E1.jpeg

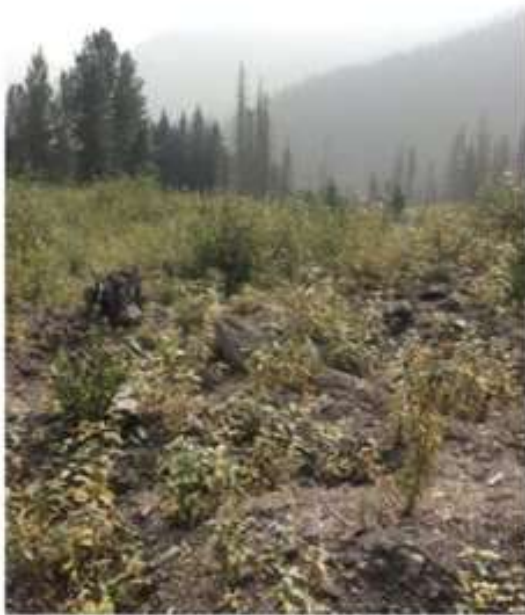
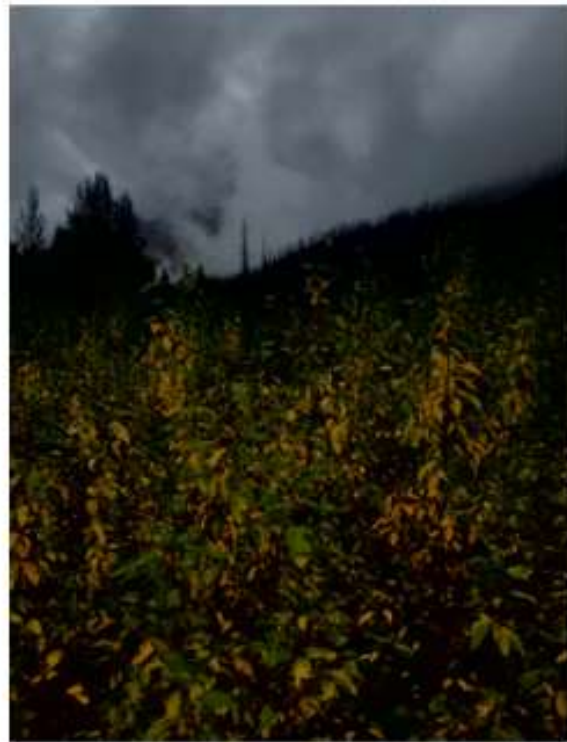
Figure 49A. Upper Spoil #7 plot T photos from 2020 and 2023

Stratum: 2020 Upper Spoil #7/Plot: T/Comments
Overview photo looks South from plot T.jpg

Stratum: 2023 Upper Spoil #7/Plot: T/Plot Name
Overview photo looks South from plot T.jpeg

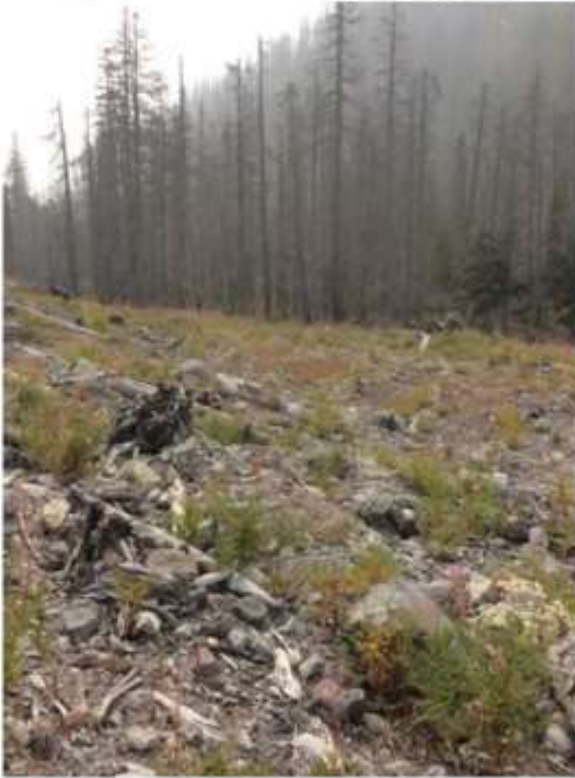
Figure 50. Upper Spoil #5 Plot F1 Photos from 2020

Upper Spoil #5 has moderately steep side slopes and is mostly flat on top, soils are gravelly and well drained. The site was fluffed up a bit to decrease compaction and increase plantability. This site is recovering well, high mortality of the planted trees was noted in 2020, but lots of conifer germinates were infilling. This site had 1000 sph of conifers in 2020, there are currently 1800 sph of conifers. Douglas fir makes up the majority of the sph with spruce and amabilis fir making up minor components. The conifers range from 10 cm to 80 cm in heights and are of good form and vigour. Black cottonwood continues to seed in and is also growing well. There are 1400 sph of black cottonwood up from 800 sph in 2020. Species diversity for shrubs is low on this site and has decreased from 23800 in 2020 to 20,800 in 2023. no species diversity was lost indicating the shrubs onsite are healthy. This site is dominated by fireweed, this species is a common pioneer species on disturbed sites and is adding biomass to the site annually helping to build soils and add nutrients. No erosion or siltation was noted on this site. This site is meeting the revegetation requirements, and no further treatments are required.

Stratum: 2020 Upper Spoil #5/Plot: F1/Comments
Overview photo looks South from plot F1.jpg

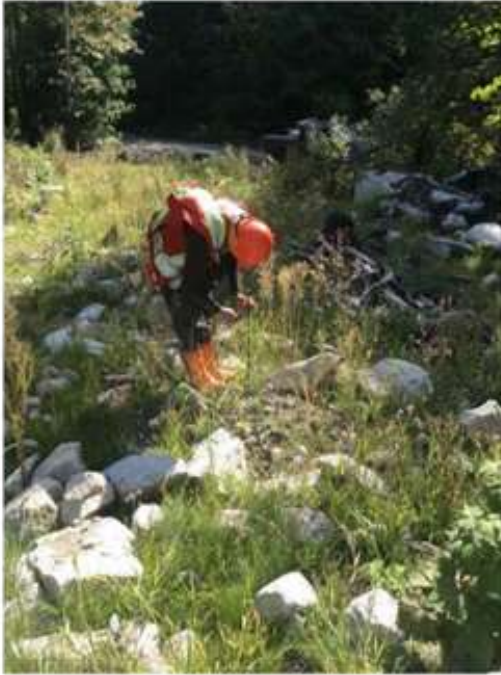
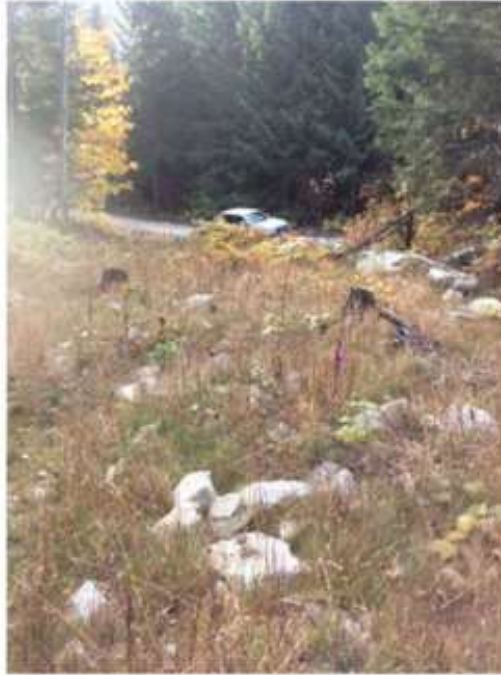
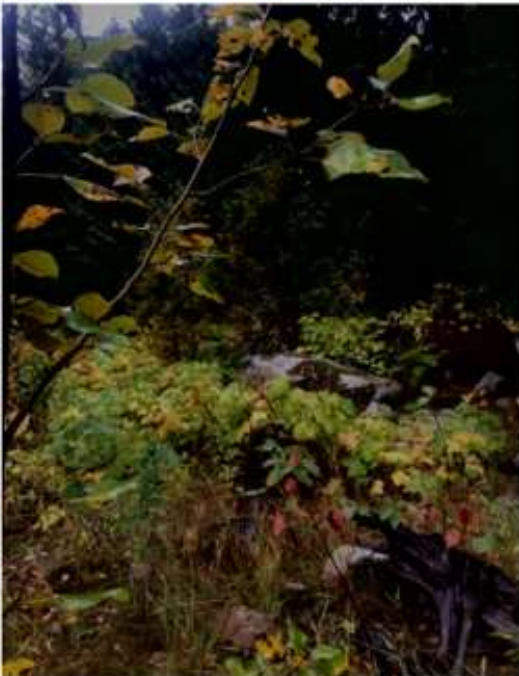
Figure 51. 53.1/56.1 Plot 31 Photos from 2018, 2020 and 2023

Stratum: 2018 53.1/56.1/Plot: 31/Comments
Sep 18, 2018 01.29.59 PM.jpg

Stratum: 2020 53.1/56.1/Plot: 31/Comments
Overview photo looks South from plot 31.jpg

Stratum: 2023 53.1/56.1 Road/Plot: 31/Plot Name
Overview photo looks South from plot 31.jpeg

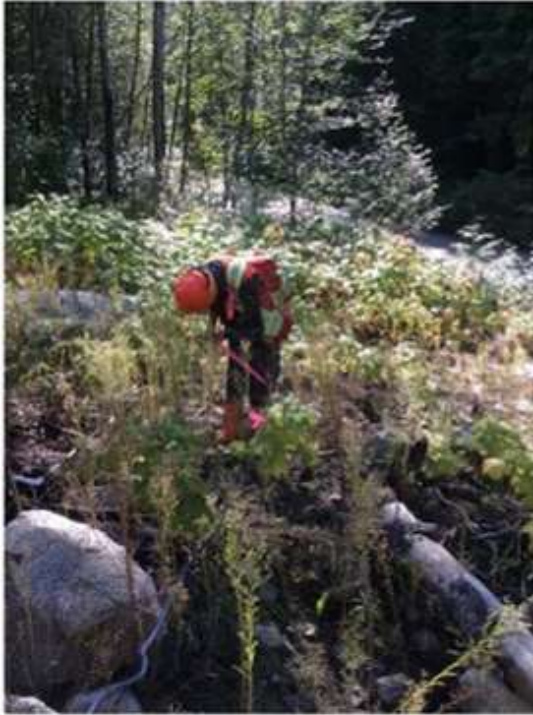
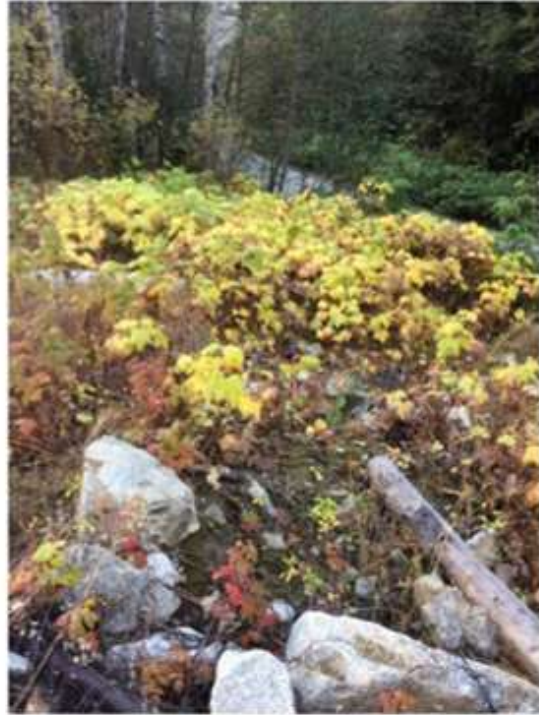
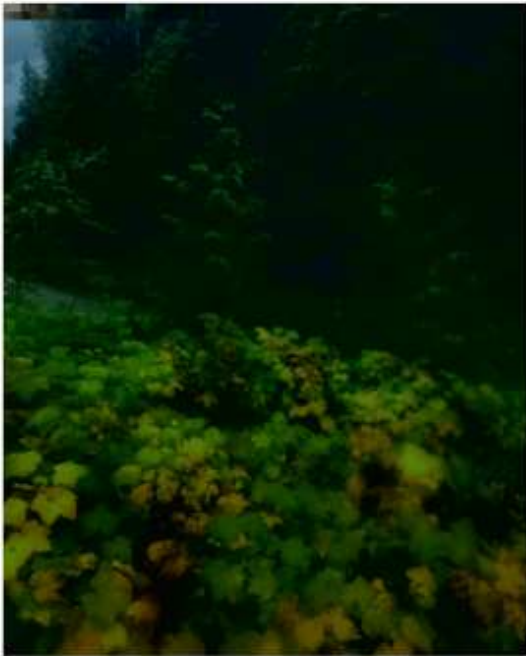
Figure 52. 73.1 Plot 30 Photos from 2018, 2020 and 2023

Stratum: 2018 73.1/Plot: 30/Comments
Sep 18, 2018 12.50.06 PM.jpg

Stratum: 2020 73.1/Plot: 30/Comments
Overview photo looks South from plot 73.1.jpg

Stratum: 2023 73.1 Road/Plot: 30/Plot Name
South from plot. 30.jpeg

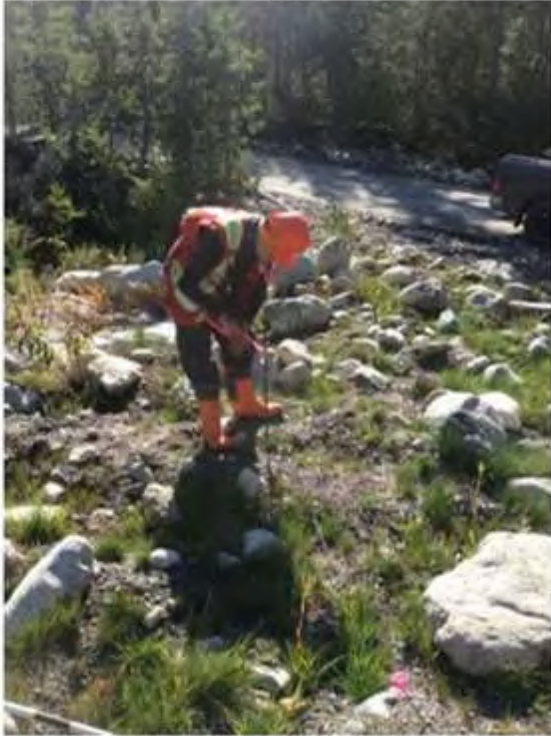
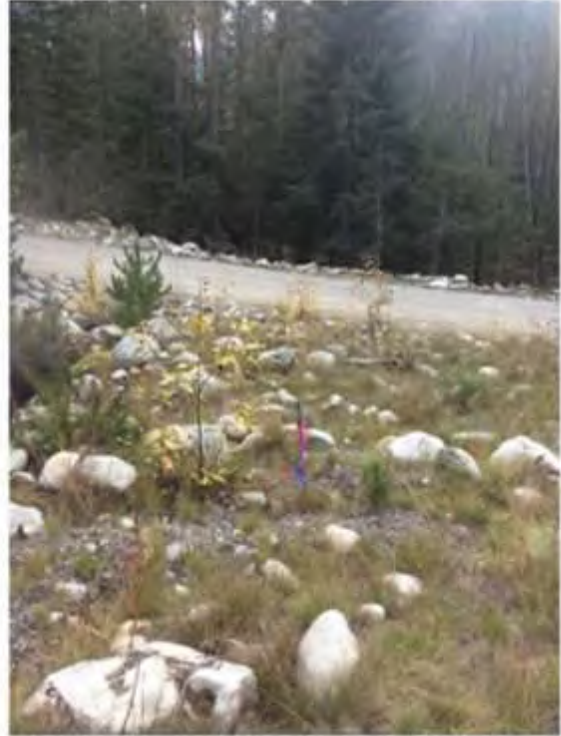
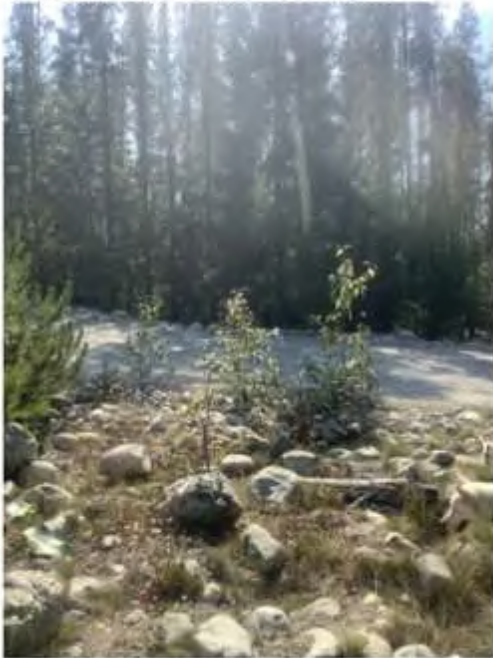
Figure 53A. 129.1 Plot 29 Photos from 2018, 2020 and 2023

Transmission line road 129.1 is deactivated and is not drivable. Soils are rapidly draining and coarse with lots of surface rock. This site was grass seeded with a fall rye blend. Lodgepole pine sph have decreased minimally from 1600 in 2020 down to 1400 in 2023. The lodgepole pine are of good form and vigour with heights ranging from 30 to 100 cm in height. Black cottonwood numbers have remained consistent between survey years. This site has decreased in the number of shrubs since 2018. This is likely due to high temperatures in the summer and a lack of soil moisture. False box numbers have decreased by half from 2018 to 2020 and was found not found onsite in 2023. Ceanothus numbers have also decreased from 400 sph in 2018 to 200 sph in 2020 and down to zero in 2023. Both species are typically drought tolerant but may be more susceptible to drought conditions when they are smaller, and their root system is not developed enough to survive season long drought conditions. Blackcap raspberry is new to the site since 2020. The grass seeding treatment could also have created more competition between plants for water. No soil erosion or siltation issues were noted, and no further revegetation treatments are required. The number of conifer and deciduous species on site has remained stable and no further treatments are required.

Stratum: 2018 129.1/Plot: 29/Comments
Sep 18, 2018 11.34.17 AM.jpg

Stratum: 2020 129.1/Plot: 29/Comments
Overview photo looks South from plot 29.jpg

Stratum: 2023 129.1 Road/Plot: 29/Plot Name
Overview photo looks South from plot 29.jpeg

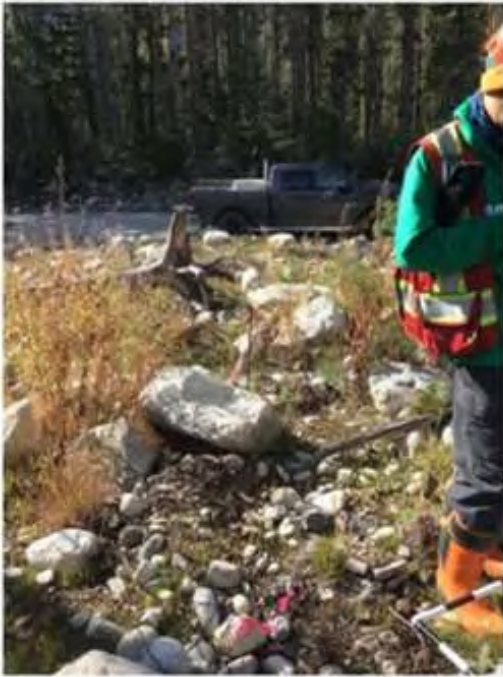
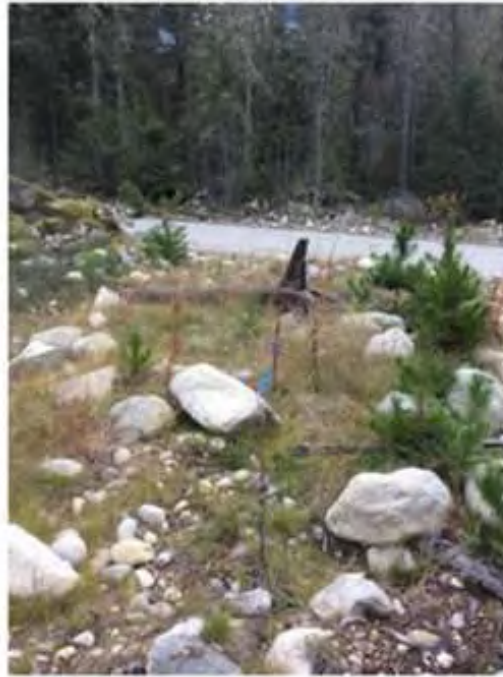
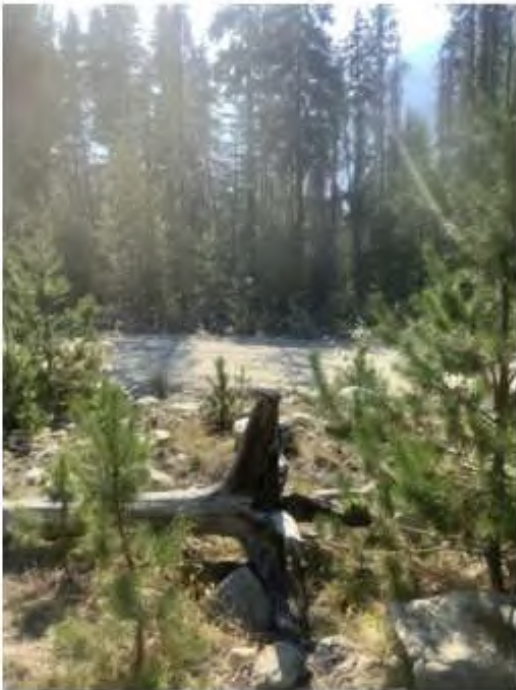
Figure 54. 130.1 Plot 28 Photos from 2018, 2020 and 2023

Card: Transmission Line
Stratum: 2018 130.1/Plot: 28/Comments
Sep 18, 2018 11.05.09 AM.jpg

Card: Transmission Line
Stratum: 2020 130.1/Plot: 28/Comments
Overview photo looks South from plot 28.jpg

Card: Transmission Line Surveys
Stratum: 2023 130.1 Road/Plot: 28/Plot Name
Overview photo looks south from 28.jpeg

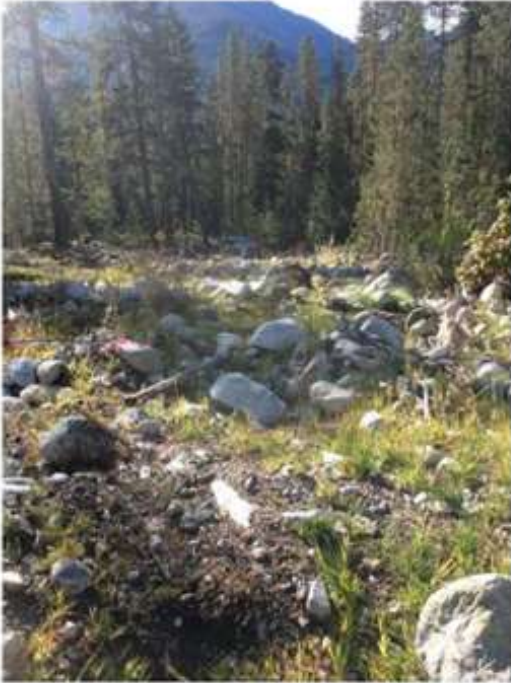
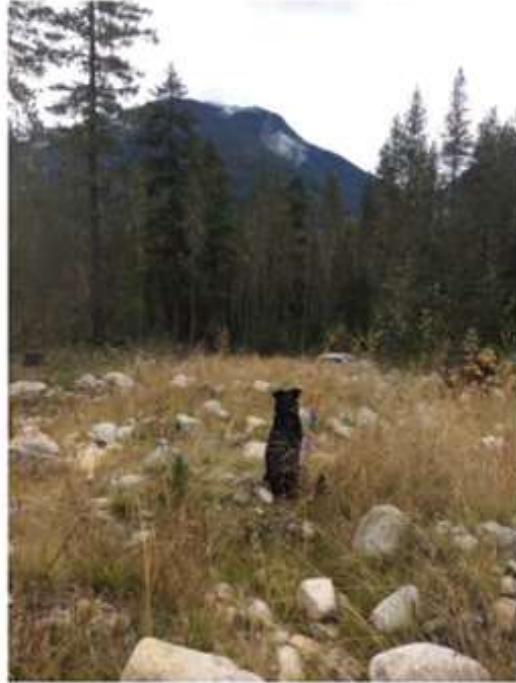
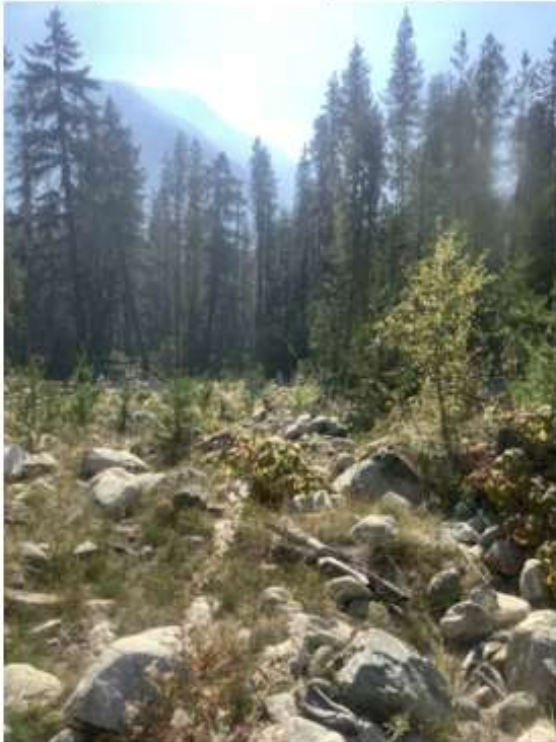
Figure 55A. 133.1 Plot 27 Photos from 2018, 2020 and 2023

Stratum: 2018 133.1/Plot: Plot 27/Comments
Sep 18, 2018 10.34.16 AM.jpg

Stratum: 2020 133.1/Plot: 27/Comments
Overview photo looks South from plot 27.jpg

Stratum: 2023 133.1/Plot: 27/Plot Name
Overview photo looks South from plot 27.jpeg

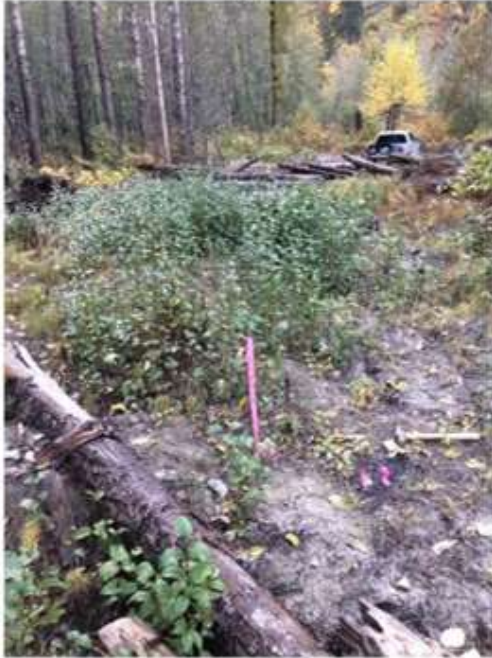
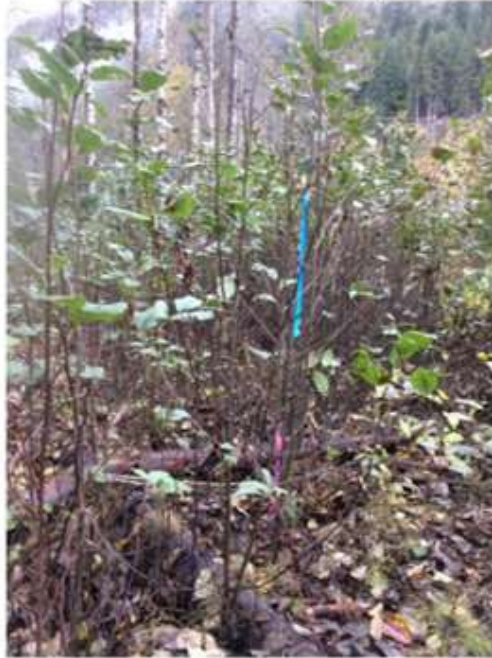
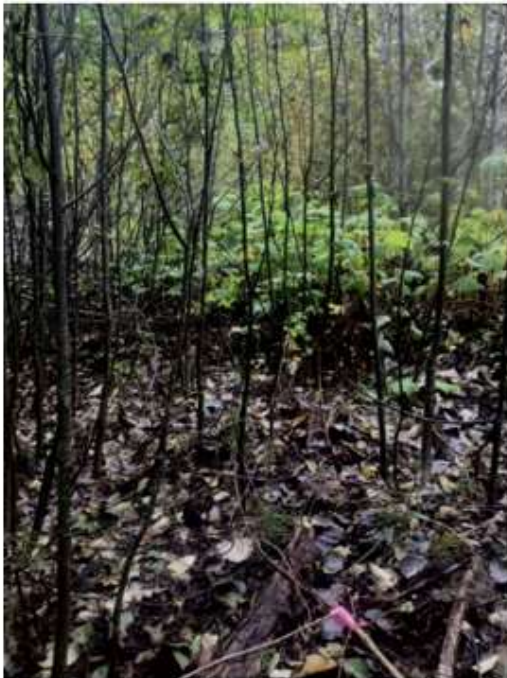
Figure 56. 140.1 Plot 35 Photos from 2018, 2020 and 2023

Stratum: 2018 140.1/Plot: Plot 35/Comments
Oct 03, 2018 11.08.39 AM.jpg

Stratum: 2020 140.1/Plot: 35/Comments
Overview photo looks South from plot 35.jpg

Stratum: 2023 140.1 Road/Plot: 35/Plot Name
Overview photo looks South from plot 35.jpeg

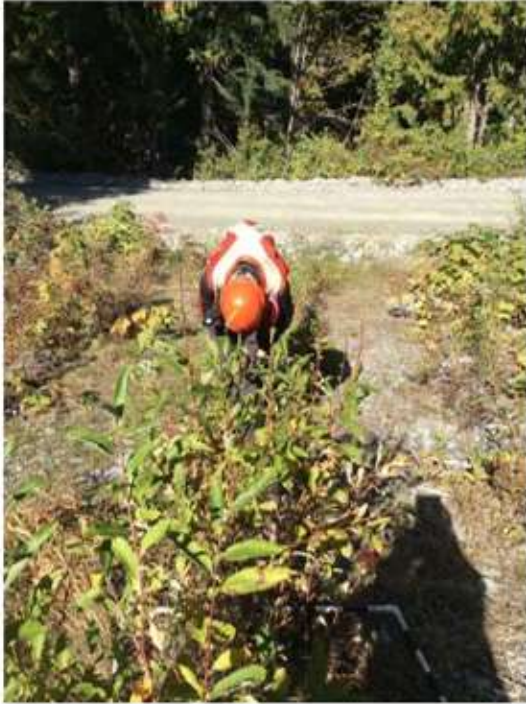
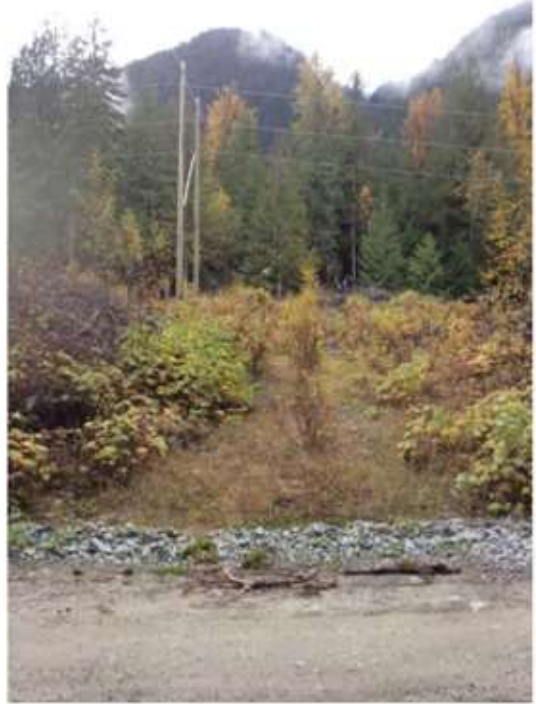
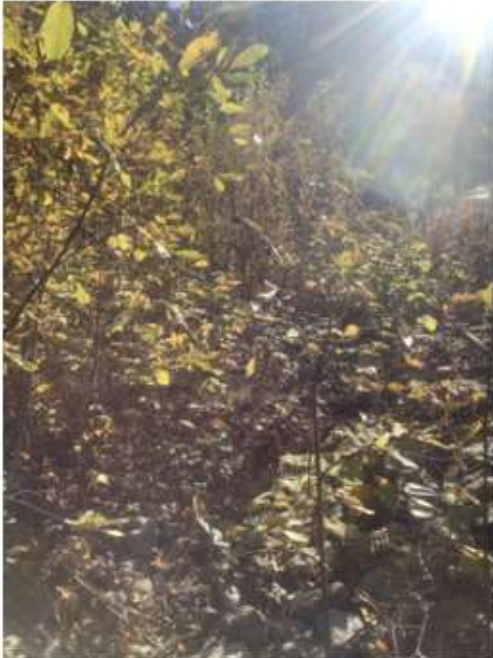
Figure 57. 163.1 Plot 35A Photos from 2018, 2020 and 2023

Transmission line road 163.1 is not deactivated. The plot was established in the middle road in 2018. When the plot was revisited in 2020 the rebar was found on the side of the road and the original plot center could not accurately be relocated. The plot was re-established off the side of the road. Due to different plot locations and the spur road not being deactivated this site should be dropped from revegetation monitoring program. If the road is no longer required to access the transmission line, it should be deactivated. This could be completed by decompacting the road and adding coarse woody debris or something less permanent such as putting boulders at the junction of the spur road and the South Lillooet FSR to block access. Plot data was not collected for this site in 2023. Despite not being deactivated this road continues to infill with shrubs and deciduous species.

Stratum: 2018 163.1/Plot: 35/Comments
Sep 25, 2018 02.02.25 PM.jpg

Stratum: 2020 163.1/Plot: 35A/Comments
Overview photo looks up road from FSR.jpg

Stratum: 2023 163.1 Road/Plot: 35A/Plot Name
Overview photo looks South from plot 35A.jpeg

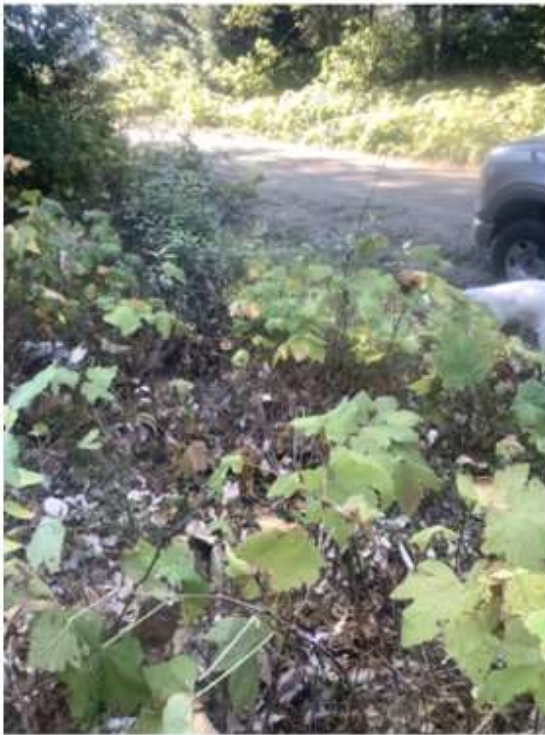
Figure 58. 237.1 Plot 34 Photos from 2018, 2020 and 2023

Stratum: 2023 237.1/Plot: 34/Plot Name
Overview photo looks S from 34 .jpeg
