Upper Lillooet Hydro Project

Operational Environmental Monitoring Year 5

April 24, 2024

Ecofish Research Ltd.

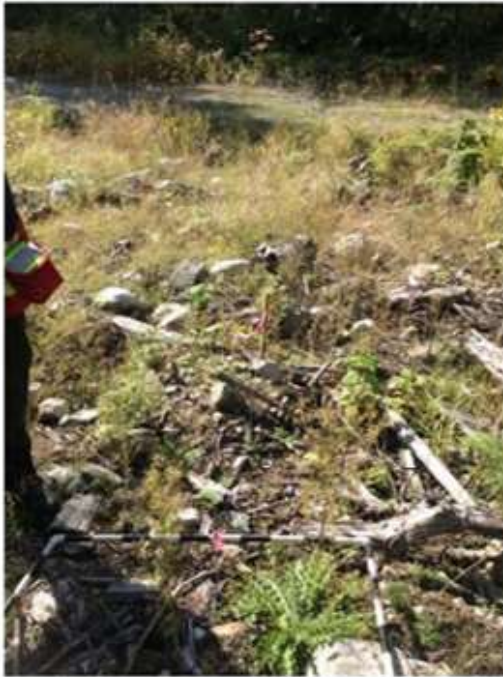
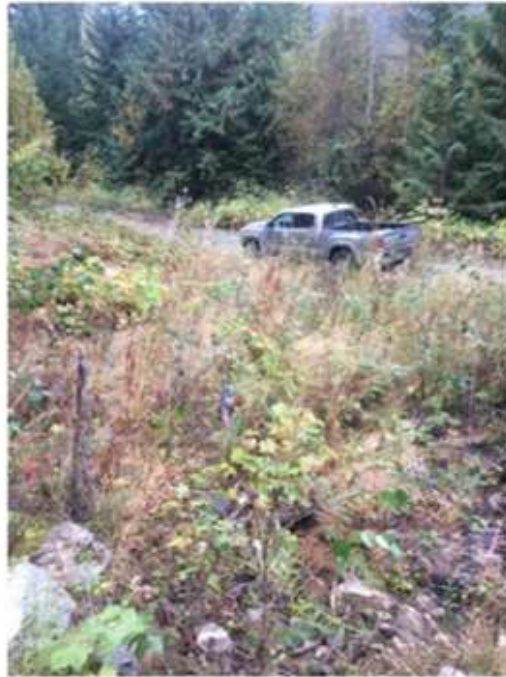
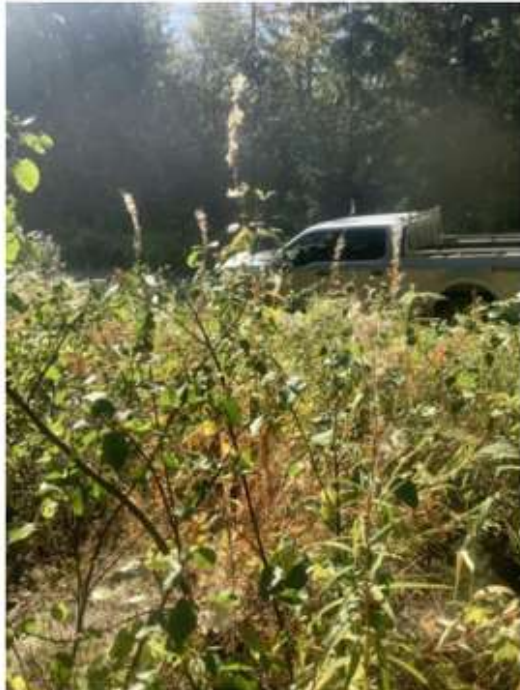
Figure 59. 238.1 Plot 33 Photos from 2018, 2020 and 2023

Stratum: 2020 238.1/Plot: 33/Plot Name
Overview photo looks South from plot 33.jpg

Stratum: 2023 238.1/Plot: 33/Plot Name
Overview photo looks South from plot 33.jpeg

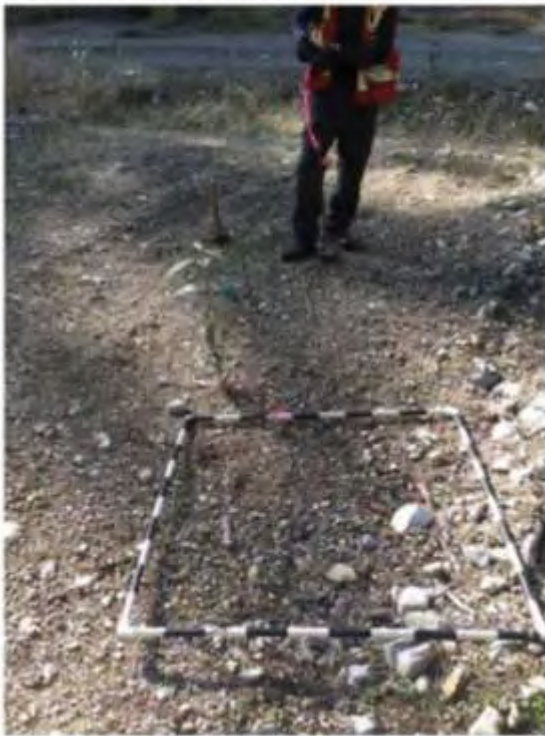
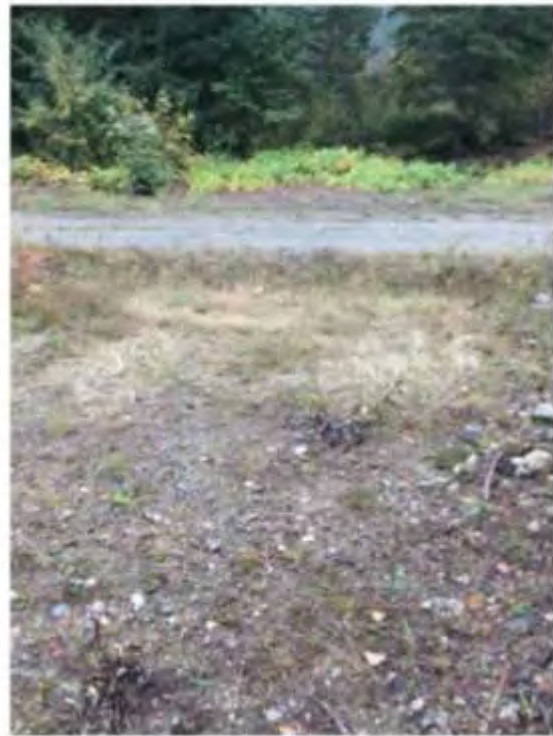
Figure 60. 239.1 Plot 32 Photos from 2018 and 2020

Transmission line road 239.1 takes off from an existing forestry road. The portion of the road built to access pole 239 is deactivated and looks similar to the other roads in the area regarding natural ingress of trees and shrubs. The plot was established on the active portion of the road, this location was likely chosen due to its location being outside of the transmission line ROW. Plot data was collected in 2020 but it is recommended that the site be dropped from the monitoring program as the original plot location is not part of the road that Innergex was required to deactivate and is actively being used by industry and recreationalists. There was no increase in species diversity and the total sph for the site has decreased from 2000 sph in 2018 to 800 sph in 2020. No plot data was collected for this site in 2023 as the road is still being actively used.

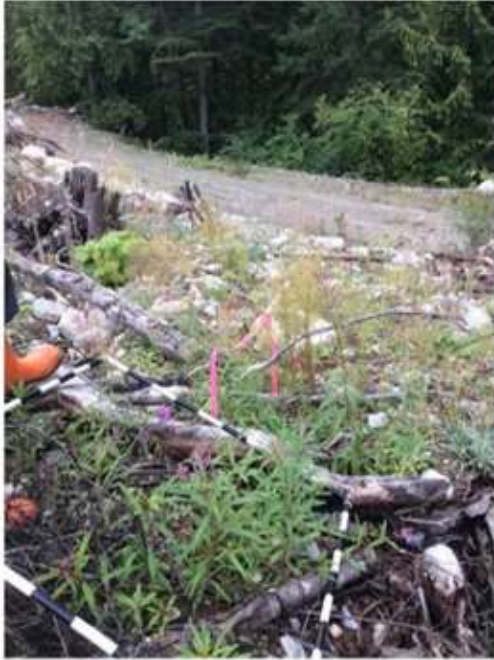
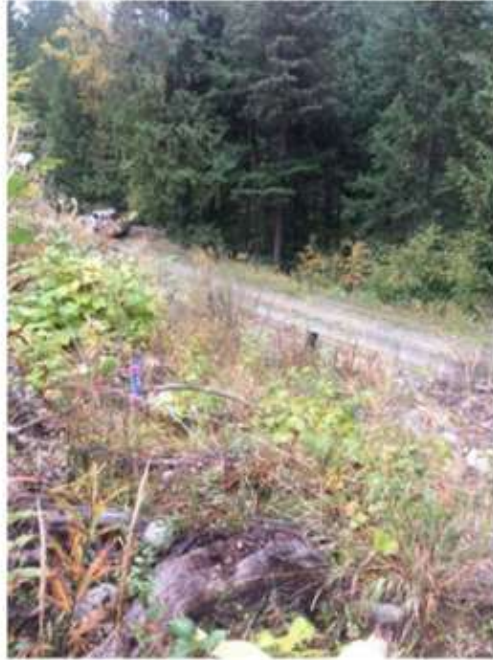
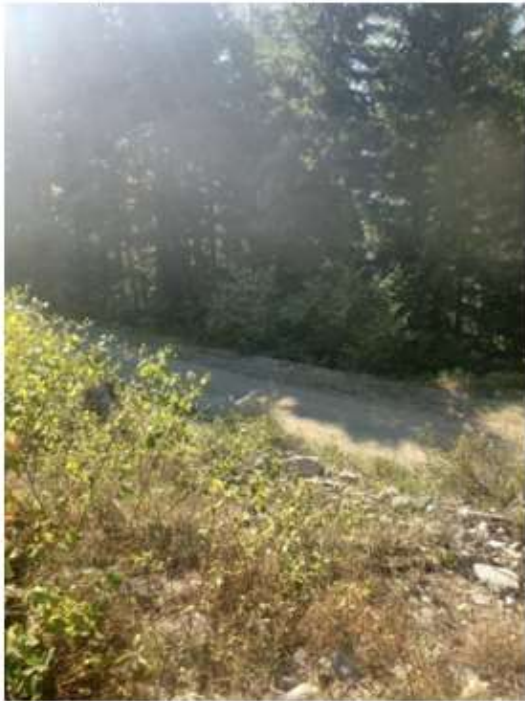
Figure 61. 245.1 Plot 26 Photos from Photos from 2018, 2020 and 2023

Card: Transmission Line
Stratum: 2020 245.1/Plot: 26/Comments
Overview photo looks South from plot 26.jpg

Card: Transmission Line Surveys
Stratum: 2023 245.1 Road/Plot: 26/Plot Name
Overview photo looks S from 26.jpeg

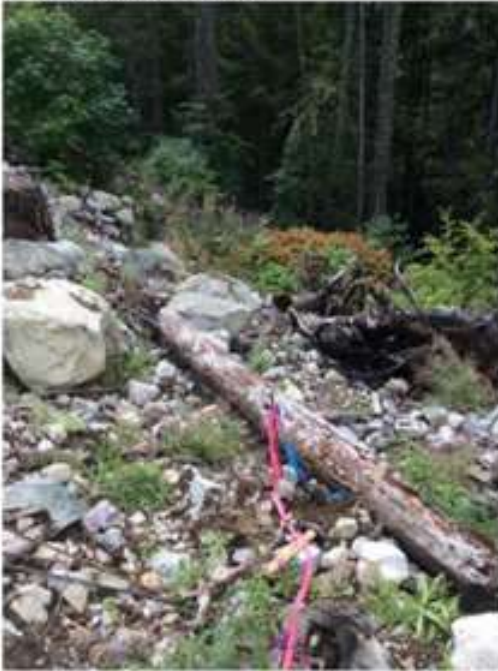
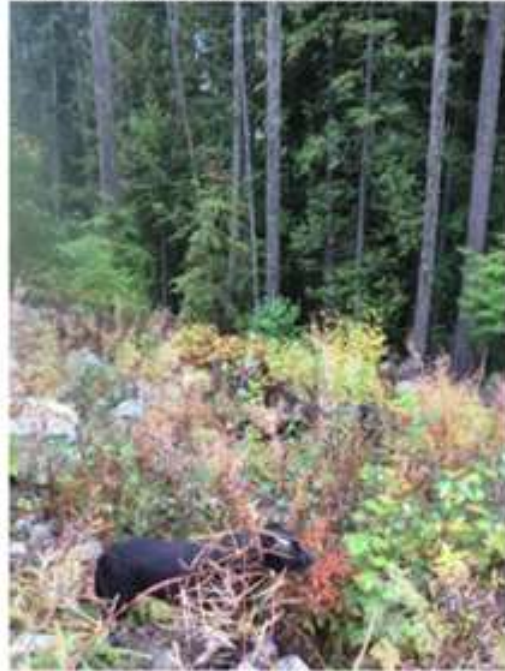
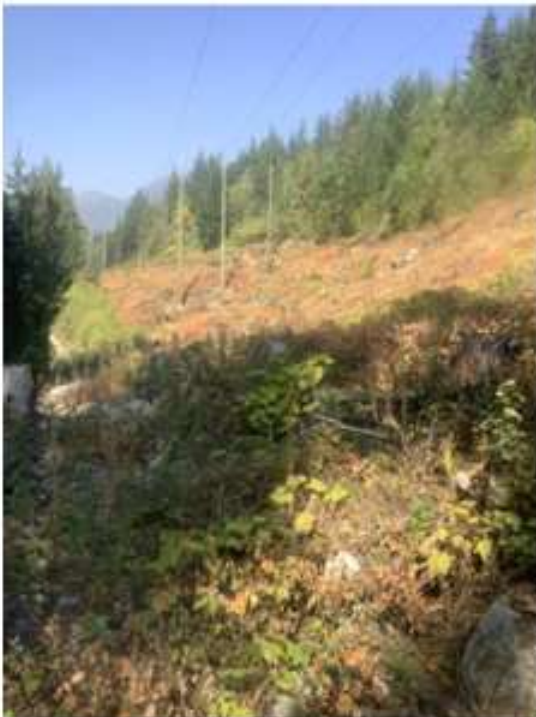
Figure 64. 250.1 Plot 24 Photos from Photos from 2018, 2020 and 2023

Card: Transmission Line Surveys
Stratum: 2023 250.1 Road/Plot: 24/Plot Name
Area was recently manually brushed.jpeg

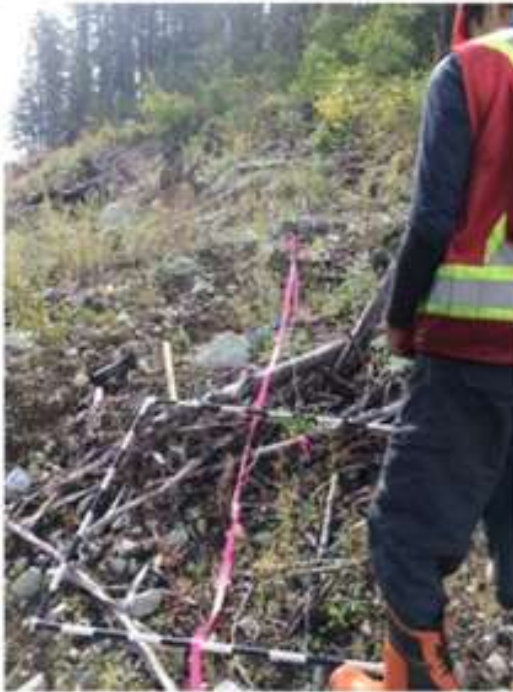
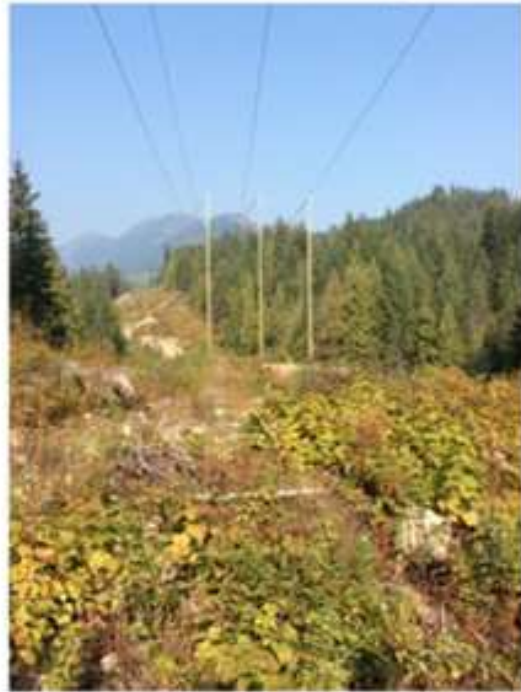
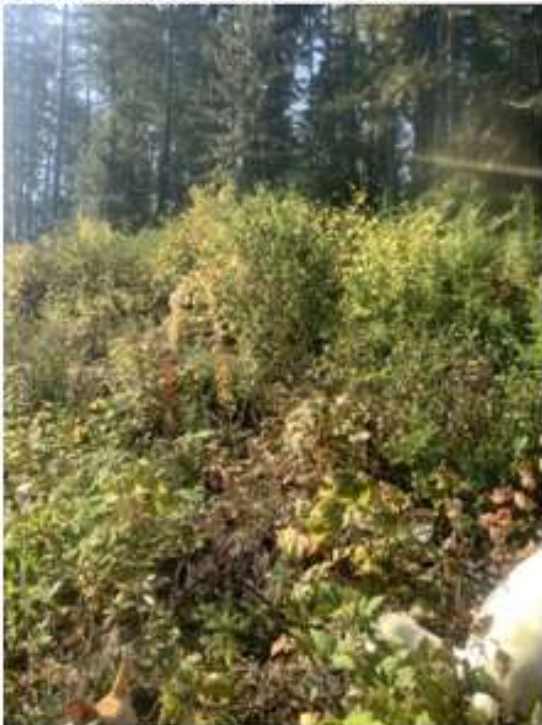
Figure 65. 255.1 Plot 23 Photos from 2018 Photos from 2018, 2020 and 2023

Stratum: 2020 255.1/Plot: 23/Comments
Overview photo looks NW from plot 23.jpg

Stratum: 2023 255.1 Road/Plot: 23/Plot Name
Overview photo looks South from plot 23.jpeg

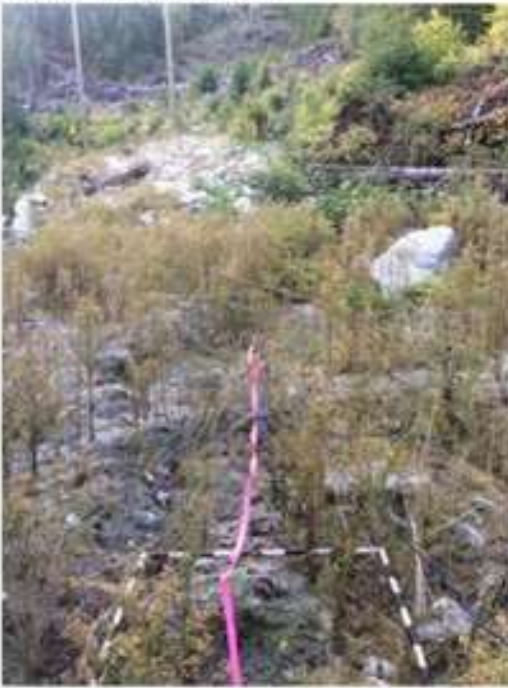
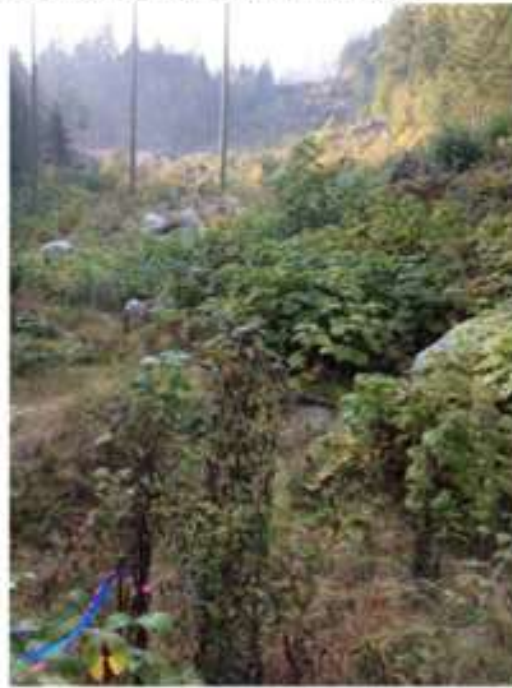
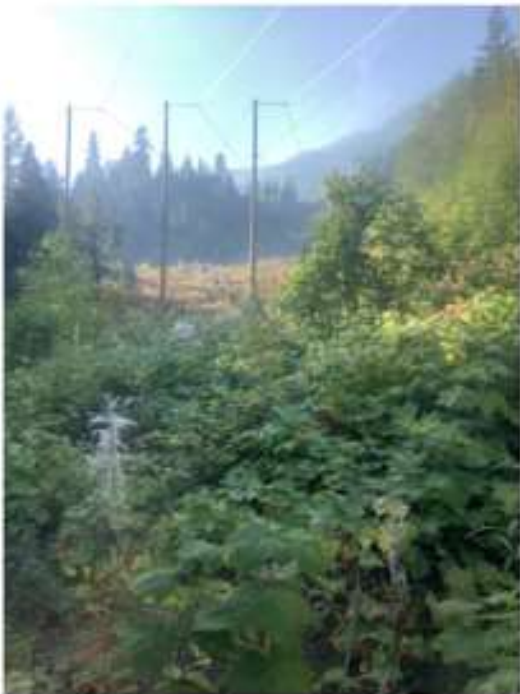
Figure 66. 260.1 Plot 21 Photos from Photos from 2018, 2020 and 2023

Card: Transmission Line
Stratum: 2020 260.1/Plot: 21/Comments
Overview photo looks South from plot 21.jpg

Card: Transmission Line Surveys
Stratum: 2023 260.1 Road/Plot: 21/Plot Name
Overphoto looks south from 21.jpeg

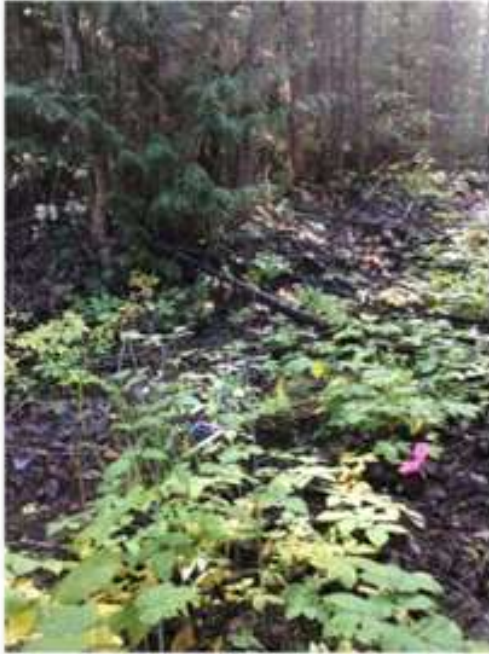
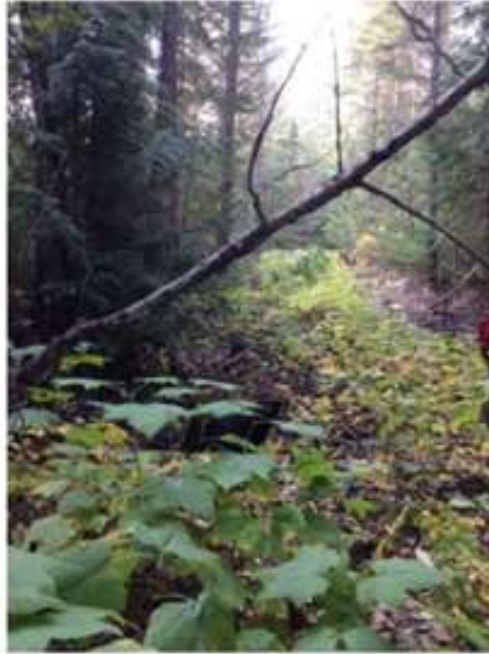
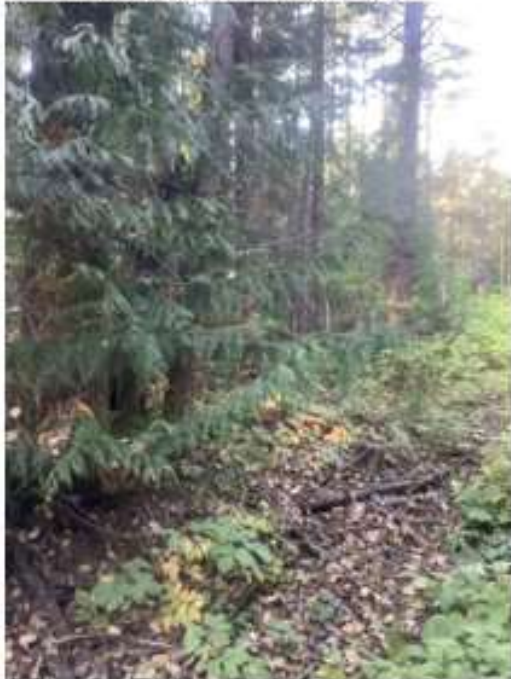
Figure 67. Ryan Crossing Photos from 2018, 2020 and 2023

The Ryan Crossing site is located in a narrow corridor with rich organic soils and low light levels. Western red cedar, a low light tolerant species is seeding in naturally from the adjacent stand. The number of seedlings has decreased from 1000 sph in 2020 to 600 sph in 2023. No deciduous stems have infilled on this low light site. Shrub densities have also decreased but the plant size and heights are slowly increasing. Species diversity of the shrubs has increased. Saskatoon, and red elderberry are now present on the site. No erosion or siltation issues were noted. Increases in moss cover are minimal but soil processes are ongoing due to leaf fall from surrounding hardwoods and shrubs. No further revegetation treatments are required for this site.

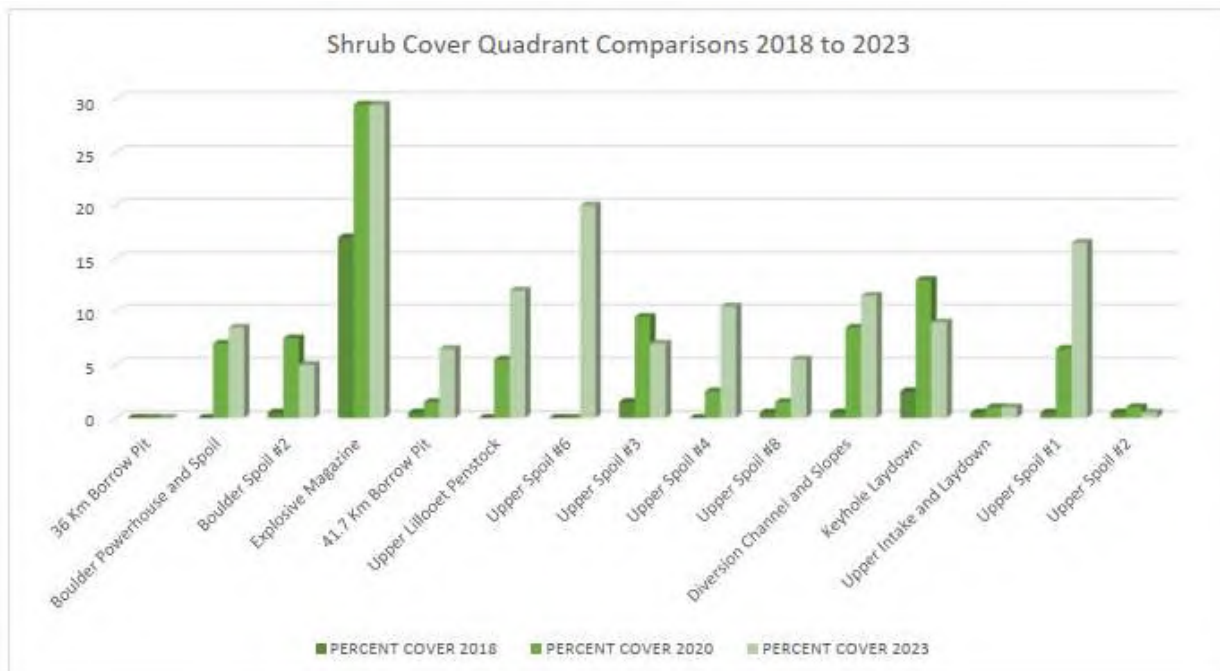
Figure 69. Civil Works Sites - Percent Cover of Shrub Layer from Quadrat Plot Data

Some sites had small decreases in percent cover in one of the layers. This was anticipated as some plants were expected to succumb to site limiting factors such as drought, interplant competition or biotic damage. Decreases in one layer led to increases in other layers. This is typical in developing plant communities and is an indication of a recovering site.

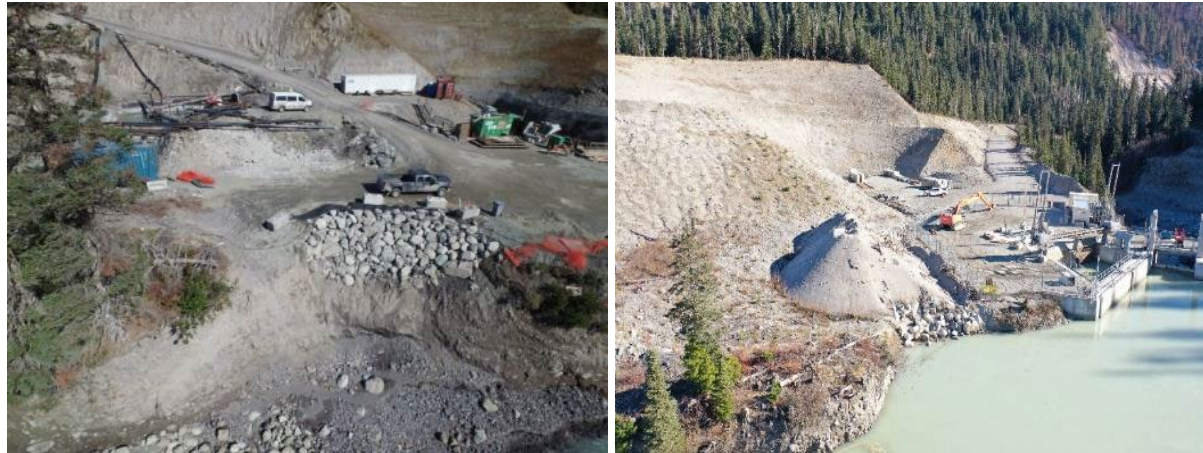
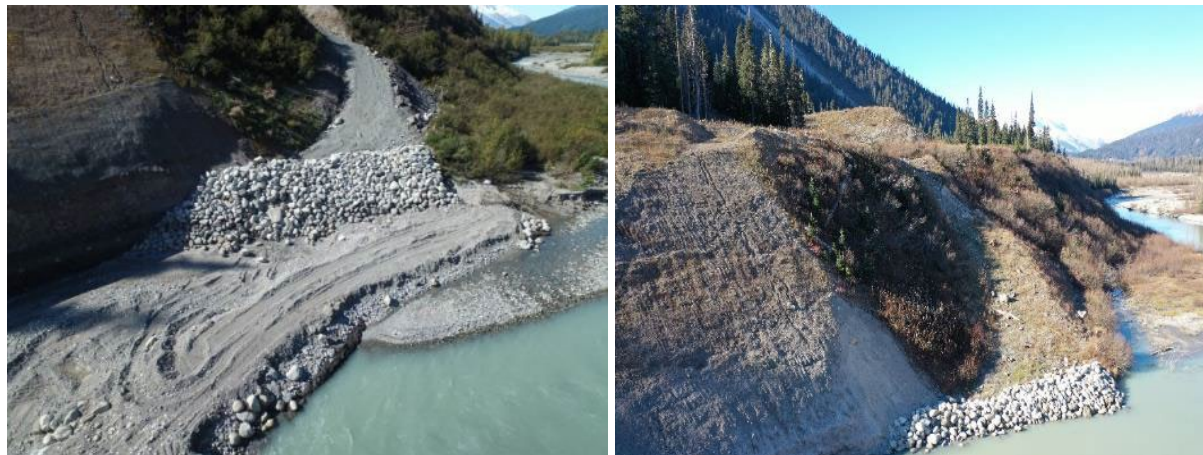
Figure 5. Continued.

c) Looking towards river left.

d) Looking towards river right.

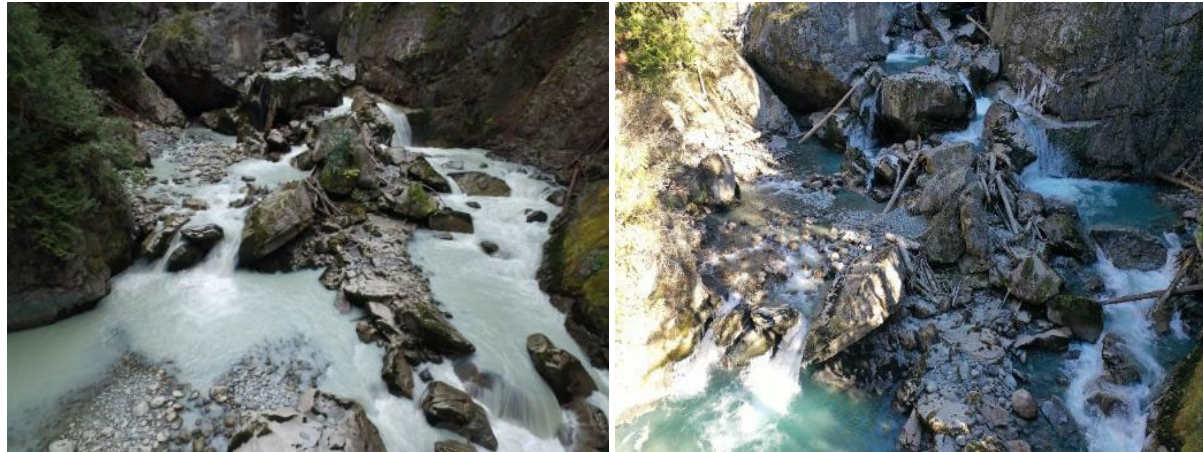
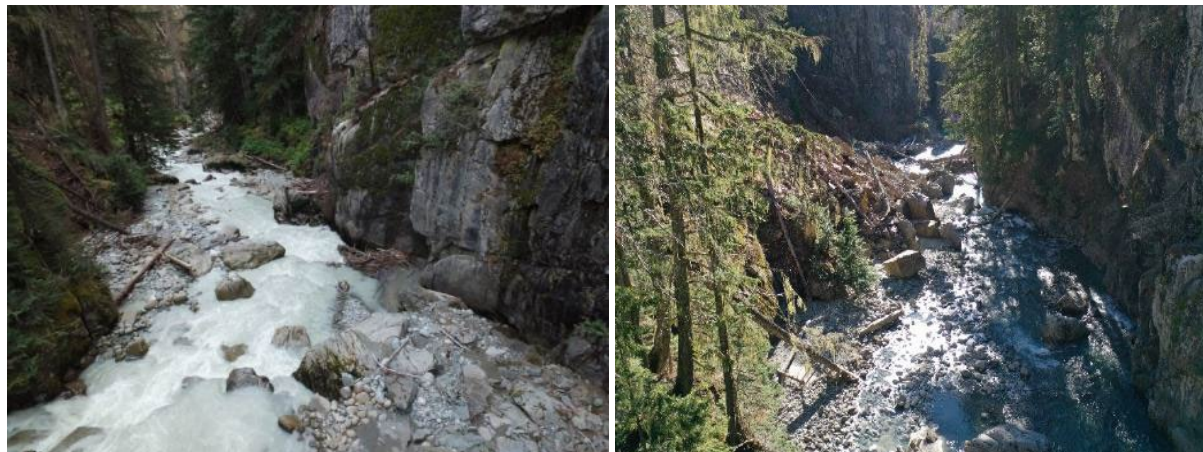
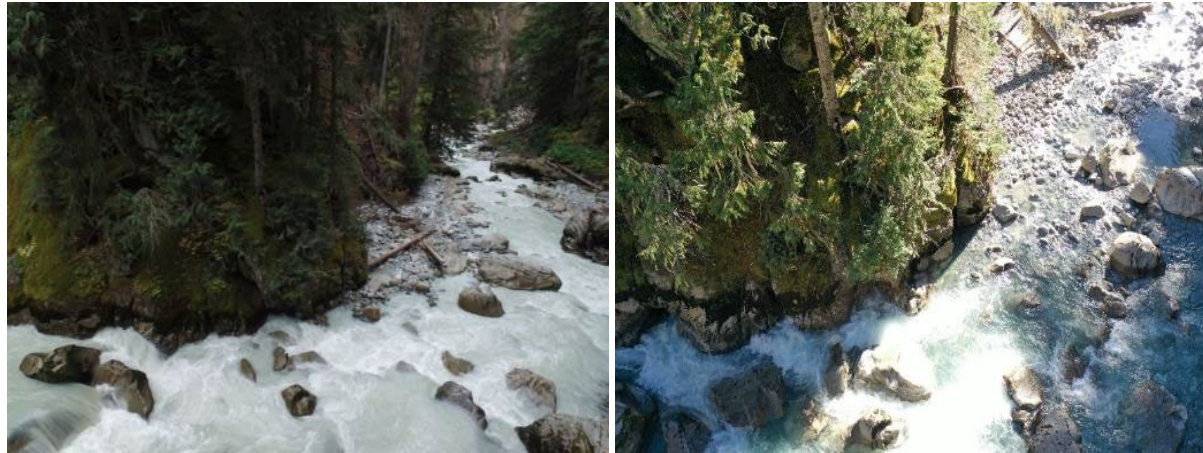
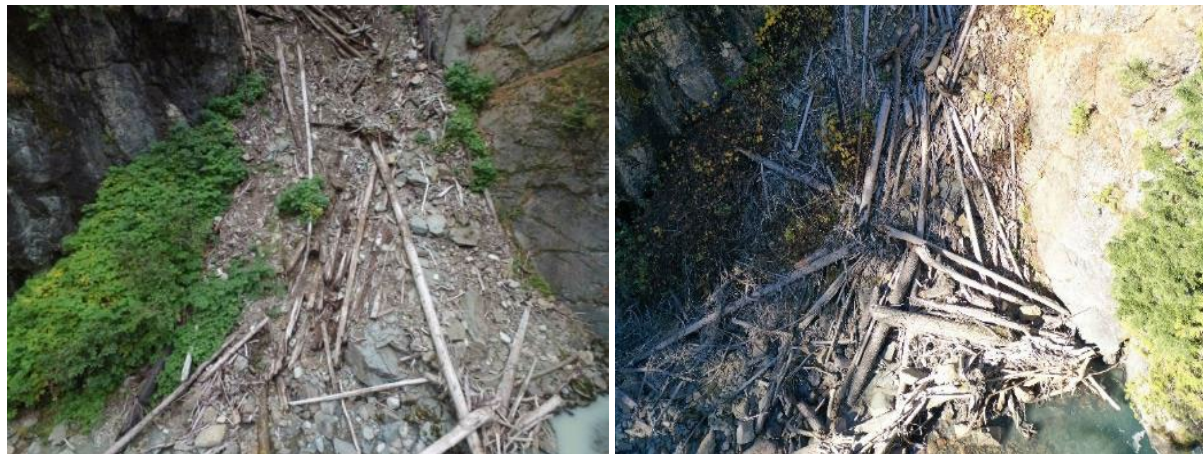
Figure 1. Boulder Creek at BDR-USGMPP01, Overview photos taken on September 24, 2016 (left) and October 28, 2023 (right).

a) Looking upstream.

b) Looking downstream.

c) Looking towards river left.

d) Looking towards river right.

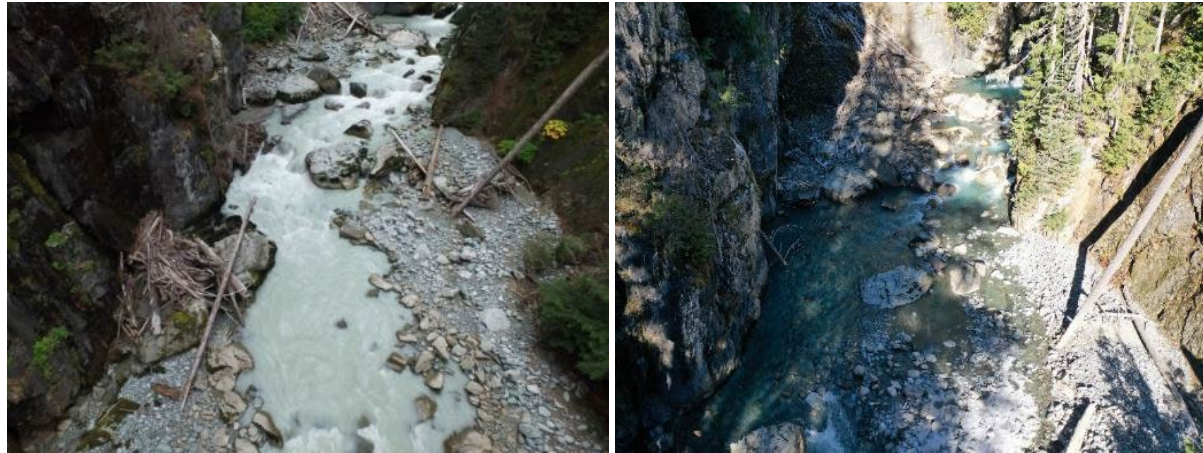
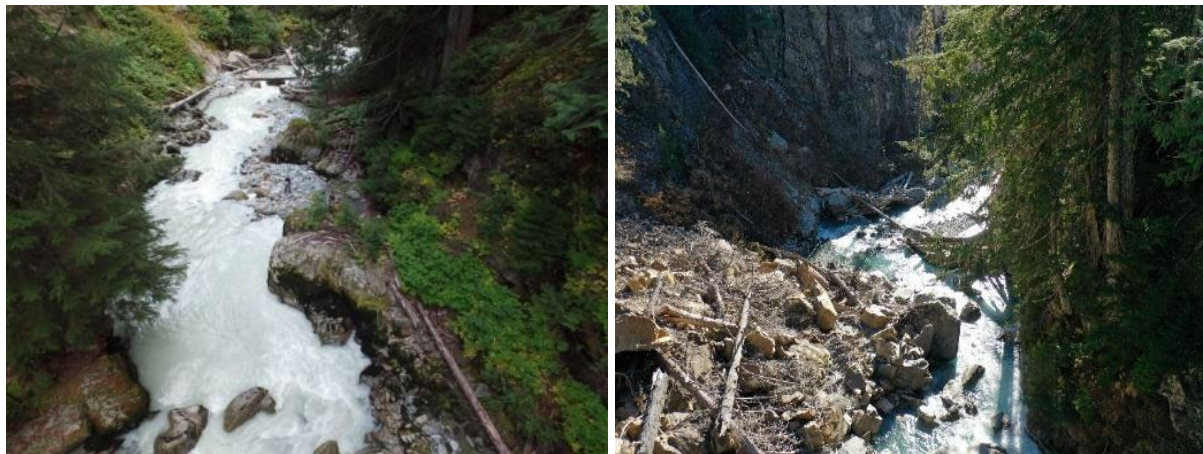
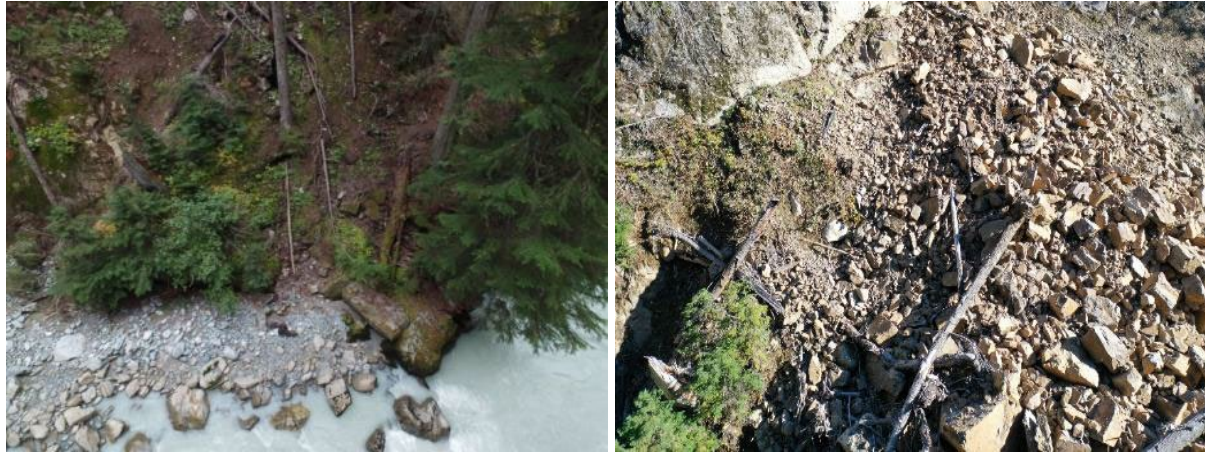
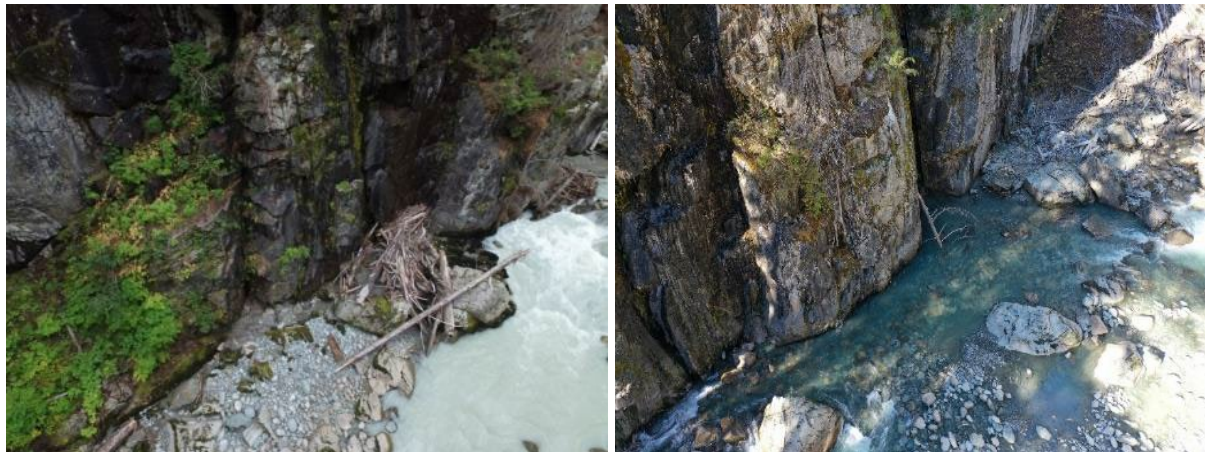
Figure 2. Boulder Creek at BDR-USGMPP02, Overview photos taken on September 24, 2016 (left) and October 28, 2023 (right).

a) Looking upstream.

b) Looking downstream.

c) Looking towards river left.

d) Looking towards river right.

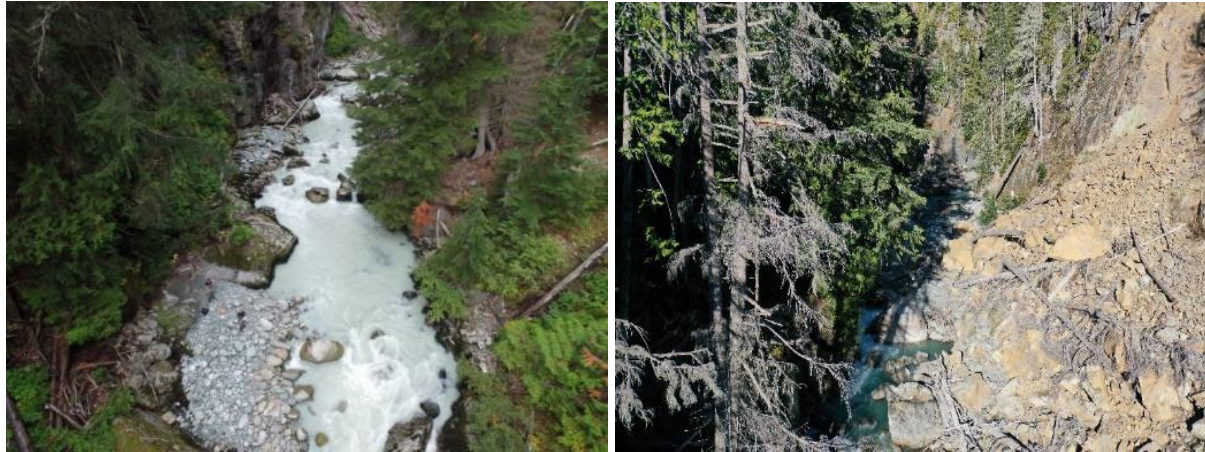
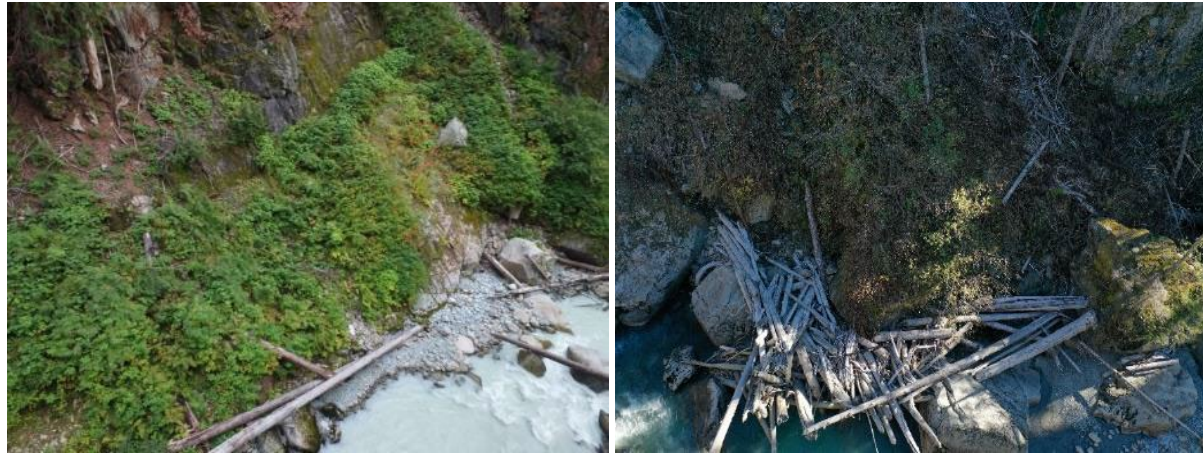
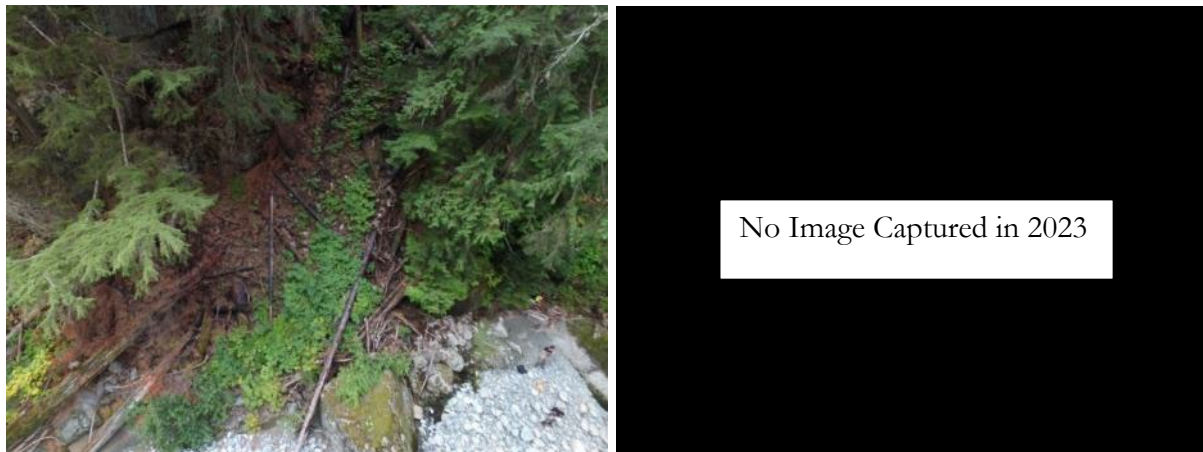
Figure 3. Boulder Creek at BDR-USGMPP03, Overview photos taken on September 24, 2016 (left) and October 28, 2023 (right).

a) Looking upstream.

c) Looking towards river left.

d) Looking towards river right.

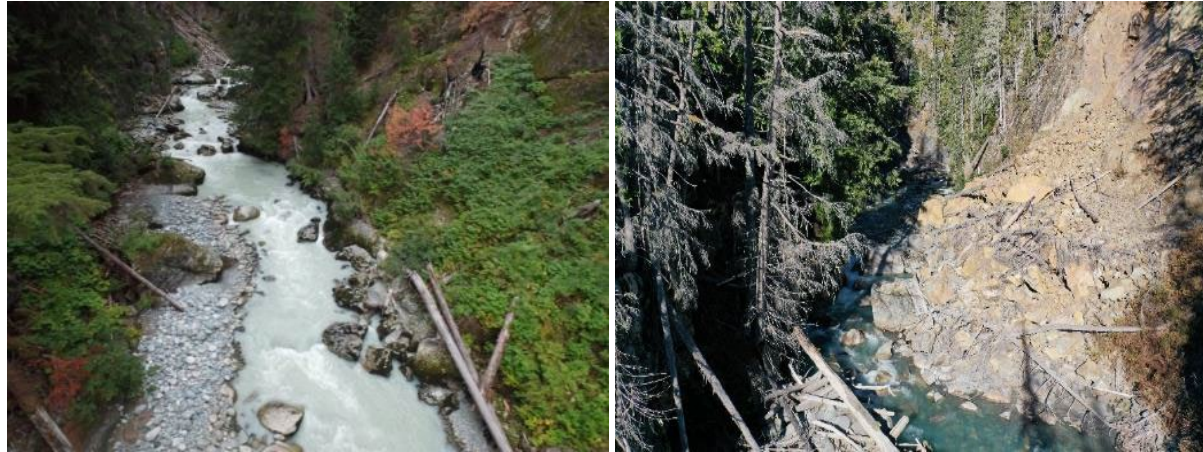
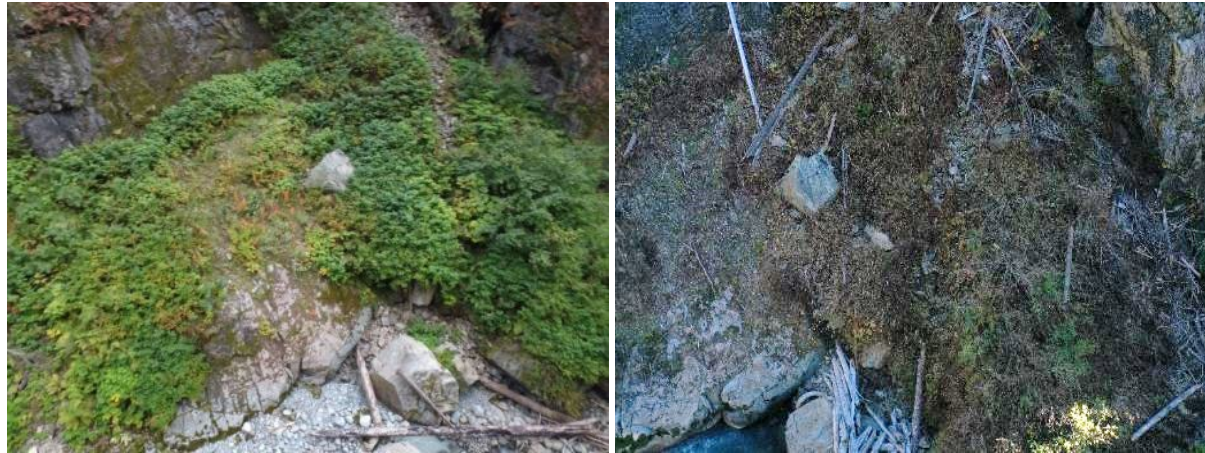
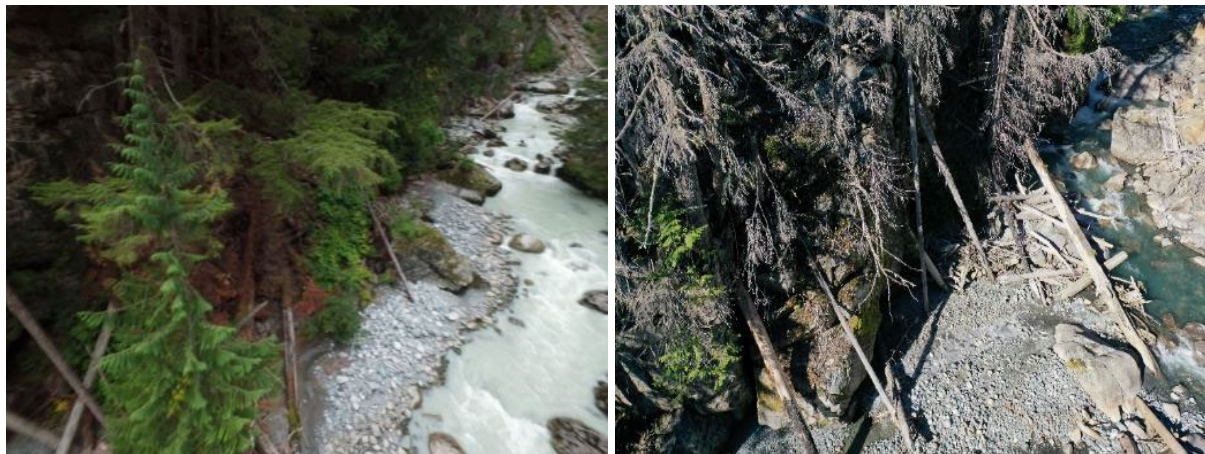
Figure 4. Boulder Creek at BDR-USGMPP04, Overview photos taken on September 24, 2016 (left) and October 28, 2023 (right).

a) Looking upstream.

c) Looking towards river left.

d) Looking towards river right.

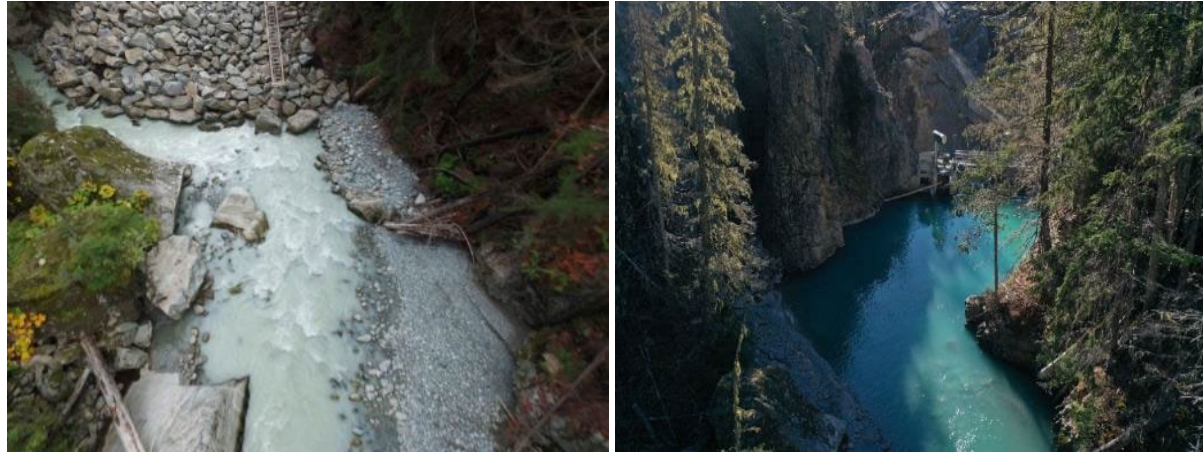
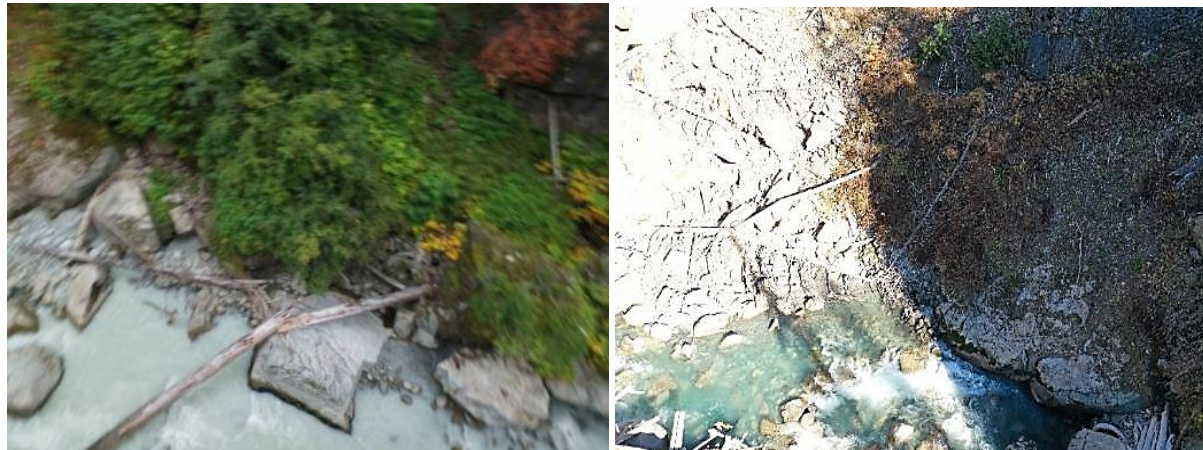
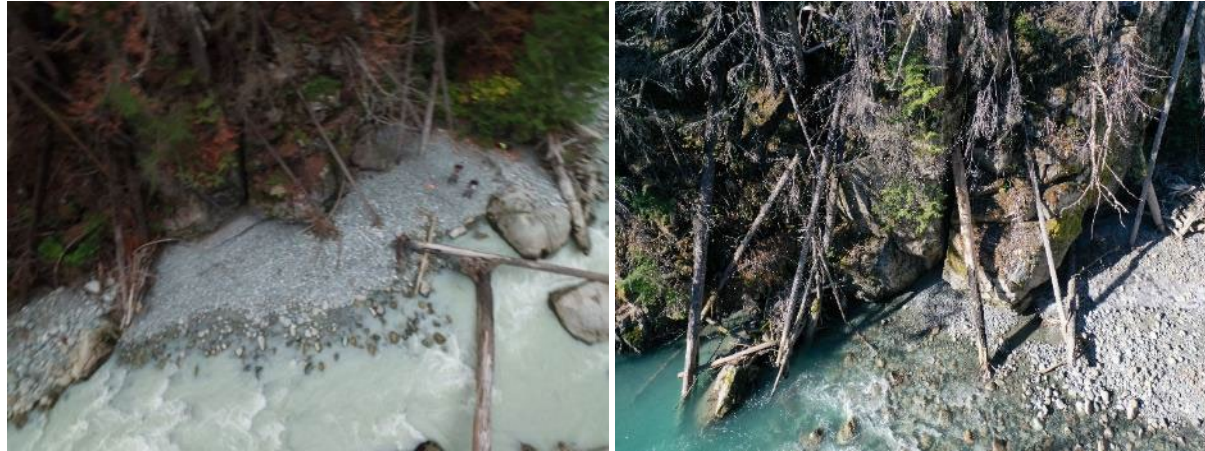
Figure 5. Boulder Creek at BDR-USGMPP05, Overview Photos taken on September 24, 2016 (left) and October 28, 2023 (right).

a) Looking downstream.

b) Looking towards river left.

c) Looking towards river right.

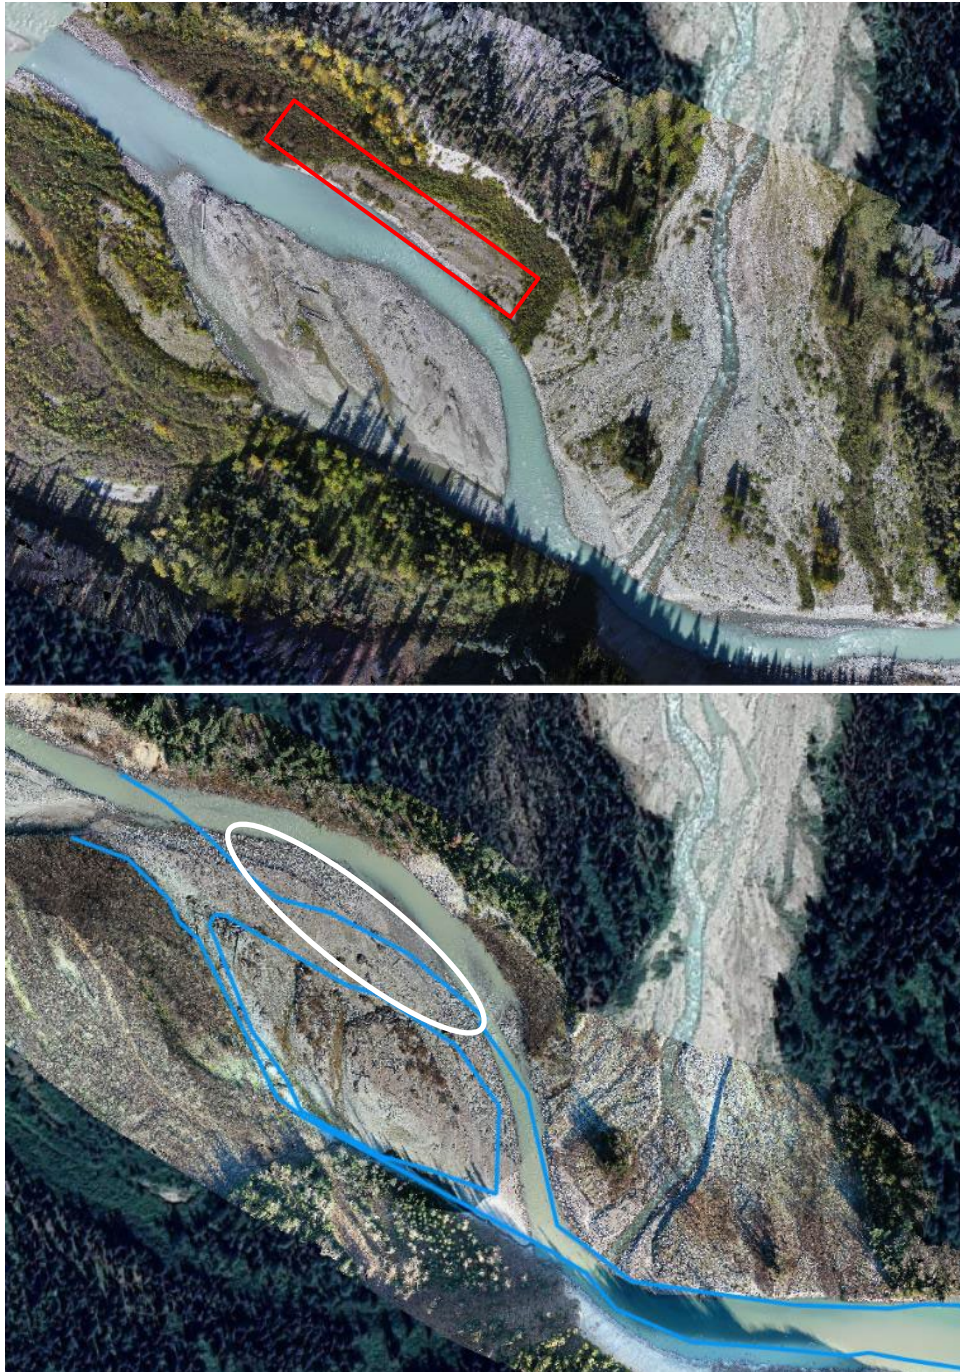
Figure 2. Upper Lillooet River Upstream Reach at the confluence of Salal Creek displaying accumulation of fines and gravel outline in green and coarsening of sediment outline in red at the mouth of Salal Creek in 2023 (bottom) in comparison to 2016 (top). Gravel bar downstream of confluence now submerged below water in 2023. Blue outline displays 2016 channel path for visual representation.

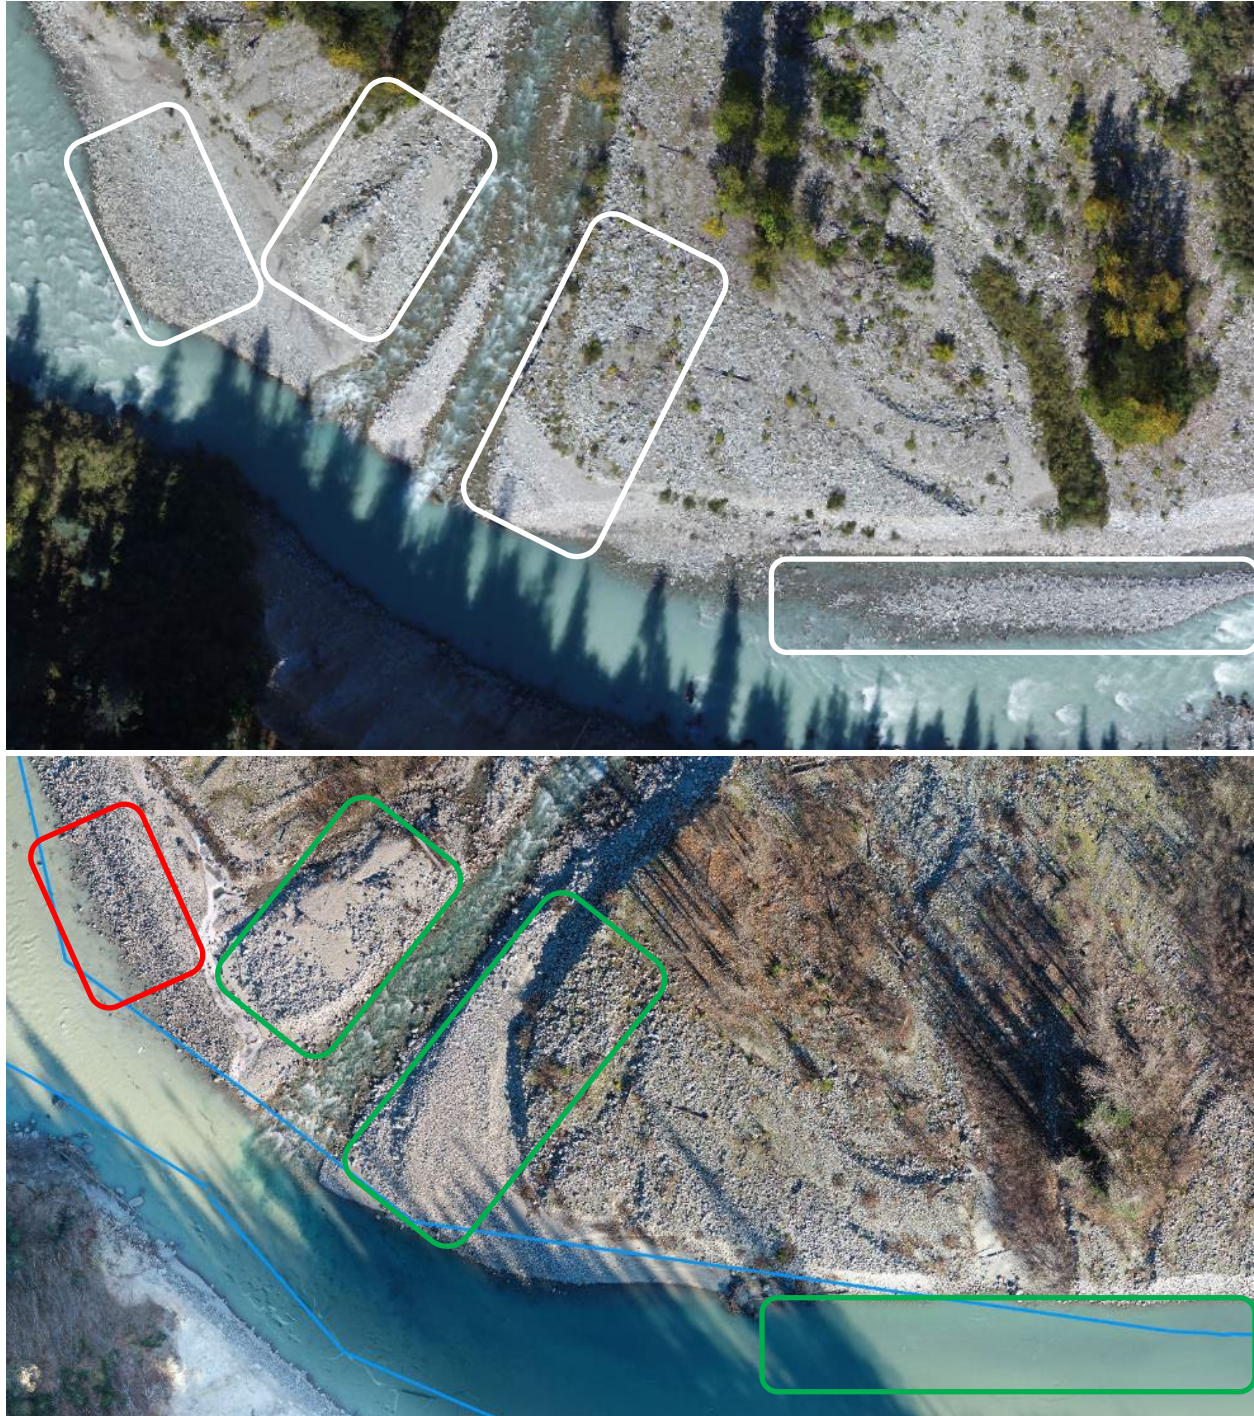
Figure 3. Upper Lillooet River Upstream Reach displaying back watering of channel caused by Upper Lillooet Intake in 2023 (bottom) in comparison to 2016 (top). Blue outline displays 2016 channel path for visual representation. Loss of riparian habitat outline in red on the river left and right bank. Exposed gravel bar outlined in white in 2016 is submerged (green) in 2023.
