Upper Lillooet Hydro Project

Operational Environmental Monitoring Year 5

April 24, 2024

Ecofish Research Ltd.

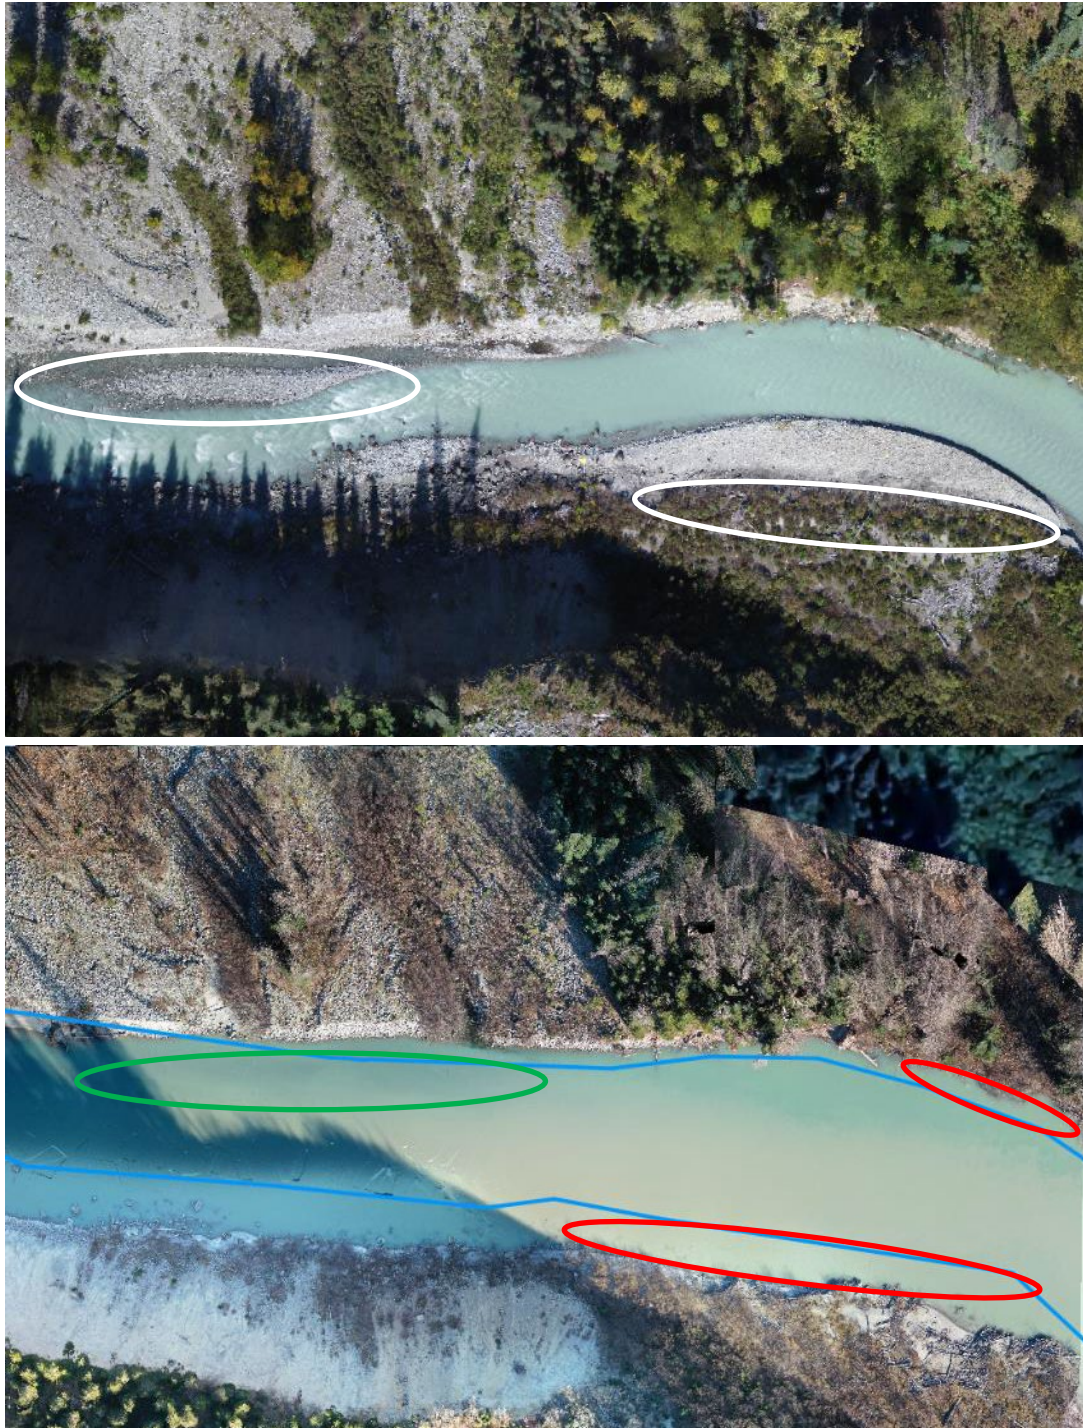
Figure 4. Upper Lillooet River Upstream Reach displaying river left bank erosion in headpond (yellow outline) in 2023 (bottom) in comparison to 2016 (top). Toe of slope outline in black has moved upslope due to water level rise and is no longer protected from flow erosion by larger cobble boulders bar causing some erosion on steep left bank into the headpond. Blue outline displays 2016 channel path for visual representation.

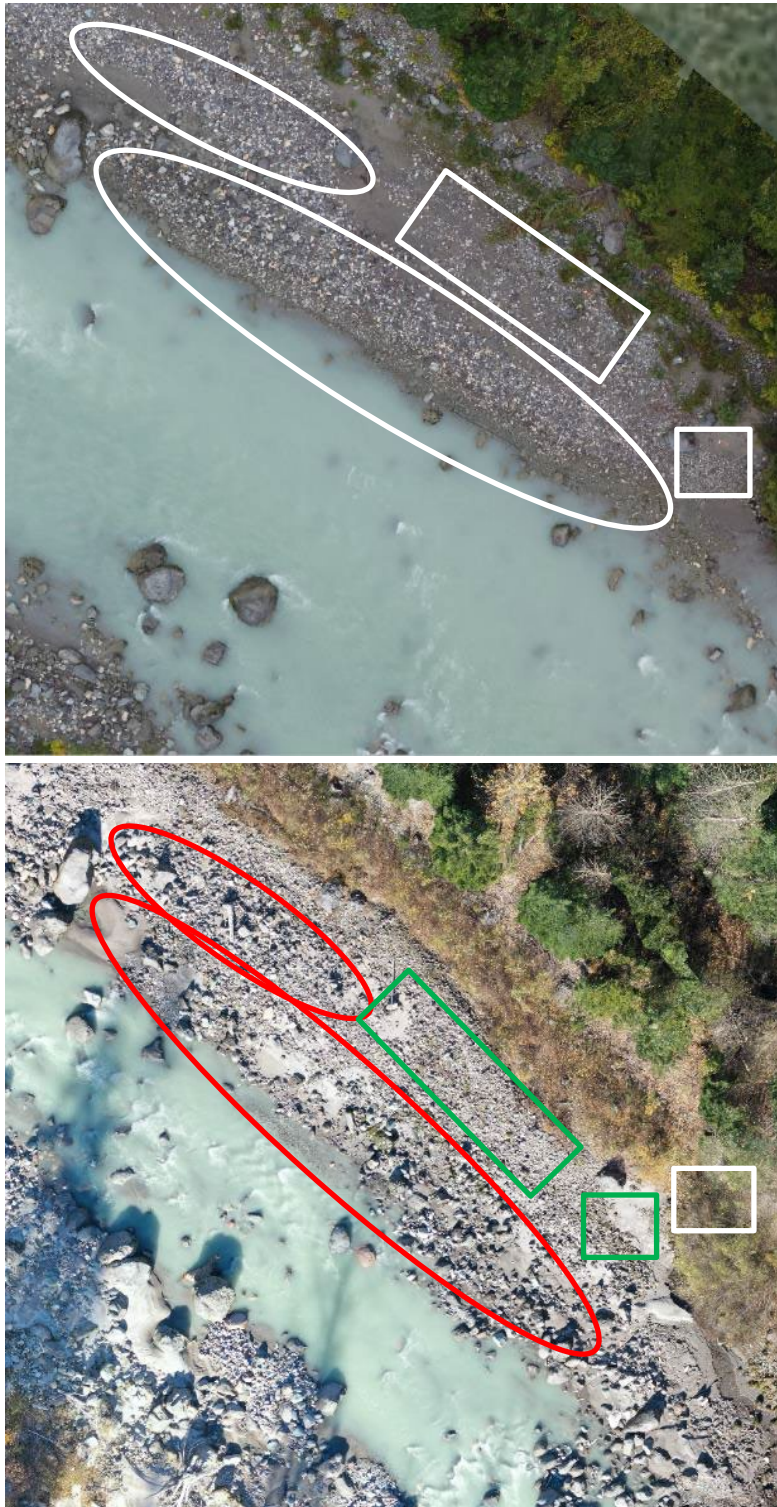
Figure 5. Upper Lillooet River Diversion Reach displaying some coarsening of gravel and loss of fines outline in red in 2023 (bottom) in comparison to 2016 (top). Two gravel patches indicated in orange spray painted in 2016 are present in 2023 outline in green.

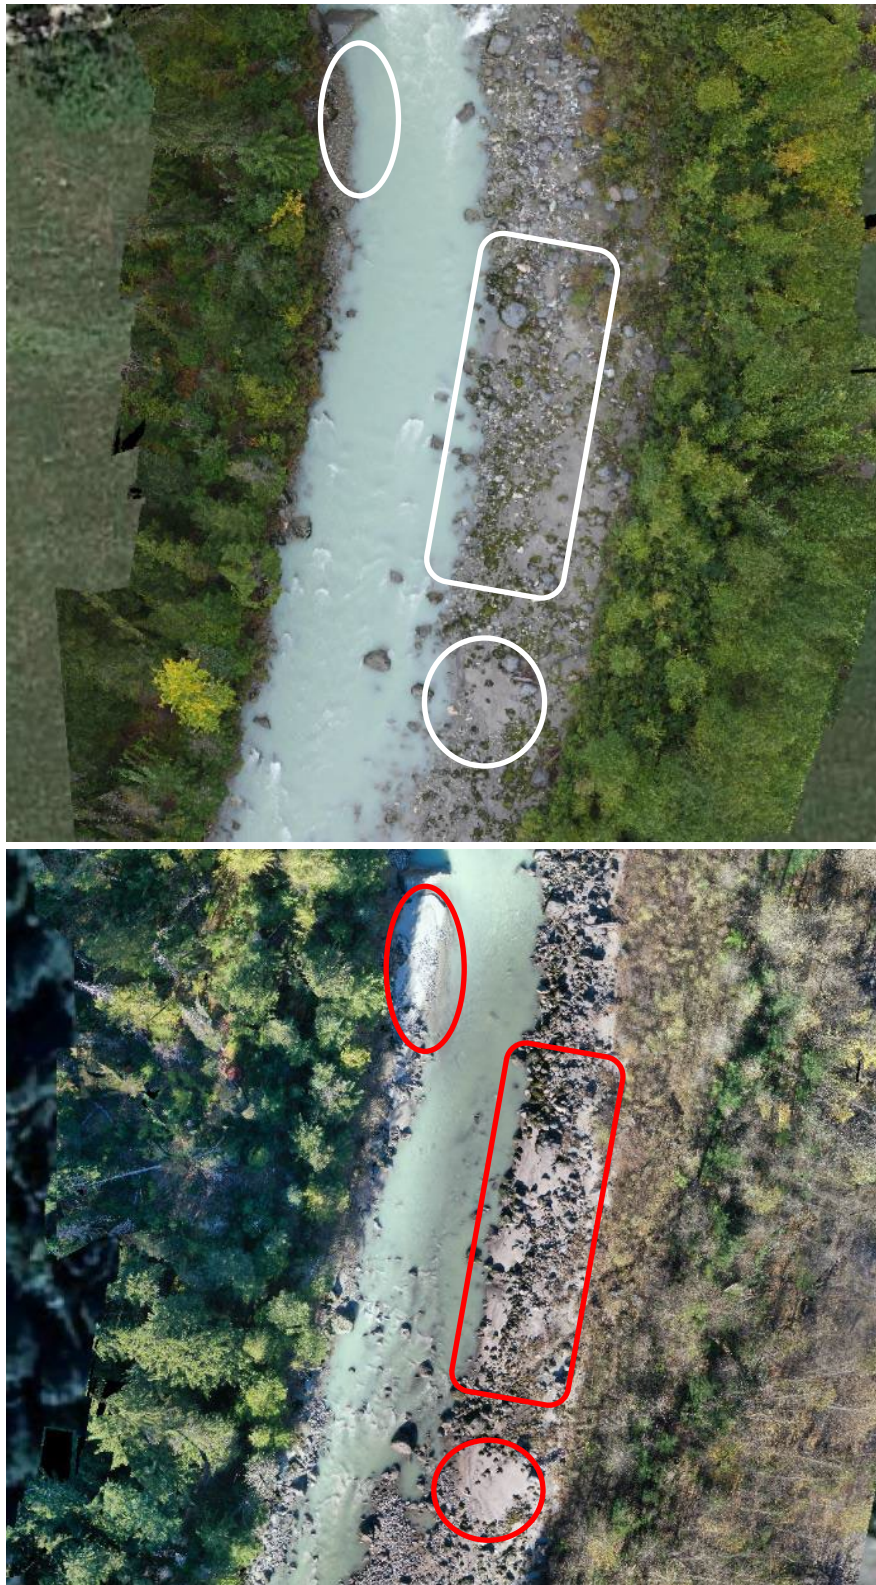
Figure 6. Upper Lillooet River Diversion Reach displaying fine sediment accumulation from 2016 (top) to 2023 (bottom).

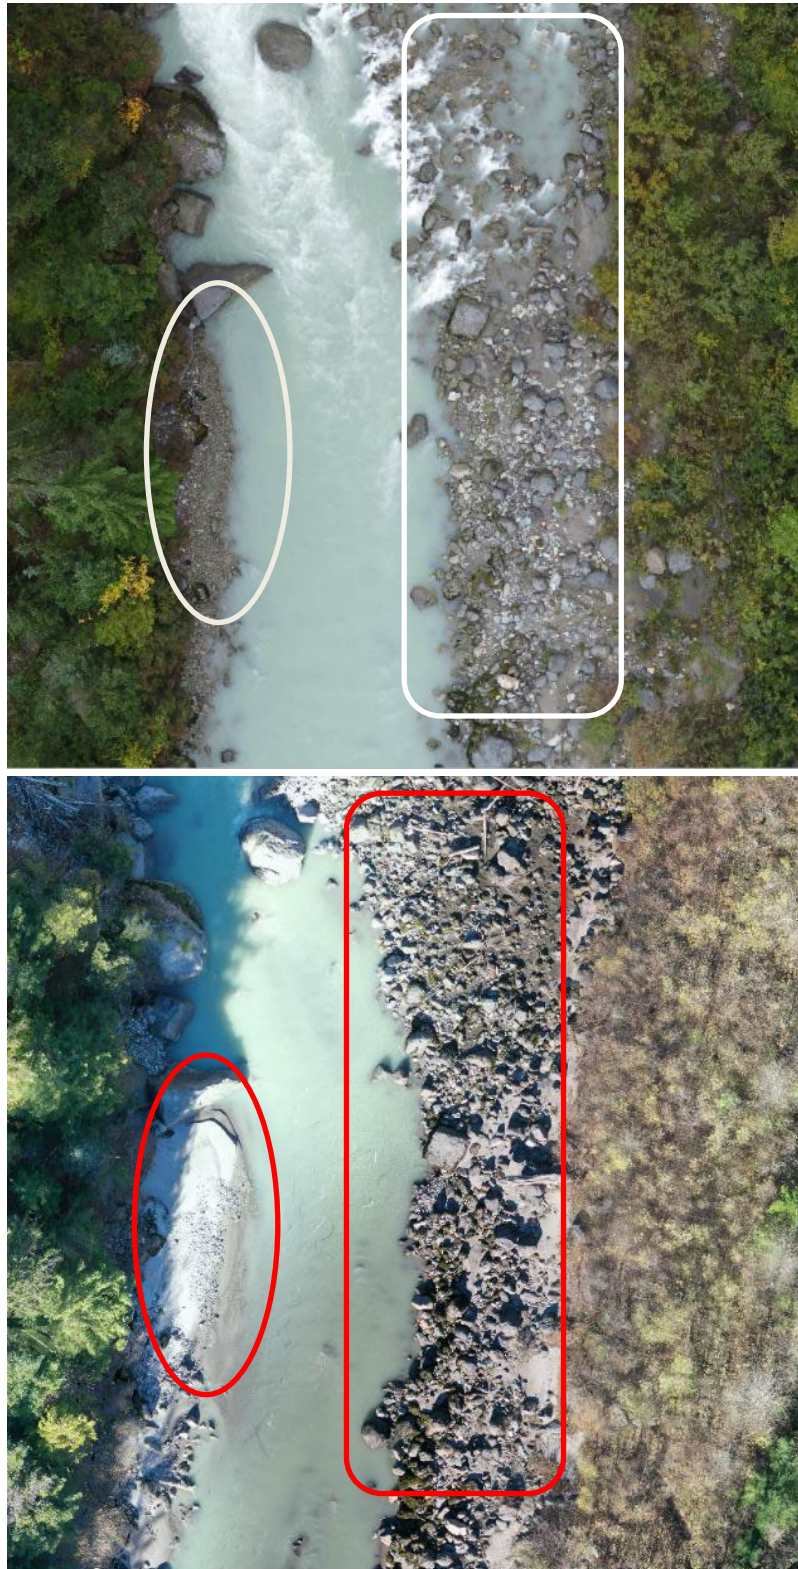
Figure 7. Upper Lillooet River Diversion Reach displaying coarsening of sediment on river left and fine sediment accumulation covering gravel on river right in 2023 (bottom) in comparison to 2016 (top).

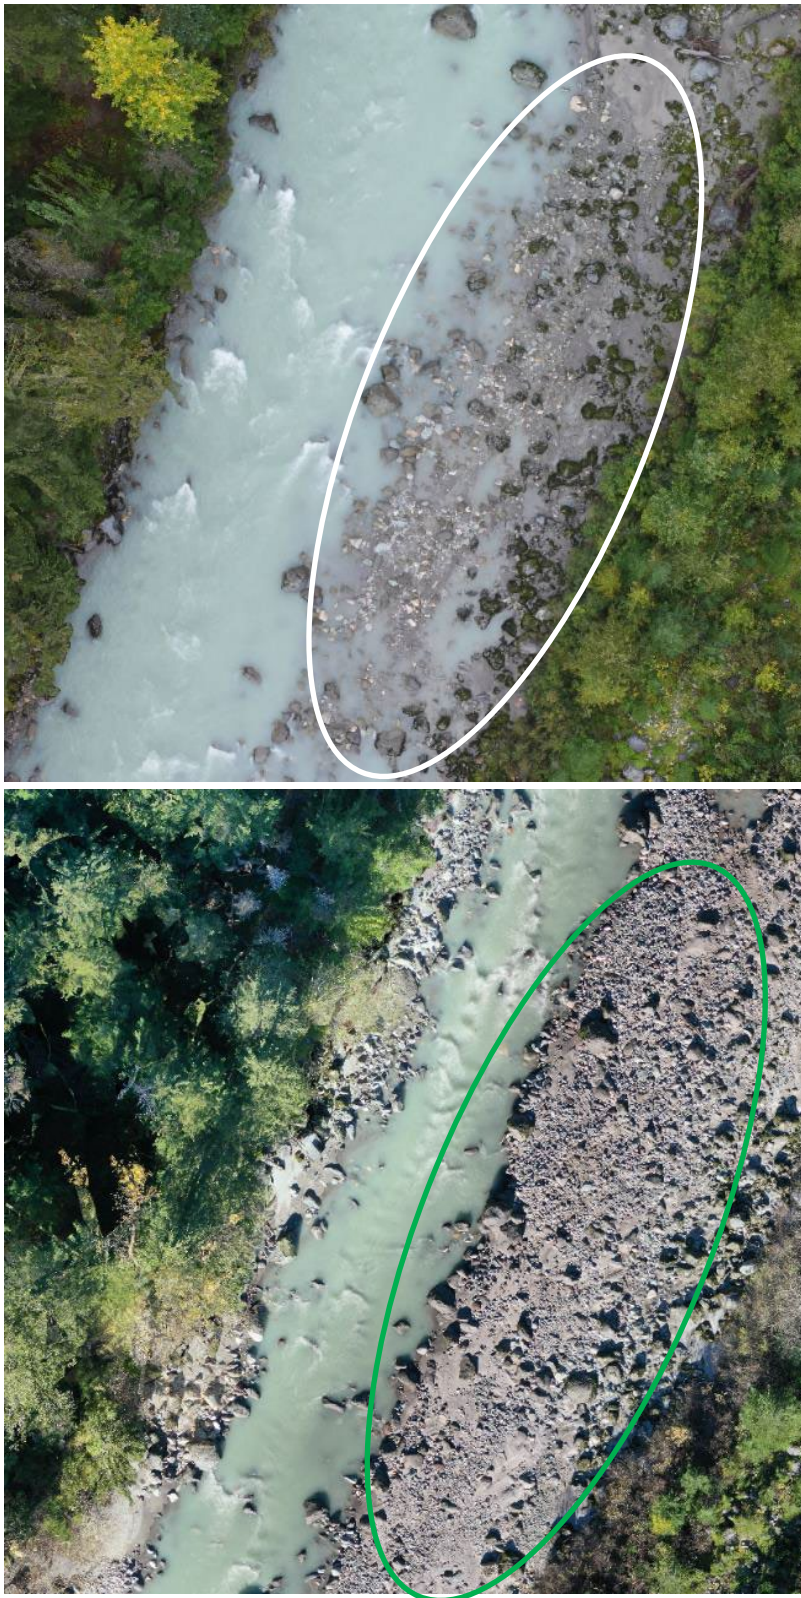
Figure 8. Upper Lillooet River Diversion Reach displaying a gain in gravel deposition on the river left gravel bar in 2023 (bottom) in comparison to 2016 (top).

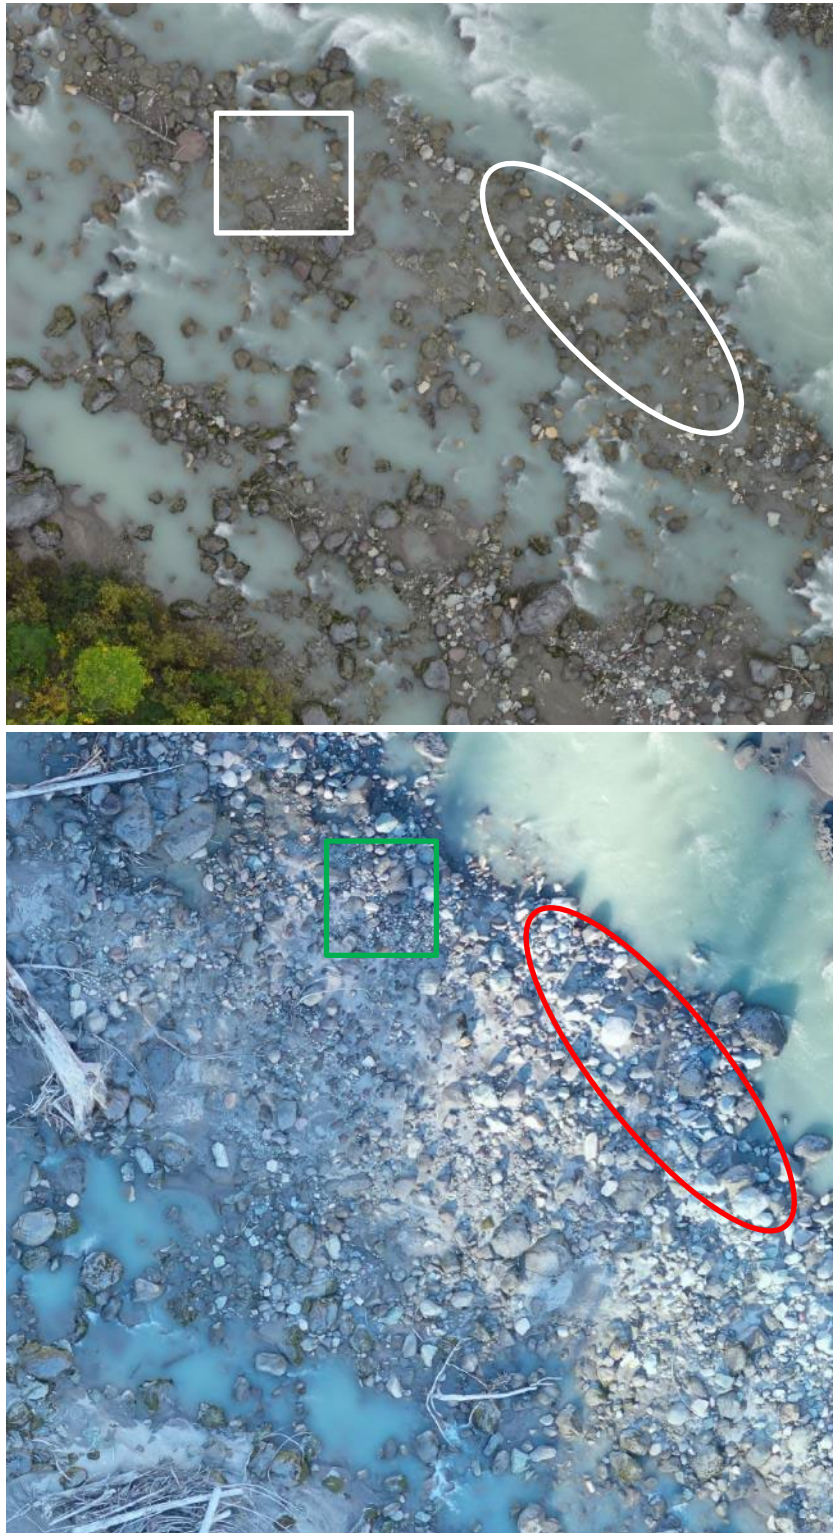
Figure 10. Upper Lillooet River Downstream Reach displaying scouring of gravel outline in red on river left margins caused by substantial gravel input from the river right tributary in 2023 (bottom). Gravel at the outlet of the tributary has been maintained with some gravel gain downstream of patch in 2023 in comparison 2016 (top).

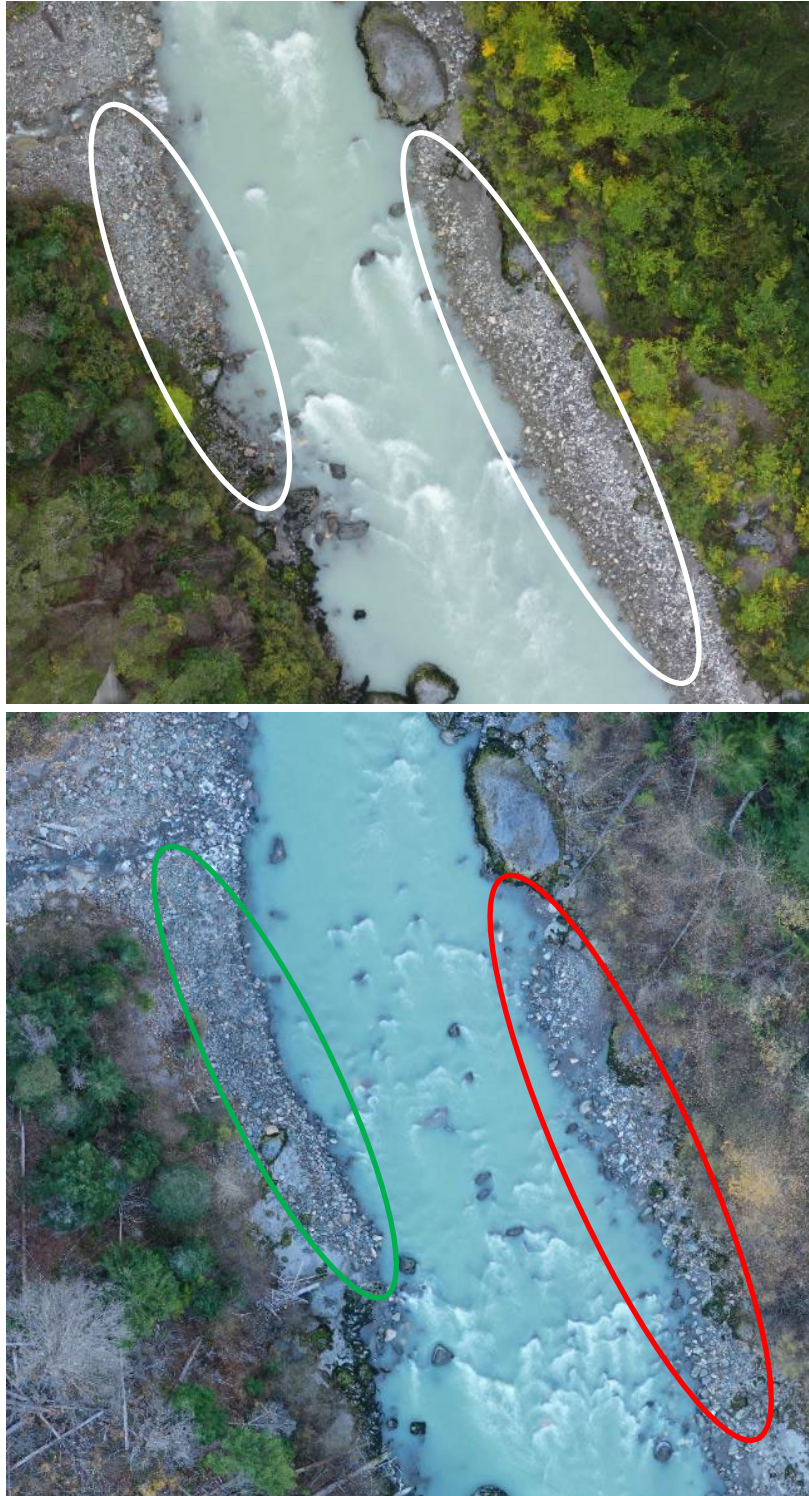
Figure 11. Upper Lillooet River Downstream Reach displaying similar gravel distribution and size outline in green from 2016 (top) to 2023 (bottom).

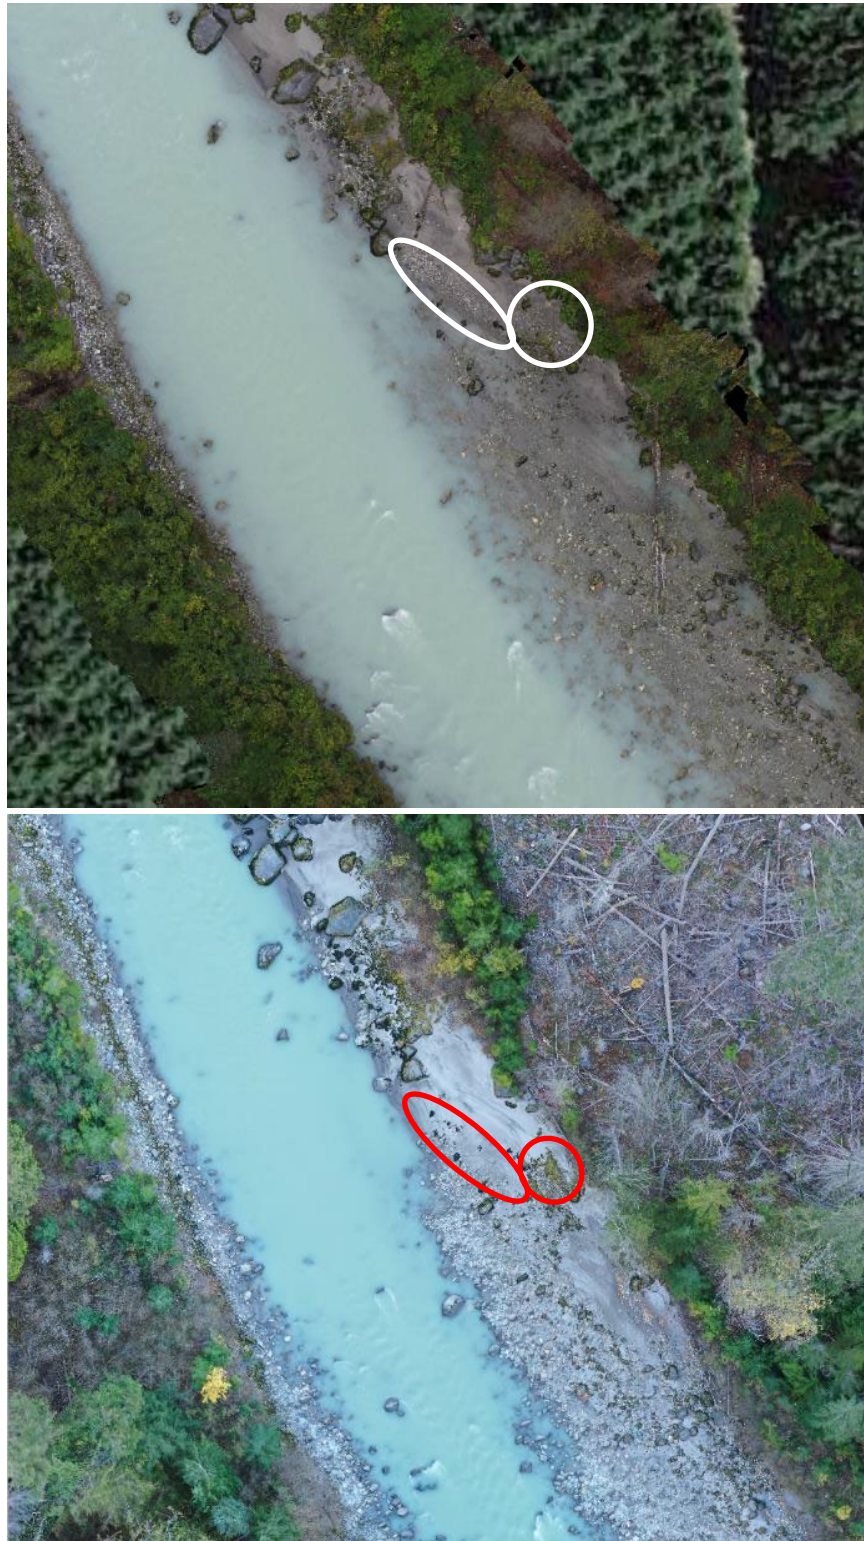
Figure 12. Upper Lillooet River Downstream Reach displaying gravel patches identified in 2016 (top image; orange spray paint) that were covered in fine sediment outlined in red in 2023 (bottom).

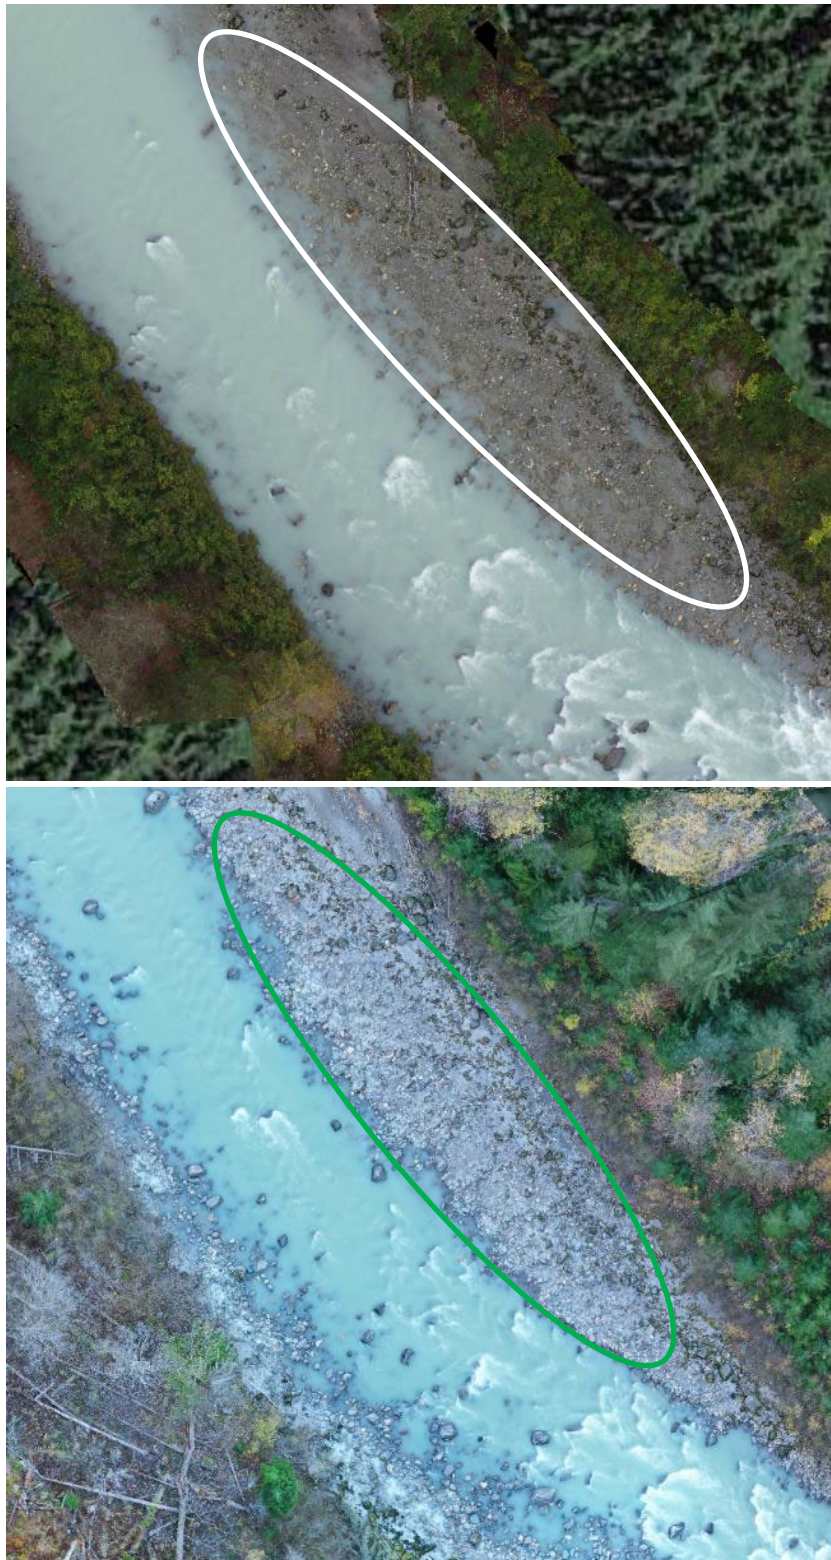
Figure 13. Upper Lillooet River Downstream Reach displaying similar gravel distribution and density outline in green in 2023 (bottom) in comparison to 2016 (top).

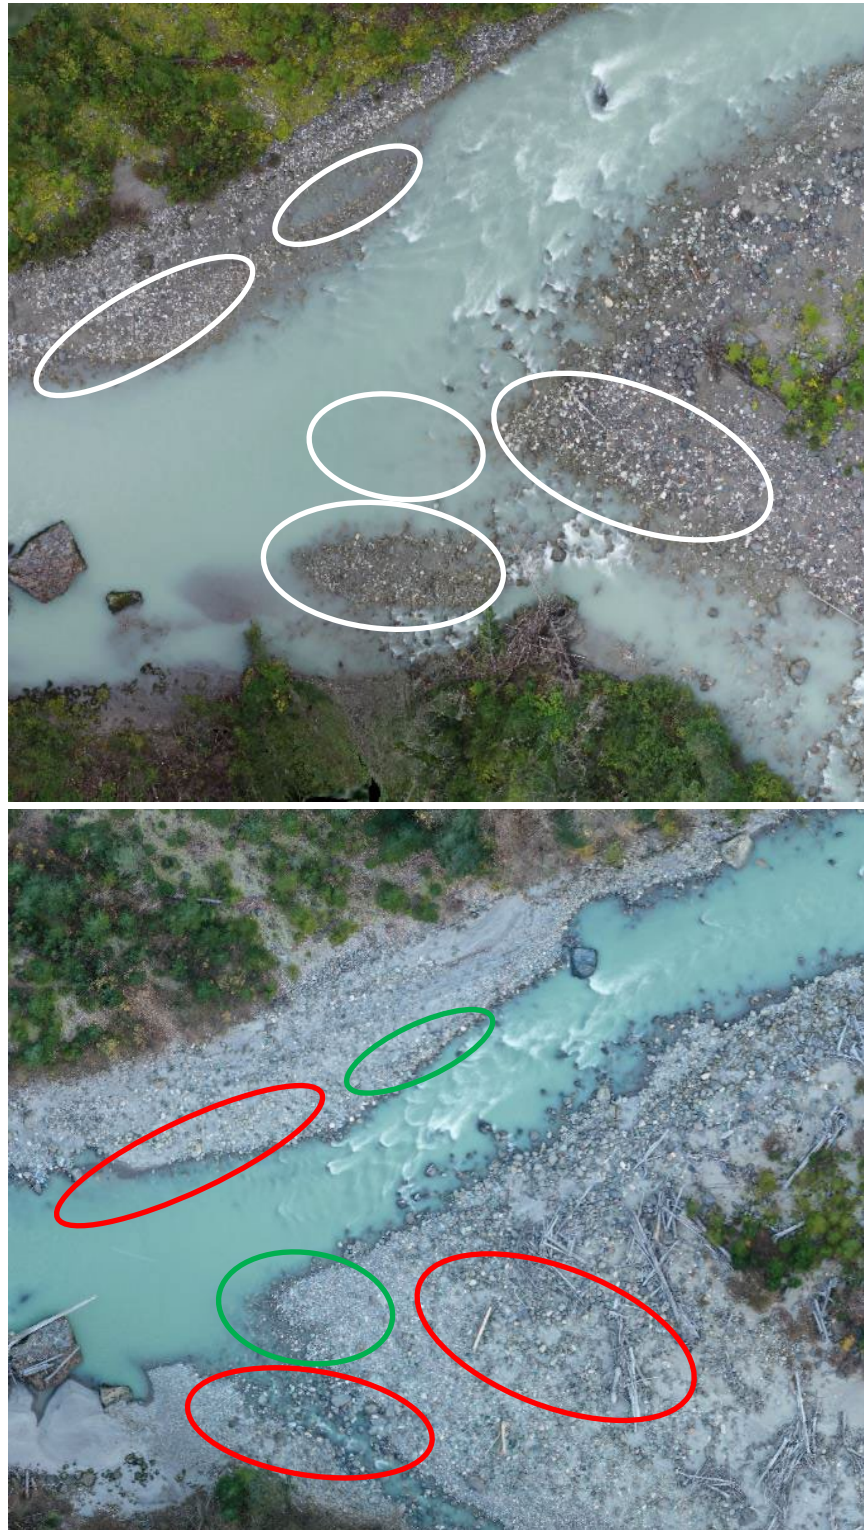
Figure 15. Upper Lillooet River Downstream Reach displaying change in gravel distribution, coarsening, and fine sediment accumulation outlined in red while green outline indicates minimal change from 2023 (bottom) to 2016 (top). Addition of nonfunctional small woody debris likely caused by 2015 firers.

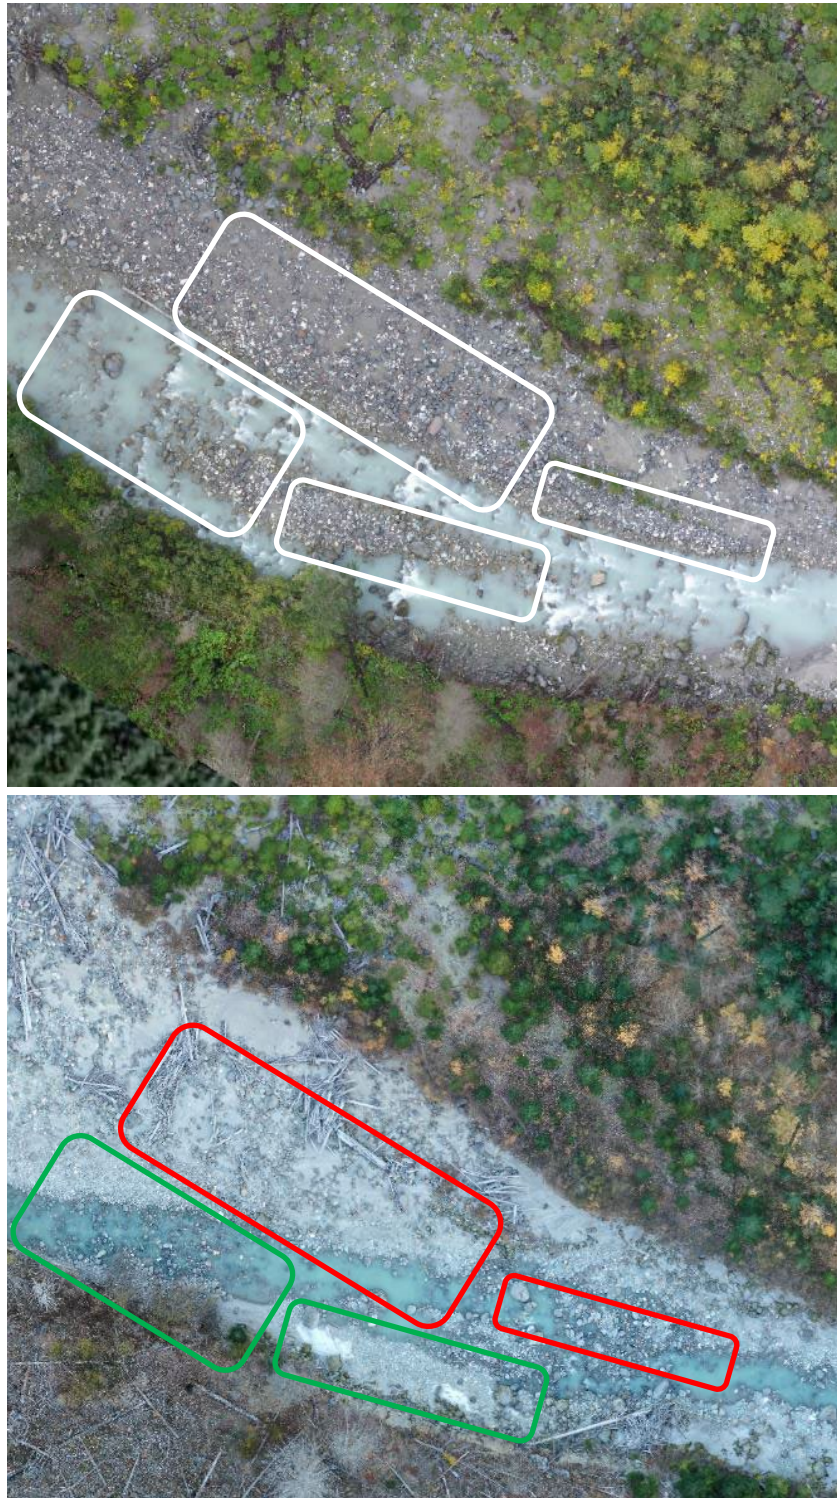
Figure 16. Upper Lillooet River Downstream Reach displaying the redistribution of gravel from 2023 (bottom) to 2016 (top).

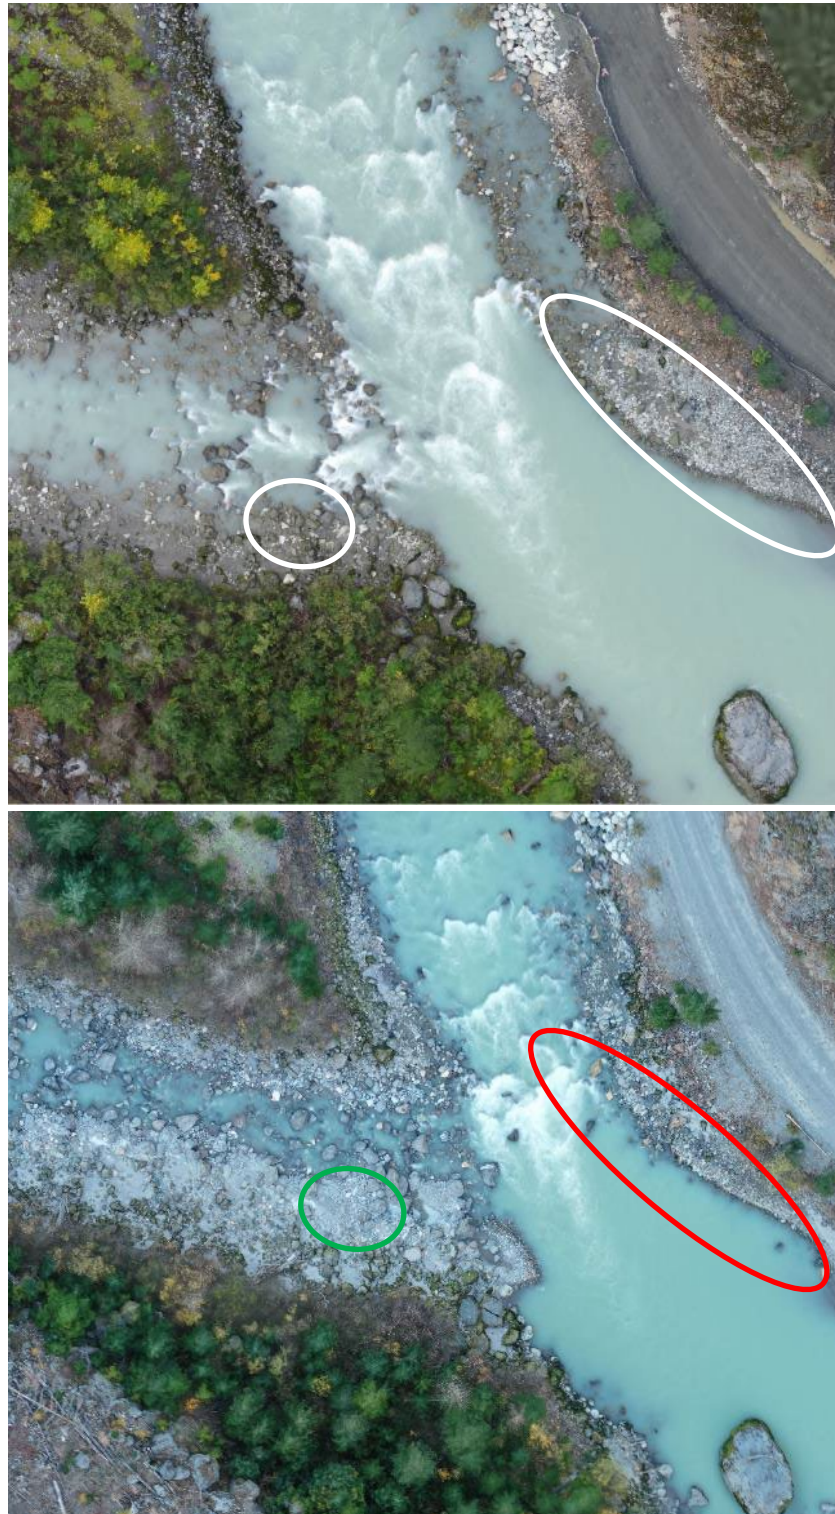
Figure 17. Upper Lillooet River Downstream Reach displaying similar gravel distribution and density in 2023 (bottom) in comparison to 2016 (top). Green outline showing increase in gravel, red outline showing loss in gravel.

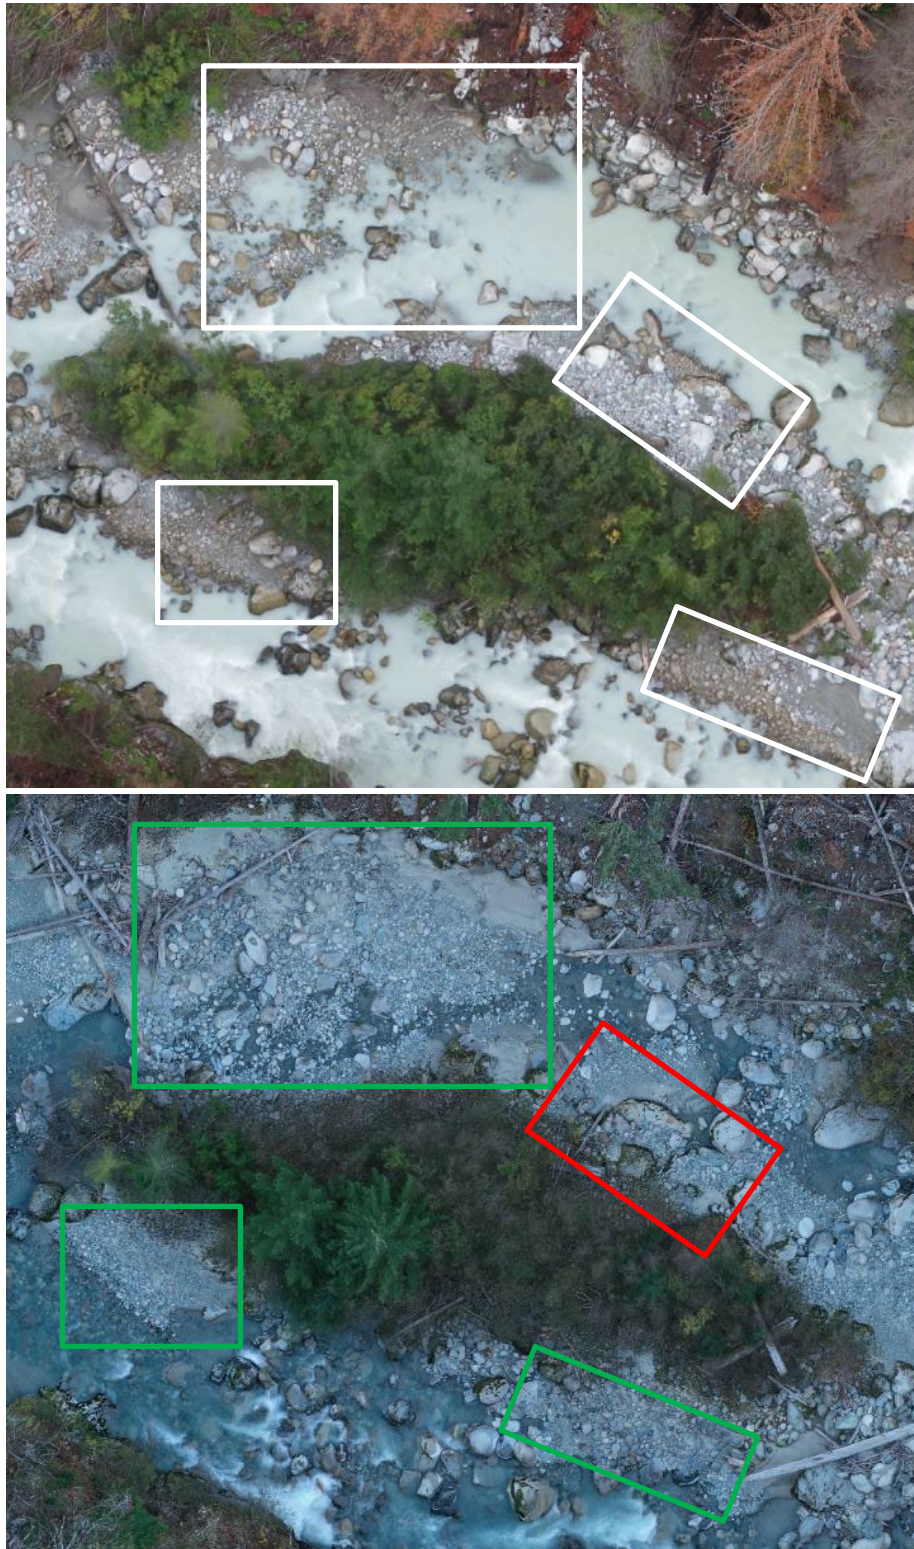
Figure 7. Boulder Creek Diversion Reach displaying gravel accumulation outline in green in most areas and some gravel loss outline in red from 2016 (top) to 2023 (bottom).

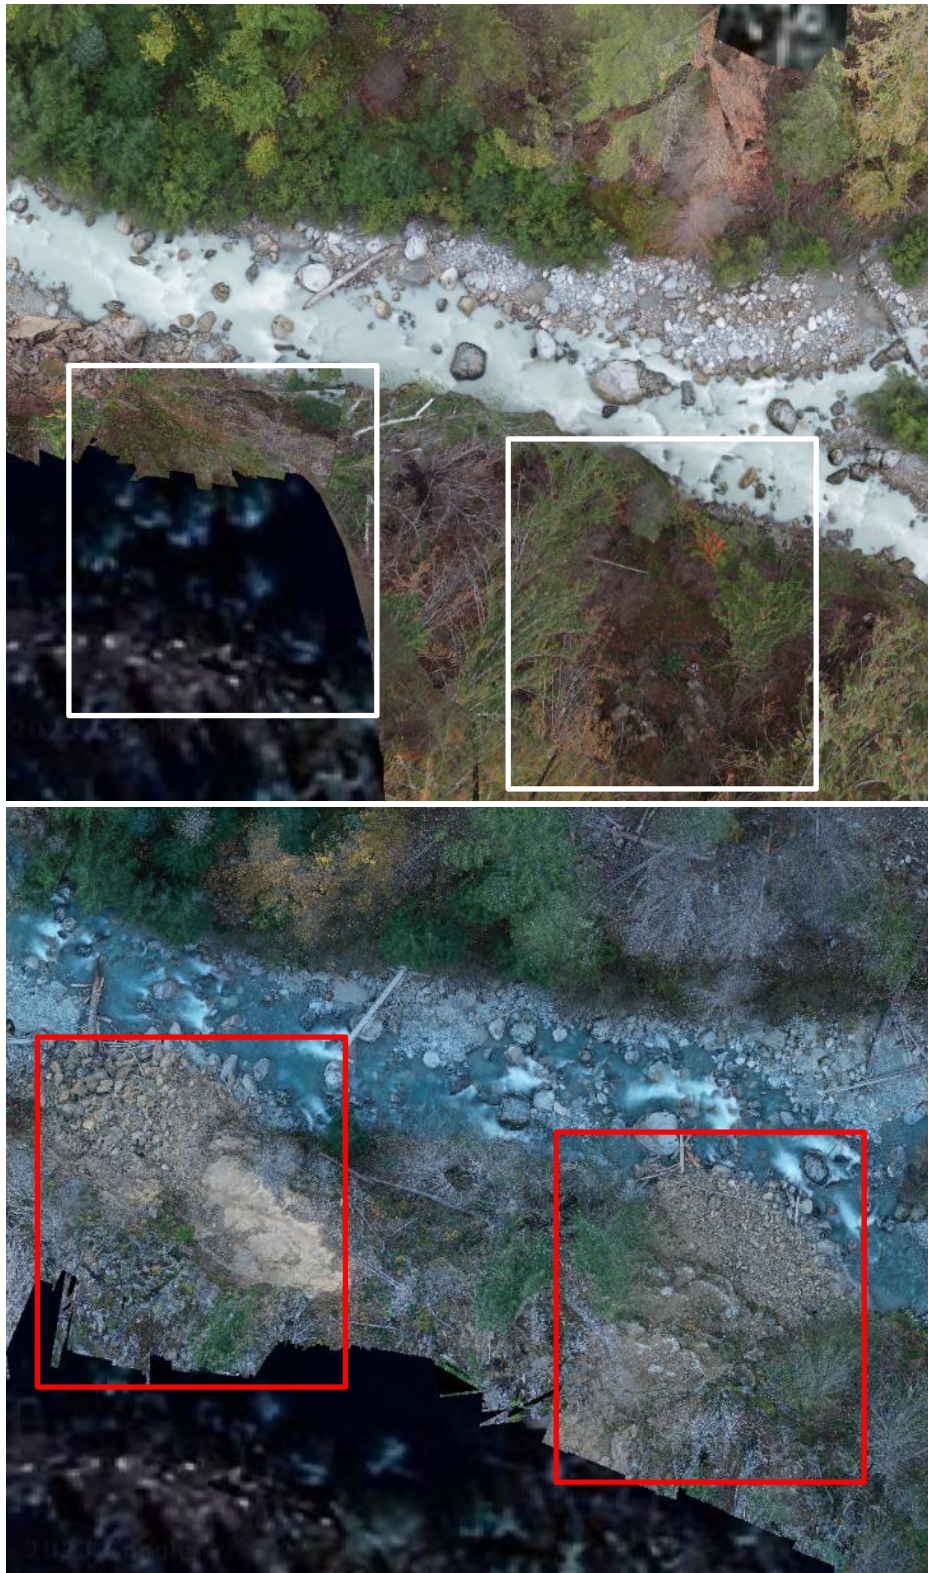
Figure 8. Boulder Creek Diversion Reach displaying naturally occurring landslides outline in red along river left bank in 2023 (bottom) compared to 2016 (top).

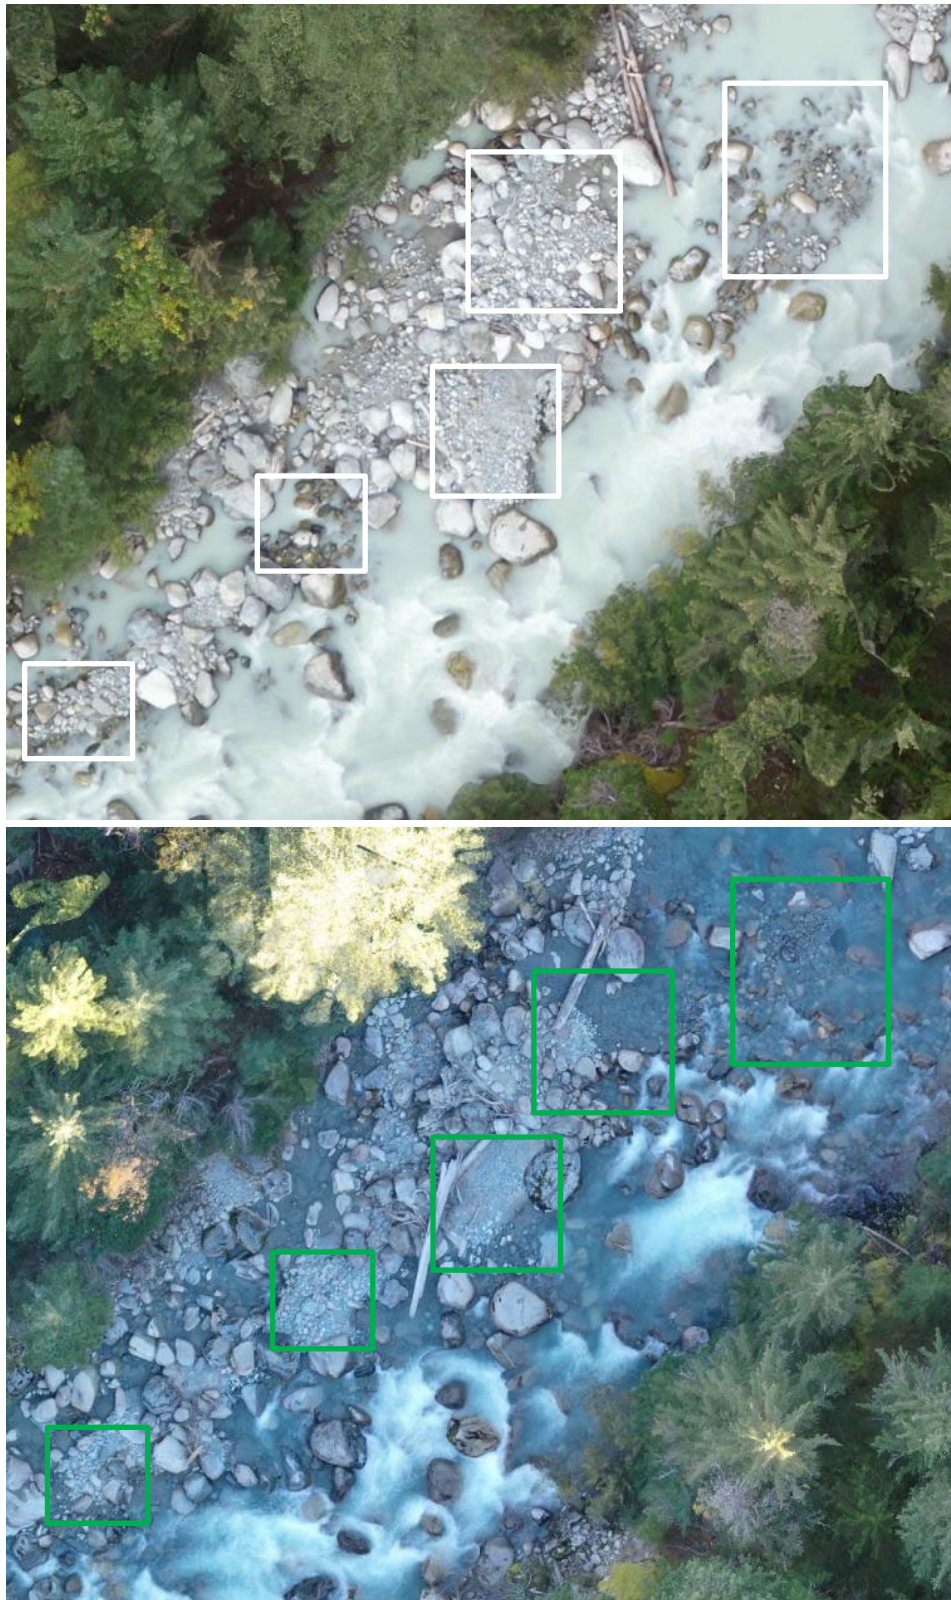
Figure 11. Boulder Creek Downstream Reach displaying similar gravel distribution and density outline in green from 2016 (top) to 2023 (bottom).

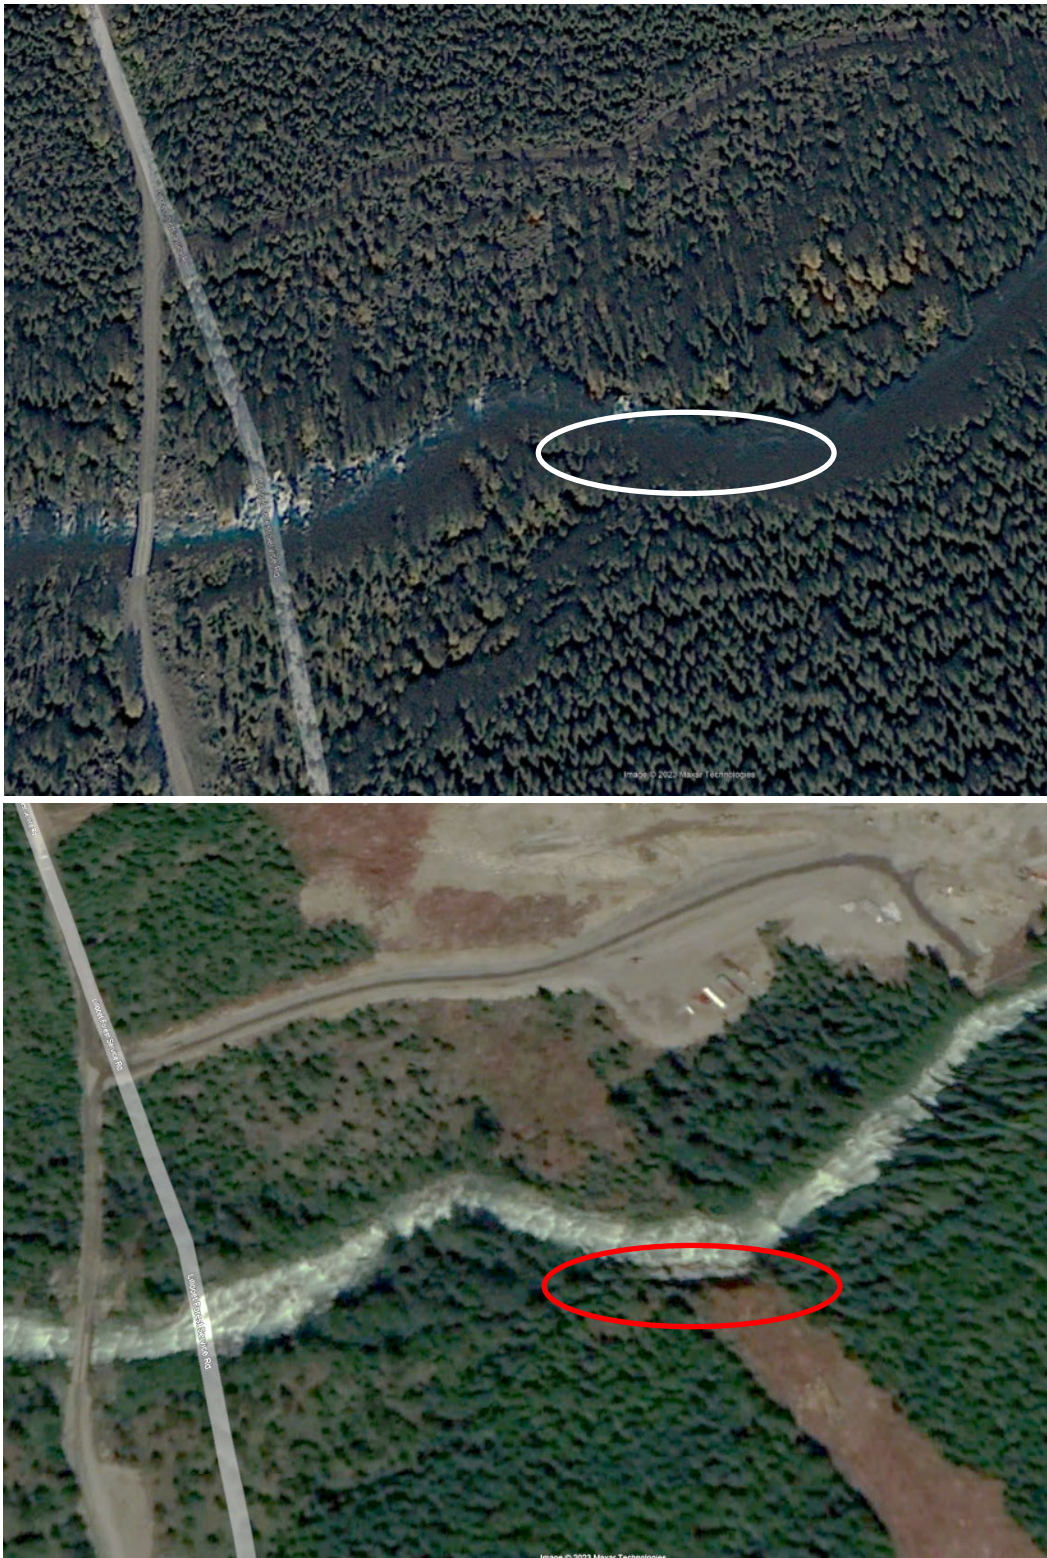
Figure 13. Boulder Creek Downstream Reach showing potential Project related slope failure below the transmission line outline in red and the shifting of the active channel from river right to river left from 2016 (top) to 2023 (bottom). Yellow line indicating toe of slope in both images for visual representation of gravel bar scouring cause be channel shifting.
