Upper Lillooet Hydro Project

Operational Environmental Monitoring Year 5

April 24, 2024

Ecofish Research Ltd.

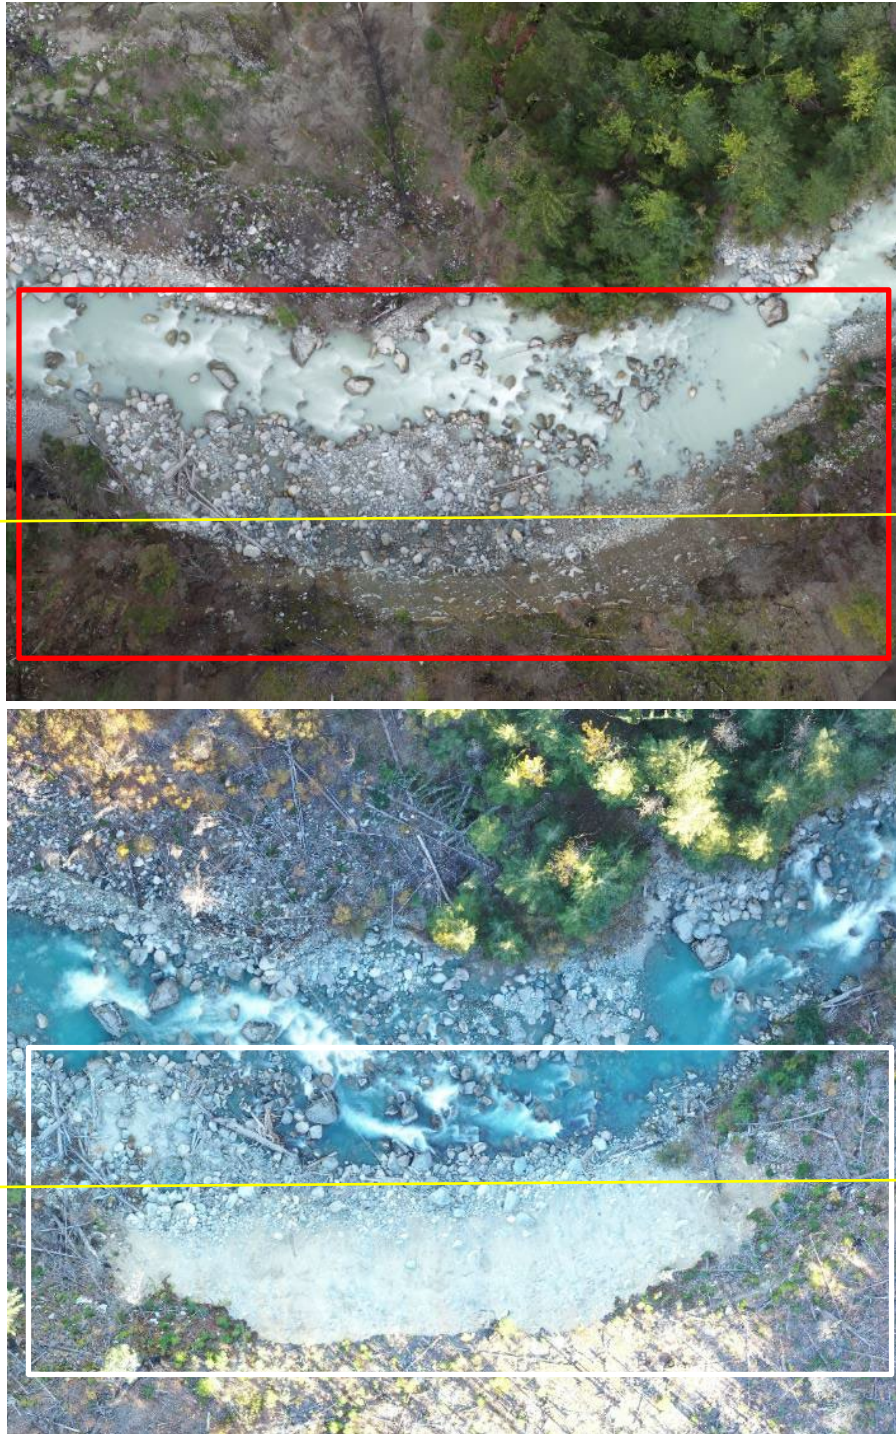
Figure 14. Boulder Creek Downstream Reach displaying both loss outlined in red and gain outlined in green of gravel from 2016 (top) to 2023 (bottom).

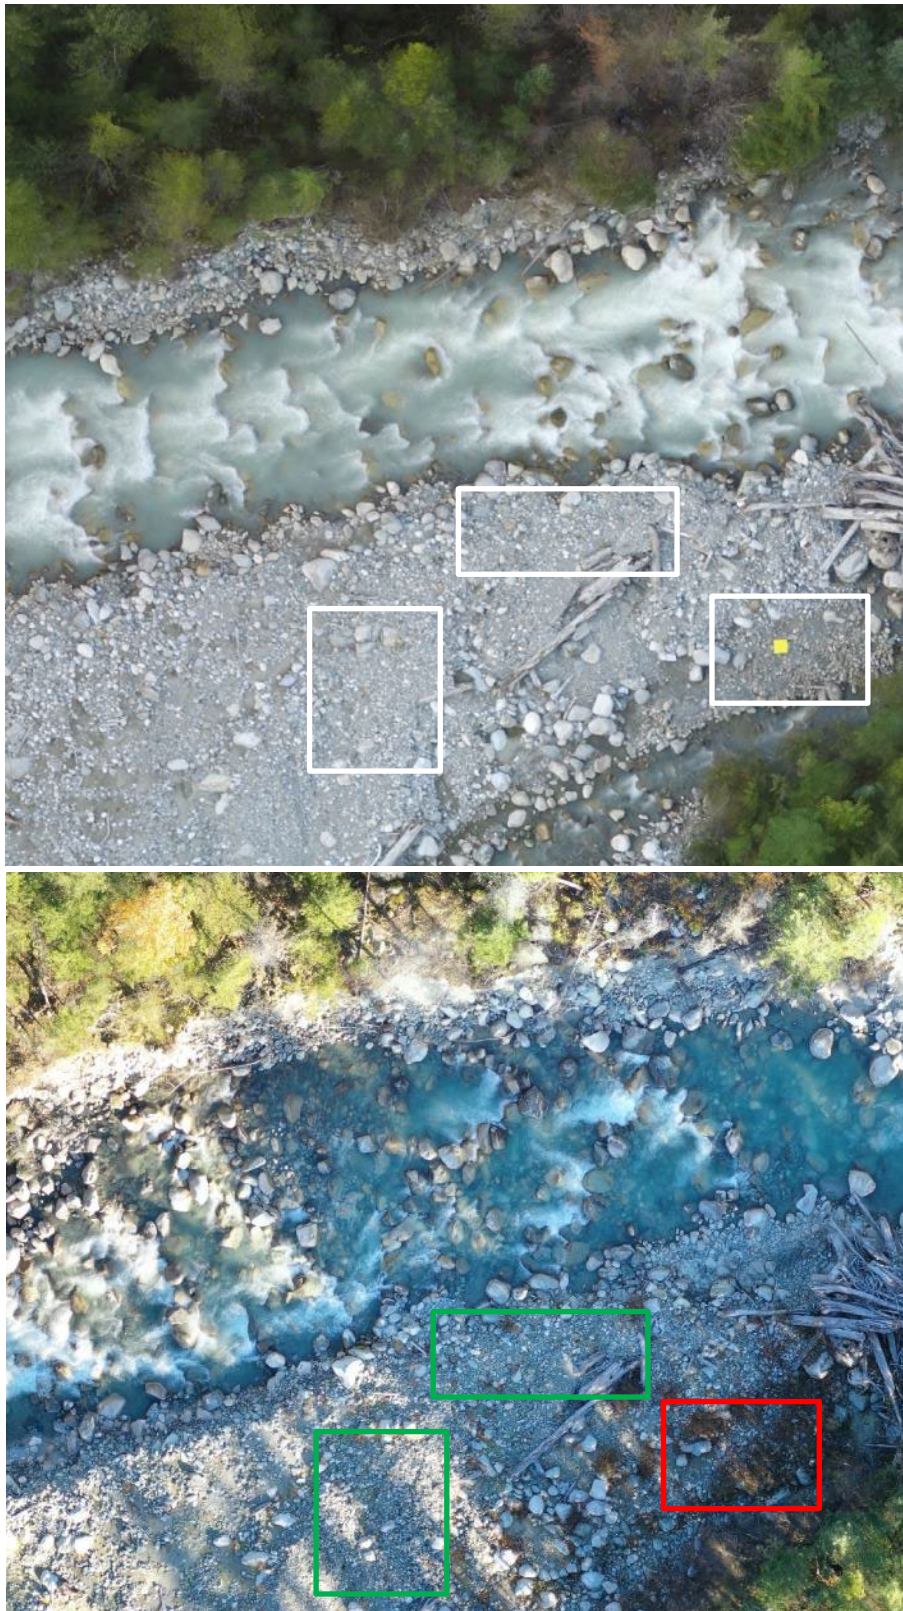
Figure 16. Boulder Creek Downstream Reach displaying both gravel loss outlined in red and gravel gain outlined in green from 2016 (top) to 2023 (bottom).

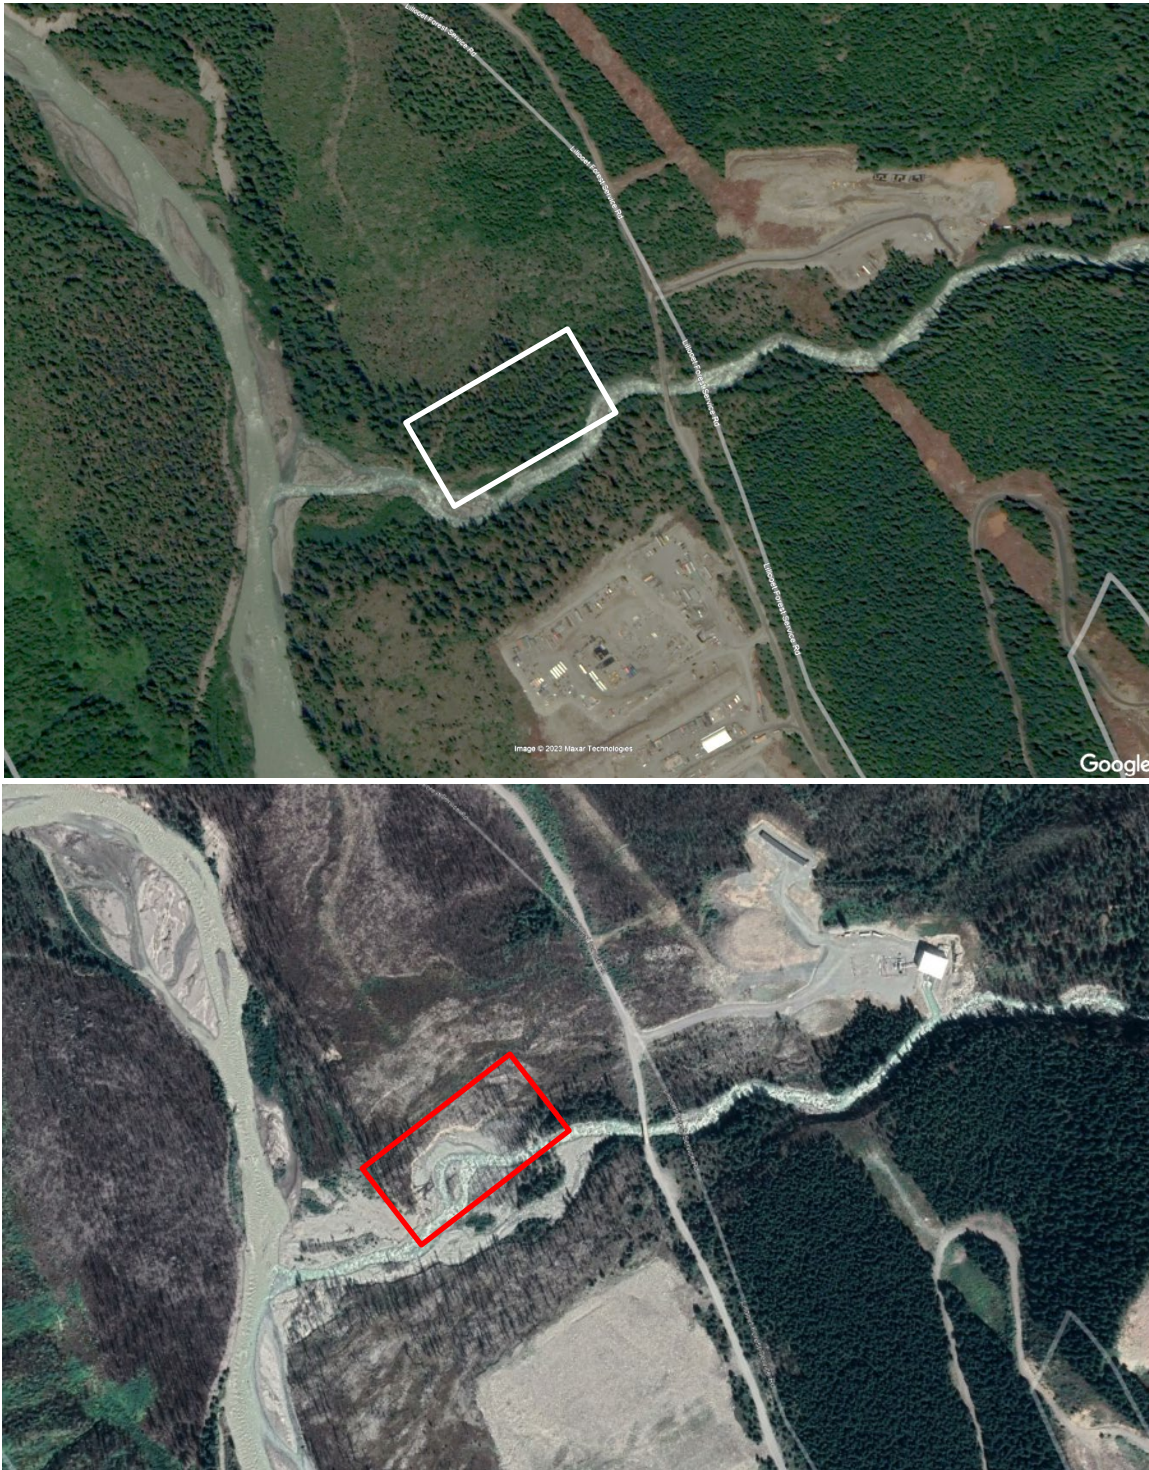
Figure 19. Boulder Creek Downstream Reach displaying minimal change at the confluence of Boulder Creek and Lillooet River. Braided outlet in 2016 (top) has become a single channel outline in green in 2023 (bottom).

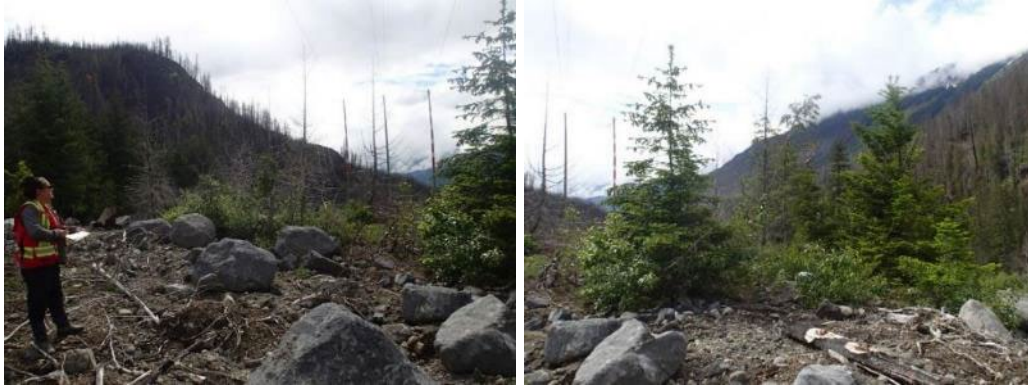
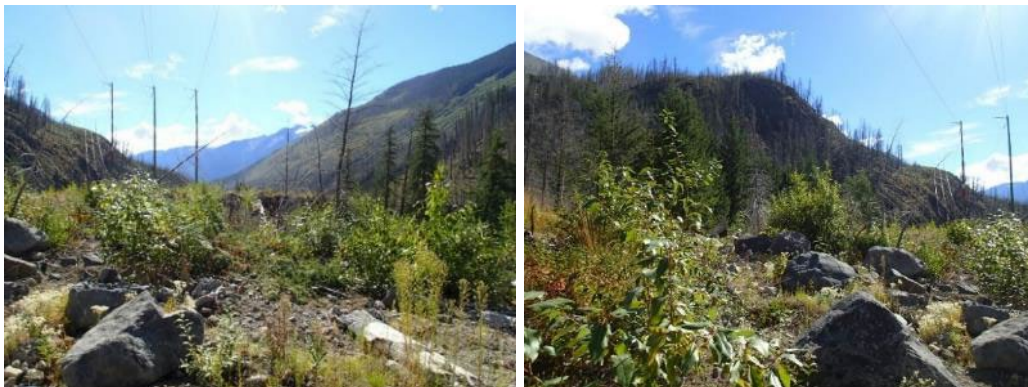
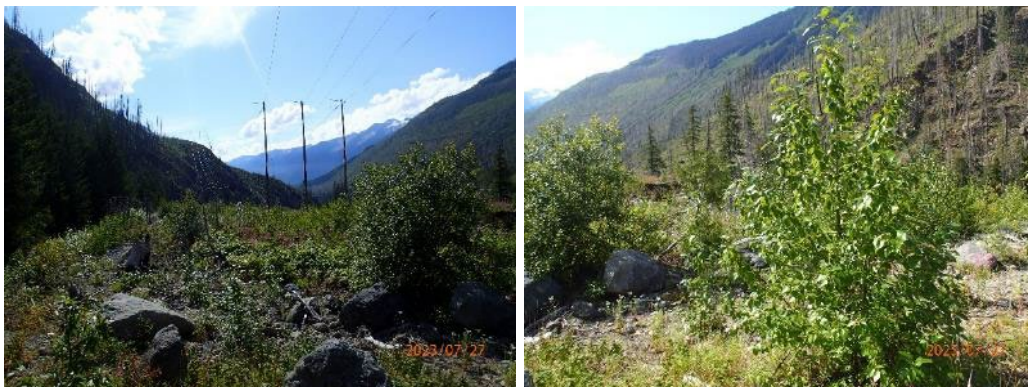
1. ULH-MAMCM01

Figure 1. Vegetated screen along the transmission line at ULH-MAMCM01, assessed on June 14, 2018.

Figure 2. Vegetated screen along the transmission line at ULH-MAMCM01, assessed on August 24, 2020.

Figure 3. Vegetated screen along the transmission line at ULH MAMCM01, assessed on July 27, 2023.

General comment:	Some sections with low heights, good natural regeneration; recovering from the Boulder Creek wildfire. On a trajectory to meet 5 m height requirement.
Species:	Grizzly Bear
Screen widths (m):	15, 10, 7
Average screen width (m):	11
Screen heights (m):	5, 3, 6
Average screen height (m):	5
% Screen coverages:	40, 30, 35
Average % screen coverage:	35

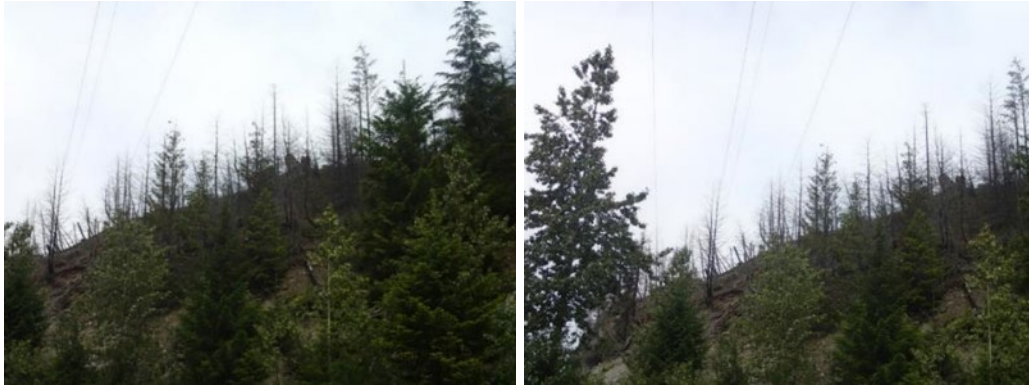
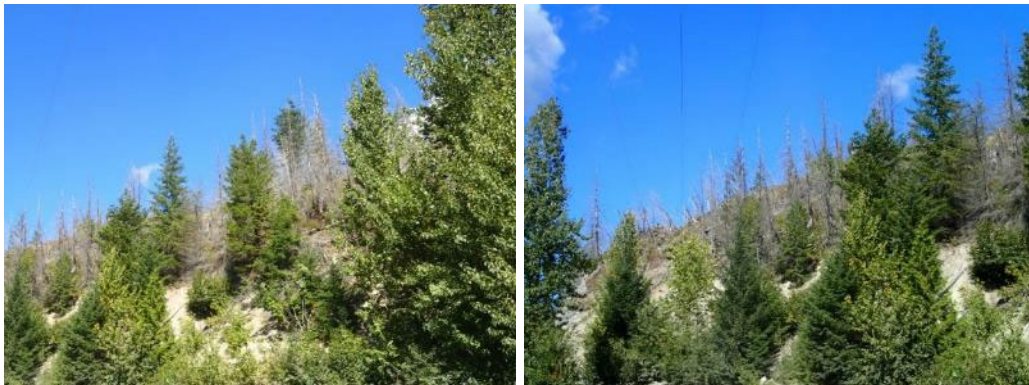
2. ULH-MAMCM02

Figure 4. Vegetated screen along the transmission line at ULH-MAMCM02 (at the top of the hill in the photo), assessed on June 14, 2018.

Figure 5. Vegetated screen along the transmission line at ULH-MAMCM02 (at the top of the hill in the photo), assessed on August 24, 2020.

General comment:	This site is very high above the road. Vegetation is slow to recover from the Boulder Creek fire. The site is high above the road; thus, the screen is not considered to be critical as wildlife are less likely to be visible from the road and traffic along the road is less likely to disturb wildlife than if the transmission line RoW was closer to the road. Further monitoring is not recommended.
Species:	Grizzly Bear
Average screen width (m):	-
Average screen height (m):	-
Average % coverage:	-

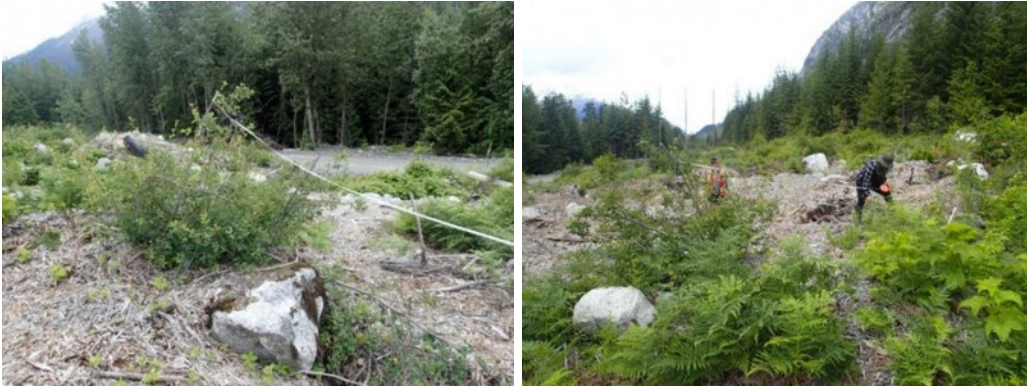
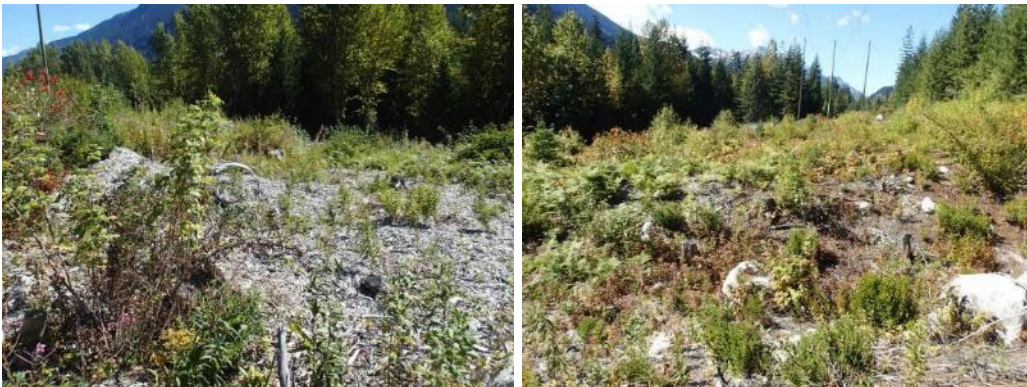
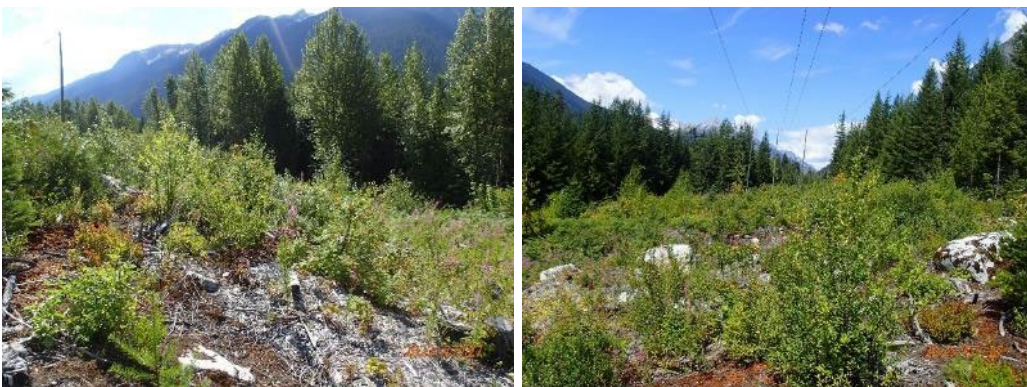
3. ULH-MAMCM04B

Figure 7. Vegetated screen along the transmission line at ULH-MAMCM04B (river right of the creek), assessed on June 14, 2018.

Figure 8. Vegetated screen along the transmission line at ULH-MAMCM04B (river right of the creek), assessed on August 24, 2020.

Figure 9. Vegetated screen along the transmission line at ULH MAMCM04B (river right of the creek), assessed on July 27, 2023.

General comment:	Excellent natural regeneration; vegetation is growing through the wood chips; increased vegetation along the road; vegetation is on track to meet the height requirement.
Species:	Grizzly Bear and Mule Deer
Screen widths (m):	10, 15, 5
Average screen width (m):	10
Screen heights (m):	2, 4, 4
Average screen height (m):	3
% Screen coverages:	30, 20, 5
Average % screen coverage:	18

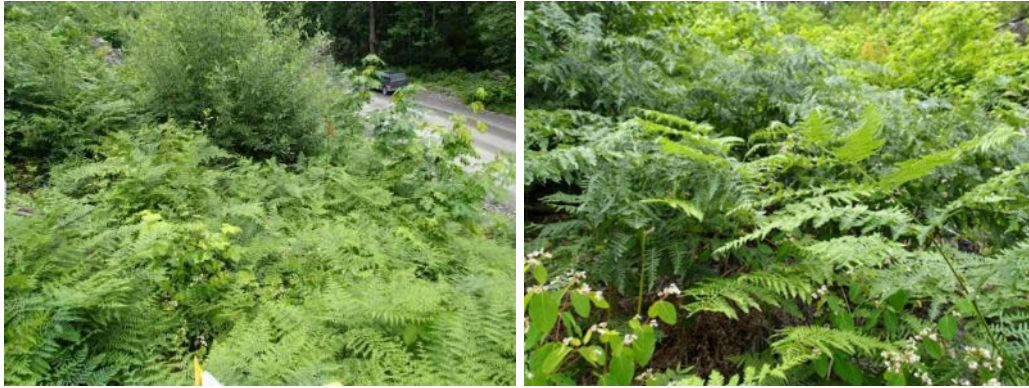
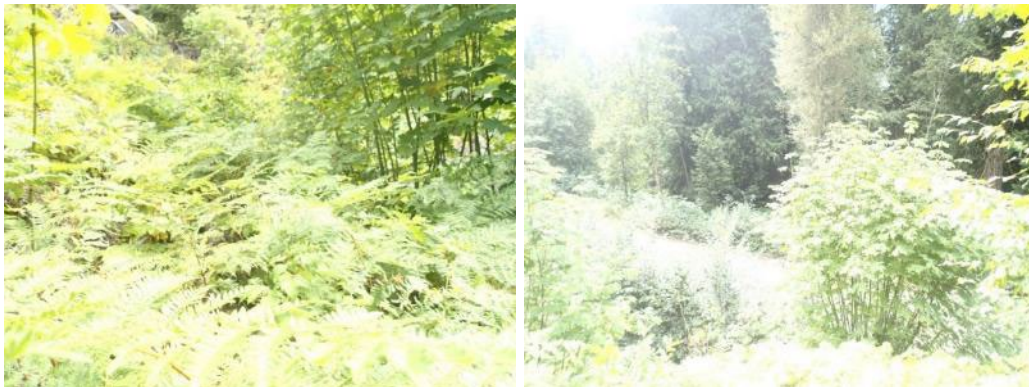
4. ULH-MAMCM06

Figure 10. Vegetated screen along the transmission line at ULH-MAMCM06, assessed on June 14, 2018.

Figure 11. Vegetated screen along the transmission line at ULH-MAMCM06, assessed on August 24, 2020.

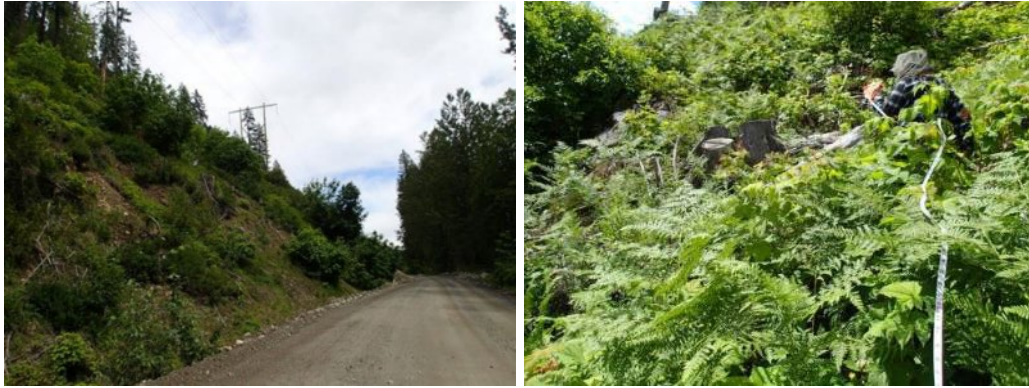
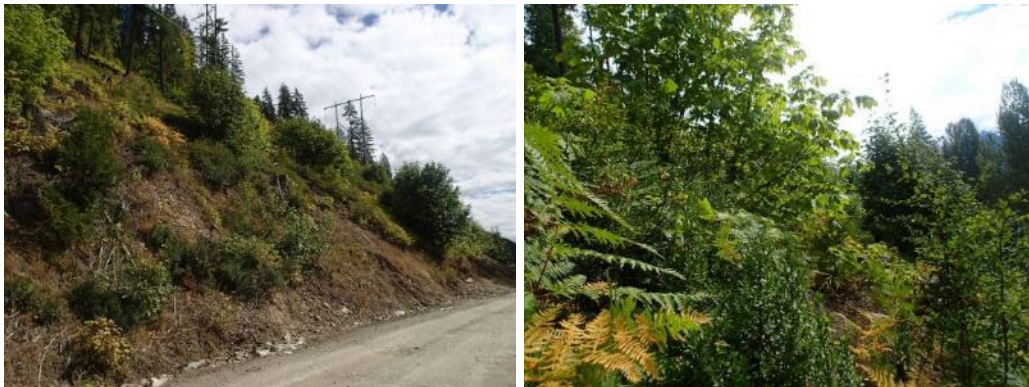
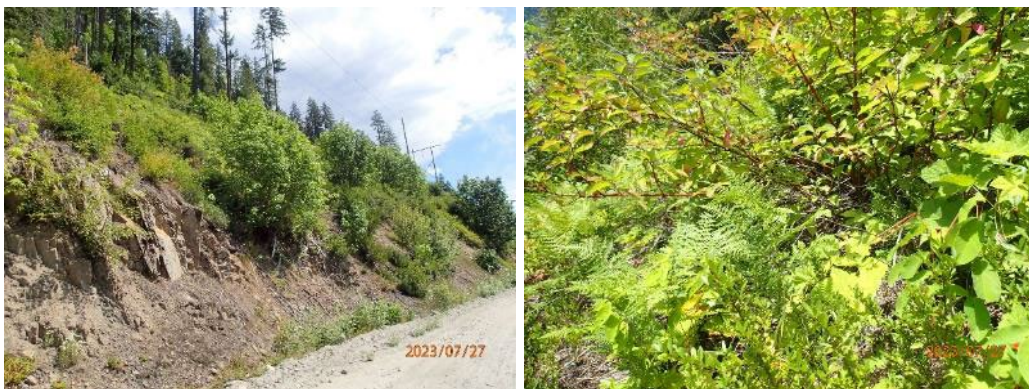
5. ULH-MAMCM08

Figure 13. Vegetated screen along the transmission line at ULH-MAMCM08, assessed on June 14, 2018.

Figure 14. Vegetated screen along the transmission line at ULH-MAMCM08, assessed on August 24, 2020.

Figure 15. Vegetated screen along the transmission line at ULH-MAMCM08, assessed on July 27, 2023.

General comment:	Abundant dense vegetation continues to regenerate naturally.
Species:	Mule Deer
Screen widths (m):	20, 25, 20
Average screen width (m):	22
Screen heights (m):	6, 5, 4
Average screen height (m):	5
% Screen coverages:	90, 80, 60
Average % screen coverage:	77

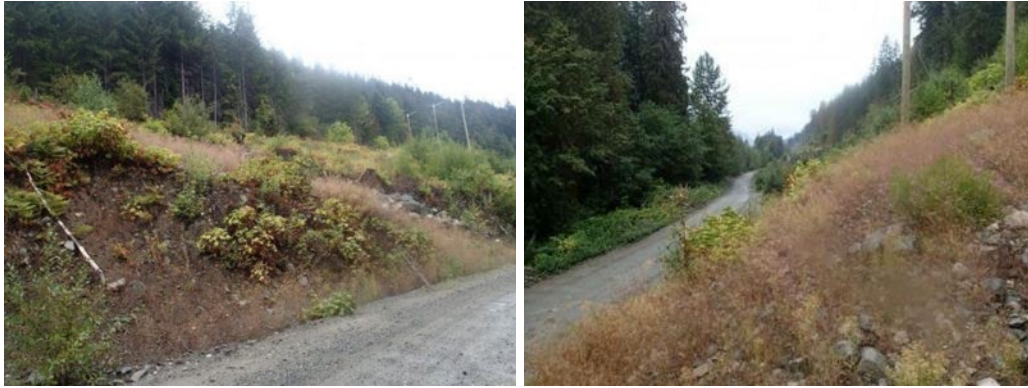
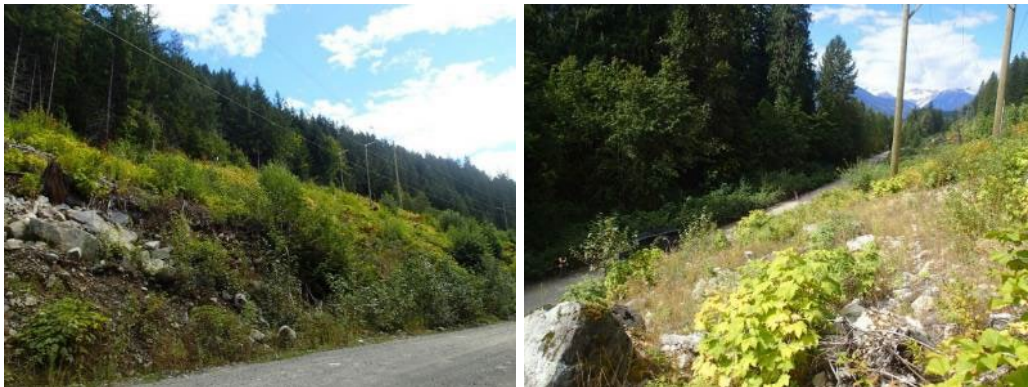
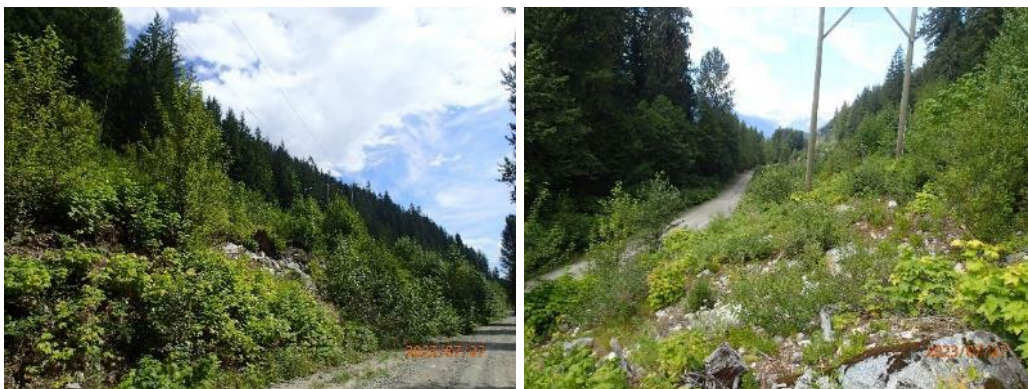
6. ULH-MAMCM09

Figure 16. Vegetated screen along the transmission line at ULH-MAMCM09, assessed on June 14, 2018.

Figure 17. Vegetated screen along the transmission line at ULH-MAMCM09, assessed on August 24, 2020.

Figure 18. Vegetated screen along the transmission line at ULH-MAMCM09, assessed on July 27, 2023.

General comment:	Some vegetation has grown tall, but there is limited growth in rocky areas. Height and coverage have increased since 2020. Overall, vegetation is on track to reach the height requirement.
Species:	Grizzly Bear and Mule Deer
Screen widths (m):	10, 5, 9
Average screen width (m):	8
Screen heights (m):	5, 2, 1.5
Average screen height (m):	3
% Screen coverages:	30, 10, 25
Average % screen coverage:	22

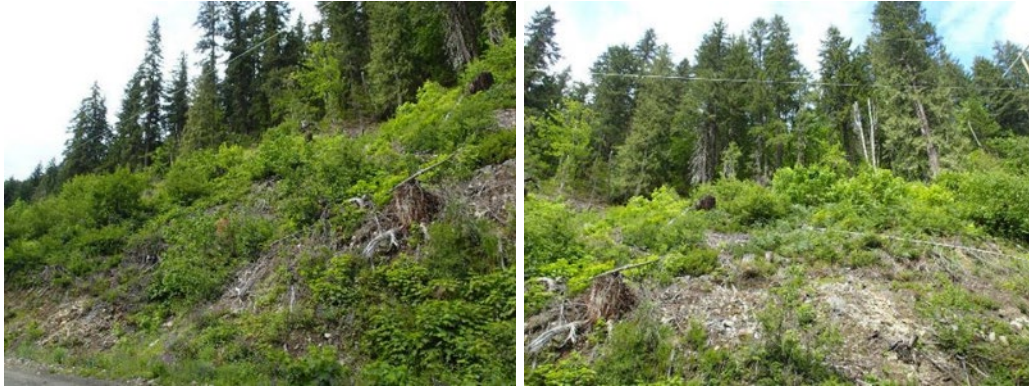
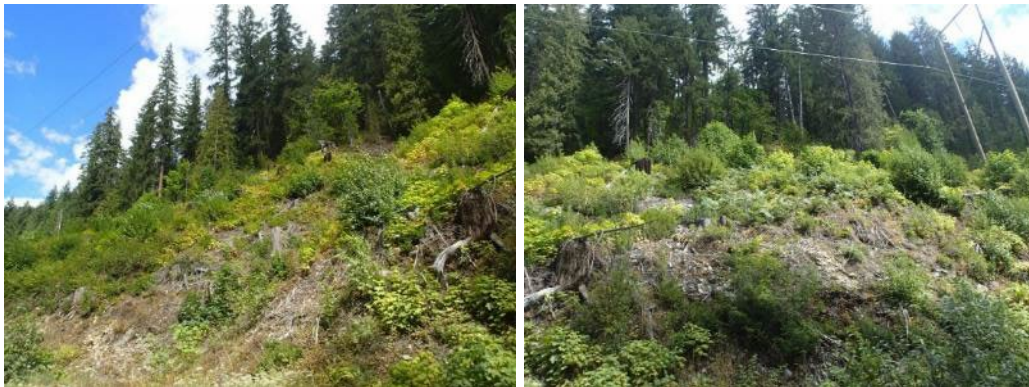
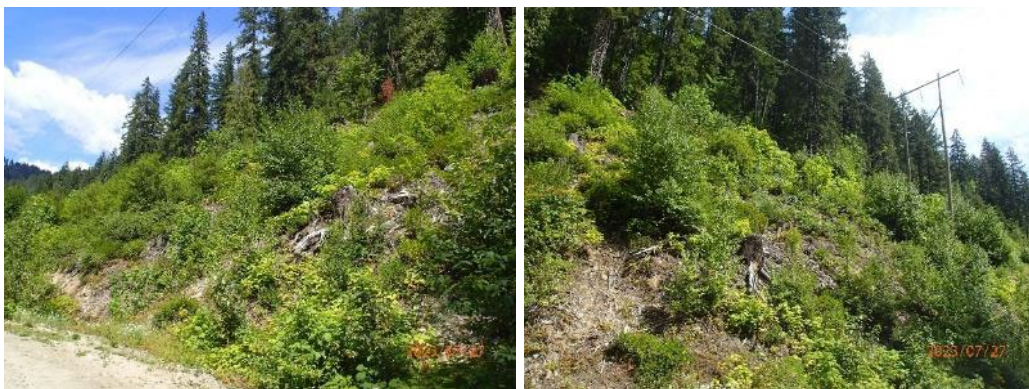
7. ULH-MAMCM10

Figure 19. Vegetated screen along the transmission line at ULH-MAMCM10, assessed on June 14, 2018.

Figure 20. Vegetated screen along the transmission line at ULH-MAMCM10, assessed on August 24, 2020.

Figure 21. Vegetated screen along the transmission line at ULH-MAMCM10, assessed on July 27, 2023.

General comment:	Good natural regeneration. Vegetation is expected to fill in and reach heights of 5 m.
Species:	Mule Deer
Screen widths (m):	15, 15, 12
Average screen width (m):	14
Screen heights (m):	5, 4, 2
Average screen height (m):	4
% Screen coverages:	30, 10, 25
Average % screen coverage:	22

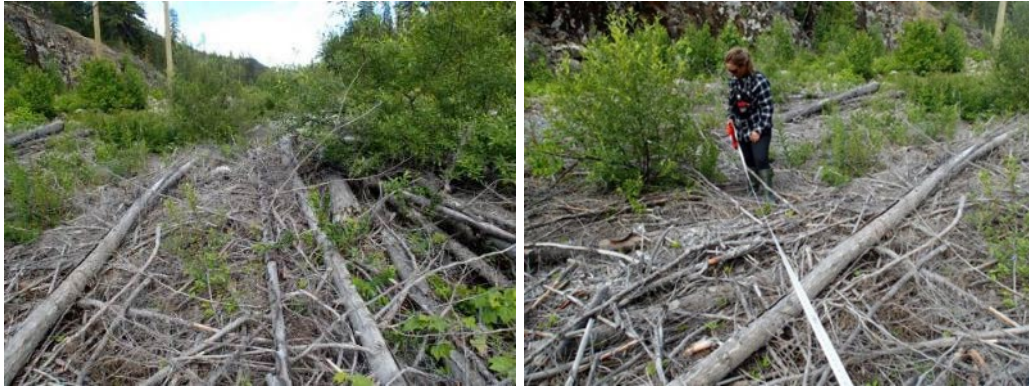
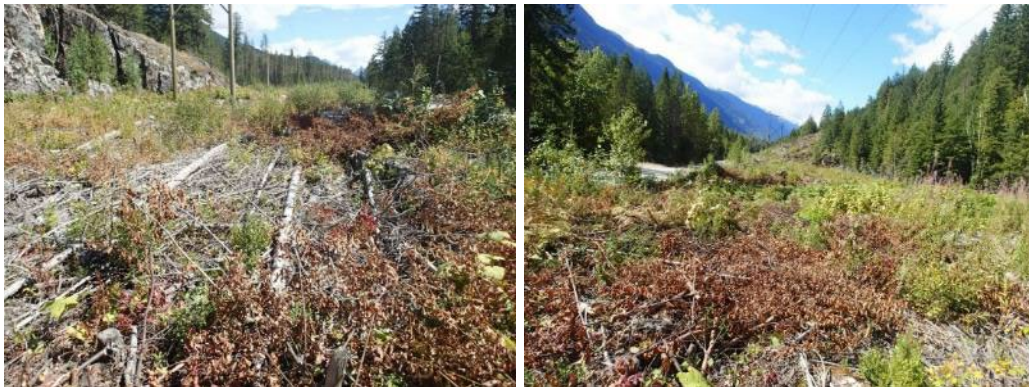
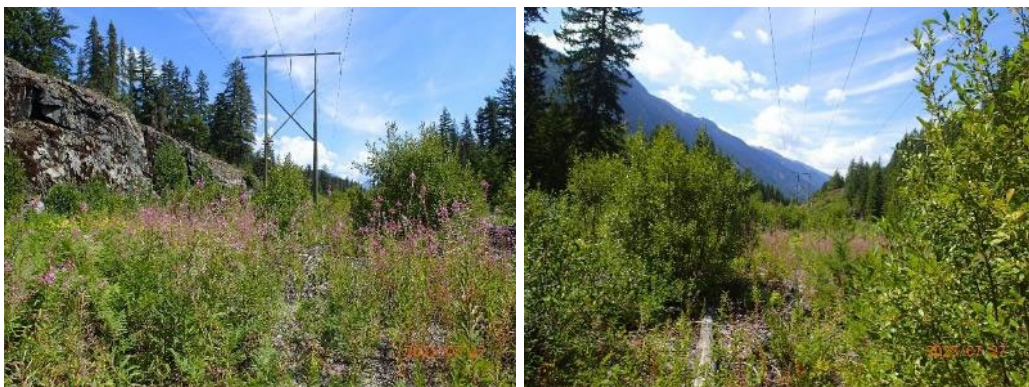
8. ULH-MAMCM12

Figure 22. Vegetated screen along the transmission line at ULH-MAMCM12, assessed on June 14, 2018.

Figure 23. Vegetated screen along the transmission line at ULH-MAMCM12, assessed on August 24, 2020.

Figure 24. Vegetated screen along the transmission line at ULH-MAMCM12, assessed on July 27, 2023.

General comment:	This site was disturbed in 2020; many alders and willows were cut down. Good natural revegetation with increased cover since 2020.
Species:	Moose
Screen widths (m):	30, 15, 8
Average screen width (m):	18
Screen heights (m):	5, 3, 2
Average screen height (m):	3
% Screen coverages:	60, 15, 40
Average % screen coverage:	38

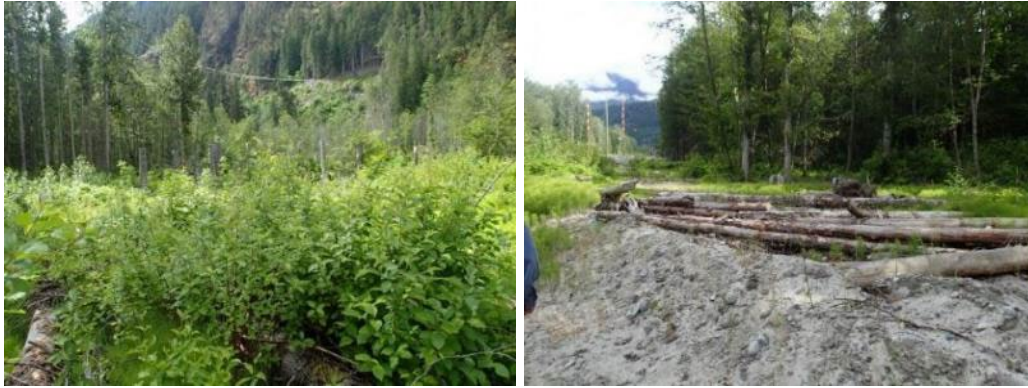
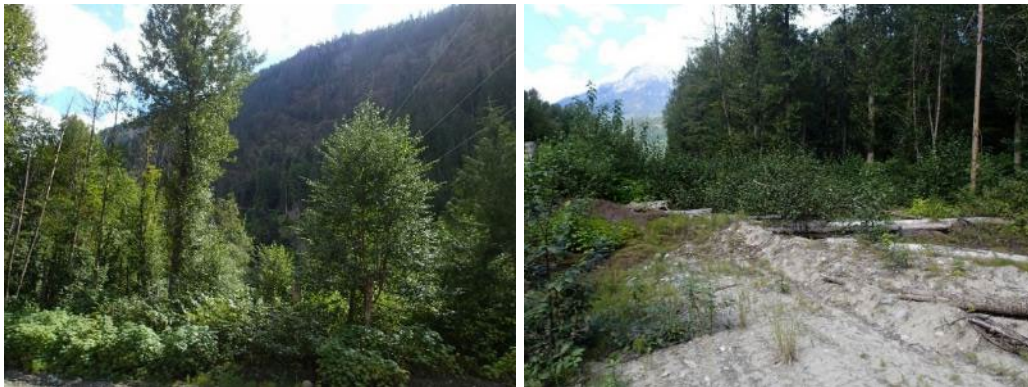
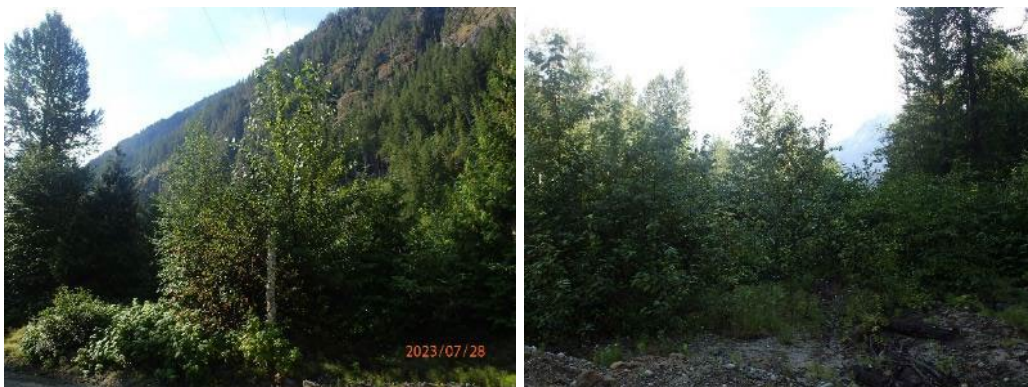
9. ULH-MAMCM14

Figure 25. Vegetated screen along the transmission line at ULH-MAMCM14, assessed on June 6, 2018.

Figure 26. Vegetated screen along the transmission line at ULH-MAMCM14, assessed on August 24, 2020.

Figure 27. Vegetated screen along the transmission line at ULH-MAMCM14, assessed on July 28, 2023.

General comment:	Abundant natural regeneration with dense bushes. Dense vegetation along the road.
Species:	Grizzly Bear and Moose
Road deactivated:	Yes
Screen widths (m):	15, 15, 20
Average screen width (m):	17
Screen heights (m):	8, 6, 5
Average screen height (m):	5
% Screen coverages:	100, 100, 100
Average % screen coverage:	100

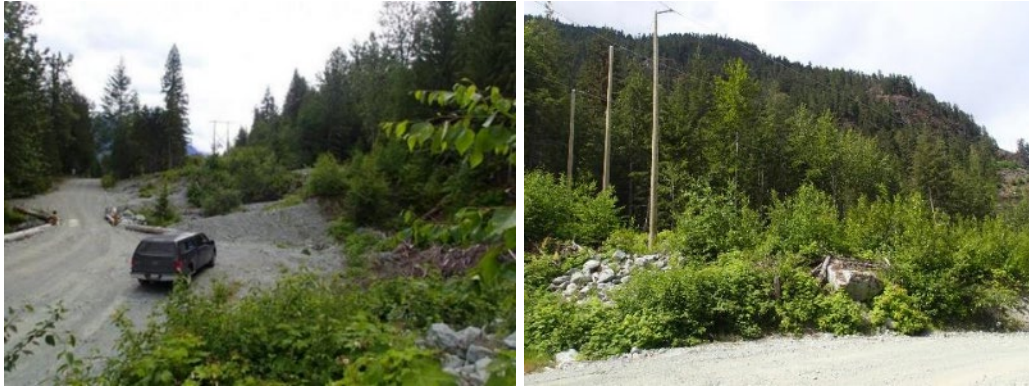
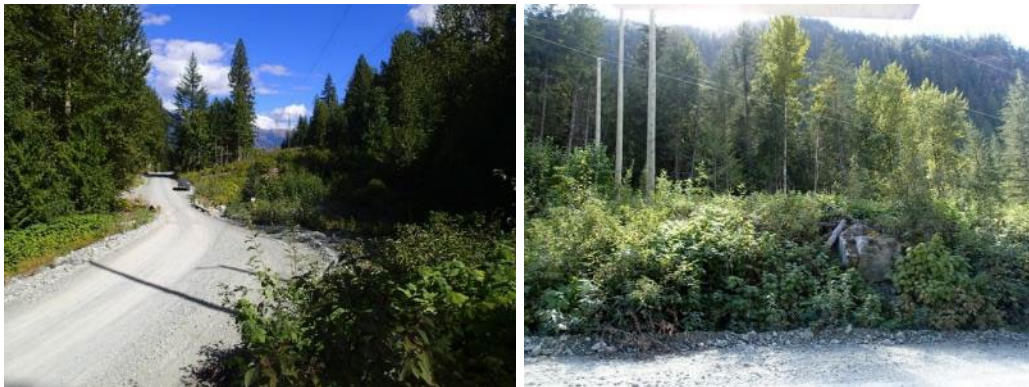
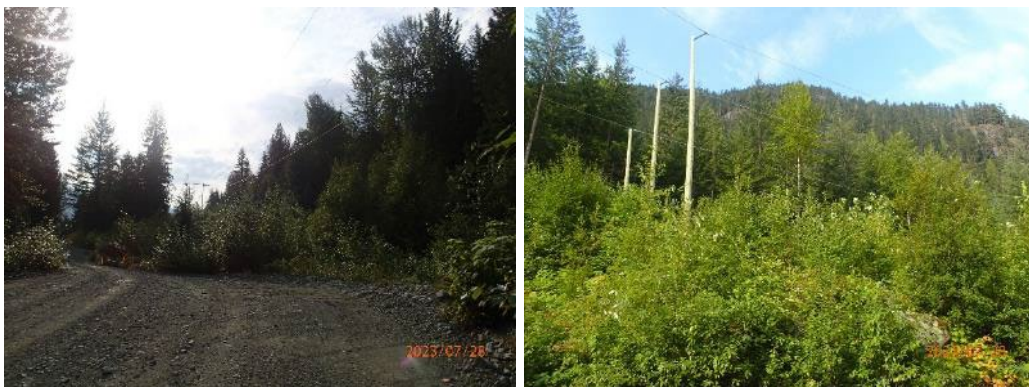
10. ULH-MAMCM17

Figure 28. Vegetated screen along the transmission line at ULH-MAMCM17, assessed on June 6, 2018.

Figure 29. Vegetated screen along the transmission line at ULH-MAMCM17, assessed on August 24, 2020.

Figure 30. Vegetated screen along the transmission line at ULH-MAMCM17, assessed on July 28, 2023.

General comment:	Abundant natural regeneration; dense vegetation along the road.
Species:	Grizzly Bear
Screen widths (m):	15, 8, 15
Average screen width (m):	13
Screen heights (m):	8, 6, 5
Average screen height (m):	6
% Screen coverages:	100, 90, 90
Average % screen coverage:	93

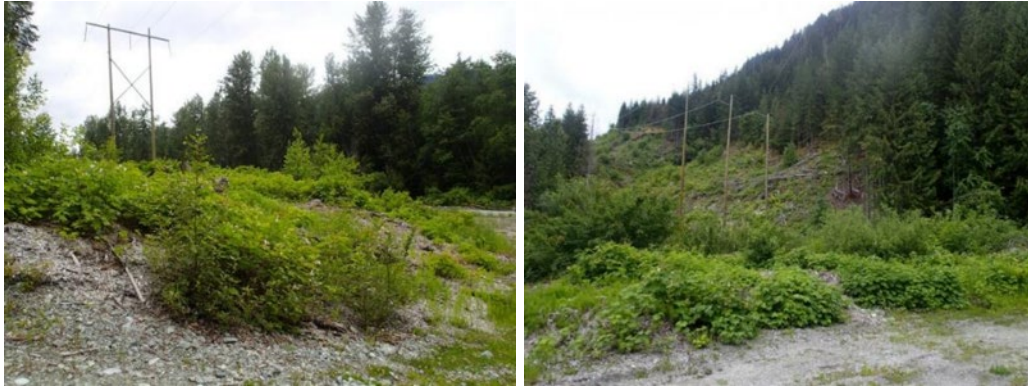
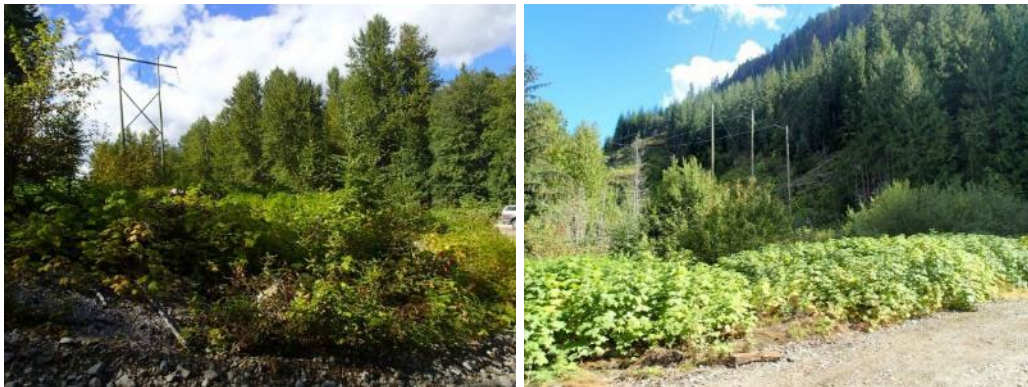
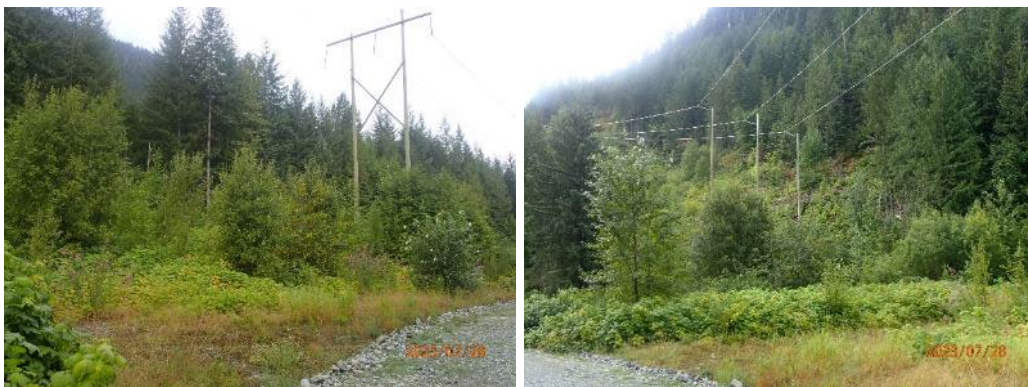
Figure 31. Vegetated screen along the transmission line at ULH-MAMCM19, assessed on June 6, 2018.

Figure 32. Vegetated screen along the transmission line at ULH-MAMCM19, assessed on August 25, 2020.

Figure 33. Vegetated screen along the transmission line at ULH-MAMCM19, assessed on July 28, 2023.

General comment:	Excellent regeneration; dense vegetation; the tower access road appears to be inactive.
Species:	Grizzly Bear
Screen widths (m):	20, 35, 40
Average screen width (m):	32
Screen heights (m):	7, 6, 5
Average screen height (m):	6
% Screen coverages:	80, 60, 20
Average % screen coverage:	53

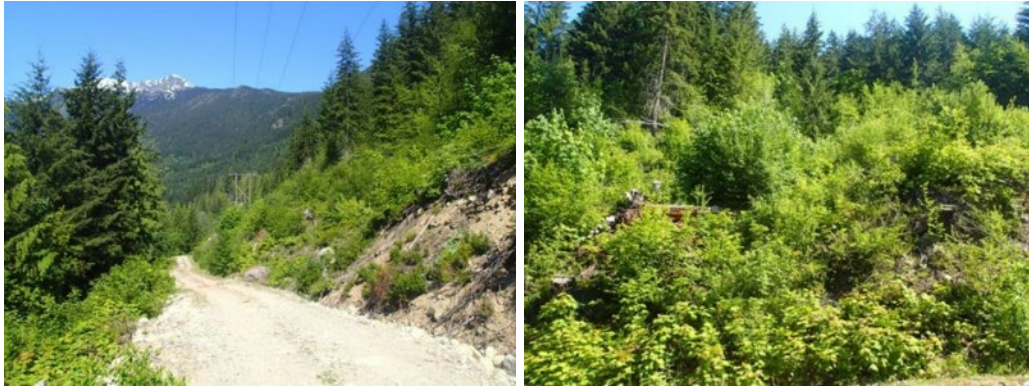
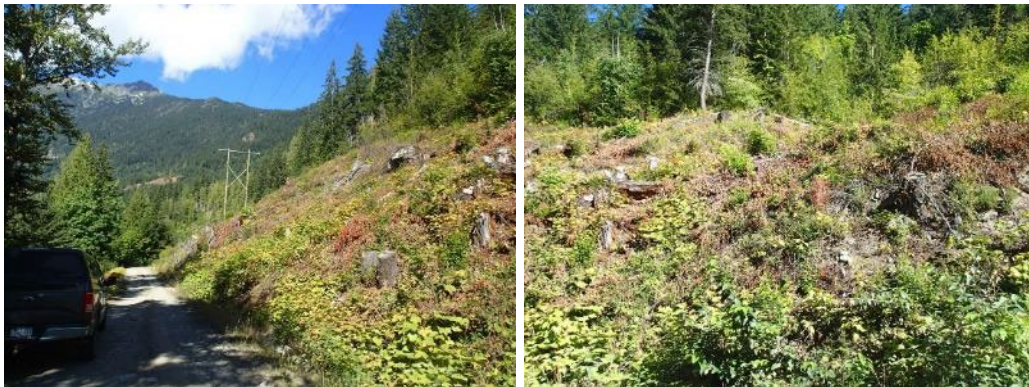
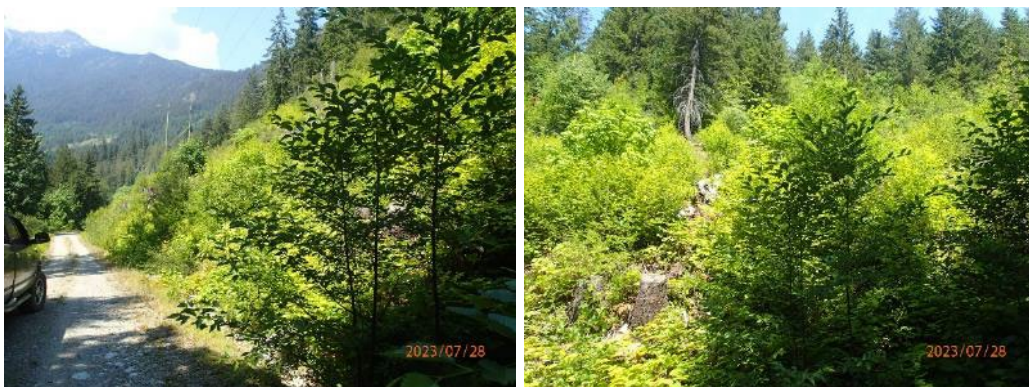
Figure 34. Vegetated screen along the transmission line at ULH-MAMCM21, assessed on June 19, 2018.

Figure 35. Vegetated screen along the transmission line at ULH-MAMCM21, assessed on August 25, 2020.

Figure 36. Vegetated screen along the transmission line at ULH-MAMCM21, assessed on July 28, 2023.

General comment:	This site was noticeably disturbed in 2020 when trees that were approximately 2-3 m in height were cut down. In 2023, significant growth was observed with excellent regeneration along the road and dense shrubs.
Species:	Grizzly Bear and Mule Deer
Screen widths (m):	25, 20, 15
Average screen width (m):	20
Screen heights (m):	6, 5, 3
Average screen height (m):	5
% Screen coverages:	75, 60, 80
Average % screen coverage:	72

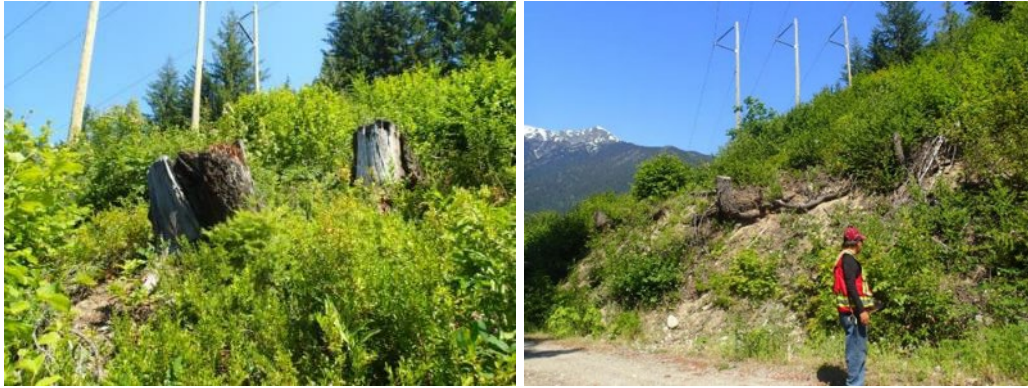
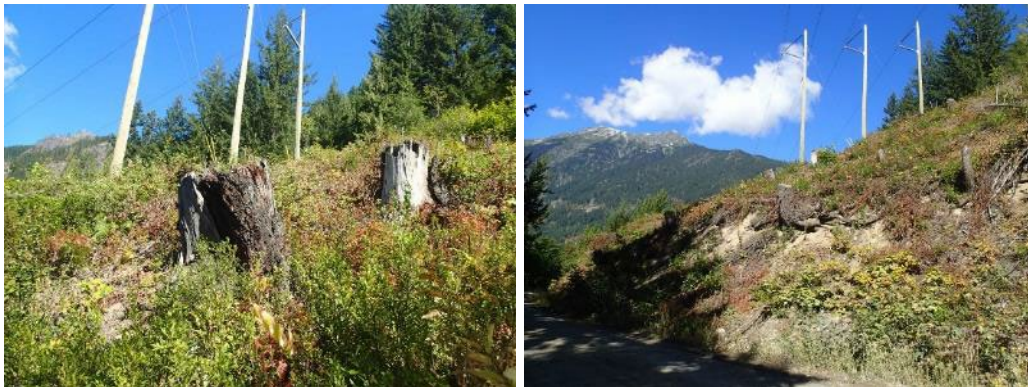
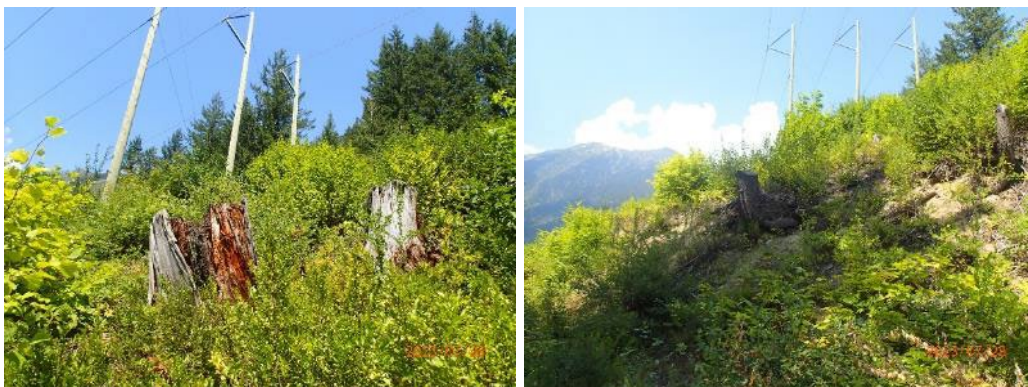
Figure 37. Vegetated screen along the transmission line at ULH-MAMCM22, assessed on June 19, 2018.

Figure 38. Vegetated screen along the transmission line at ULH-MAMCM22, assessed on August 25, 2020.

Figure 39. Vegetated screen along the transmission line at ULH-MAMCM22, assessed on July 28, 2023.

General comment:	This site was noticeably disturbed in 2020; all shrubs that were approximately 2-3 m in height in 2018 were cut down. In 2023 good regeneration with increased vegetation height and dense shrubs were observed. The site is on a trajectory to meet the 5 m height requirement.
Species:	Grizzly Bear
Screen widths (m):	10, 20, 12
Average screen width (m):	14
Screen heights (m):	5, 3, 2
Average screen height (m):	3
% Screen coverages:	40, 70, 45
Average % screen coverage:	62

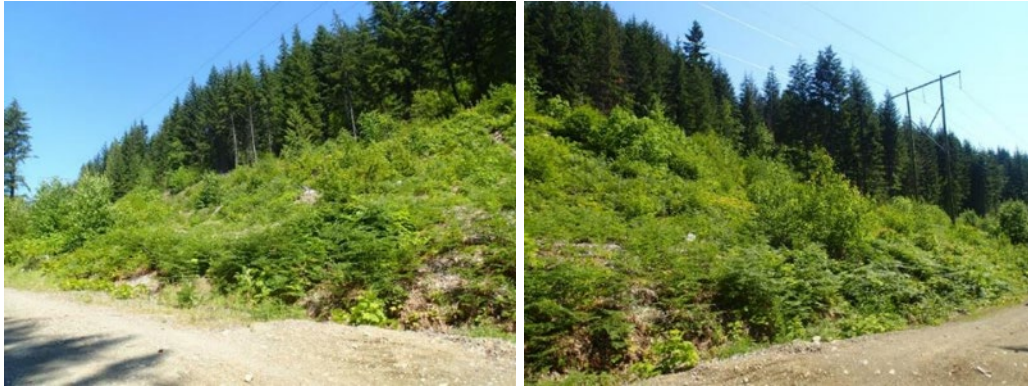
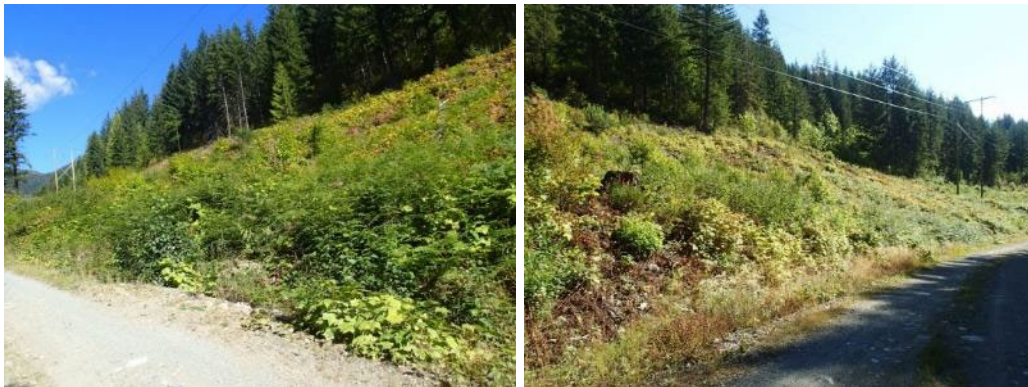
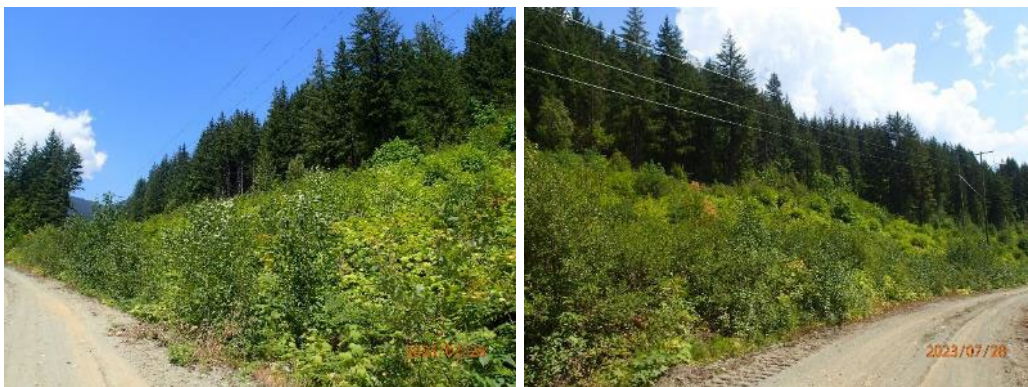
Figure 40. Vegetated screen along the transmission line at ULH-MAMCM23, assessed on June 19, 2018.

Figure 41. Vegetated screen along the transmission line at ULH-MAMCM23, assessed on August 25, 2020.

Figure 42. Vegetated screen along the transmission line at ULH-MAMCM23, assessed July 28, 2023.

General comment:	Roadside vegetation has grown tall; dense shrubs; excellent regeneration.
Species:	Grizzly Bear
Screen widths (m):	20, 15, 25
Average screen width (m):	20
Screen heights (m):	5, 4, 5
Average screen height (m):	5
% Screen coverages:	100, 80, 40
Average % screen coverage:	73
