Upper Lillooet Hydro Project

Operational Environmental Monitoring Year 5

April 24, 2024

Ecofish Research Ltd.

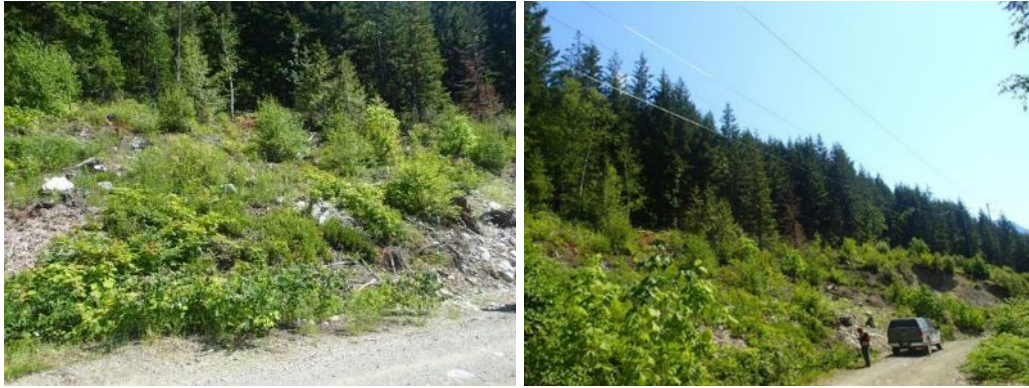
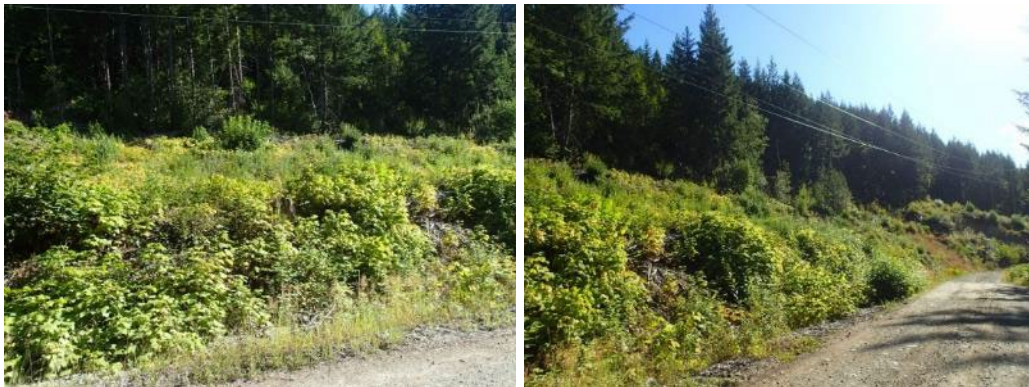
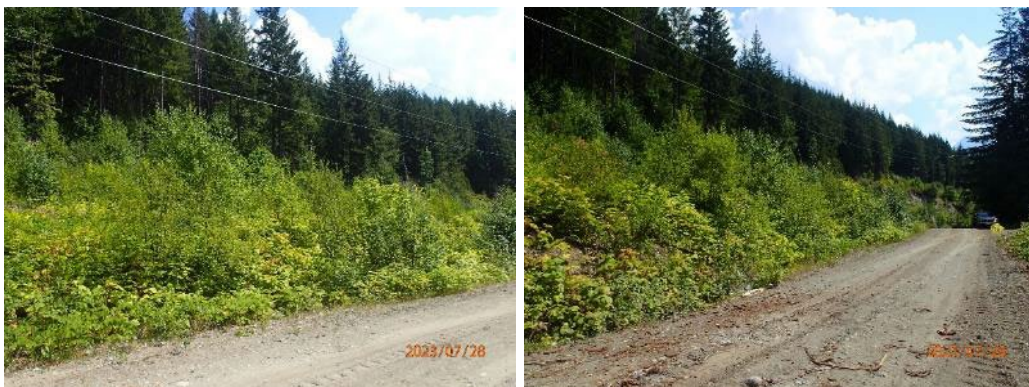
Figure 43. Vegetated screen along the transmission line at ULH-MAMCM24, assessed on June 19, 2018.

Figure 44. Vegetated screen along the transmission line at ULH-MAMCM24, assessed on August 25, 2020.

Figure 45. Vegetated screen along the transmission line at ULH-MAMCM24, assessed on July 28, 2023.

General comment:	Roadside vegetation has grown tall; dense shrubs; excellent regeneration.
Species:	Grizzly Bear and Mule Deer
Screen widths (m):	15, 20, 10
Average screen width (m):	15
Screen heights (m):	5, 3, 7
Average screen height (m):	5
% Screen coverages:	50, 75, 80
Average % screen coverage:	68

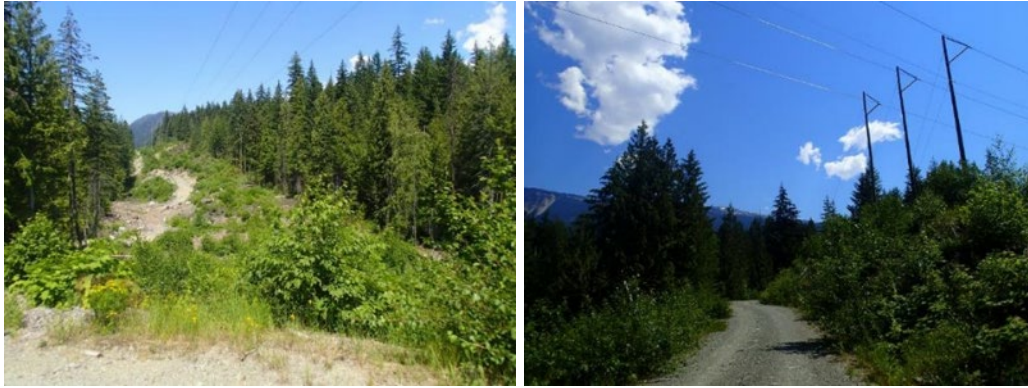
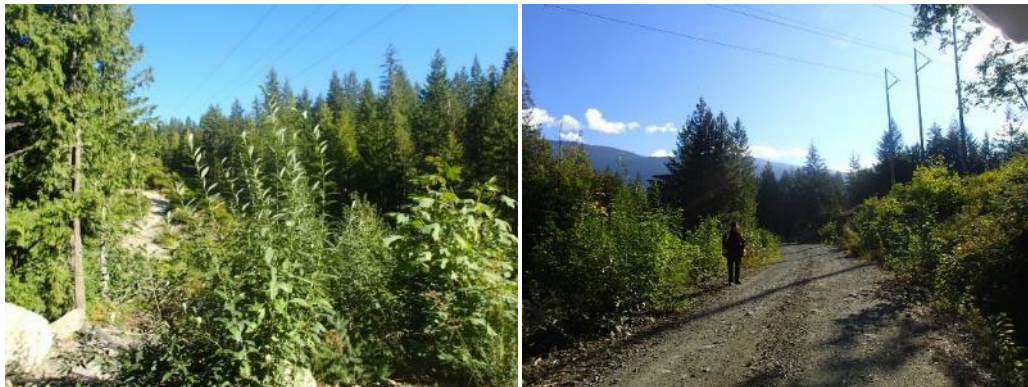
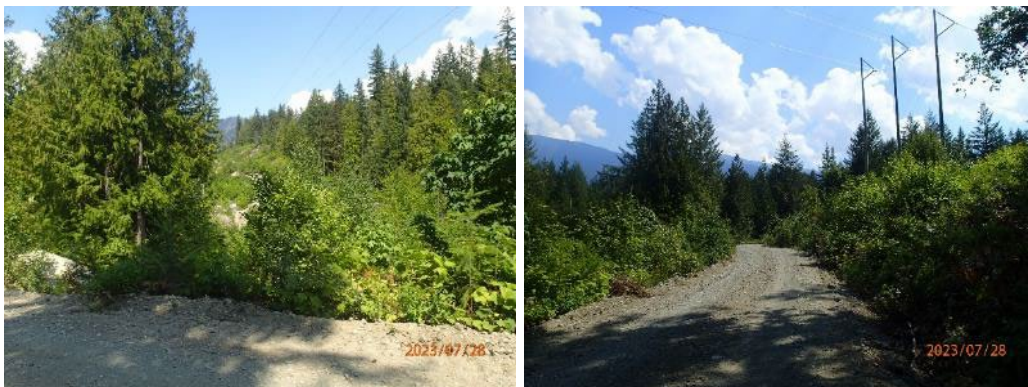
Figure 46. Vegetated screen along the transmission line at ULH-MAMCM26, assessed on June 19, 2018.

Figure 47. Vegetated screen along the transmission line at ULH-MAMCM26, assessed on August 25, 2020.

Figure 48. Vegetated screen along the transmission line at ULH-MAMCM26, assessed on July 28, 2023.

General comment:	Excellent regeneration along with the road; dense shrubs.
Species:	Grizzly Bear and Mule Deer
Screen widths (m):	50, 50, 45
Average screen width (m):	47
Screen heights (m):	5, 6, 4
Average screen height (m):	5
% Screen coverages:	95, 60, 50
Average % screen coverage:	68

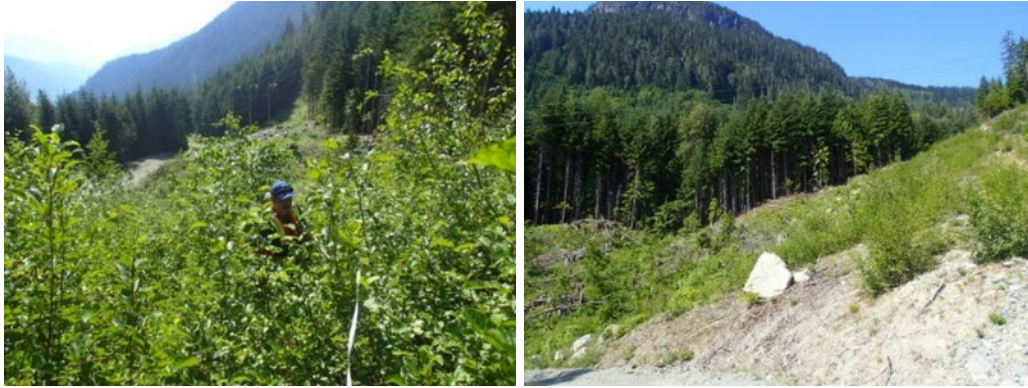
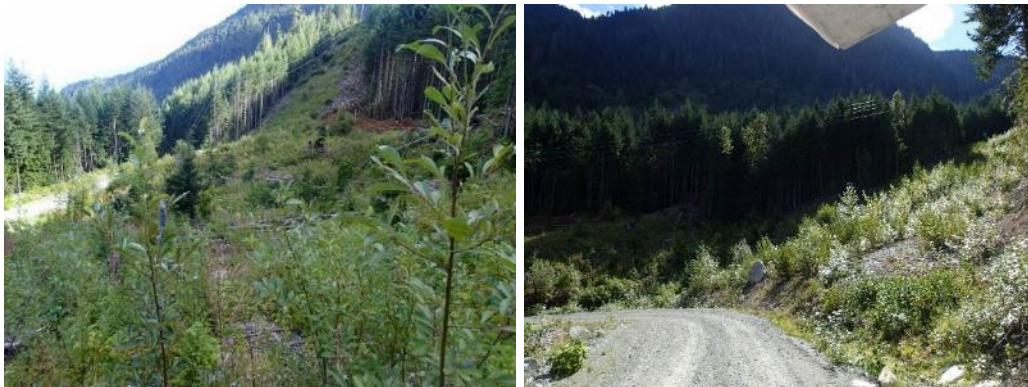
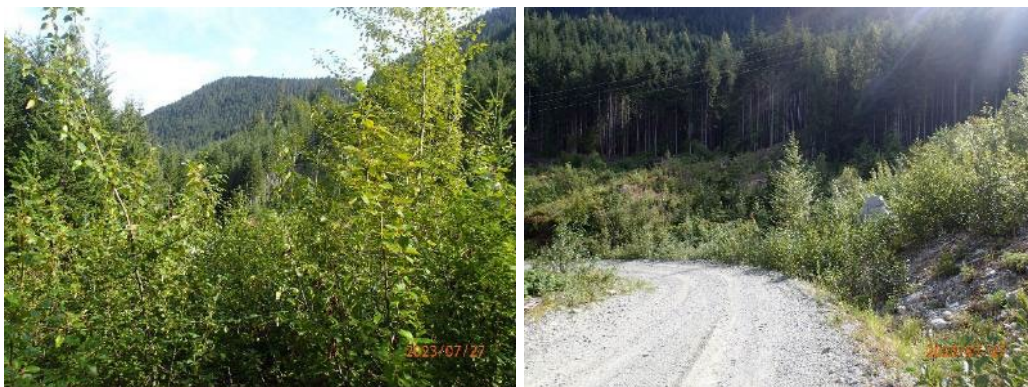
Figure 49. Vegetated screen along the transmission line at ULH-MAMCM27, assessed on June 21, 2018.

Figure 50. Vegetated screen along the transmission line at ULH-MAMCM27, assessed on August 25, 2020.

Figure 51. Vegetated screen along the transmission line at ULH-MAMCM27, assessed on July 27, 2023.

General comment:	Abundant natural regeneration; vegetation; good mix of conifers and deciduous trees.
Species:	Grizzly Bear
Screen widths (m):	60, 65, 45
Average screen width (m):	57
Screen heights (m):	7, 3, 5
Average screen height (m):	5
% Screen coverages:	90, 100, 85
Average % screen coverage:	93

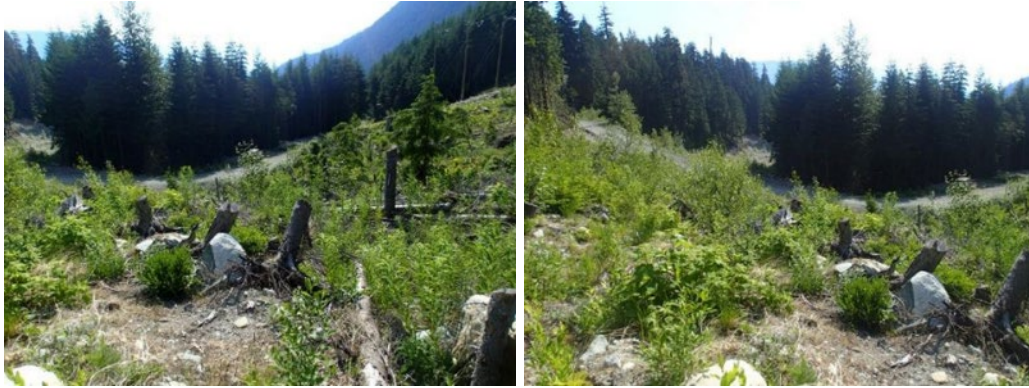
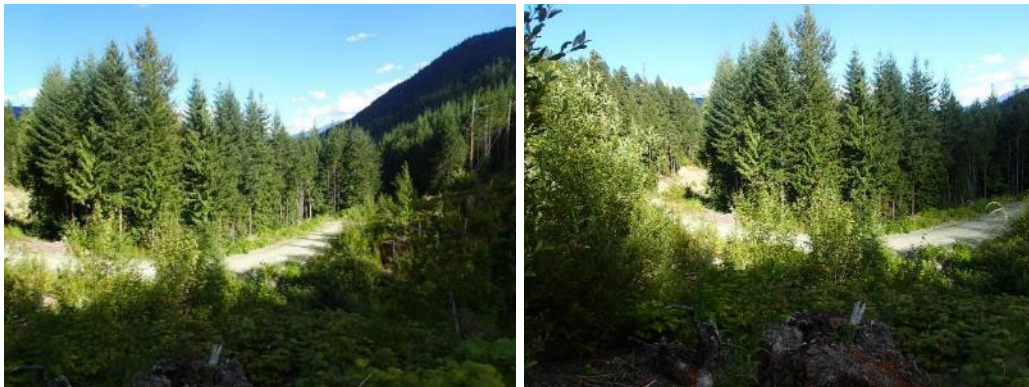
Figure 52. Vegetated screen along the transmission line at ULH-MAMCM28, assessed on June 21, 2018.

Figure 53. Vegetated screen along the transmission line at ULH-MAMCM28, assessed on August 25, 2020.
