Upper Lillooet Hydro Project

Weekly Environmental Monitoring Report #4

Reporting Period: October 6th – October 12th, 2013

Lillooet River Forest Service Road (FSR) realignment and Transmission Line Clearing (Seg. 1 & 2)

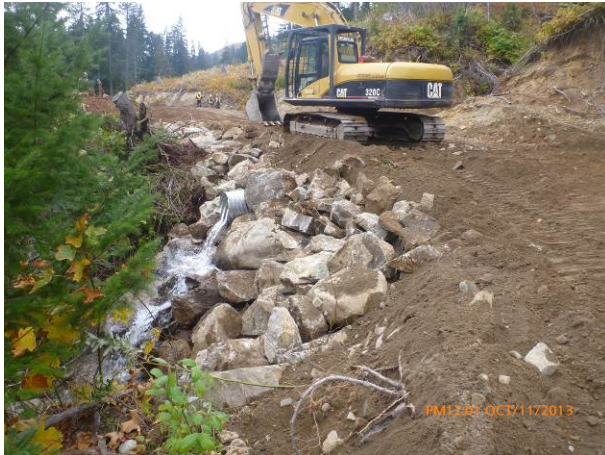
CTFs were observed or captured. A CTF isolation and salvage of the Stn. 1+160 culvert replacement work area occurred on Oct. 9 prior to culvert replacement works, which occurred on Oct. 10 & 11 (Photo 1). In total 26 tadpoles were captured and relocated to suitable habitat upstream of the work area. A survey of the riparian area was completed to ensure no adult CTF were located within the works area. Culvert replacement works were performed under full time supervision of the IEM and employed standard dewatering BMPs (Photo 2). A pulse of elevated turbidity was observed during commissioning of the of Stn. 1 +160 culvert resulting in a temporary exceedance of BCWQG, which lasted less than 30 minutes (see WQ results presented below).

Photo 1. Finalizing the culvert replacement at Stn. 1+160 (Oct 11, 2013).

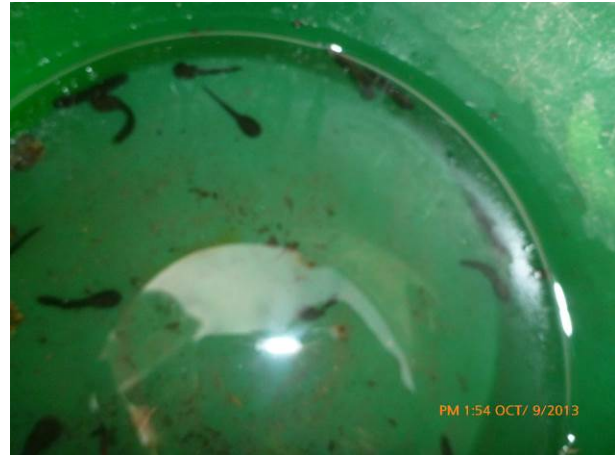
Photo 2. Coastal Tailed Frog tadpoles captured and relocated to suitable upstream habitat within the Stn. 1+160 watercourse (Oct 9, 2013).

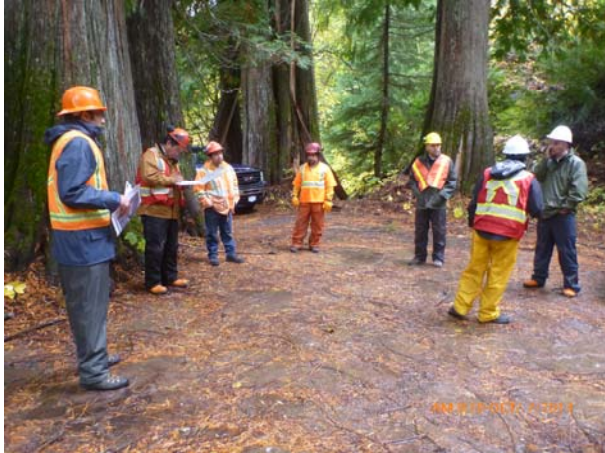
Photo 3. Truckwash Creek Trail pre-construction meeting (Oct 7, 2013).

Date	Communication Type	Participants	Issues Discussed	ITM ID No.
Oct. 7	Truckwash Creek Trail construction pre-work meeting	CRT-EBC, Hedberg, Innergex, SES	<ul style="list-style-type: none"> Reviewed work plan and protocols for constructing foot paths and plank bridges around watercourses (Photo 3) 	N/A
Oct 9	TX Line RVMA clearing prescription pre-work meeting	WEL, Mumleqs, Hedberg, Innergex, SES	<ul style="list-style-type: none"> Reviewed updated clearing prescription for RVMA's for Segment 1 and 2 of the Transmission Line and discussed/reviewed the approach to temporary watercourse crossings and discussed how watercourse crossings will be conducted upon approval of the LTC. 	N/A
Oct 10	Email notification	WEL, SES	<ul style="list-style-type: none"> The IEM was notified via email that hand clearing within 100m of Boulder Creek (Coastal Tailed Frog habitat) was completed without IEM notification or presence onsite 	TL-1

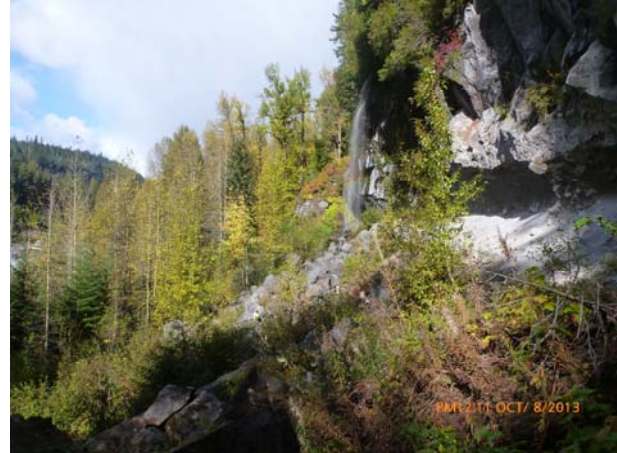
Photo 4. Looking towards the waterfall above first watercourse crossing along the trail alignment. (Oct 8, 2013).

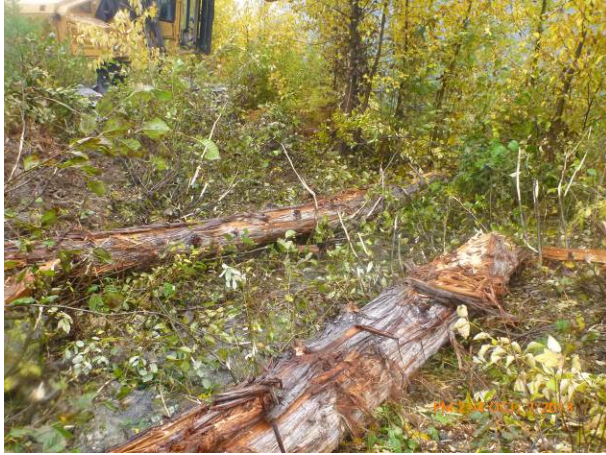
- Log loader and skidder were active within Class 1 Grizzly Bear forage habitat (poles 1 - 4.5).
- Feller buncher clearing progressed to pole 37.5 this week. Temporary crossings were completed according to DFO operational statement to access previously decommissioned roads. All streams were crossed by placing logs on the stream banks and walking the tracked machine over the logs while ensuring no impact to the channel substrates or banks. The environmental monitor was present for all stream crossings and for placement of logs on the stream banks. No WQ or stability concerns were observed. (Photo 5).

Photo 5. One example of a temporary crossing installed by the feller buncher to cross an open channel without impacting the stream banks or substrate (Oct. 7, 2013).

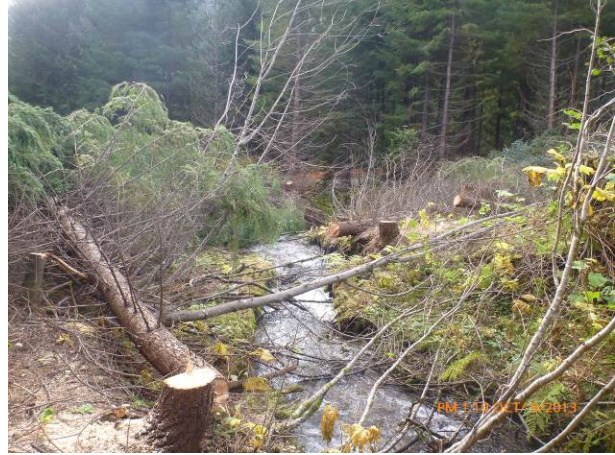
- Hand falling within the Stream 9 RVMA was monitored on Oct. 9. No environmental concerns were noted (Photo 6).

Photo 6. Conditions within stream 9 RVMA following hand clearing. No trees were felled into the watercourse. (Oct. 9, 2013).
