Upper Lillooet Hydro Project

Environmental Monitoring Summary Report

Reporting Period: August 23rd – September 11th, 2013

Construction Camp Water Well Site Preparations and Drilling

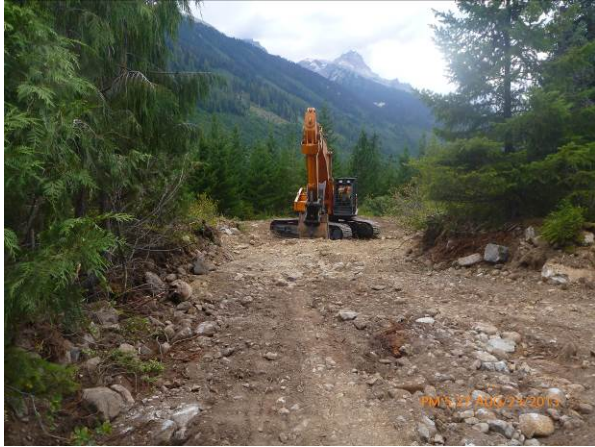
In preparation for production well drilling, two 10m² areas were cleared of vegetation within the authorized construction camp footprint. Site #1 was located near the western boundary of the camp (Photo 1) and Site #2 was located at the southern camp boundary (Photo 2). Both locations were chosen to minimize the extent of tree clearing required. The IEM was onsite and all machinery was inspected for leaks and to ensure spill kits were onsite prior to conducting the works. No environmental concerns were noted.

Photo 1. Production Well site #1 clearing. (Aug. 23, 2013)

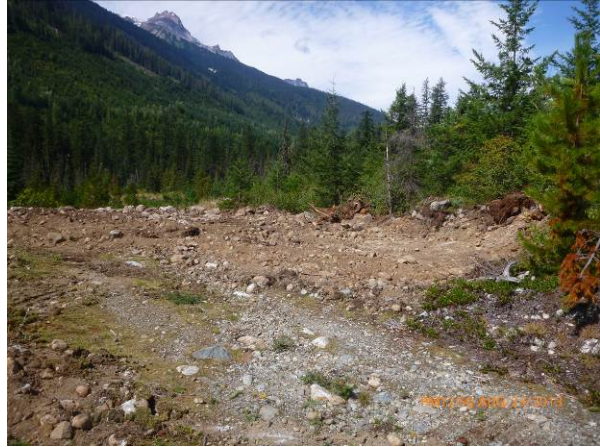
Photo 2. Production Well site #2 clearing. (Aug. 23, 2013)

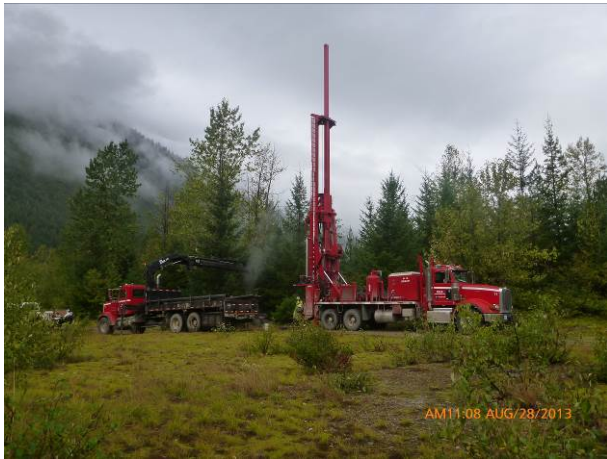
The drilling and installation of three groundwater quality monitoring wells, was completed from August 27th to August 30th. The IEM participated in a pre-job safety meeting and work plan review prior to the start of works. All equipment was inspected and found to be free of leaks, off-site vegetative debris, and complete with appropriately sized spill kits. The IEM was onsite during drilling for the monitoring wells on August 27th and 28th (Photo 3), and for production well drilling on September 4th at Site #1 (Photo 4). No environmental concerns were noted during drilling activities.

Photo 3. Monitoring well drilling. (Aug 28, 2013)

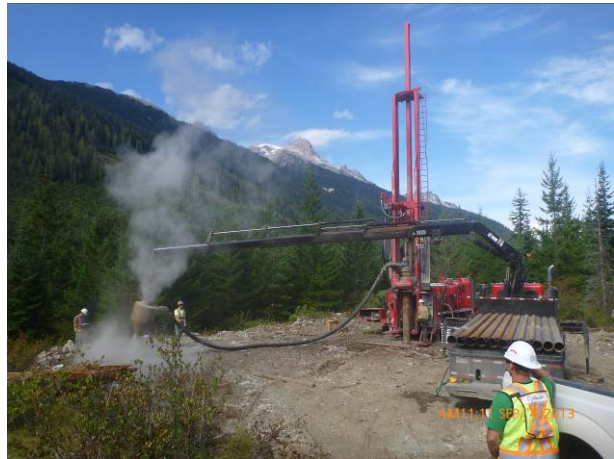
Photo 4. Production well drilling at site #1. (Sept. 4, 2013)

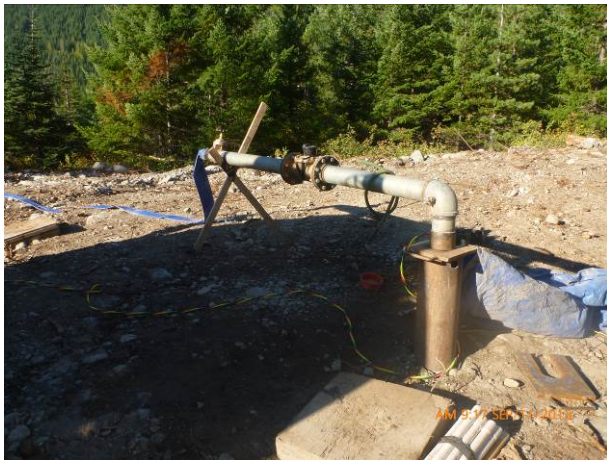
The Site #1 production well was tested using three pump rate tests (75, 150, & 250 GPM) on the morning of September 11th. The pump setup (Photo 5) and discharge location (Photo 6) was inspected prior to beginning the tests. Scour at the discharge location was prevented by wrapping the outlet in a heavy tarp, which provided effective energy dissipation and protected against soil erosion. The preliminary results of the pump rate test determined that the Site #1 well would be sufficient to supply the construction camp with the needed volume of water. Therefore the Site #2 well was not drilled or developed. No environmental concerns were noted.

Photo 5. Production well testing setup. (Sept. 11, 2013)

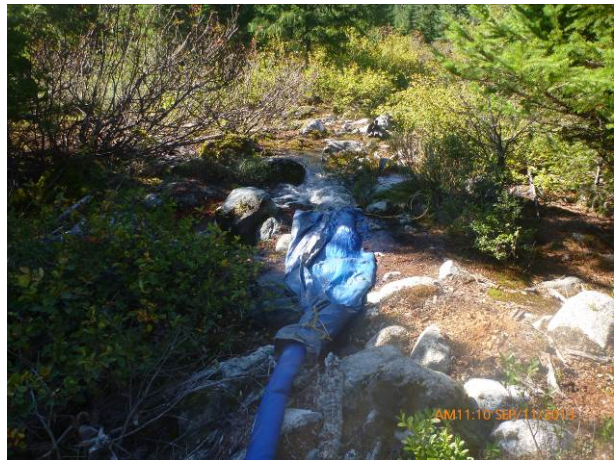
Photo 6. Production well testing discharge location. (Sept. 11, 2013)
