# Upper Lillooet Hydro Project

## Weekly Environmental Monitoring Report #6

Reporting Period: October 20<sup>th</sup> – October 26<sup>th</sup>, 2013

Upper Lillooet River Hydroelectric Facility (Water File No. 2002561, Water licence No. C130613),  
Boulder Creek Hydroelectric Facility (Water File No. 2003049, Water licence No. C129969) &  
Transmission Line (TX Line)

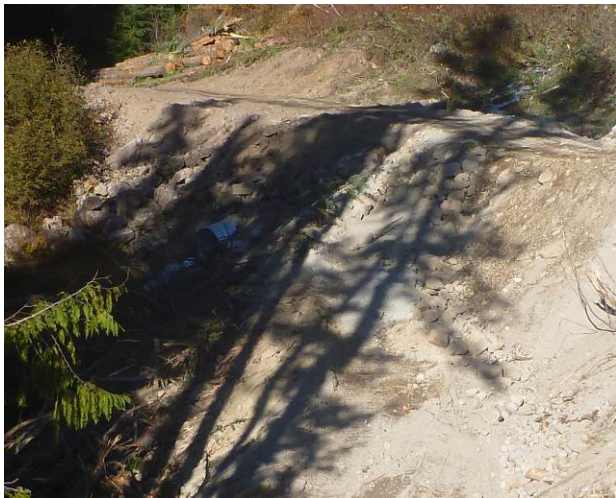
**Photo 1. Road base backfill placed over 1600mm culvert at Stn. 1+430 (Oct. 25, 2013).**

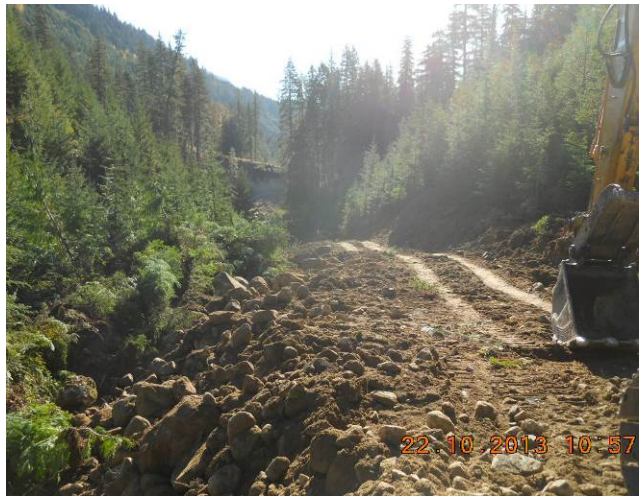
- IEM was onsite periodically throughout this reporting period to oversee general construction activities (including grubbing) and full-time during clearing (Photo 2) in Grizzly Bear Class 1 suitable summer and fall forage habitat (ULL-GB05). Clearing limits were minimized.
- CRT-EBC provided the IEM and Innergex with adaptive noise reduction mitigations on October 16<sup>th</sup> to address ongoing blasting activities occurring up until October 31 as part of the FSR realignment works within ULL-GB05 (Grizzly Bear Class 1 summer and fall forage habitat). Approved blasting mitigations remained effective during monitoring of blasting activities throughout this reporting period.

**Photo 2. Clearing and grubbing within 500m of Grizzly Bear Class 1 habitat (suitable summer and fall forage; ULL-GB05) at the east heading of the Truckwash Creek FSR realignment (Oct. 23, 2013).**

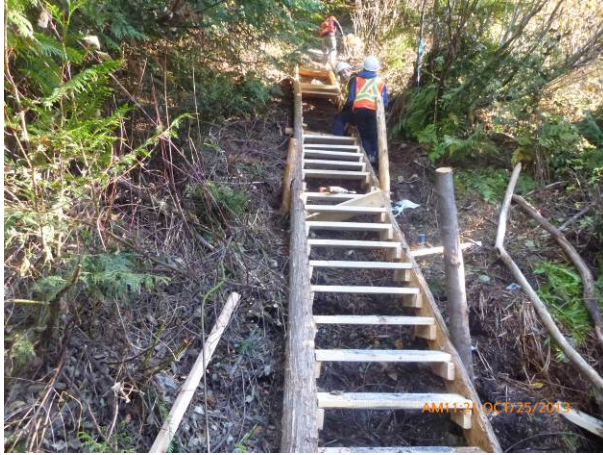
- Crews achieved 95% completion of the trail construction to the left bank abutment of the footbridge to be installed over Truckwash Creek. Hand tools were used to grub and clear a footpath along a surveyed/flagged centerline. Upgrades to rocky sections and steeper sections (Photo 3) of the trail also occurred during this reporting period.

**Photo 3. Construction of stairs required for a steep section of the trail. (Oct. 25, 2013).**

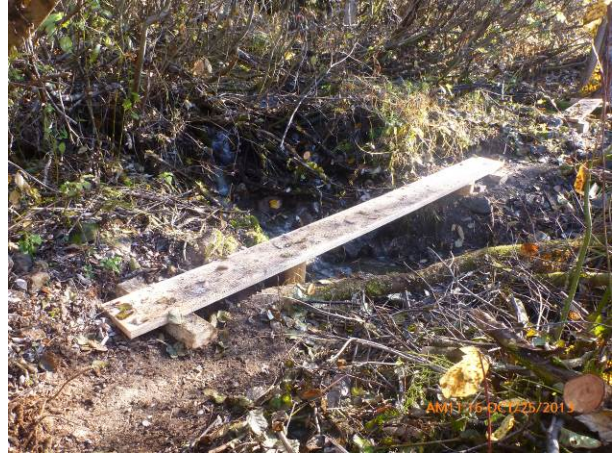
- The construction of wooden plank footbridges over flowing sections of small watercourses and wet areas occurred during this reporting period (Photo 4). All crossing structures are wooden and were installed on existing ground surface, outside of the wetted channel.

**Photo 4. Boardwalk constructed over sections of flowing water (Oct. 25, 2013).**

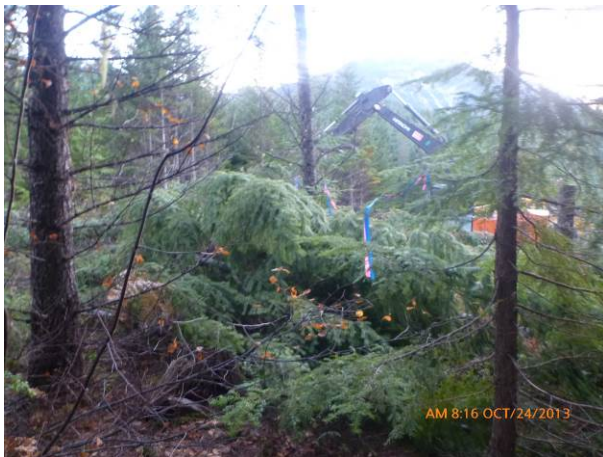
- The IEM was onsite and reviewed the clean-up prescriptions in each 15m RVMA boundary prior to beginning activities. All equipment remained outside the 15m buffer and reached in to remove debris. A spotter was onsite equipped with an extra spill kit to quickly identify and respond to spills throughout works within 30m of a watercourse; however, no spills occurred within these areas during this reporting period. No environmental concerns were noted.
- No ESC or WQ issues were observed throughout the active works areas.

**Photo 5.** Clean-up activities within 15m of Boulder Creek. Notice the pink and blue flagging that delineates the 15m RVMA area. Equipment did not pass this line during clean-up works (Oct. 24, 2013).

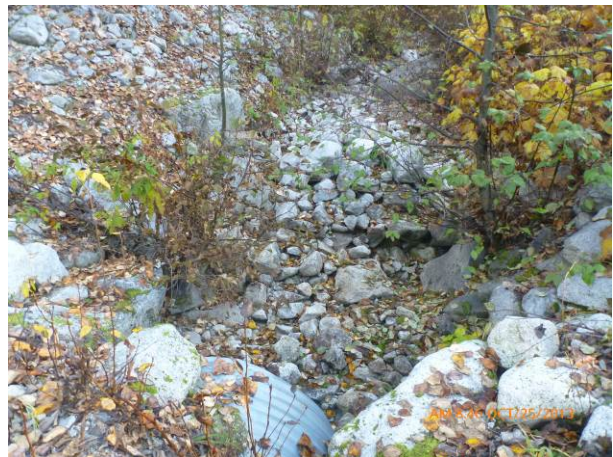
The IEM was onsite to verify the dry condition of km 29.2 Tributary (Photo 6), oversee clearing activities within 500m of km 29.2 Tributary, and ensure clearing boundaries were minimized, and works were conducted according to the agreed upon adaptive management strategy. Clearing occurred from Poles 60-63 and 65-70 on October 24<sup>th</sup> and 25<sup>th</sup>, respectively.

**Photo 6.** Dry conditions of Stream 29.2 on October 25th (Oct. 25, 2013).
