Upper Lillooet Hydro Project

Weekly Environmental Monitoring Report #7

Reporting Period: October 27th – November 2nd, 2013

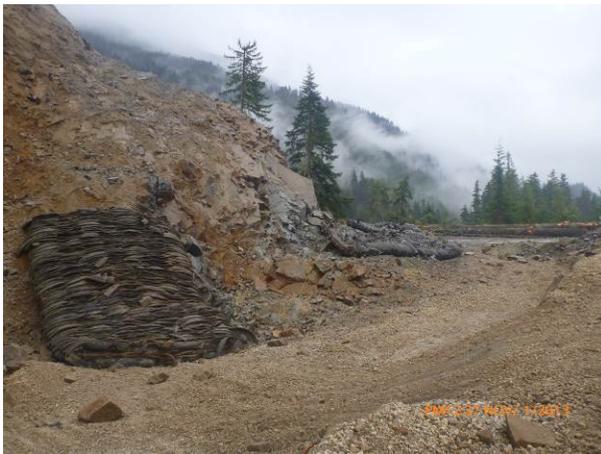
Photo 1. Blast mats used during blasts within 500m of Grizzly Bear Class 1 habitat (suitable summer and fall forage; ULL-GB05) and with 500m of Mountain Goat UWR (UL11) at the west heading of the Truckwash Creek FSR realignment (Nov 1, 2013).

November 1st to document adherence to blasting noise level restrictions within 500m of the Mountain Goat UWR (specifically UL-11) and within the migration corridor. Blast mats were used as the primary noise reduction mitigation for all blasts beginning November 1st, 2013 ([Photo 1](#)). The data recorded after November 1st, 2013 is currently being analysed by BKL (noise monitoring consultants) and results of the data analysis will be provided in the following reporting period.

- Based on recent monitoring results, the IEM recommends continued implementation of current blast mitigation measures (maximum 10-hole sets and use of minimum required charges) with the addition of blast mats for all remaining blasting activities within 500m of ULL-GB05 and within 500m of the Mountain Goat UWR (specifically UL-11) or within the migration corridor.

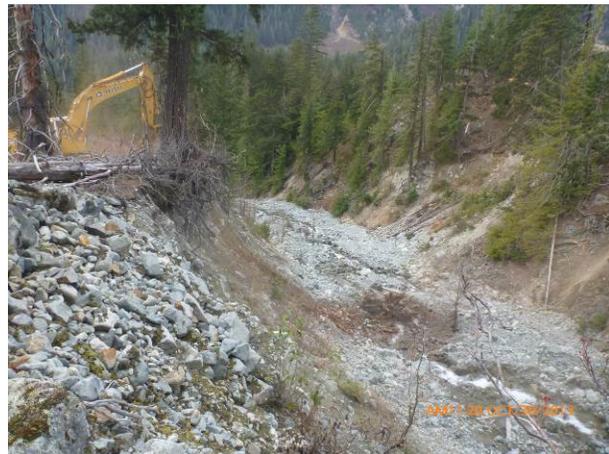
- On October 30th, an onsite pre-activity meeting was held with the CRT-EBC supervisor, excavator operator and the IEM to discuss the procedure for removing the large stump overhanging Truckwash Creek at the east bridge abutment location. Water quality concerns and equipment operation within the riparian area were discussed. As planned, the operator attempted to remove the stump by grasping the stump with the thumb and bucket of the excavator. While attempting the operation the stump and roots were found to be in a state of advanced decay, and when the roots broke away the excavator was unable to grasp the stump, and it slid down into Truckwash Creek below high water mark (11:19am; [Photo 2](#)). A temporary pulse of sediment was observed and a water quality sample within Truckwash Creek was taken as soon as possible following the event. Water quality was taken at 11:29am the turbidity was found to be within BCWQG (see [Water Quality Results](#)). Removal of the stump from within Truckwash Creek is not recommended at this time as removal would generate significant amounts of turbid water (as it would need to be dragged up the left bank), and the stump is likely to break apart if attempts are made to remove it.

Photo 2. Accidental release of stump into Truckwash Creek (Oct. 30, 2013).

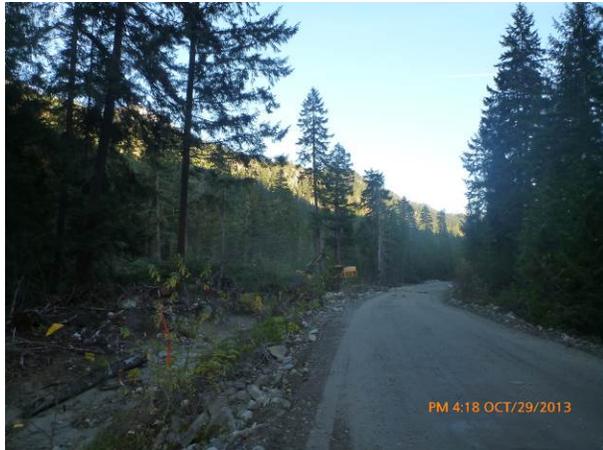
Photo 3. Monitoring of feller buncher clearing within legally designated OGMA near North Creek (Pole 135). Equipment did not enter or clear within the North Creek RVMA during clearing works (Oct. 29, 2013).

- Feller buncher clearing activities began in Segment 5 during this reporting period (Poles 126 – 138.5) ([Photo 3](#)).
- Hand falling was completed in the following areas;
 - Poles 23 – 24; 37.5 – 40; 50 – 52; and 57 – 59.
- No activities occurred within RVMAs during this reporting period.

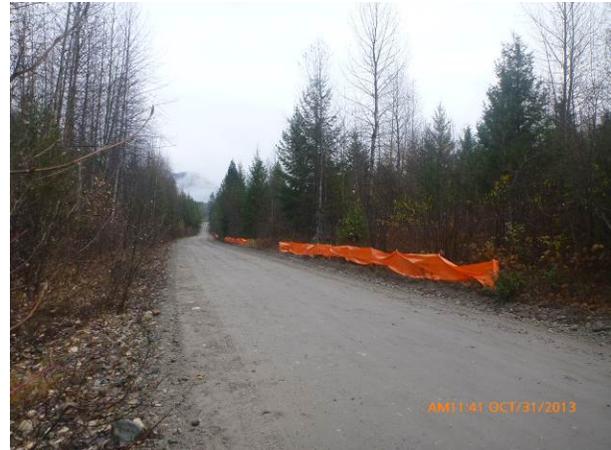
Photo 4. Gaps installed in the visual barrier fencing installed to protect the adjacent wetland areas along the Lillooet River FSR (Oct. 31, 2013).

- IEM was onsite to ensure clearing boundaries were minimized for all clearing works within wildlife timing restriction areas as identified in Section **3.0**. No environmental concerns were noted.
- Gaps were made in the visual barrier fencing installed to protect the adjacent wetland areas along the Lillooet River FSR ([Photo 4](#)). The IEM has verified that all currently required 30m wetland barrier fencing is installed according to the CEMP commitments.
- No ESC or WQ issues were observed throughout the active works areas.
