Upper Lillooet Hydro Project

Weekly Environmental Monitoring Report #8

Reporting Period: November 3rd – November 9th, 2013

Upper Lillooet River Hydroelectric Facility (Water File No. 2002561, Water licence No. C130613),
Boulder Creek Hydroelectric Facility (Water File No. 2003049, Water licence No. C129969) &
Transmission Line (TX Line)

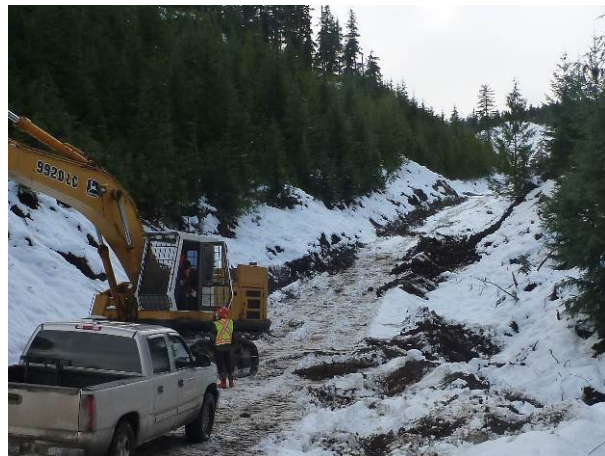
- Construction at the east heading included clearing and grubbing, bulk excavation and road base construction. Winterization works included; armouring of the 1600mm culvert inlet ([Photo 1](#)), as well as ditching and cross ditching in completed sections of road grade ([Photo 2](#)). Bulk excavation at the first switchback was the focus of this week's activities at the east heading.
- Removal of a large tree overhanging Truckwash Creek was conducted at the east bridge abutment location of Truckwash Creek FSR realignment (within 500m of ULL-GB05) on November 4th, 2013.

Photo 2. Ditching and cross ditching installed along completed section of road alignment on the east heading of Truckwash Creek. Work was completed as part of winterization of the site. (Nov 8, 2013).

- formalization and armouring of ditch lines along complete sections of road; and,
 - cross ditching across steep road grades along complete sections of road.

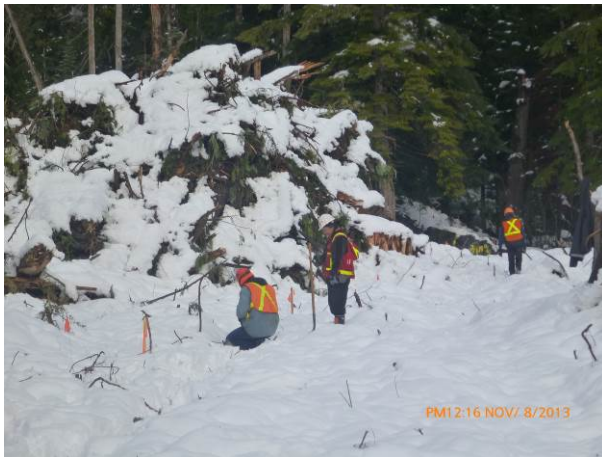
- Seismic survey work was completed on November 8th at the ULRHEF intake area ([Photo 3](#)). The IEM and archeology monitor were onsite to monitor works and oversee activities with 50m of the identified archeology site, respectively.

Photo 3. Seismic survey work being conducted in the presence of the archeology monitor at the ULRHEF intake area (Nov 8, 2013).

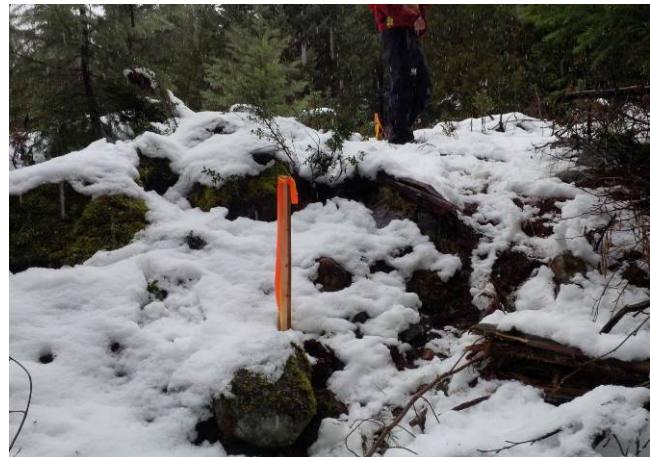
- Seismic survey work was completed at the BDRHEF powerhouse on November 9th ([Photo 4](#)). The IEM was onsite to monitor work activities within 100m of Coastal Tailed Frog (CTF) habitat (Boulder Creek). Prior to work occurring in the area the IEM conducted a precautionary amphibian sweep along alignment to ensure no CTFs were present. No CTFs were observed or relocated during the precautionary sweep.

Photo 4. Seismic survey alignment at the BDRHEF powerhouse area. The IEM conducted a precautionary Coastal Tailed Frog salvage prior to the start of work within 100m of Boulder Creek (Nov 9, 2013).
