# Upper Lillooet Hydro Project

## Weekly Environmental Monitoring Report #8 (Rev01)

**Reporting Period: November 3<sup>rd</sup> – November 9<sup>th</sup>, 2013**

Upper Lillooet River Hydroelectric Facility (Water File No. 2002561, Water licence No. C130613),  
Boulder Creek Hydroelectric Facility (Water File No. 2003049, Water licence No. C129969) &  
Transmission Line (TX Line)

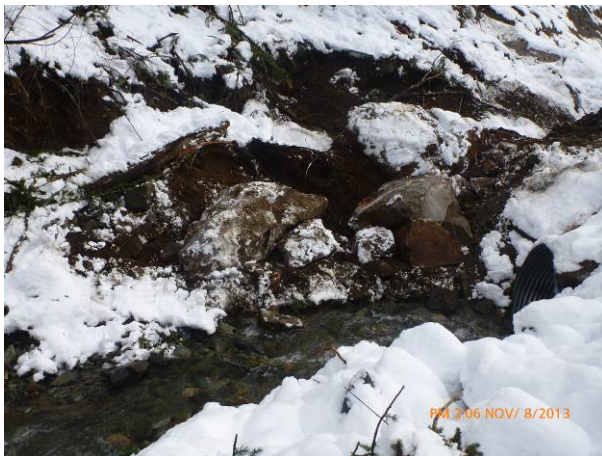
- Construction at the east heading included clearing and grubbing, bulk excavation and road base construction. Winterization works included; armouring of the 1600mm culvert inlet ([Photo 1](#)), as well as ditching and cross ditching in completed sections of road grade ([Photo 2](#)). Bulk excavation at the first switchback was the focus of this week's activities at the east heading.
- Removal of a large tree overhanging Truckwash Creek was conducted at the east bridge abutment location of Truckwash Creek FSR realignment (within 500m of ULL-GB05) on November 4<sup>th</sup>, 2013.

Photo 1. Culvert inlet armouring being installed in the dry above the waterline at the 1600mm culvert, following hand removal of woody debris from around the culvert inlet. The IEM was onsite to monitor this work and no WQ concerns were noted (Nov 8, 2013).

- culvert inlet armouring finalization at the 1600mm culvert located along east alignment (armouring to be completed in the dry);
  - removal of woody debris within the channel upstream of the 1600mm culvert;

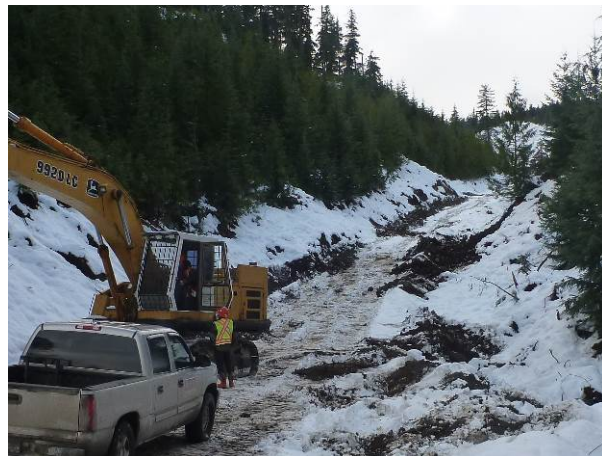
Photo 2. Ditching and cross ditching installed along completed section of road alignment on the east heading of Truckwash Creek. Work was completed as part of winterization of the site. (Nov 8, 2013).

- formalization and armouring of ditch lines along complete sections of road; and,
  - cross ditching across steep road grades along complete sections of road.

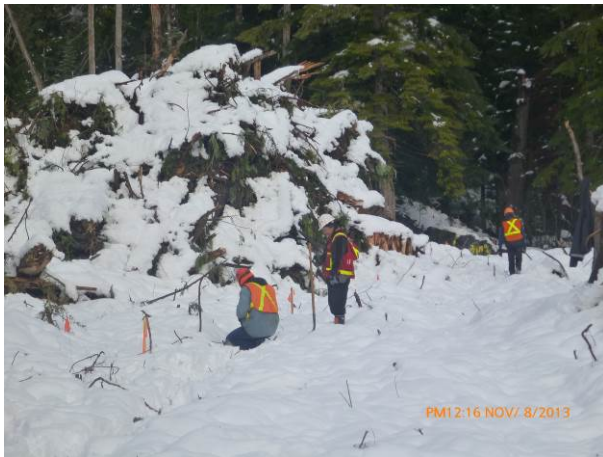
- Seismic survey work was completed on November 8<sup>th</sup> at the ULRHEF powerhouse area ([Photo 3](#)). The IEM and Archeological Monitor were onsite to monitor works and oversee activities within 50m of the identified archeological site (EdRu-3).

**Photo 3. Seismic survey work being conducted in the presence of the archeology monitor at the ULRHEF powerhouse area (Nov 8, 2013).**

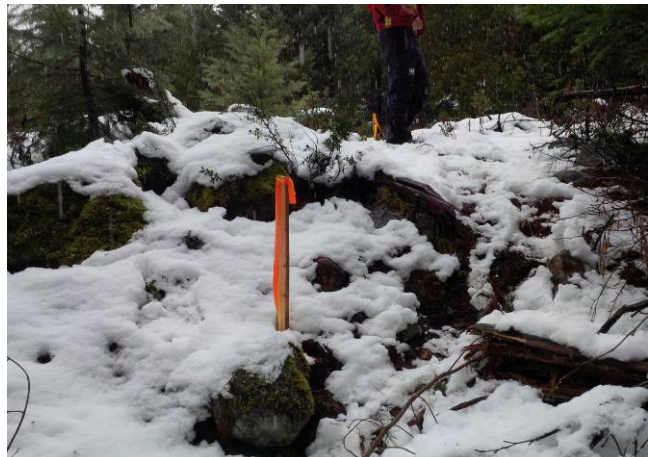
- Seismic survey work was completed at the BDRHEF powerhouse on November 9<sup>th</sup> ([Photo 4](#)). The IEM was onsite to monitor work activities within 100m of Coastal Tailed Frog (CTF) habitat (Boulder Creek). Prior to work occurring in the area the IEM conducted a precautionary amphibian sweep along alignment to ensure no CTFs were present. No CTFs were observed or relocated during the precautionary sweep.

**Photo 4. Seismic survey alignment at the BDRHEF powerhouse area. The IEM conducted a precautionary Coastal Tailed Frog salvage prior to the start of work within 100m of Boulder Creek (Nov 9, 2013).**
