Upper Lillooet Hydro Project

Weekly Environmental Monitoring Report #11

Reporting Period: November 24th – November 30th, 2013

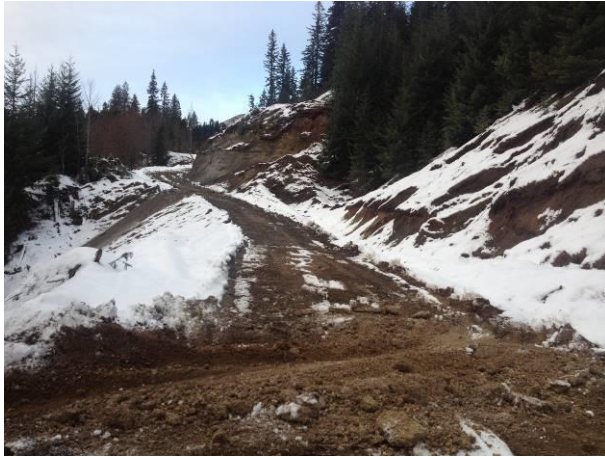
- No construction activities occurred in the vicinity of the Truckwash Creek Migration Corridor during this reporting period.
- Construction at the east heading included clearing and grubbing, bulk excavation and road base construction. Work activities were suspended for the season on November 26th, 2013. Prior to demobilization ditching and cross-ditching was installed along steep sections of the alignment to provide temporary drainage and winterization of the site ([Photos 1 & 2](#)).

Photo 1. Two cross ditches installed across the road grade at the east heading of the Lillooet River FSR realignment (outside of the Truckwash Creek Mountain Goat Migration Corridor). (Nov.26, 2013).

- Winterization measures were installed at the east heading of the Truckwash Creek FSR realignment prior to demobilization from site on November 26th, 2013. Works at the east heading have now been suspended for the season and will resume in the spring. The winterization measures installed included:

- Temporary ditch lines were installed along unfinished sections of road that will be completed next season. Final drainage will be installed once the road construction is complete; and,

- cross ditching was installed to direct water off of the road alignment and prevent runoff water from eroding steep sections of the road surface.
- No water quality concerns were noted during monitoring inspections this week.

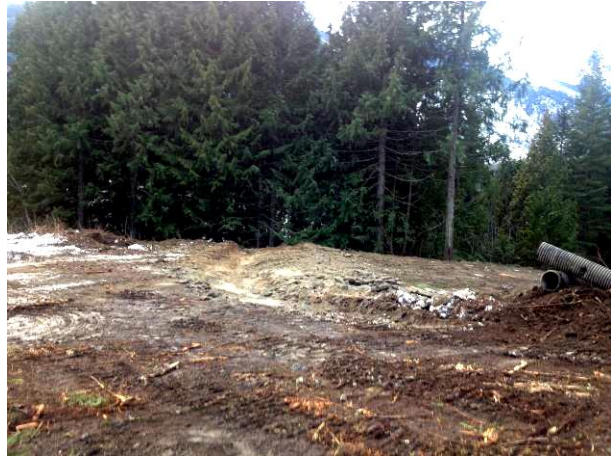
Photo 2. Additional cross ditching installed across the road grade at the east heading of the Lillooet River FSR realignment (outside of the Truckwash Creek Mountain Goat Migration Corridor). (Nov.26, 2013)

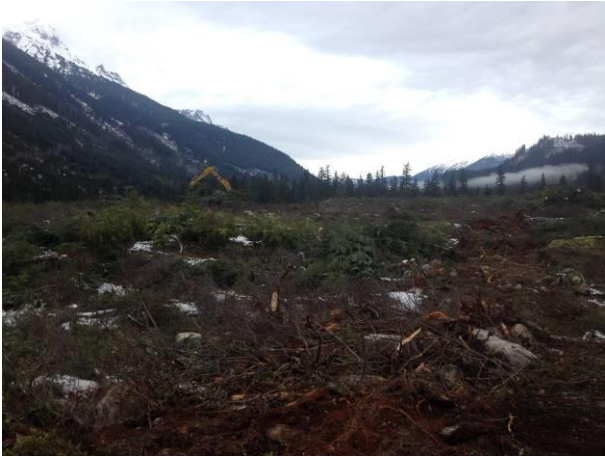
- Excavators were used to pile slash and fallen trees at the future construction camp location this week, beginning on November 27, 2013 ([Photo 3](#)). Two test pits were dug and filled in with the excavated material following the investigative works ([Photo 4](#)). All clearing and investigative works were conducted within the clearing boundary and all trees were piled within the camp area.

Photo 3. Piling trees with an excavator at the construction camp. (Nov 27, 2013).

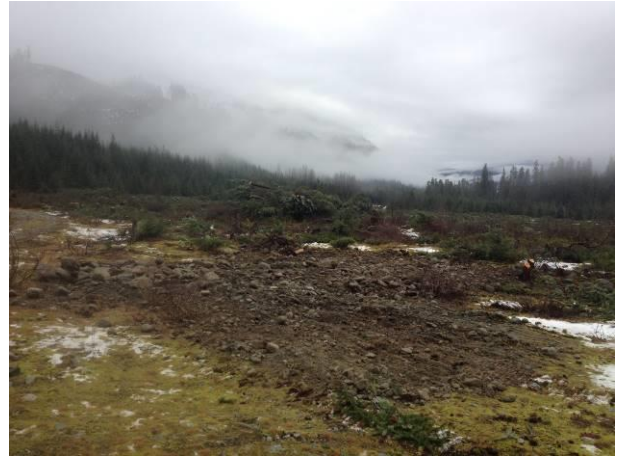
Photo 4. New test pit at the construction camp. (Nov 28, 2013).

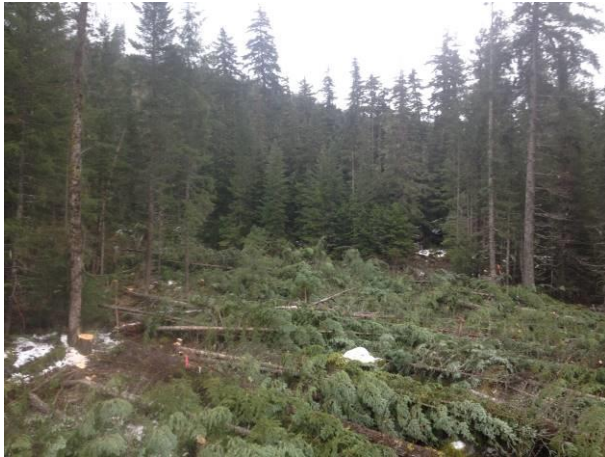
- Clearing trees from within the footprint of the Boulder Creek Powerhouse facilities was performed by certified fallers this week ([Photo 5](#)).

Photo 5. Results of clearing within the Boulder Creek Powerhouse footprint. Looking towards the future tail race location (Nov.28, 2013).

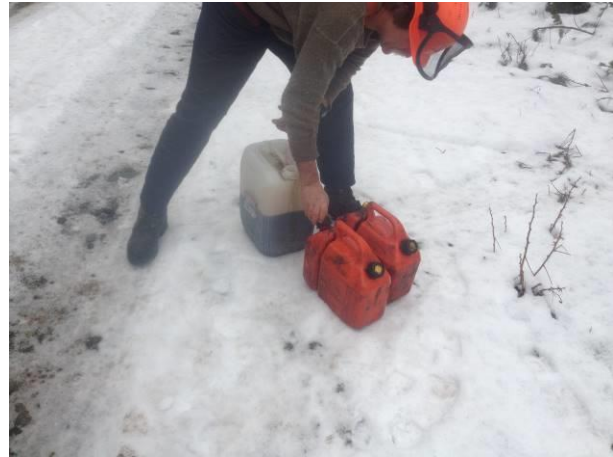
- A precautionary CTF survey was completed prior to clearing within 100m of CTF habitat adjacent to Boulder Creek. The survey concentrated effort within shallow depressions and within and around piles of coarse woody debris.
- Fallers used bio-degradable bar/chain oil when clearing within 30m of Boulder Creek. ([Photo 6](#))
- No CTF were observed and no environmental concerns were noted during clearing activities.
- The IEM was onsite to monitoring and ensure clearing within the designated OGMA (adjacent to Boulder Creek) was minimized.

Photo 6. Re-fueling with bio-degradable bar oil. (Nov 28, 2013).

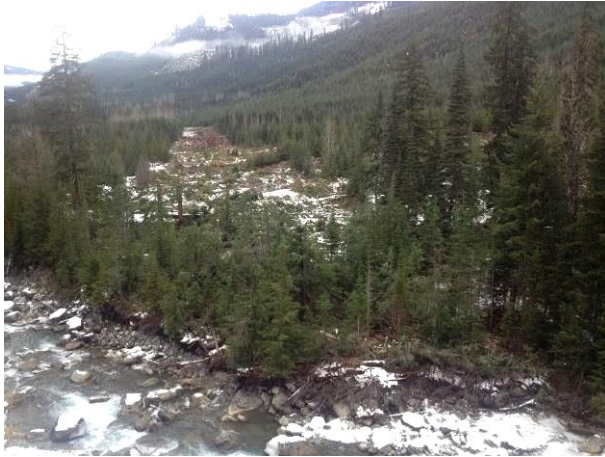
- Tree topping with the Boulder Creek RVMA was completed during this reporting period ([Photos 7 & 8](#)).

Photo 7. Results of tree topping on the right bank of the Boulder creek RVMA (Nov.27, 2013).

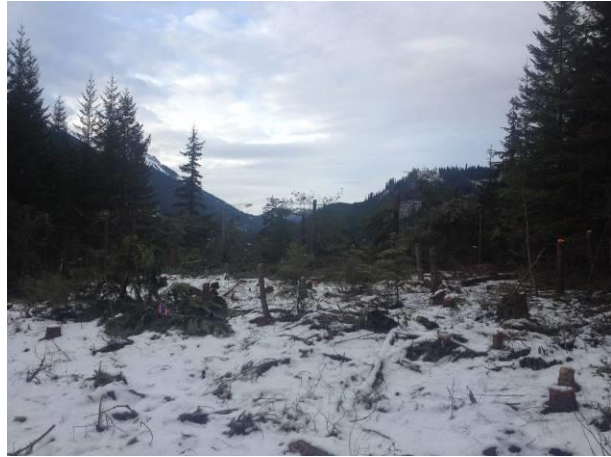
Photo 8. Results of tree topping on the left bank of the Boulder creek RVMA (Nov.27, 2013).
