Upper Lillooet Hydro Project

Weekly Environmental Monitoring Report #12

Reporting Period: December 1st – December 7th, 2013

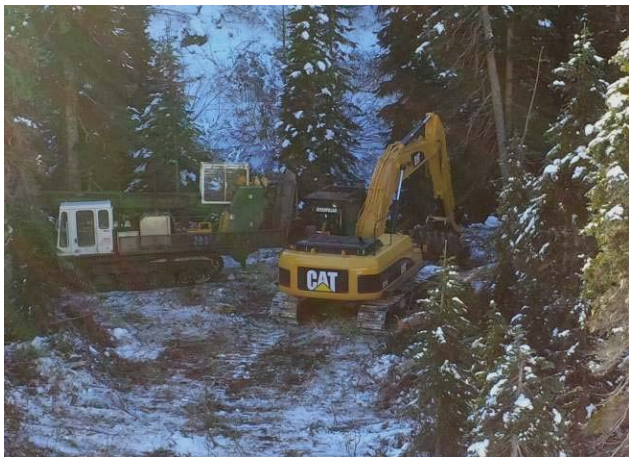
- Snow plowing and sanding of the FSR, drill site preparation, and borehole drilling on the north and south bank of the Lillooet River was completed at the future intake location ([Photo 1](#)) during this monitoring period.
- All trees within the powerhouse footprint were hand-felled, test pits were dug and backfilled, and a drill pad was prepared, at the future powerhouse location during this monitoring period.

Photo 1. Excavator and drilling equipment operation on the north (left) bank on the ULRHEF intake (Dec 3, 2013).

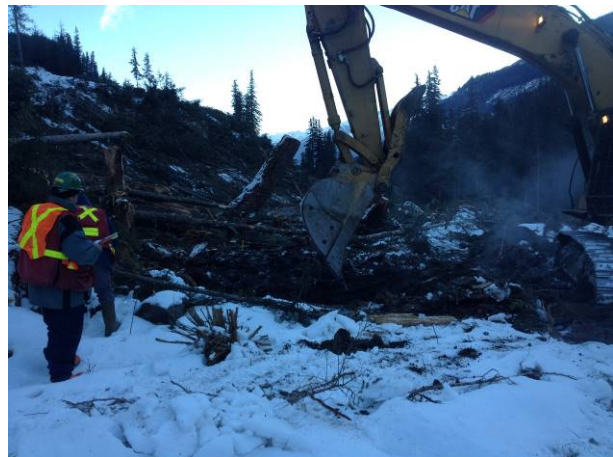
- An archeological monitor was present for all investigative works which included excavation activities for test pits within 50m of the identified archeology site in the vicinity of the future powerhouse location.
- Prior to plowing snow or working within 500m of UWR habitats (UL11, UL19, and Migration Corridor), and after confirmation of conclusion of the two-week Mountain Goat shutdown, noise monitoring equipment was installed (December 2) to monitor background noise levels and exceedances of the 75dbA noise level maximum resulting from construction/investigative drilling activities. Noise monitoring data will be summarized in the forthcoming report from BKL noise monitoring consultants. No adaptive noise mitigation strategies have been implemented at this time.

Photo 2. Test pitting at the ULRHEF powerhouse within 50m of the identified archeological site, in the presence of the archeology monitor (Dec 6, 2013).

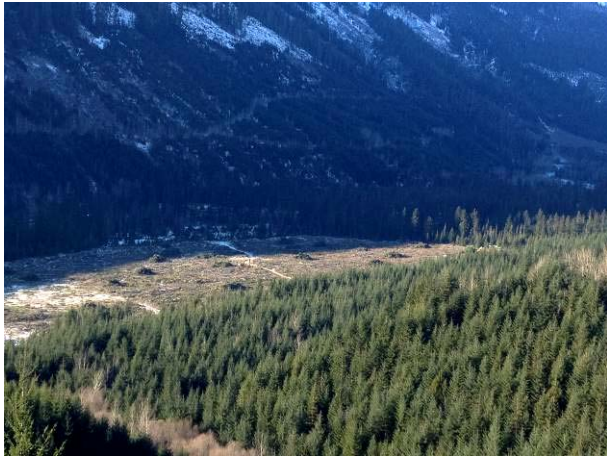
- Excavators continued to pile slash and fallen trees at the future construction camp location this week. All works were conducted within the clearing boundary ([Photo 3](#)).
- Grubbing and grading of the construction camp location began following a kick-off meeting on December 7th, 2013 ([Photo 4](#)).

Photo 3. Piles of trees within the future construction camp location (Dec 7, 2013).

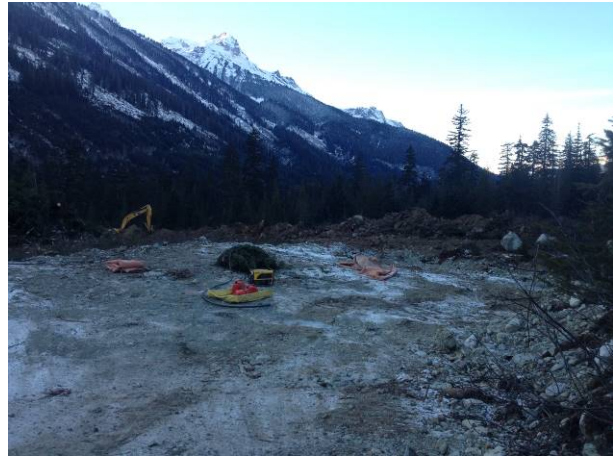
Photo 4. Grubbing began at the future construction camp location (Dec 7, 2013).

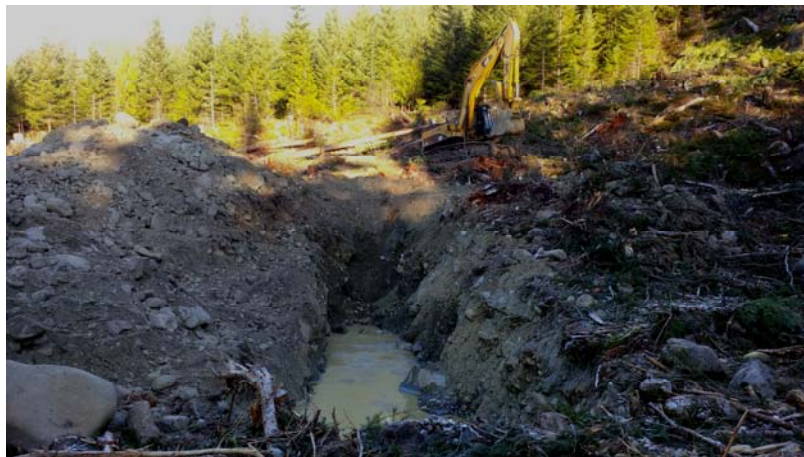
- Test pits and a trench were excavated within the footprint of the Boulder Creek Powerhouse facilities this week ([Photo 5](#)). Investigations were performed to characterize the existing material and confirm the presence of bedrock. All materials were replaced upon completion of the excavation and natural ground contours were restored to the greatest extent possible.

Photo 5. Test trench at the BDRHEF powerhouse location (Dec 3, 2013).

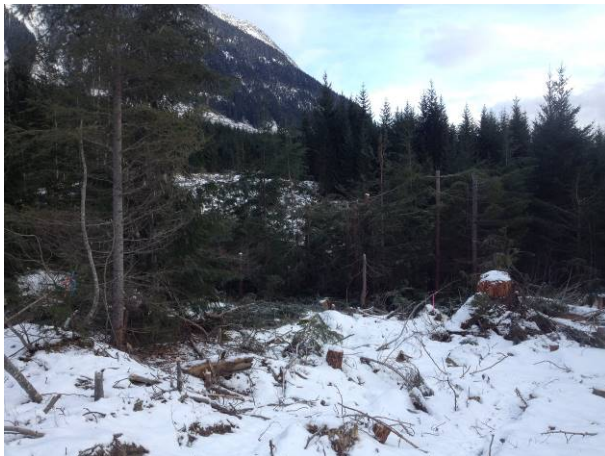
- Tree topping within the Stream 27A RVMA began during this reporting period ([Photo 6](#)).
- One day of minor construction works to construct a foot trail and helicopter landing pad at Pole structure 142 was completed on December 5th, 2013. Temporary minor works (trail construction and helicopter pads) in Segment 6 commenced, and was subsequently suspended due to unfavorable site/weather conditions and will resume in 2014. No trail was cleared.

Photo 6. Conditions of the Stream 27A RVMA (Dec 6, 2013).

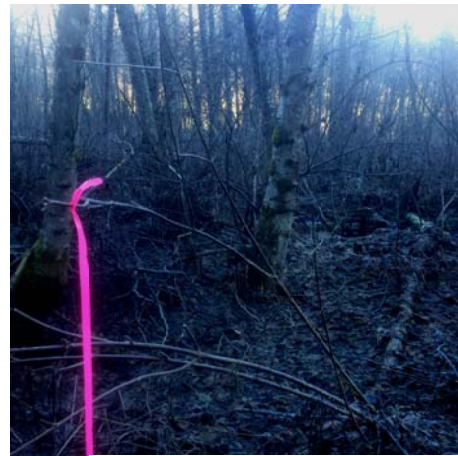
Photo 7. Transect location flagged within the MWRFMZ (Dec 4, 2013).
