Upper Lillooet Hydro Project

Weekly Environmental Monitoring Report #13

Reporting Period: December 8th – December 14th, 2013

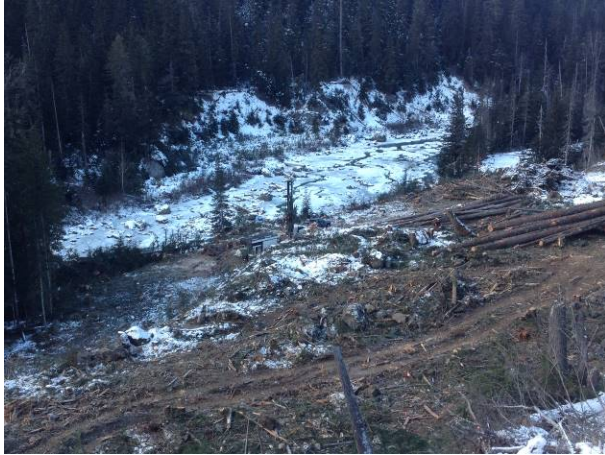
- Borehole drilling within the powerhouse footprint was completed during this monitoring period ([Photo 1](#)).
- Two boreholes were drilled and logged near the ULRHEF intake during this reporting period. The first was completed on the south bank of the Lillooet River at the future intake location. The second was completed on the access road immediate north of the future intake location ([Photo 2](#)).

Photo 1. Drilling equipment in operation and site conditions at the ULRHEF powerhouse (Dec 8, 2013).

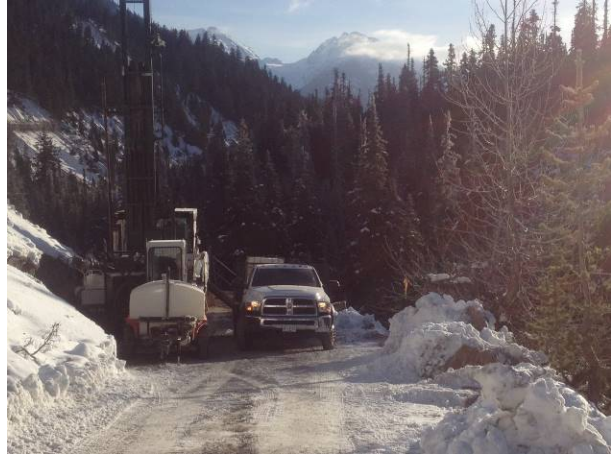
Photo 2. Borehole drilling on the access road north of the ULRHEF intake. (Dec 9, 2013).

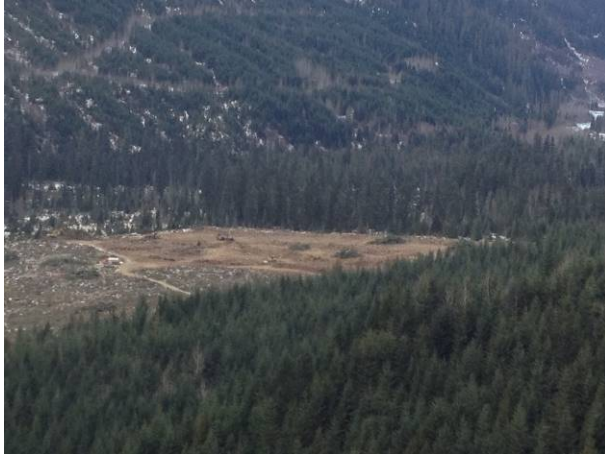
- Excavators continued to pile slash and fallen trees at the future construction camp location this week. All works were conducted within the clearing boundary.
- Grubbing and grading of the construction camp continued during this monitoring period ([Photo 3](#)).
- Organic soils stripped during the grubbing works were temporarily piled in rows, and once the organic material was sorted from large rocks, it was used to construct a visual/auditory berm. The berm was compacted in lifts of material with a dozer and by running over the surface with rock trucks. This berm will separate the future camp location from the works yard location ([Photo 4](#)).

Photo 3. Overview of grubbing activities completed at the future construction camp location (Dec 10, 2013).

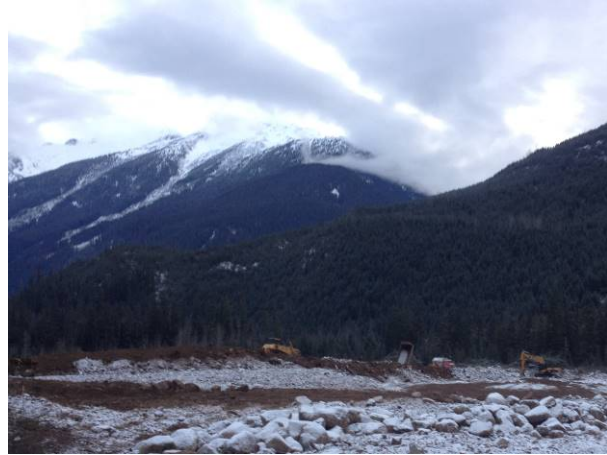
Photo 4. Construction of the visual/auditory berm at the future construction camp location. (Dec 11, 2013).

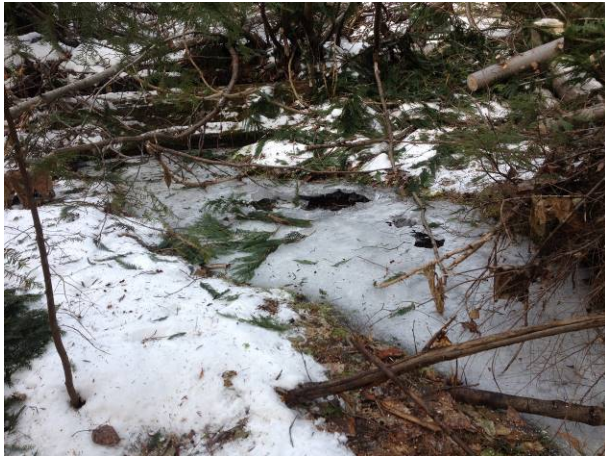
- Tree topping within the Stream 27A RVMA and the Stream 30A RVMA was completed during this reporting period ([Photo 6 & 7](#)).

Photo 6. Conditions of Stream 27A following removal of all slash and debris from within the channel, which was frozen over on Dec 9, 2013.

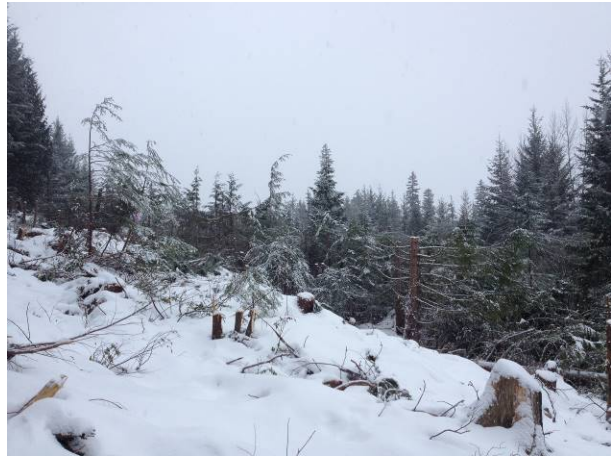
- A review of the clearing prescription was performed prior to tree topping within the Stream 30A RVMA. Fallers used bio-degradable bar/chain oil when working within 30m of Stream 30A. No environmental concerns were noted during topping activities.

Photo 7. Conditions on the Stream 30A RVMA following completion of tree topping activities (Dec 12, 2013).
