# Upper Lillooet Hydro Project

## Weekly Environmental Monitoring Report #21

**Reporting Period: May 11<sup>th</sup> – May 17<sup>th</sup>, 2014**

Upper Lillooet River Hydroelectric Facility (Water File No. 2002561, Water licence No. C130613),  
Boulder Creek Hydroelectric Facility (Water File No. 2003049, Water licence No. C129969) &  
Transmission Line (TX Line)

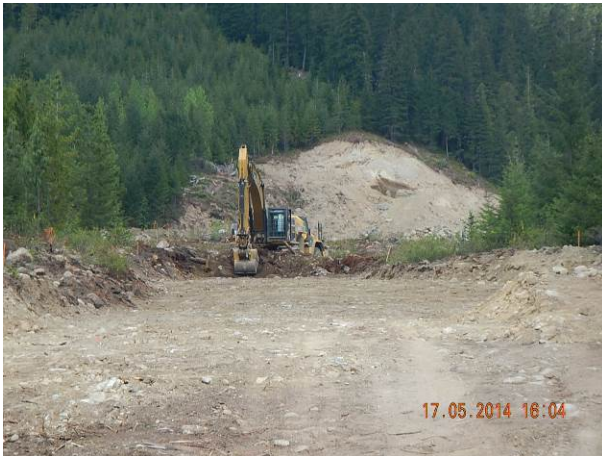
- Remaining trees at the BDRHEF Portal location and along the Powerhouse Access Road within authorized areas were cleared on May 12<sup>th</sup> (OLTC L49816; Amendment 2) following the completion of a fourth AMBNS (performed by Ecofish, May 12<sup>th</sup>). Merchantable timber and woody debris was removed on May 13<sup>th</sup> and stripping and grubbing of newly cleared areas began. Bulk excavation began following stripping and grubbing of organic material, and continued for the remainder of the week at the portal location. Rough grading on the access road was completed in conjunction with the bulk excavation works and was completed on May 17<sup>th</sup>.

Photo 1. Rough grading of the BDRHEF powerhouse access road works. The stripped and grubbed portal location can be seen in the background (May 17, 2014).

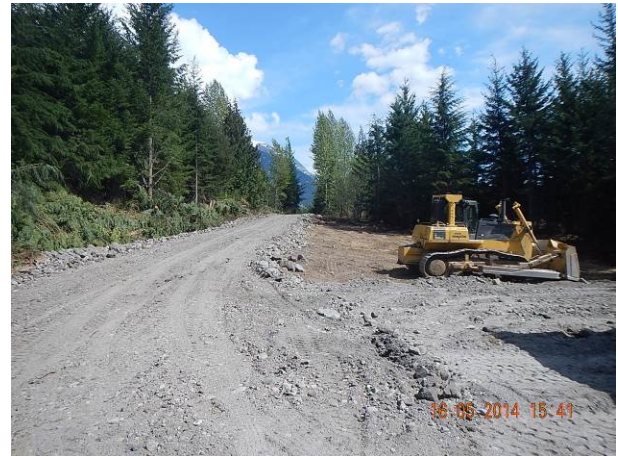
- Clearing of the Explosive Magazine area began and was completed on May 13<sup>th</sup>, following a pre-work meeting and review of the results of the AMBNS. Re-enforcement of the log-box culvert over Stream 9 began and was completed prior to beginning stripping and grubbing activities, which involved hauling over the log-box culvert. The re-enforcement included installation of geo-textile fabric below steel road plates and placement and compaction of road surface fill. Stripping and grubbing spoil material was hauled to the nearby spoil area identified in the work plan. The road surfacing material was hauled to site and graded prior to the installation of the explosive magazine on May 16<sup>th</sup>. A lockable gate was installed prior to storing explosives and detonation materials onsite as per the Magazine Licence.

Photo 2. Upgraded section of the access road (01/2.1) to the Explosive magazine area. (May 16, 2014).

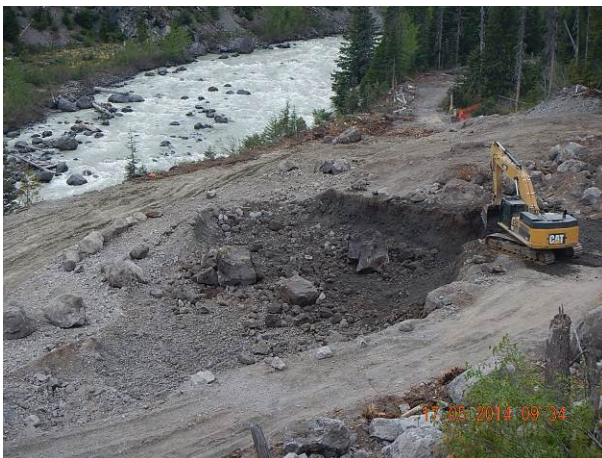
- Bench excavation at the ULRHEF began outside of 30m from the Lillooet River on May 15<sup>th</sup>. Material from the excavation was used on road surfaces of the FSR, and the Explosive Magazine Access Road. No environmental concerns were noted.

**Photo 3. Bench excavation at the ULRHEF powerhouse area. (May 17, 2014).**

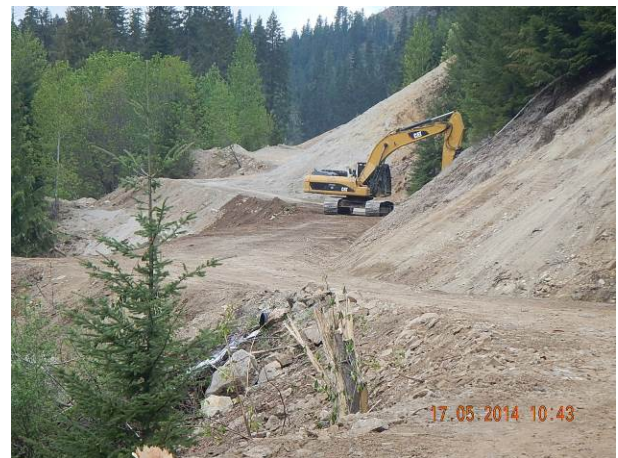
- Bulk excavation and road works occurred throughout the reporting period on the eastern portion of the road alignment, outside of the Mountain Goat Migration Corridor 200m buffer. Drainage ditch installation occurred in the dry, and no additional vegetation clearing occurred as part of the works. Work within the Mountain Goat Migration Corridor and 200m buffer will begin once the minimum 2-week spring shutdown is lifted. No environmental concerns were noted.

**Photo 4. Road construction along the Truckwash Creek Bypass road. (May 17, 2014).**

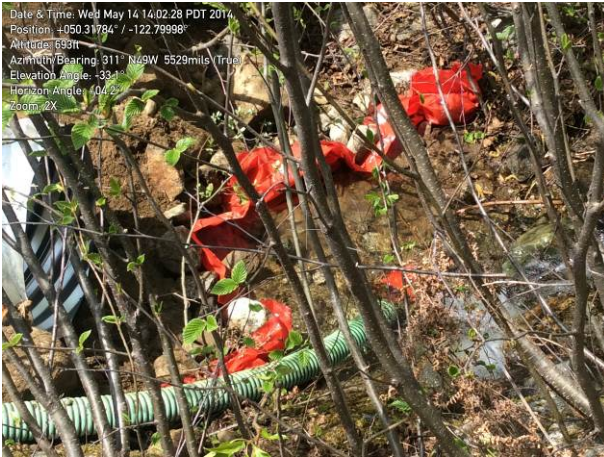
- Culvert installation works (Stream 35b) were performed in the dry by using a pump to divert water around the work area. The IEM was onsite for the duration of the culvert installation works to monitor activities and document adherence to water quality guidelines. Water quality results are summarized below. No water quality concerns were noted

**Photo 5. Intake hose installed to divert stream 35b around the active work area during the culvert installation (May 14, 2014).**

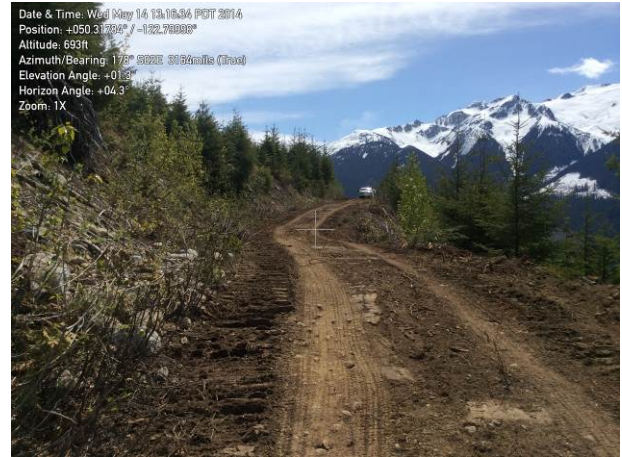
- Road upgrade work began on May 13<sup>th</sup> following a pre-work site meeting on May 12<sup>th</sup>. The pre-work meeting was conducted to review work methods for drainage upgrades (cross drains and ditch improvements) verses culvert installations within identified watercourses. Cross drains and ditch upgrades were performed within NCDs to eliminate surface flows over the access roads. One permanent culvert was installed on May 14<sup>th</sup> to convey Stream 35B (non-fish bearing) through the access road (Pebble Branch D.1).

**Photo 6. Pebble Branch D.1 access road following access road upgrades (May 14, 2014).**
