Upper Lillooet Hydro Project

Weekly Environmental Monitoring Report #22

Reporting Period: May 18th – May 24th, 2014

Upper Lillooet River Hydroelectric Facility (Water File No. 2002561, Water licence No. C130613),
Boulder Creek Hydroelectric Facility (Water File No. 2003049, Water licence No. C129969) &
Transmission Line (TX Line)

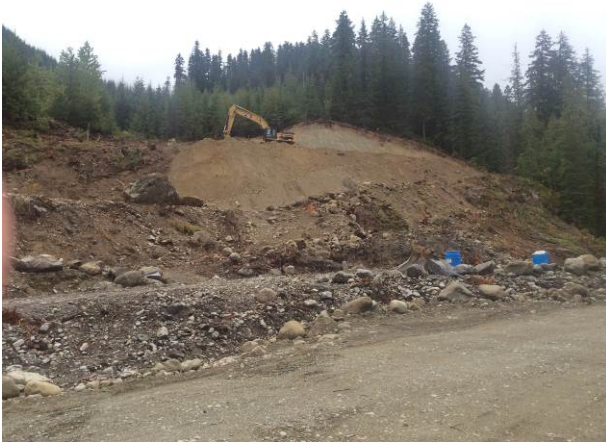
- Bulk excavation of the access road alignment and portal location began following stripping and grubbing of organic material, and continued for the remainder of the week at the portal location. Once the access road alignment was finalized an access road was constructed to the Boulder Creek water withdrawal site authorized in Short Term Water Use Approval (No.A2006123). The 3" intake pump was outfitted with a 1/4" mesh fish screen and was powered by a generator. Water was used by a water truck for dust suppression along the FSR and construction access roads.

Photo 1. Bulk excavation of the BDRHEF downstream portal location (May 23, 2014).

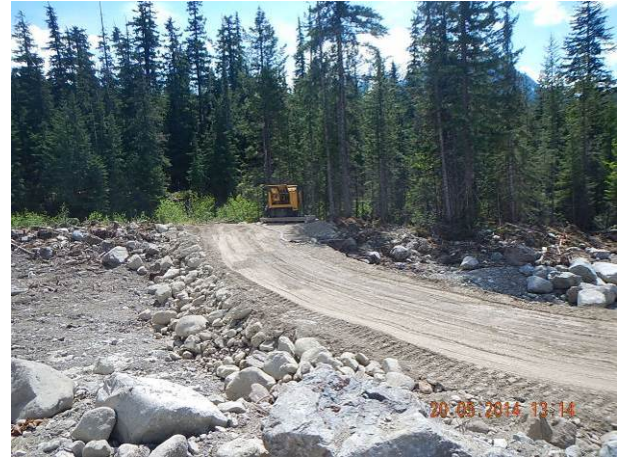
Photo 2. Road used by the water truck to access the water extraction point on Boulder Creek. (May 20, 2014).

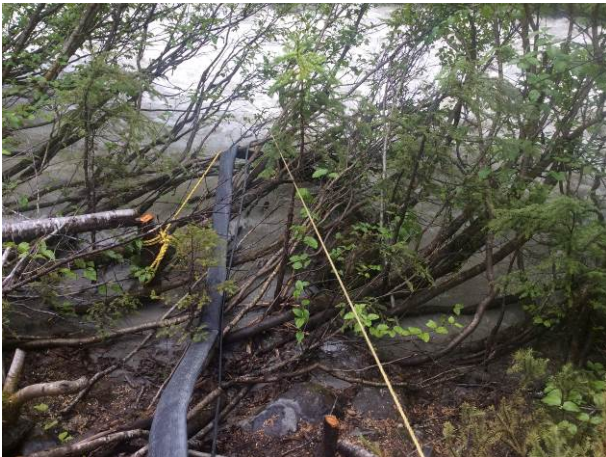
- The IEM was onsite to monitor the construction of the road accessing the water extraction point. The pump was installed in Boulder Creek and the inlet was outfitted with 1/4" wire mesh. The generator was double walled and stored within secondary containment.
- No blasting occurred in the area this week and no water quality concerns were noted.
- On May 23rd, 2014, the IEM was notified via email of a tree felled containing a potentially active bird nest at the BDRHEF powerhouse access road (EIR#001). The environmental incident has been included in the ITM as ULR#003. Further details of the incident, potential environmental impacts, action items and targeted completion dates will be appended to the WEMR and updated in the ITM once the EIR is finalized by CRT-ebc and reviewed/accepted by the IEM.

Photo 3. Boulder Creek water withdrawal site, 3" intake pump was outfitted with a 1/4" mesh fish screen (May 23, 2014).

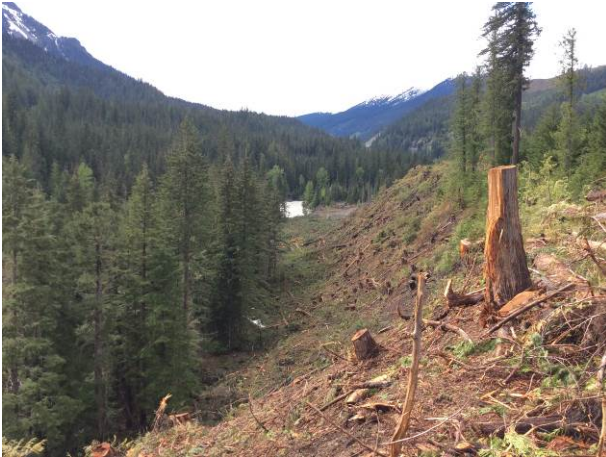
- Clearing of the powerhouse access road resumed on May 20th following a review of the AMBNS results and a field visit from the Lil'wat Nation and Arrowstone Consulting, who confirmed that the site did not contain a potentially significant archaeological site. Following the completion of hand falling in the area, Mumlegs began yarding and decking merchantable timber road side along the FSR.
- Bench excavation at the ULRHEF continued outside of 30m from the Lillooet River this week. Material from the excavation was used on road surfaces of the FSR, and the Explosive Magazine Access Road. No environmental concerns were noted.

Photo 4. Results of clearing along the ULRHEF powerhouse access road. (May 23, 2014).

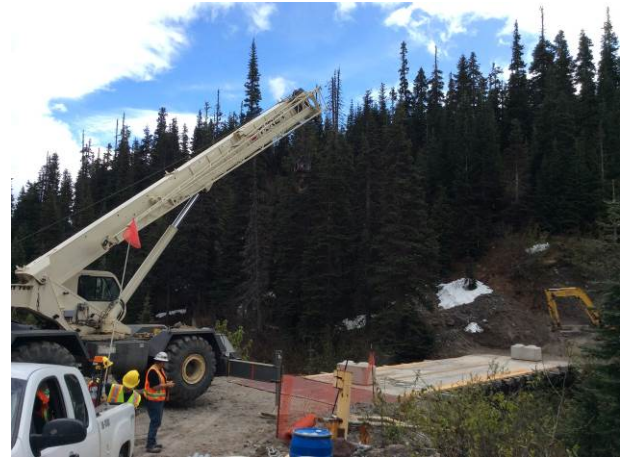
- Re-enforcement of the bridge deck located at 48km of the non-status road (the Keyhole Bridge), began on May 23rd, following the kick-off meeting.

Photo 5. Keyhole Bridge re-enforcement works. (May 24, 2014).

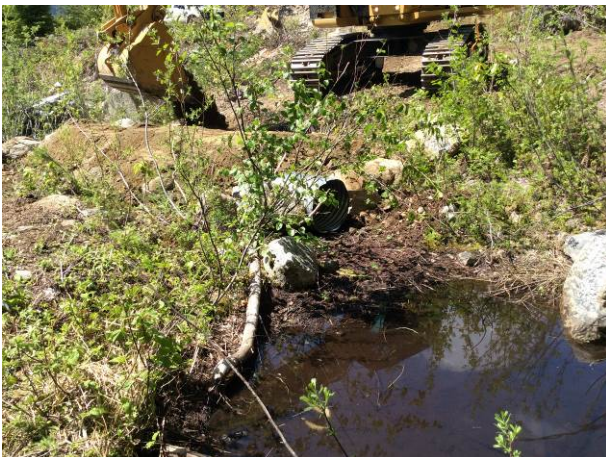
- Culvert installation works were performed in the dry by using a pump to divert water around the work area. The IEM was onsite for the duration of the culvert installation works to monitor activities and document adherence to water quality guidelines. Water quality results are summarized below. No water quality concerns were noted

Photo 6. Dewatering of the work area during the culvert installation; Pebble D.1 Branch road (May 20, 2014).

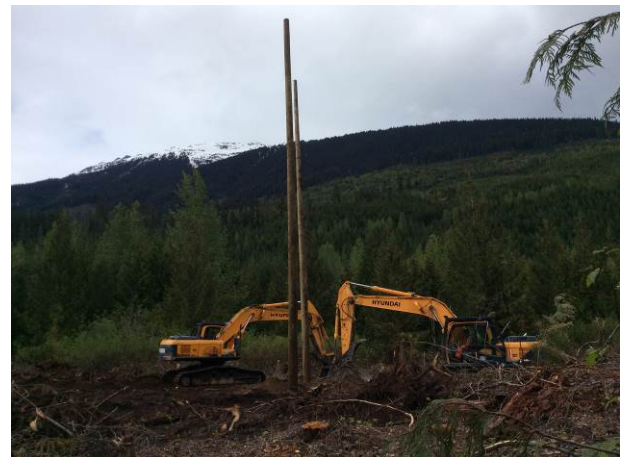
- Pole installation and dressing began in Segments 1 and 2 this week. Temporary access tracks to the pole locations were constructed. No environmental concerns were noted.

Photo 7. Pole installation work in Segment 1 (May 23, 2014).
