Upper Lillooet Hydro Project

Weekly Environmental Monitoring Report #26

Reporting Period: June 15th – June 21st, 2014

Upper Lillooet River Hydroelectric Facility (Water File No. 2002561, Water licence No. C130613),
Boulder Creek Hydroelectric Facility (Water File No. 2003049, Water licence No. C129969) &
Transmission Line (TX Line)

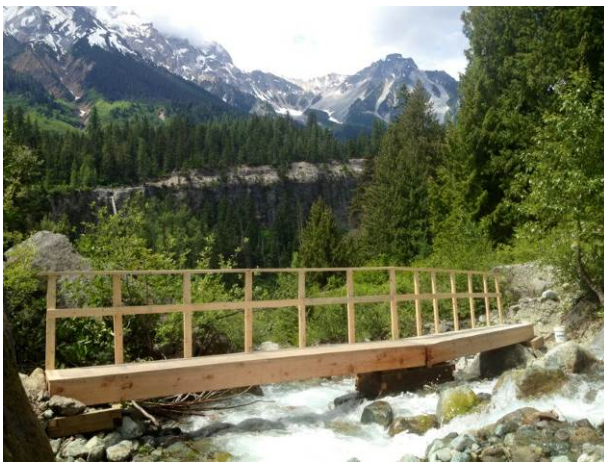
- Construction of the Upper Lillooet River Trail was complete on June 19th. Trail work included minor brushing, clearing a foot path with hand tools and the construction of a temporary footbridge over Truckwash Creek (Photo 1). No environmental concerns were noted.

Photo 1. Temporary Truckwash Creek crossing (June 19, 2014).

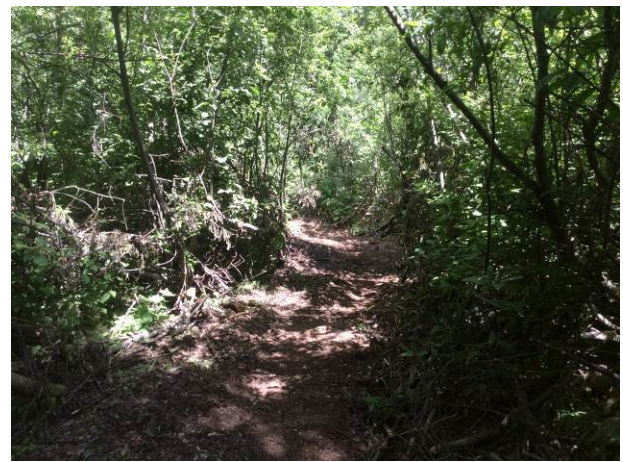
- The IEM completed an AMBNS (June 17th) prior to the clearing of a foot path through understory vegetation between the 42.5km parking area and the Upper Lillooet Trail head. The IEM determined that a reduced survey effort was applicable at this location, as minimal understory vegetation was slated for clearing and detectability of nests in the area was high given the vegetation type. No active nests or nesting activities were observed, and permission to complete brushing and foot path construction was granted following the survey (Photo 2).

Photo 2. Brushing of trail between 42.5km parking area and trail head completed on June 18th. No trees were felled.

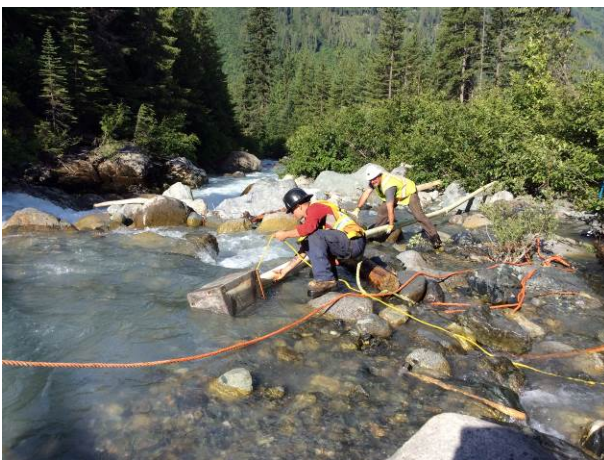
- The gravity fed water diversion system was installed under IEM supervision and in accordance with Short Term Water Use Approval (No.A2006123). The intake of the system was fitted with an intake end-of-pipe fish exclusion screen according to specifications in the DFO guidelines (Photo 3). The diversion flows through 6`` PVC pipes into a holding tank and overflow is directed back into Boulder Creek through an outlet hose. No fish screen is installed on the outlet hose as it is placed outside of the wetted perimeter and the risk of fish access is currently nil. During commissioning of the system, overflow water was directed to a vegetated area until the system was flushed and water quality was recorded to be within allowable limits. Water is extracted from the holding tank via a pump and will be used for tunnel drilling activities. No environmental concerns were noted.

Photo 3. Installing the gravity-fed water diversion in Boulder Creek (June 21, 2014).

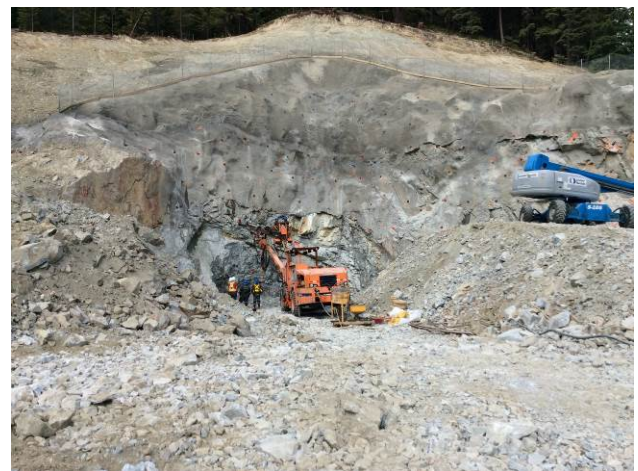
- The drilling/blasting of the boulder portal rock face was completed on June 15th.
- Shotcrete and rock bolt stabilization of the lower sections of the downstream tunnel portal rock face began this week (Photo 4).
- Installation of a gravity-fed water diversion through a holding tank began on June 20th and was completed on June 21st.
- Installation of a series of three settling ponds began this week. The ponds are being constructed to manage water quality from potential seepages that may be encountered during tunnelling activities and to manage excess process water.

Photo 4. Stabilization works at the tunnel portal. (June 21, 2014).

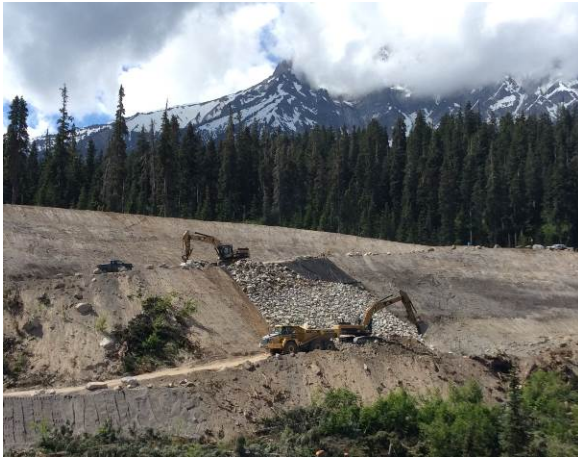
- The right bank diversion channel excavation continued this week. From June 16th – 18th CRT-ebc installed geo-textile fabric and rock riprap as a slope stabilization measure where a small seepage was encountered. No environmental concerns were noted (Photo 5).

Photo 5. Slope protection installed at the right bank diversion excavation (June 18, 2014).

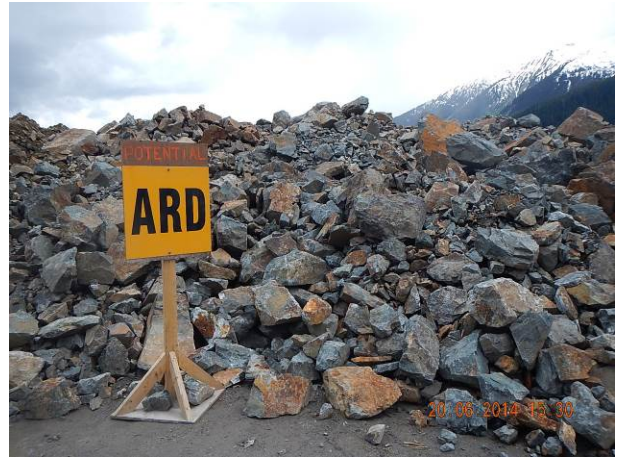
- On June 16th, Innergex informed the IEM that a stockpile containing ~2270m² of rock at the Truckwash west heading was tested according to the ARD/ML Monitoring and Control Plan and found to be potentially acid generating (PAG). The IEM will monitor run-off emanating from this stockpile and submit water quality samples for lab analysis on a monthly basis according to the ARD/ML management plan. No seepage or surface run-off from this stockpile has been observed to date (Photo 6).
- Noise monitoring stations were removed on June 16th, signalling the end of the spring noise monitoring requirement. The results are currently being analyzed and results will be communicated once the data has been reviewed. No Mountain

Photo 6. PAG stockpile at Truckwash Creek west heading (June 20, 2014).

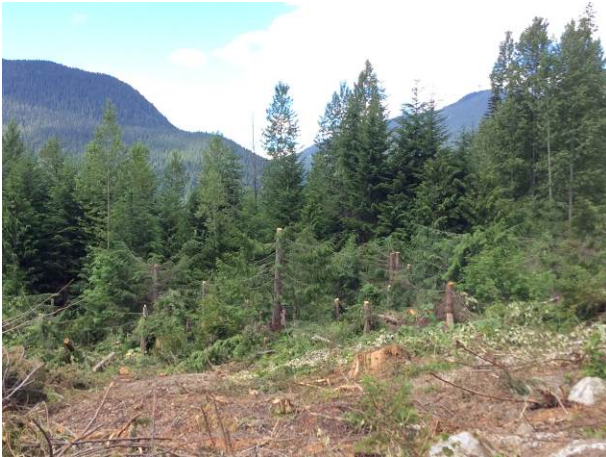
- Continued RVMA topping (Photo 7) in Segment 2.
- Pole installation and dressing continued in Segments 1 and 2 this week (Photo 8). Temporary access tracks to the pole locations were constructed. No environmental concerns were noted.

Photo 7. RVMA topping in Segment 2 (June 17, 2014).

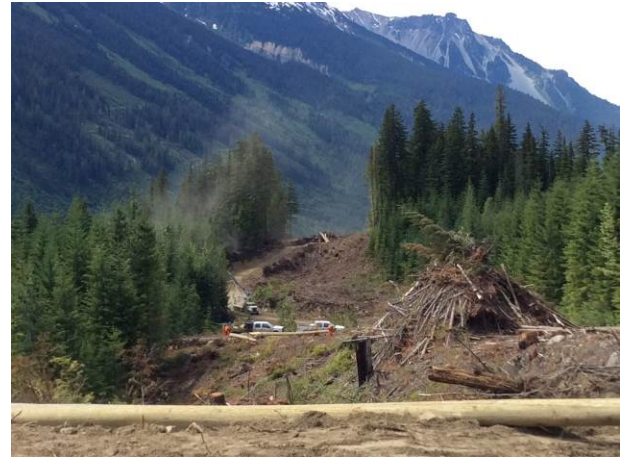
Photo 8. Pole installation work in Segment 2 (June 21, 2014).

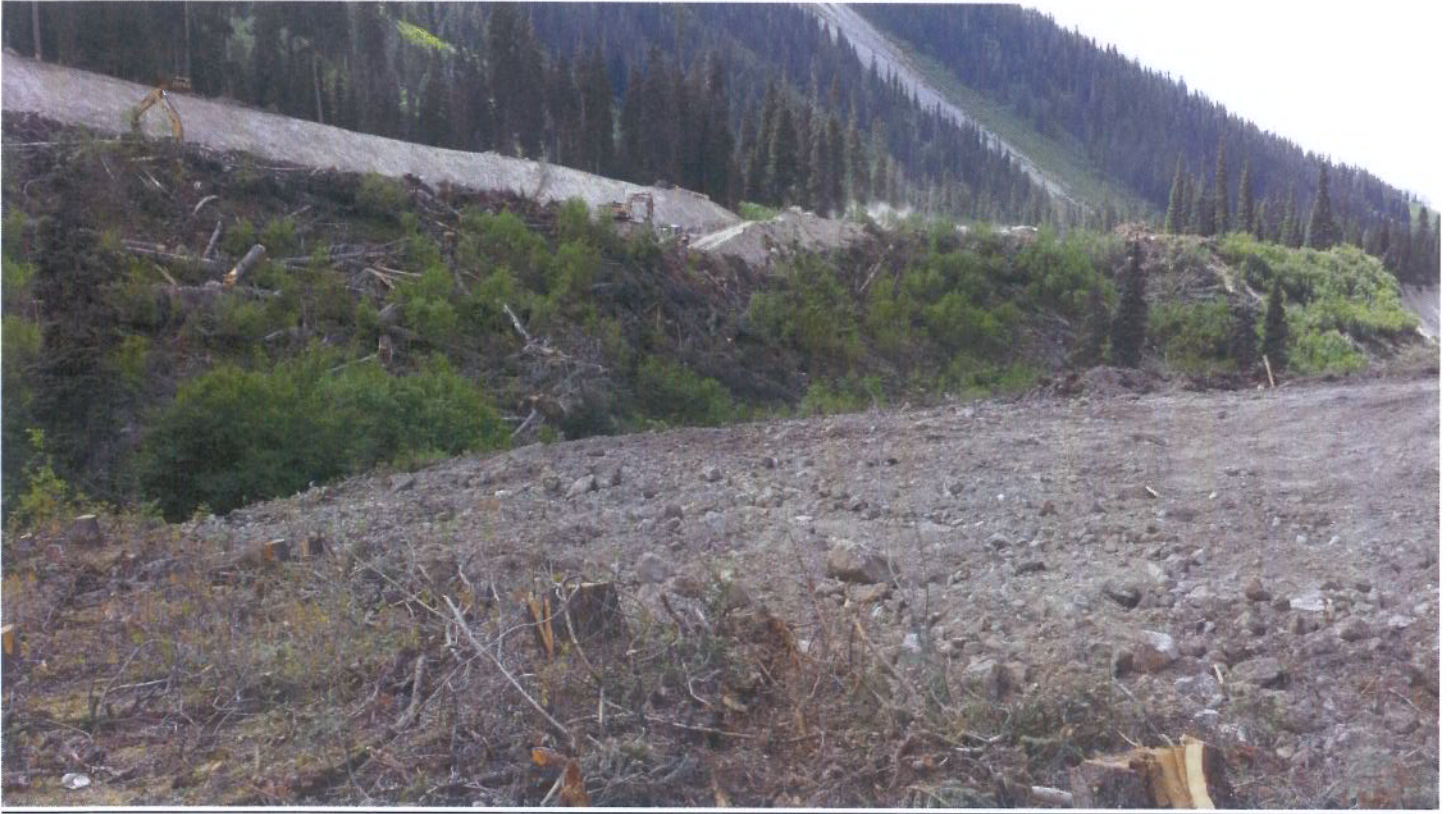
- On June 12th, grubbing & stripping of the ULR HEF intake (North; River Left) was carried out by CRT-ebc Superintendent (Roger Pelletier) and Foreman (Nicholas Grondin) without an approved workplan/LTC, without a kick-off meeting, and without notifying the IEM of works within the riparian area.
- On the same day at the end of shift (4:30pm), the IEM (Tom Hicks) observed the non-compliance and reported it to CRT-ebc (Ian McKeachie) via phone that night. There were no observed environmental impacts associated with the grubbing works, but CRT-ebc is aware that in this case the approval process and IEM notification protocol were improperly followed, and this has the potential to have environmental impacts.

- The cause is two-fold.
 - 1) The Provincial process overseen by the IE on behalf of MFLNRO was not followed, and
 - 2) The IEM was not notified of work occurring within the riparian area and was therefore not on site. No approved work plan was in place prior to the initiation of works by the Superintendent (Roger Pelletier) and Foremen (Nicholas Grondin), resulting in grubbing being completed prior to receiving formal approval.

Photo 1: Grubbed and stripped area at
Upper Lillooet River HEF Intake (North; River
Left)

4. CRT-ebc to prepare and submit a work plan for bulk excavation of the left bank for review and approval prior to resuming work on the left bank.

5. Issuance of LTC prior to resuming work on the left bank.
