# Upper Lillooet Hydro Project

## Weekly Environmental Monitoring Report #27

Reporting Period: June 22<sup>nd</sup> – June 28<sup>th</sup>, 2014

Upper Lillooet River Hydroelectric Facility (Water File No. 2002561, Water licence No. C130613),  
Boulder Creek Hydroelectric Facility (Water File No. 2003049, Water licence No. C129969) &  
Transmission Line (TX Line)

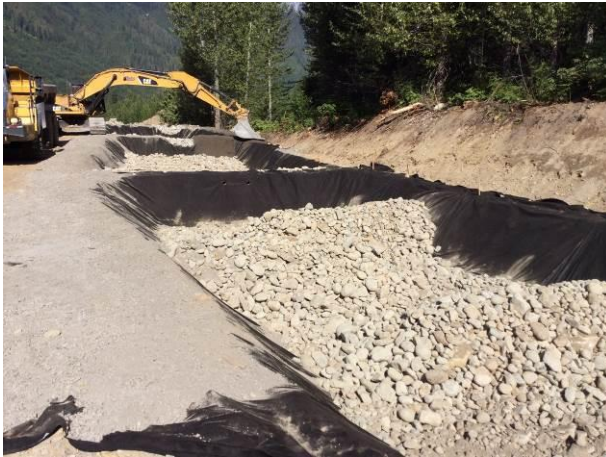
- The drilling/blasting of the boulder portal rock face continued this week.
- Shotcrete and rock bolt stabilization of the lower sections of the downstream tunnel portal rock face was completed and work began on stabilizing the tunnel portal entrance (Photo 2).
- Tunneling activities (including: drilling, blasting, excavation, rock bolts and shotcrete/mesh installation) began on June 22<sup>nd</sup>.
- Installation of a series of three settling ponds continued this week (Photo 1). The ponds are being constructed to manage water quality from potential seepages that may be encountered during tunnelling activities and to manage excess process water.

Photo 1. Installing the series of settling ponds at the BDRHEF downstream tunnel portal work area. (June 26, 2014).

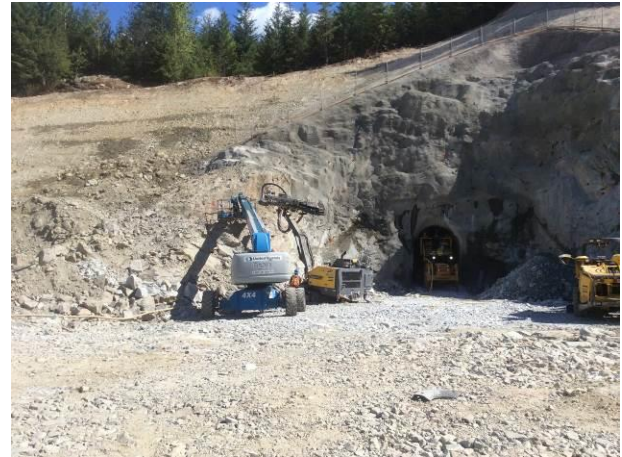
Photo 2. Rock bolt stabilization and tunneling works at the tunnel portal entrance. (June 26, 2014).

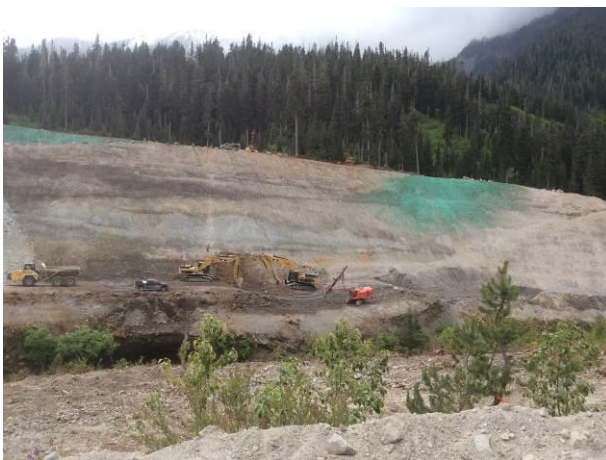
- The right bank diversion channel excavation continued this week. Hydro-seeding of the exposed cut-slopes with a legume free seed mix began on June 27<sup>th</sup> (Photo 3). No environmental concerns were noted.

**Photo 3. Excavation activities and hydro-seeding works at the ULRHEF intake diversion (June 27, 2014).**

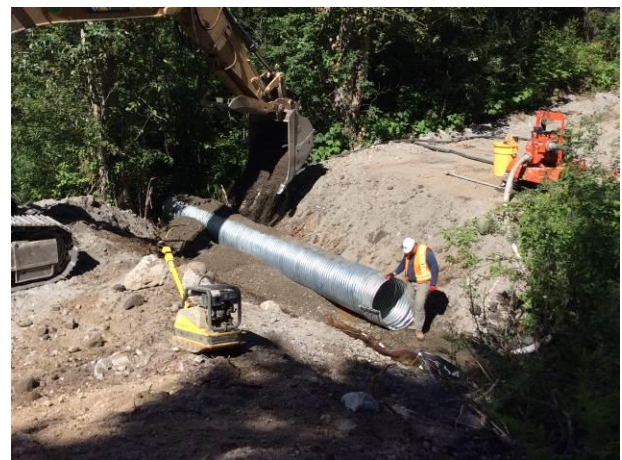
- Three culverts along the east heading were replaced following isolation of the work areas and Coastal Tailed Frog salvages. Coastal Tailed Frogs were salvaged by Ecofish according to conditions of the Wildlife Act Permit (SU14-95304). All works were completed under IEM supervision on June 22<sup>nd</sup>, 24<sup>th</sup>, and 25<sup>th</sup> (Photo 4).

- Water quality was monitored full-time during culvert installation works along the east heading of the Truckwash Creek Bypass road (See Water Quality Results Section). All works occurred in the dry by diverting water around the work area with pumps following Coastal Tailed Frog salvages. Short term turbidity exceedances were recorded during culvert commissioning works; however levels returned to within acceptable levels shortly after commissioning and no environmental incident occurred.

**Photo 4. Culvert installation works at the Truckwash Creek east heading (June 25, 2014).**

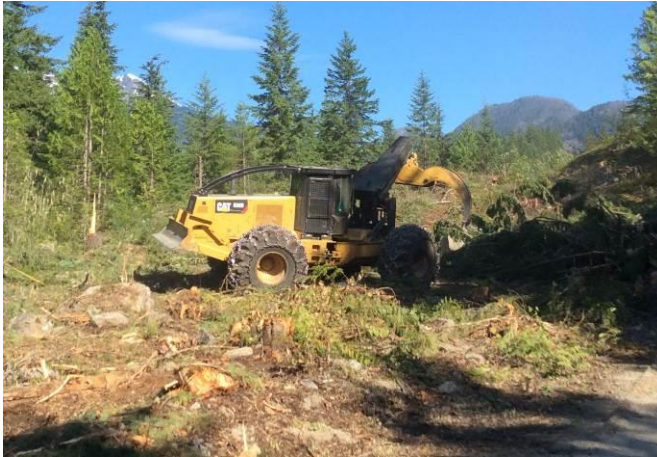
- Clearing occurred in Segment 3, 4, 5, and 10 following the completion of AMBNS (Photo 5).
- Access roads branching from the Lillooet River FSR were conducted in Segments 4, 5, & 10 this week.
- Clearing of helicopter access pads in Segment 6 has been completed; clearing of the Segment 6 right-of-way is currently on hold. Due to the steep terrain and access limitation, the IEM will conduct raptor monitoring from the north side of the Lillooet River from a good vantage point located at 17km of the Lillooet River FSR, when work resumes.

**Photo 5. Decking merchantable timber roadside in Segment 10 (June 23, 2014).**

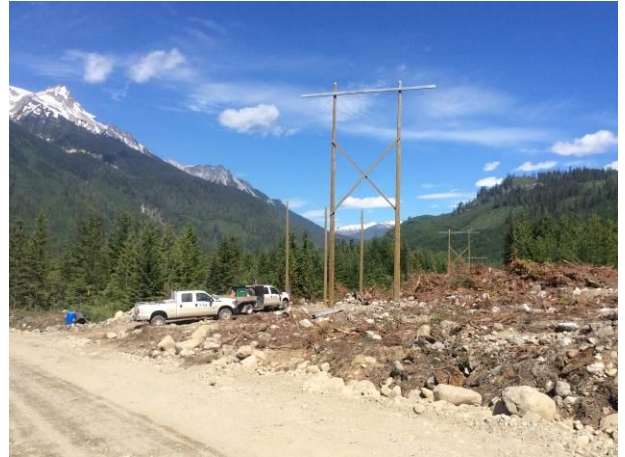
- Pole installation and dressing continued in Segments 1 and 2 this week (Photo 6). Temporary access tracks to the pole locations were constructed. No environmental concerns were noted.

**Photo 6. Pole installation work in Segment 1 (June 26, 2014).**

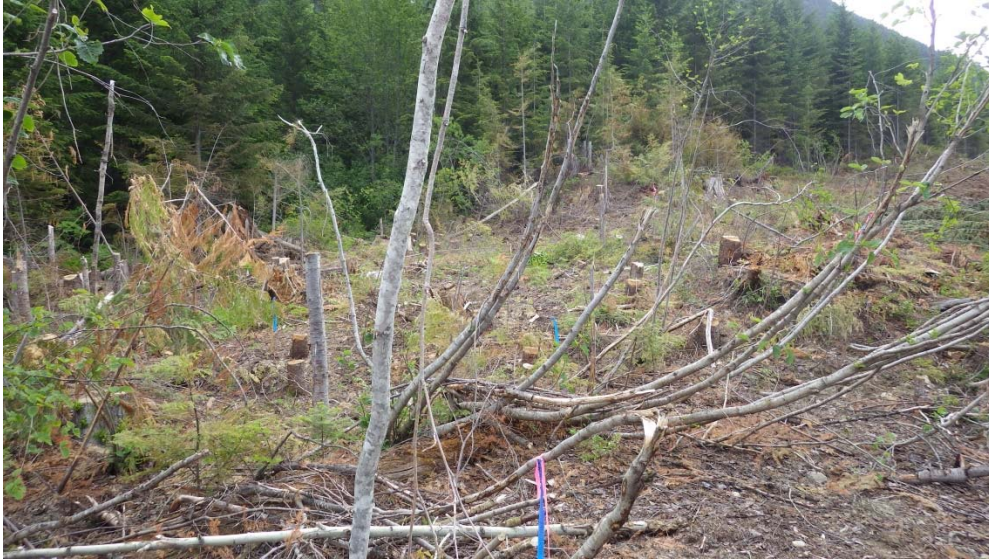
<input type="checkbox"/> Snow	
<b>Specific Incident Location:</b> Structure 30, located off of Pebble Main.									
<b>Description and Cause of Incident:</b>									
<u>Description:</u>									
<ul style="list-style-type: none"> <li>The Independent Environmental Monitor (IEM) was not given notice for works carried out within the Riparian Vegetation Management Area (RVMA) associated with stream 30A. As a result, works within this RVMA were carried out without IEM monitoring.</li> </ul>

<u>Cause:</u>									
<ul style="list-style-type: none"> <li>Line crews mistakenly interpreted an email sent on June 23 describing mitigation measures required when working close to, or within, an RVMA as indicating that it was OK to begin works, as long as mitigation steps were followed. Ultimately, the required process of providing notice to the IEM prior to any works within an RVMA was not followed.</li> </ul>									
<b>Incident Witness:</b> Brad Henderson and Kevin Solmundson									
<b>Were there any Potential Environmental impacts as a result of the incident?</b> (e.g., surface contamination, storm sewers, or fish/wildlife mortalities)							<b>Yes</b> <input type="checkbox"/>	<b>None Observed</b> <input checked="" type="checkbox"/>	
<b>If Yes, please describe:</b>									
<b>Has Wildlife Salvage Protocol been followed?</b>							<b>Yes</b> <input type="checkbox"/>	<b>No</b> <input type="checkbox"/>	<b>N/A</b> <input checked="" type="checkbox"/>

**Photo 1.** Taken on June 10, 2014, from within RVMA, showing future locations of poles (indicated by wooden stakes with blue flagging) located near and within the RVMA boundary (indicated with pink and blue flagging hanging on vegetation).

- As per standard protocol, the IEM was included in the initial email communication of the mitigation measures associated with the RVMA works from WEL's Environmental Manager to the line crews and was satisfied with the prescriptions. Work planning communications have been sufficient to this point and no alteration to current protocol is recommended.
- All Westpark field personnel have been reminded of the strict requirement to provide a minimum of 48 hour notice prior to any works impacting an RVMA.

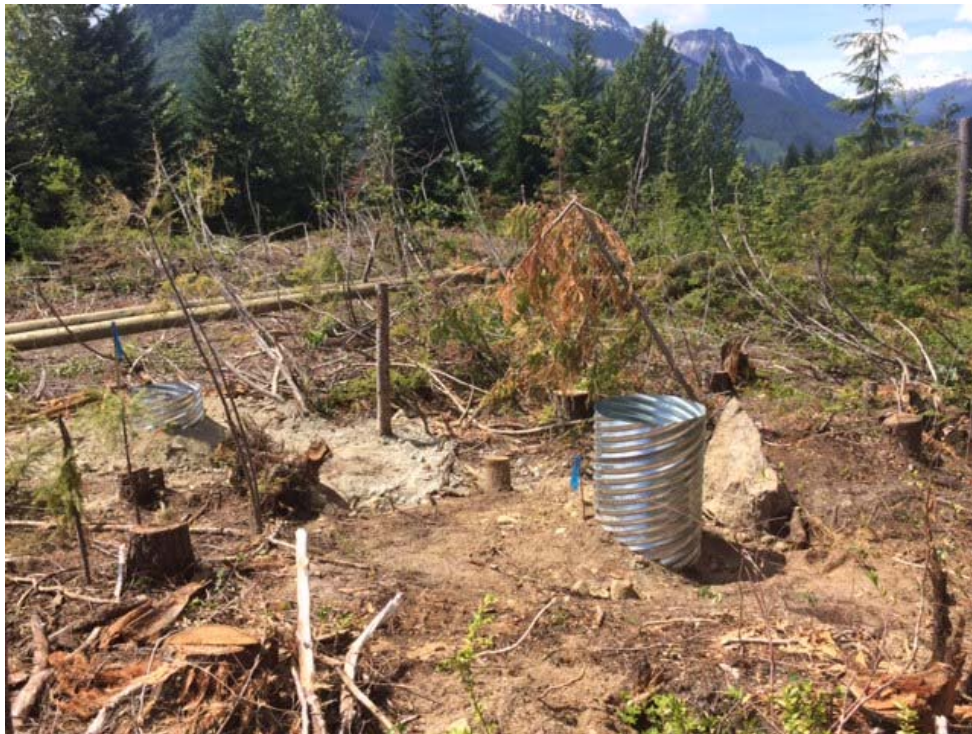
**Photo 2.** Taken on June 25, 2014, from outside of the RVMA, showing culvert liners installed along the edge and within the RVMA.
