Upper Lillooet Hydro Project

Weekly Environmental Monitoring Report #28

Reporting Period: June 29th – July 5th, 2014

Upper Lillooet River Hydroelectric Facility (Water File No. 2002561, Water licence No. C130613),
Boulder Creek Hydroelectric Facility (Water File No. 2003049, Water licence No. C129969) &
Transmission Line (TX Line)

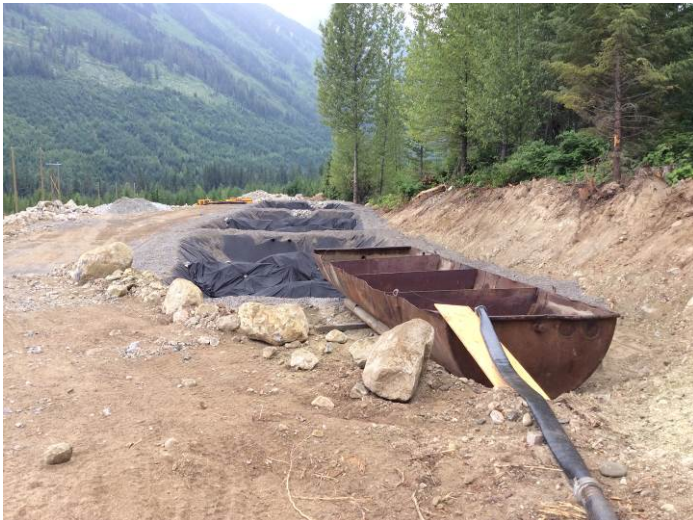
Photo 1. Series of three settling ponds at the BDRHEF downstream tunnel portal work area. (July 4, 2014).

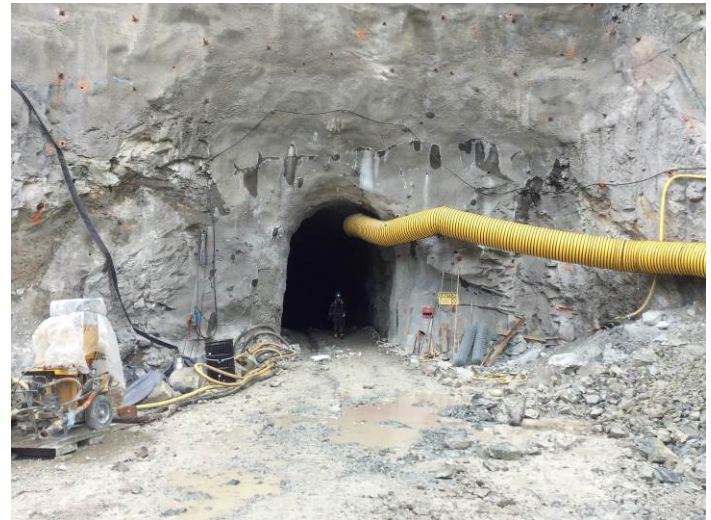
- Tunneling activities (including: drilling, blasting, excavation, rock bolts and shotcrete/mesh installation) continued (Photo 2).
- Installation of a series of three settling ponds was completed on July 2 (Photo 1). The ponds are being used to manage water quality from seepages encountered during tunnelling activities and to manage excess process water. Once the

Photo 2. Tunneling works at the tunnel portal entrance. (July 4, 2014).

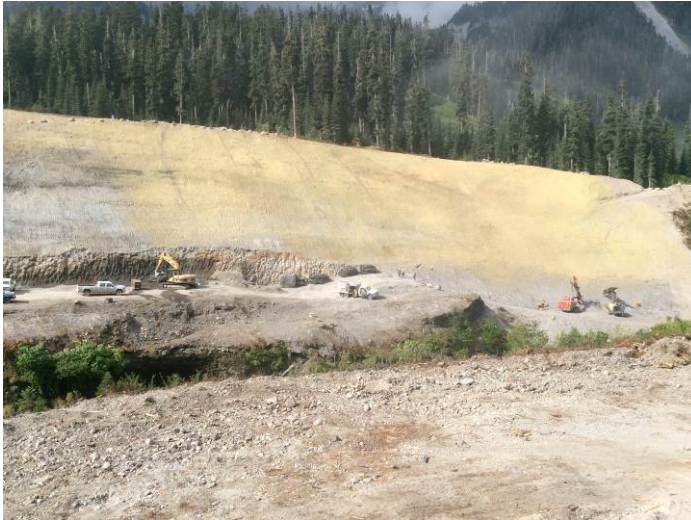
- The hydro-seeding of the exposed cut-slopes does not appear to have successfully re-vegetated the slope. This slope may need to be hydro-seeded again once suitable weather conditions are forecast or other interim mitigation measures will need to be employed prior to the rainy season (e.g. poly sheeting) (Photo 3).

Photo 3. Excavation activities and hydro-seeding that has not successfully germinated at the ULRHEF intake diversion (July 4, 2014).

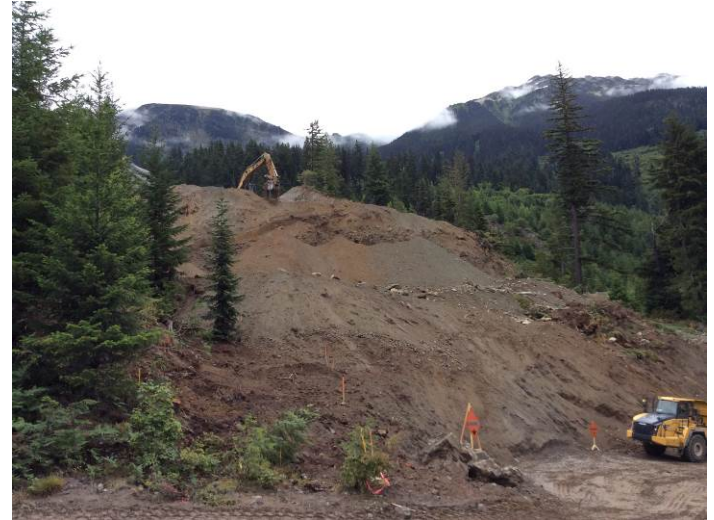
- Excavation of the ULRHEF portal continued throughout the week (Photo 4). Once bedrock was exposed, hand scaling and the installation of chain link mesh was completed to protect workers from falling rock. Spoil material were hauled to the lower spoil area. No environmental concerns were noted.

Photo 4. Excavation of the ULRHEF downstream portal (July 5, 2014).

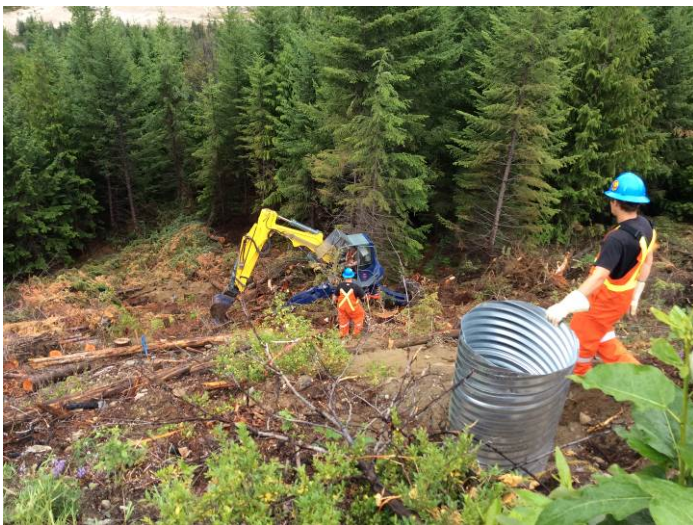
Photo 5. Pole foundation installation in Segment 2 with an excavator capable of working on steep slopes (July 5, 2014).

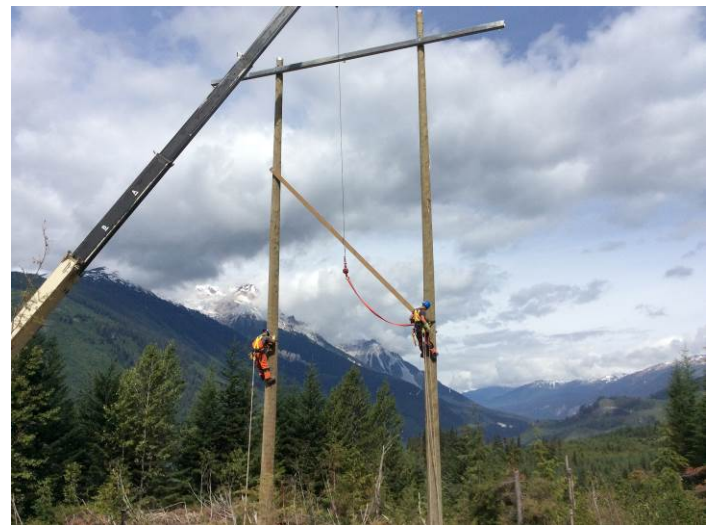
- Pole installation and dressing continued in Segments 1 and 2 this week (Photo 6). Temporary access tracks to the pole locations were constructed and pole foundations were installed on steep slopes using a specialized excavator (i.e. a spider hoe). No environmental concerns were noted.

Photo 6. Pole dressing work in Segment 2 (July 4, 2014).
