Upper Lillooet Hydro Project

Weekly Environmental Monitoring Report #30

Reporting Period: July 13th – July 19th, 2014

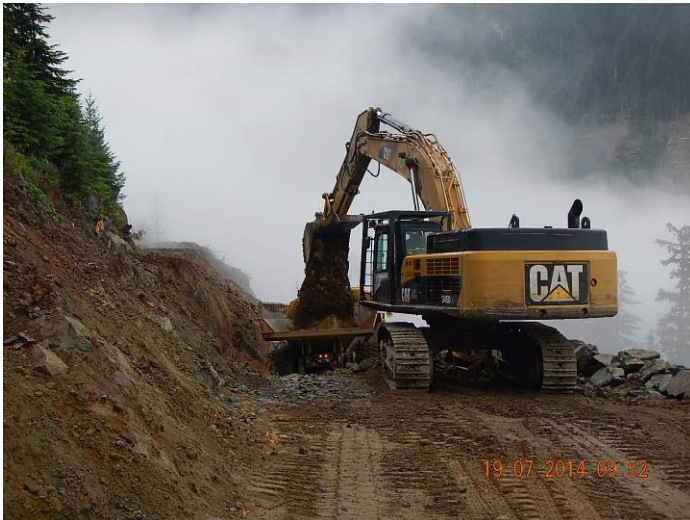
- Construction of the new section of the access road continued during this reporting period (Photo 1).
- Blasting of bedrock within the road alignment was completed using revised blasting mitigations as the use of blast mats was not feasible due to the steepness of the terrain.

Photo 1. Construction of the BDR intake access road. (July 19, 2014).

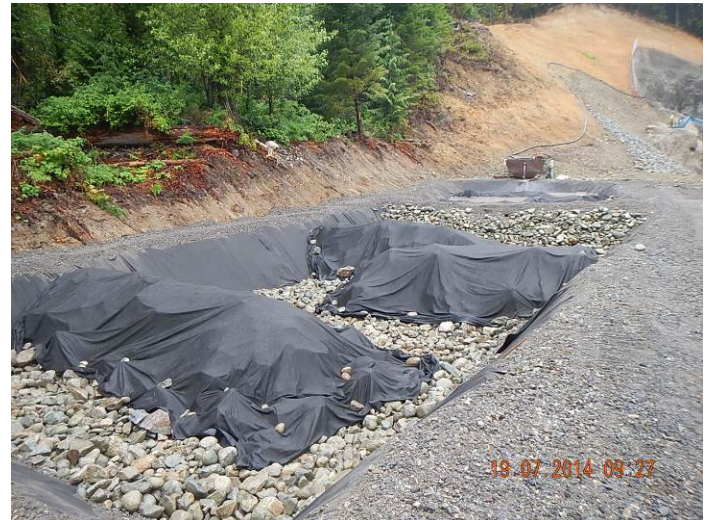
- Tunneling activities encountered seepage water during this monitoring period. The water flowed out of the tunnel, and was collected at the portal tunnel entrance in a sump. The water was then pumped from the sump to the oil/water separator, pH adjustment holding tank, and settlement ponds for treatment. The pH was monitored daily by the contractor and a CO₂ diffuser was used as necessary to ensure pH was within acceptable surface water quality guidelines (pH 6.5 – 9). No discharge from the treatment ponds occurred during this reporting period; therefore the IEM did not collect water quality results (Photo 2).

Photo 2. Dewatering of seepage from the tunneling activities was performed this week but the water has not yet reached the second pond treatment pond (July 19, 2014).

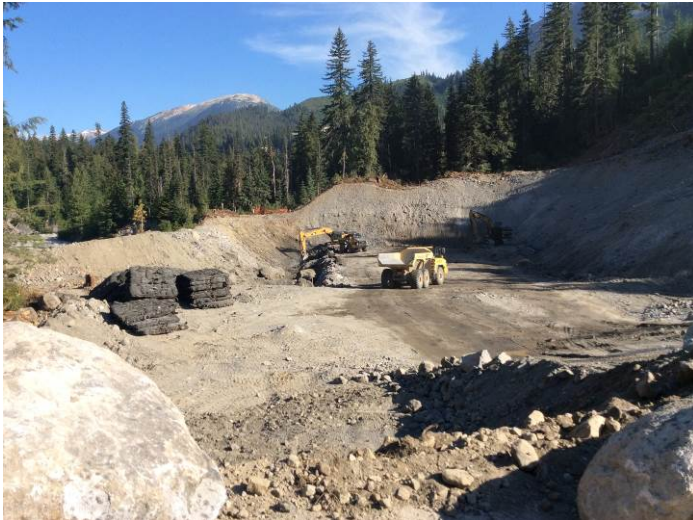
- Excavation at the ULRHEF powerhouse continued this week (Photo 3). The excavated material was dumped within the limits of the powerhouse spoil area and suitable material was separated and hauled to the crushing/screening plant located near 38km of the Lillooet River FSR. Blasting of exposed boulders occurred July 14th-18th. Blasts mats were used and approved blasting mitigation measures were deployed.

Photo 3. Excavation of the ULRHEF powerhouse footprint (July 15, 2014).

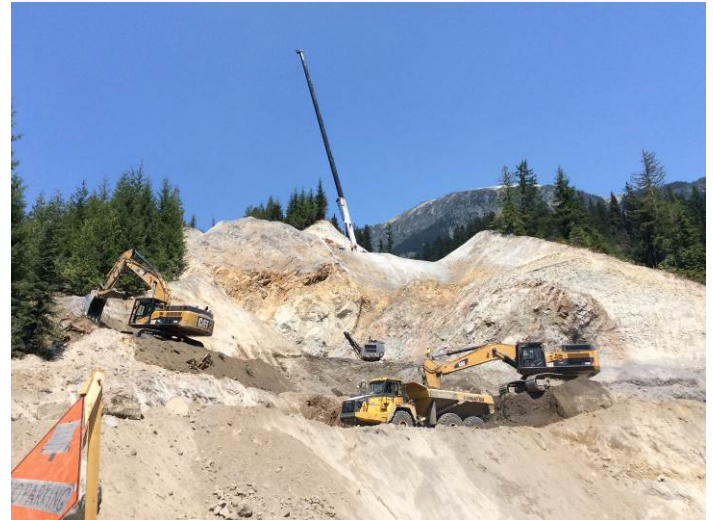
- Excavation of the ULRHEF portal continued throughout the week. Once bedrock was exposed, hand scaling and the installation of chain link mesh was completed to protect workers from falling rock. Overburden spoil material was hauled to the lower spoil area. No environmental concerns were noted.

Photo 4. Excavation and mesh installation at the ULRHEF downstream tunnel portal location (July 14, 2014).

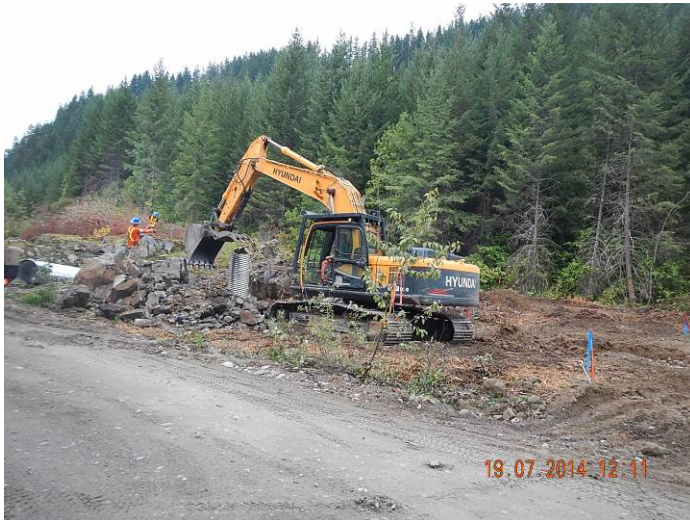
- Pole installation and dressing continued in Segment 5 and began in Segment 4 this week (Photo 5 & 6).
- Clearing occurred in Segment 4, within the Stream 80A RVMA following the completion of AMBNS.
- Access roads were upgraded/constructed in Segments 7 & 10 this week.

Photo 5. Pole foundation installation in Segment 5 (July 19, 2014).

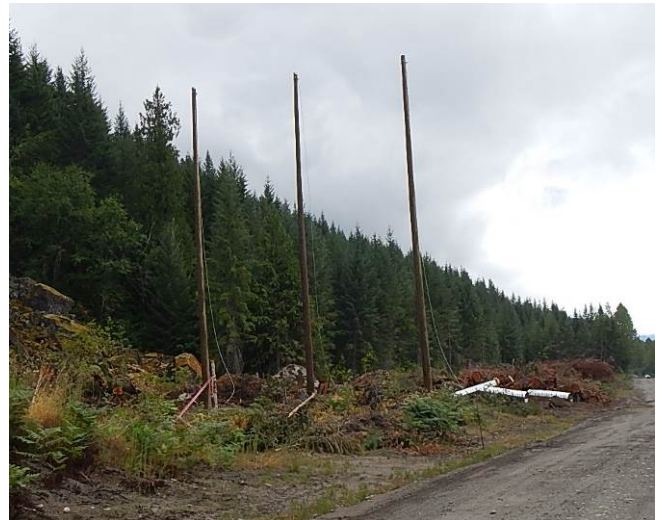
Photo 6. Poles installation underway in Segment 4 (July 19, 2014).
