Upper Lillooet Hydro Project

Weekly Environmental Monitoring Report #33

Reporting Period: August 3rd – August 9th, 2014

Upper Lillooet River Hydroelectric Facility (Water File No. 2002561, Water licence No. C130613), Boulder Creek Hydroelectric Facility (Water File No. 2003049, Water licence No. C129969) & Transmission Line (TX Line)

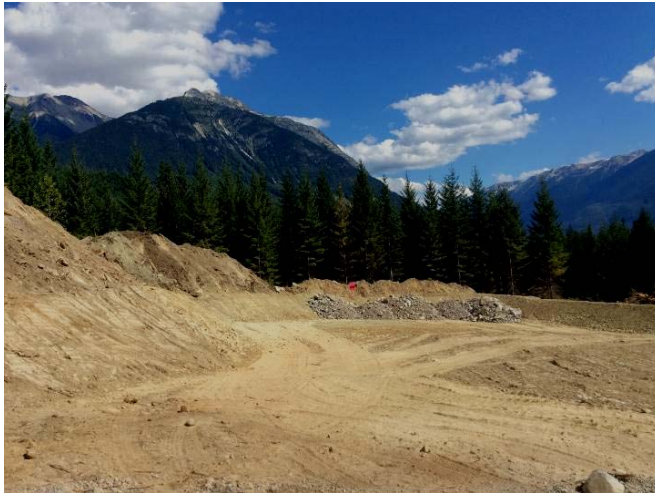
Photo 1. Preparing BDR-4 as a temporary storage area for PAG generated from the Boulder Intake access road construction. This area will be used once works resume following the removal of the Stop Work Order (August 6, 2014).

All items of the IE issued Stop Work Order for the Boulder Creek intake access road and crane pad construction must be addressed in a timely manner to the satisfaction of the IE prior to resuming works.

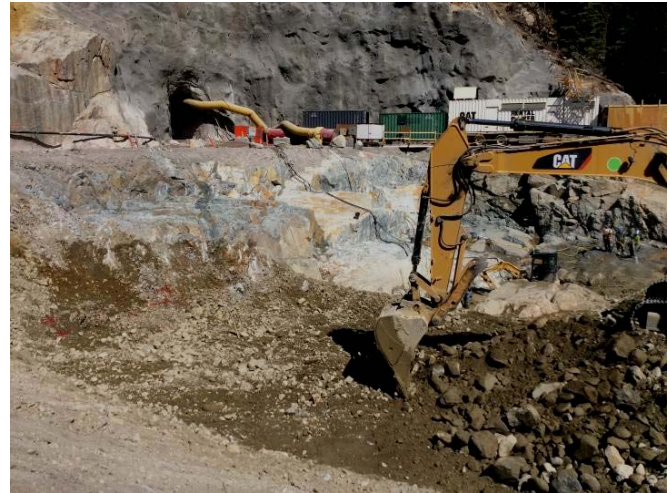
- The powerhouse excavation continued this week. Seepage water from the excavation seepage is being directed to a central sump and pumped to the sediment ponds currently being used to manage seepage/process water from the tunneling operations (Photo 2).

Photo 2. Dewatering of seepage from within the powerhouse excavation was pumped to the sediment ponds. Water has not yet reached the second treatment pond (August 9, 2014).

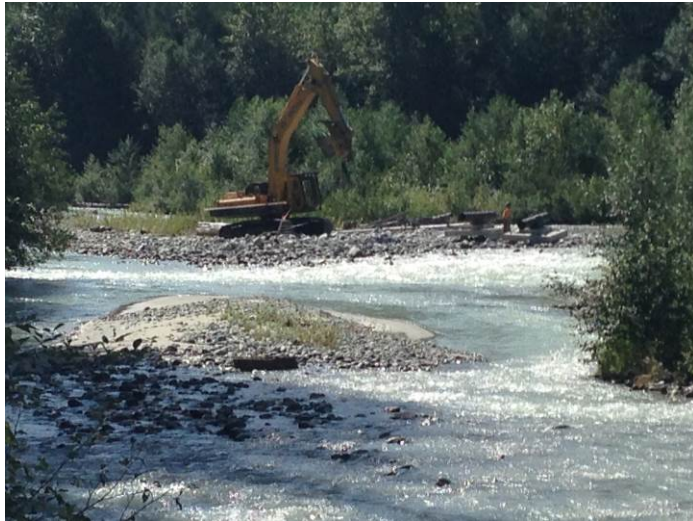
- The wet crossing of an excavator across the Ryan River was completed following review of the work plan and an according to BMPs during the instream works window. The excavator operator successfully minimized impacts to the channel substrates by not altering his direction of travel while crossing the wetted portions of the channel. Water quality was monitored full time during the wet crossing and no measureable exceedances were observed (See WQ results below).

Photo 5. Wet crossing of the Ryan River. (August 9, 2014).
