Upper Lillooet Hydro Project

Weekly Environmental Monitoring Report #35

Reporting Period: August 17th – August 23rd, 2014

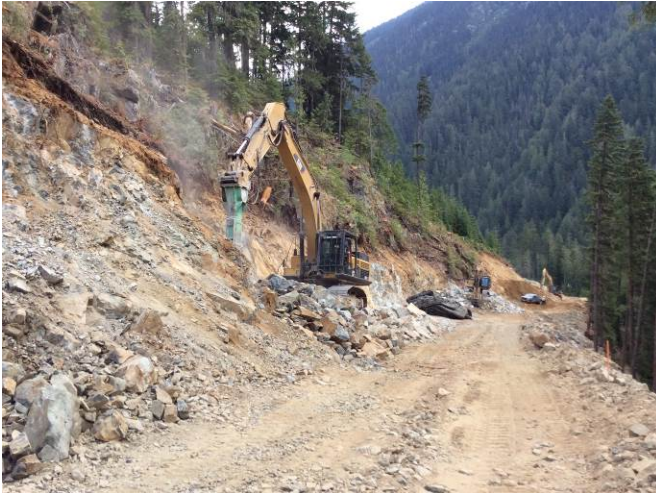
Photo 1. Completing slope stabilization along the new Boulder Intake access road following prescription outlined in the work plan. (August 21, 2014).

- Road construction and repair work was completed according to methods outlined in the work plan and continued under IEM supervision this week (Photo 1). The IEM can confirm that all excavator operators performing the repair and stabilization works demonstrated due care when operating on and adjacent to steep slopes. To the extent possible operators prevented rocks and debris from rolling downhill during the repair works to prevent additional impacts to standing timber outside of the approved OLTC boundaries.

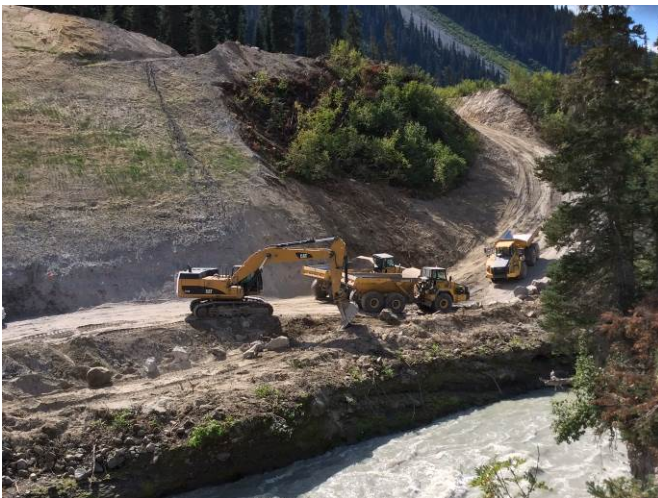
Photo 3. ULRHEF intake diversion channel excavation adjacent to the Lillooet River. (August 21, 2014).

- Works associated with the intake diversion channel occurred daily as the landslide risk remained within acceptable limits during this reporting period (Photo 3). Works included drilling, blasting, excavation, and slope stabilization (shotcrete application). Night shift works at the intake began on August 20th and the IEM was onsite to monitor when excavation and construction activities took place within 30m of the Lillooet River.

The installation of ESC measures (including hydro-seeding, protection with poly-sheeting) should be performed on all cut-slopes at risk of eroding during rain events. In particular, the steep cut slopes at the ULRHEF diversion channel, ULRHEF downstream tunnel portal, ULRHEF powerhouse, and BDRHEF tunnel portal, are all at risk of developing rills during heavy rain events. Where these cut slopes are permanent a permanent solution is recommended.

The IEM recommends that a shallow interception ditch or swale be installed at the top of the ULRHEF intake diversion channel cut-slope. This ditch/swale should be installed to direct the surface runoff towards the adjacent forested area for infiltration, and prevent it from flowing over the slope. The intent is to prevent further generation of rills that have already begun to develop.

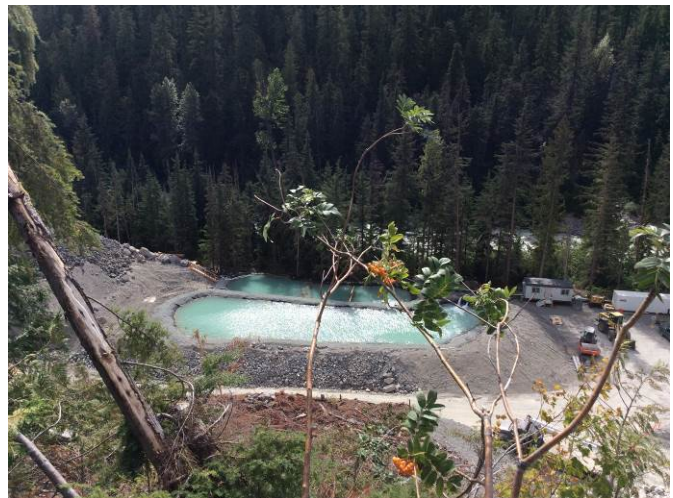
Photo 4. Conditions of the ULR HEF powerhouse sediment ponds. (August 20, 2014).

- Sediment ponds were used to treat seepage water from within the powerhouse excavation (Photo 4). Water from the ponds discharged to vegetation prior to reaching the Lillooet River. Further to routine weekly WQ sampling (see below), turbidity was visually monitored during periodic component visits by the IEM both upstream and downstream of the discharge point on the Lillooet River. Water entering the Lillooet River remained visually less turbid than the River itself during each inspection and works within the powerhouse excavation did not come in contact with the seepage water during this reporting period. No WQ concerns were noted during this reporting period and moving forward, WQ (other than routine), will only be conducted if the construction activities occurring within the powerhouse excavation (now completed to grade) occur that have the potential to affect WQ.

- The IEM was onsite full time during dayshift and night shift for all blasts and excavation activities to document that all efforts to prevent rocks from entering the Lillooet River were made and to record approximate quantities in the event rocks do enter the River. The IEM recognizes that large rocks are not a deleterious substance and that rock entering the river at this location is unlikely to cause serious harm to fish given the marginal fish habitat present at this location due to the water velocity within the rock canyon.
- A gravity fed water extraction system was used for drilling activities according to the conditions of the Short Term Water Use Approval (No.A2006123) (Photo 4).

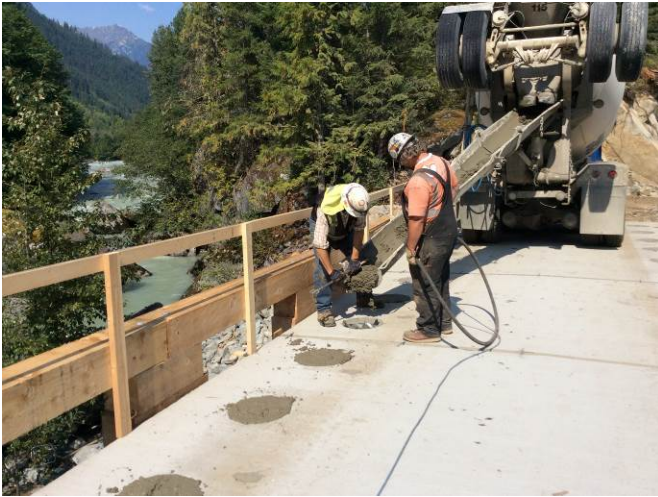
Photo 5. Grouting of Ryan River bridge deck panels (August 22, 2014).

- Access roads were upgraded/constructed in Segments 10 this week. The Ryan River precast decking was installed and grouted during this reporting period following IEM inspection of the form work (Photo 5). No environmental concerns were noted during the grouting activities or during other environmental monitoring inspections.

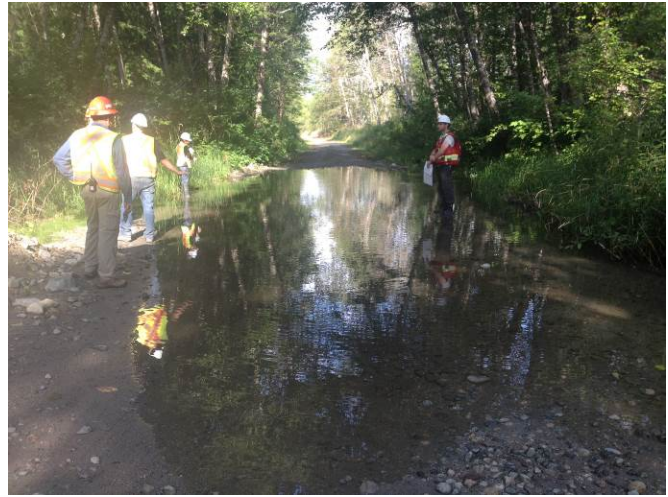
Photo 6. Flooded section of the South Lillooet River FSR containing fish. (August 20, 2014).

Date	Communication Type	Participants	Issues Discussed	ITM ID No.
August 20	Pre-work meeting	SES, WEL, Mumleqs, Hedberg, Innergex,	Pre-activity meeting to review the construction work plan for Segment 7. Discussion focused on access to steep terrain and safety requirements, as well as areas where IEM monitoring is required	N/A
	Pre-work meeting	SES, Innergex, CRT-ebc	Pre-activity meeting to discuss the mud slab concrete pour at the BDR HEF powerhouse. Discussions focused on dewatering and treatment of water in contact with the curing concrete. All dewatering was directed to the sediment treatment/infiltration ponds for pH treatment.	N/A
	Pre-work meeting	SES, WEL, Mumleqs, Hedberg, Innergex,	Pre-activity meeting to review the South Lillooet FSR upgrade prescriptions and access construction work plans for Segment 6. Discussion focused on the need to isolate the work area and conduct a fish salvage in areas of the flooded FSR where fish were observed and on dewatering plans to be implemented prior to adding road ballast to the flooded sections of the road ROW.	N/A
