Upper Lillooet Hydro Project

Weekly Environmental Monitoring Report #36

Reporting Period: August 24th – August 30th, 2014

Upper Lillooet River Hydroelectric Facility (Water File No. 2002561, Water licence No. C130613),
Boulder Creek Hydroelectric Facility (Water File No. 2003049, Water licence No. C129969) &
Transmission Line (TX Line)

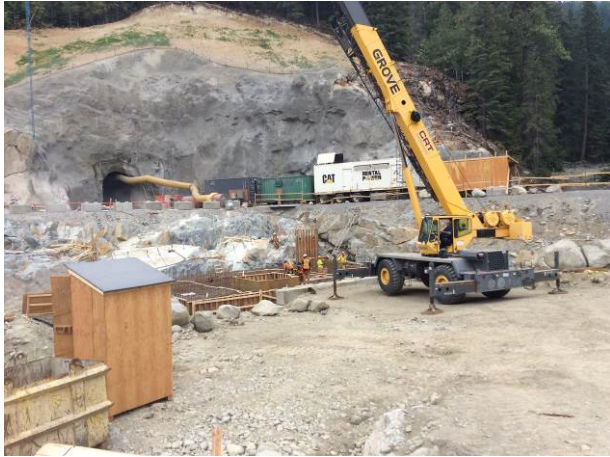
Photo 1 – Formworks at powerhouse and tunnel portal (August 25th, 2014)

- Concrete works – Powerhouse foundation pours occurred on August 24th and 29th.
- Rebar installation and formworks (Photo 1) at the powerhouse commenced during this reporting period.

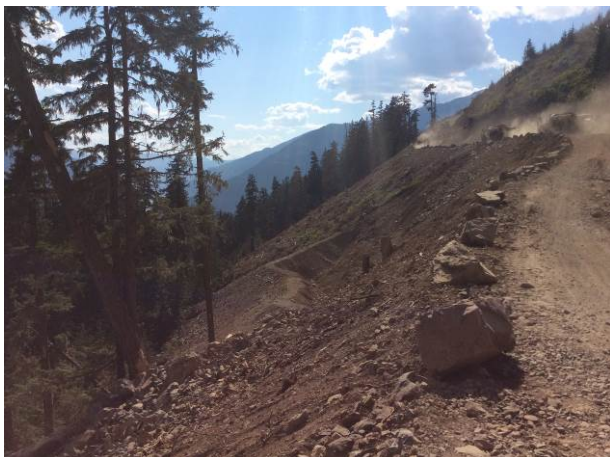
Photo 3 – BDRHEF Intake access road construction with OLTC protection berm (August 24th, 2014)

- Construction activities occurring along the BDRHEF intake access road and crane pad with the IEM onsite for clearing activities within UWR and construction activities within 30 m of Boulder Creek and other smaller watercourses. Ditching and culvert works (August 28th & 29th) were completed with the IEM on-site and no environmental issues were observed.

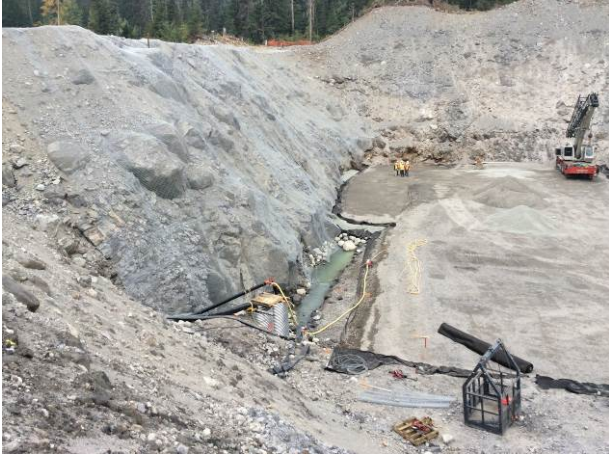
Photo 5 – Powerhouse excavation showing French drain in construction, back fill and compaction (August 25th, 2014)

- Mesh fencing was installed on slopes above the powerhouse excavation to improve slope stability.
- A French drain (Photo 5) was installed on the riverside of the powerhouse excavation. Two pumps (6” and 10”) previously installed in the sump draining seepage waters in the powerhouse excavation continued to convey water to the existing settling ponds (Photo 6). No flowing surface water was observed within the excavation and pump capacity appears to be adequate to maintain isolation from active work areas.
- Continued backfill and compaction in preparation for mud slab pour and foundation formworks.

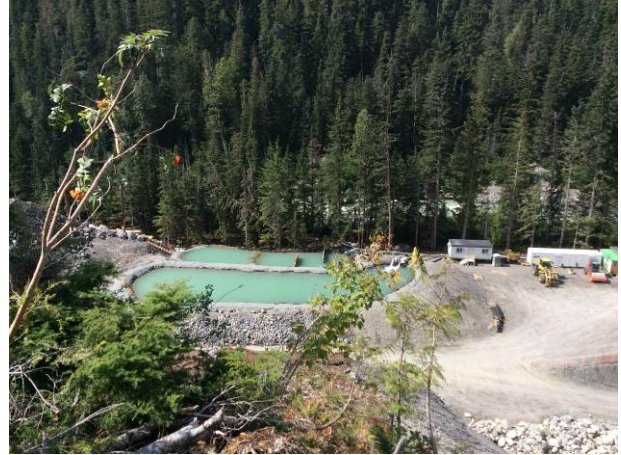
Photo 6 – Settling ponds at ULRHEF powerhouse (August 24th, 2014)

- The sediment ponds installed adjacent to Truckwash Creek were used to treat the seepage and process water emanating from the tunnel. No surface discharge from the sediment ponds was observed this week; therefore no WQ measurements were taken by the IEM.
- Blast rock was hauled to the lower spoil area and managed according to the ULRHEF ARD/ML Monitoring and Control Plan.

- Settling ponds at the downstream portal should be continually monitored to ensure appropriate treatment of seepage from tunnelling activities is occurring. Although dry weather persists, rain events typical of the changing season may result in increased water volumes and current infiltration rates may result in discharge from the ponds. The IEM will continue to monitor the effectiveness of the treatment systems to ensure water meets the approved guidelines prior to discharge.

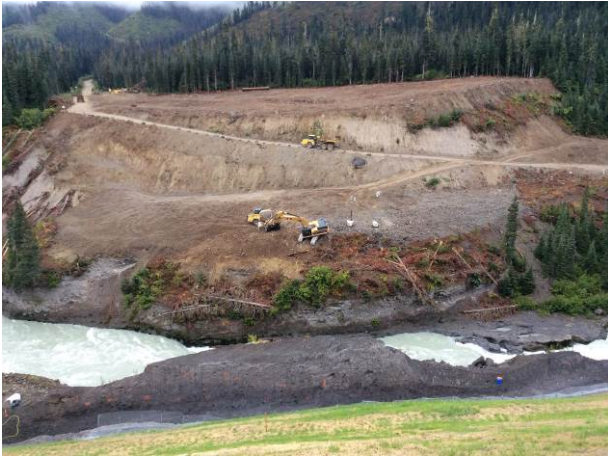
Photo 9 – Stripping and grubbing on north side of Lillooet River at intake (August 30th, 2014)

- The IEM was onsite full time during day shift and night shift for all construction activities occurring on both the north and south sides of the river during day and night shift. On the south side within and adjacent to the intake diversion channel, the IEM documented occurrences of non-deleterious materials (large boulders) entering the watercourse and confirmed that all efforts to prevent rocks from entering the Lillooet River were taken.
- In order to address recommendations made by the IEM in the preceding monitoring reports CE installed a shallow interception ditch along the top of slope at the ULRHEF intake diversion cut slope during this reporting period.
- No environmental issues were observed on the north side of the Lillooet River during stripping and grubbing of the open cut.

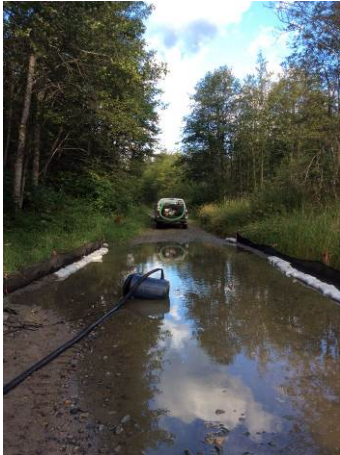
Photo 12 – Continued dewatering of salvaged and isolated wetted areas to vegetation prior to road ballasting (August 28th, 2014).

- Works along the Lillooet South FSR adjacent to wetlands on either side of the road were monitored fulltime to ensure construction was completed, to the extents possible and practical, out of the wetted perimeter of the wetland and the watercourses running adjacent to the FSR. Excavator used for works near water was filled with synthetic biodegradable hydraulic fluid. WEL's QP performed fish salvages (following isolation) within the wetted portions of the road where the wetland frequently overtops during elevated water levels. Trash pumps were used following isolation of the work area to pump the standing water remaining on the FSR to

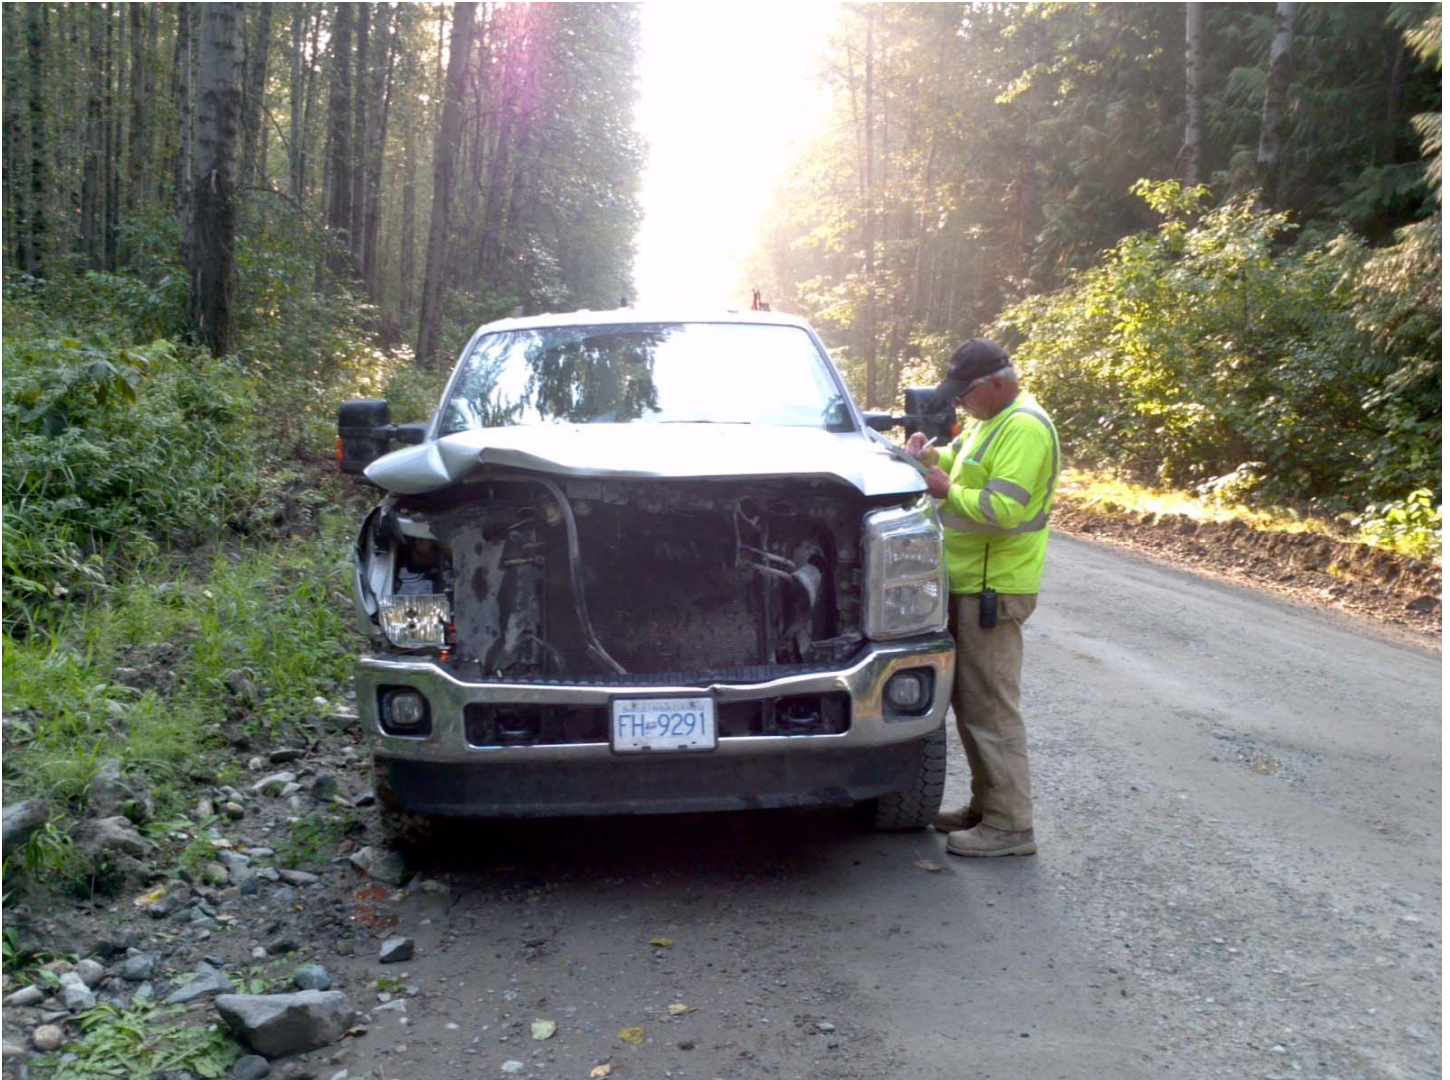
Photo 1: Damaged pick-up.

| Incident Profile | | | | | | | | |
|---|---|---|---|---|--|---|---|---|
| Description and Cause of Incident: <u>Description:</u> <ul style="list-style-type: none"> On August 23rd, at approximately 7:15AM Summit Camp foreman Peter Barharn was travelling at ~ 70km/h in a Ford F350 crew cab pick-up truck, up the Lillooet River FSR at approximately km13.5 and struck a juvenile bull moose which darted onto the road causing it serious injury. The moose landed in the ditch on the road side, did not get up, and showed signs of severe pain and injury. After ensuring the safety of passengers in the vehicle, Pete called CRT-ebc safety manager Eric Martin Gagnon on the radio to inform him of the incident. The regional conservation officer was contacted and informed immediately by CRT-ebc environment manager Ian McKeachie. As the conservation officer had not arrived after more than an hour, a local working in the area communicated by phone with conservation officer Tim Schumacher, and received authorization to permit a colleague who was on the scene to use his firearm to humanely euthanize the moose. This was done safely. At 9:09AM the conservation officer attended the scene and removed the carcass from the area. <u>Cause:</u> <ul style="list-style-type: none"> The speed of the vehicle at the time of the collision exceeded 50km/h and this was primary cause of the accident. The area has high numbers of animal crossings, which increased the risk of collision. | | | | | | | | |
