Upper Lillooet Hydro Project

Weekly Environmental Monitoring Report #37

Reporting Period: August 31 – September 6, 2014

Upper Lillooet River Hydroelectric Facility (Water File No. 2002561, Water licence No. C130613),
 Boulder Creek Hydroelectric Facility (Water File No. 2003049, Water licence No. C129969) &
 Transmission Line (TX Line)

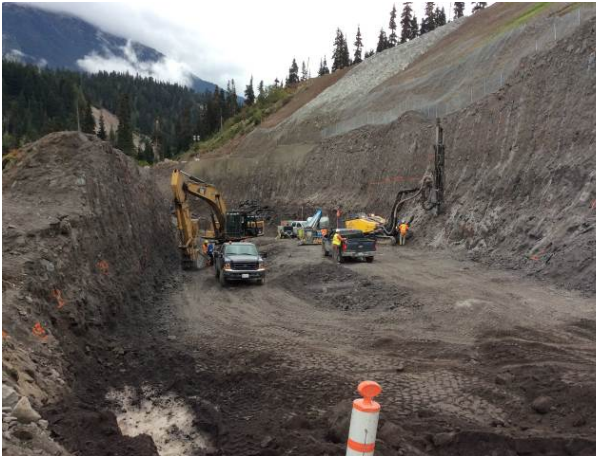
- Drilling, blasting and excavation works continued during day and night shift within the intake diversion channel (Photo 1) on the south side of the Lillooet River throughout this reporting period. Rock anchoring and grouting of anchor plates was completed as necessary for stabilization (Photo 2).

Photo 1 – Drilling and blasting at ULRHEF intake diversion channel (September 1, 2014).

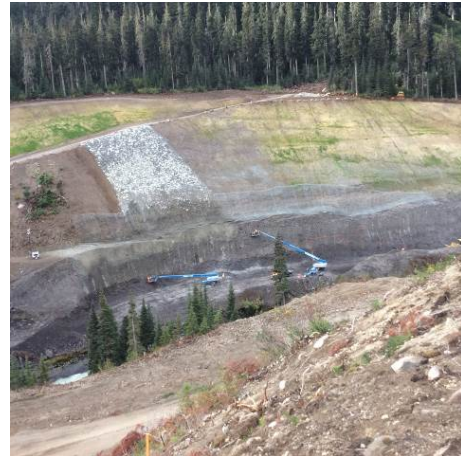
Photo 2 – ULRHEF intake diversion channel, vertical slope anchoring (August 31, 2014)

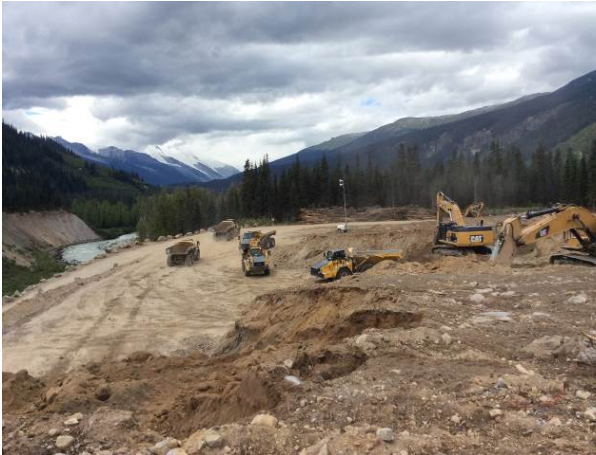
- Bulk excavation activities for the ULRHEF upstream tunnel portal commenced on the north side (Photo 3 and Photo 4) of the Lillooet River on August 31st following issuance of the LTC for ULRHEF Intake Bulk Excavation to elevation 666m. A pre-work meeting for this activity was completed during the previous reporting period.
- A gravity fed water extraction system was used for drilling activities according to the conditions of the Short Term Water Use Approval (No.A2006123).

Photo 3 – Commencement of bulk excavation at the ULRHEF intake open cut on the north side of the Lillooet River (August 31, 2014)

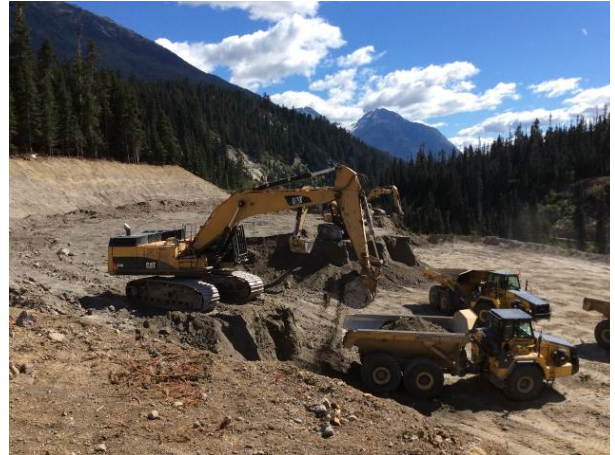
Photo 4 – Continued bulk excavation at the ULRHEF intake open cut on the north side of the Lillooet River (September 3, 2014).

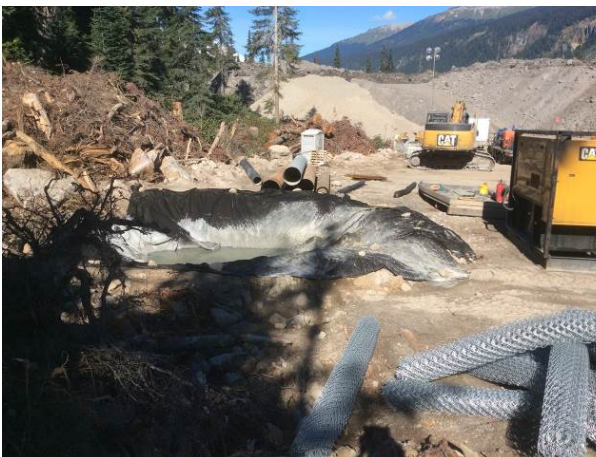
Photo 5 – Concrete wash out pit in spoil area on south side of Lillooet River at ULRHEF intake (September 4, 2014).

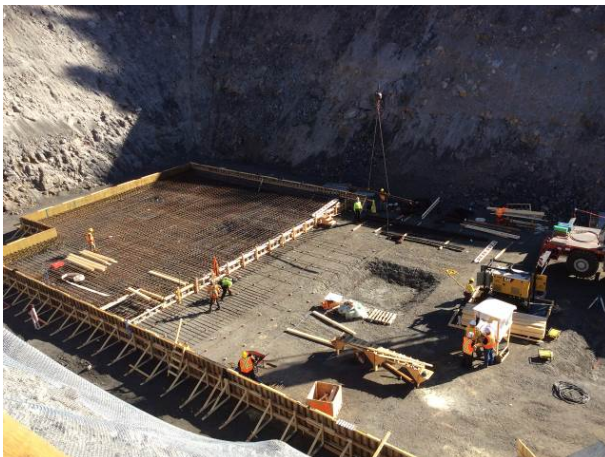
- Rebar installation and form works for the powerhouse foundation began on September 2, following the mud slab pours (Photo 6).
- Concrete mud slab were poured on August 31 & September 1, and a portion of the foundation was poured on September 6.
- Two pumps (6" and 10") previously installed in the sump draining seepage waters in the powerhouse excavation continued to convey water to the existing settling ponds. No flowing surface water was observed within the excavation and pump capacity appears to be adequate to maintain isolation from active work areas.

Photo 6 – ULRHEF powerhouse rebar installation and formworks (September 4, 2014)

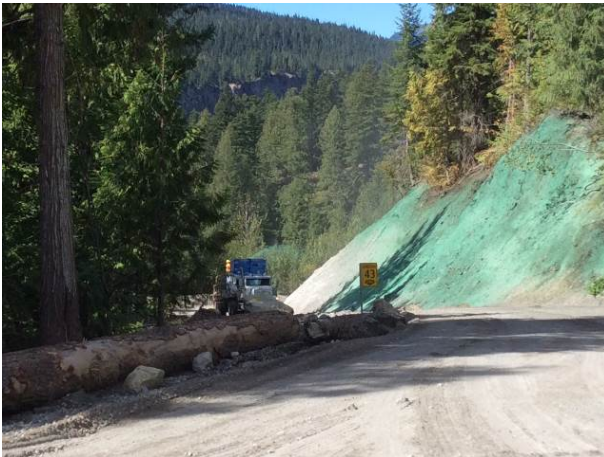
- Hydroseeding slopes adjacent to new Lillooet River FSR switchback alignment over Truckwash Creek (Photo 7)
- Material crushing and screening plant operation continued throughout this reporting period. A watering hose was used effectively for dust control at the screening plant.

Photo 7 – Hydroseeding near KM 43 on Lillooet River FSR (September 3, 2014)

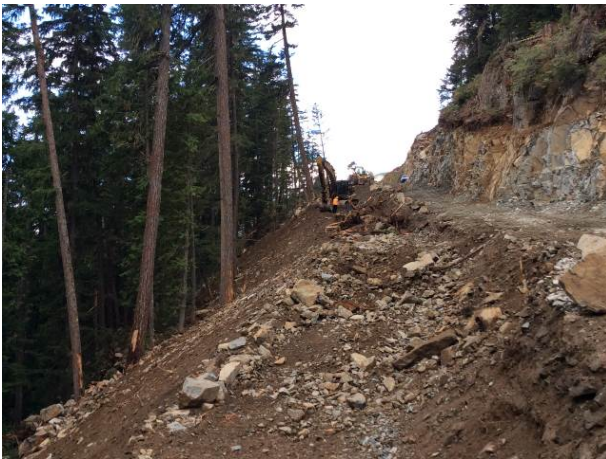
- Intake access road construction, including the removal of timber from the toe of slope; slope contouring (Photo 8); drilling and blasting; and road fill/grading continued throughout the reporting period. A berm and access to the spoil area near the KM 4 mark was constructed at the toe of slope to protect OLTC boundary against falling debris.
- Grubbing, stripping and removal of merchantable timber continued at the crane pad (Photo 9). Once grubbing and merchantable timber removal was completed, drilling and blasting and blast rock excavation began on the top bench of the crane pad footprint.

Photo 8 – BDRHEF Intake access road construction including slope contouring and LWD/boulder removal from toe of slope (August 31, 2014)

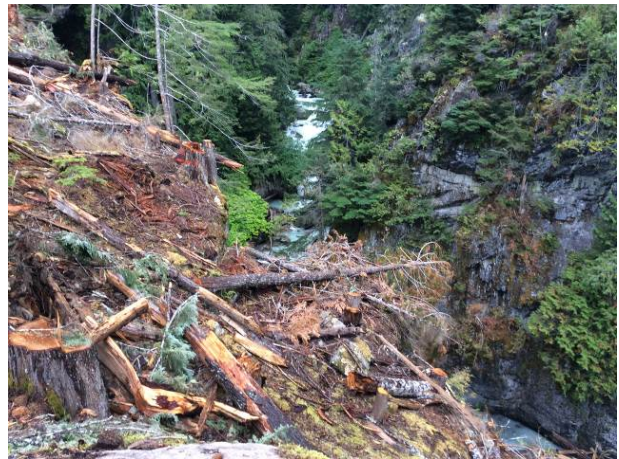
- Construction activities occurred along the BDRHEF intake access road and crane pad with the IEM onsite for construction activities within 30m of Boulder Creek.

Photo 9 – BDRHEF crane pad within 30 m of Boulder Creek (August 31, 2014)

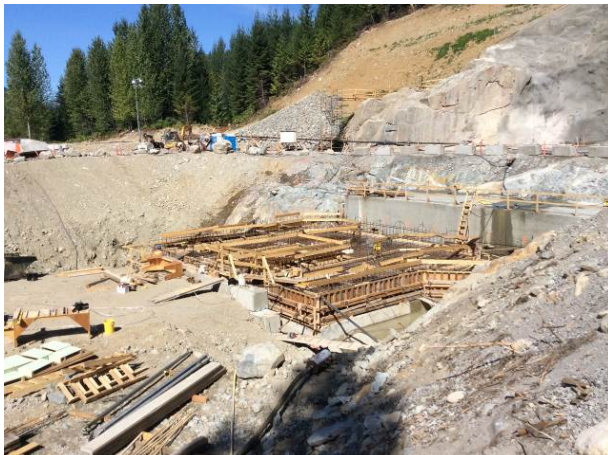
- Rebar installation and formworks (Photo 10) at the powerhouse continued throughout the reporting period.
- Concrete works – Powerhouse foundation pour occurred on September 6, 2014.

Photo 10 – Continued formworks at BDRHEF powerhouse (September 4, 2014)

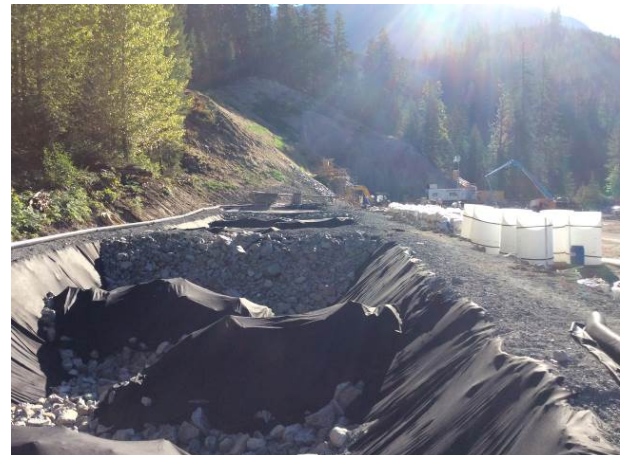
- Seepage flowing out of the tunnel continues to be collected at the portal tunnel entrance in a sump and this water is then pumped from the sump to the oil/water separator, pH adjustment holding tank, and settlement ponds for treatment. The pH was monitored daily by the contractor and a CO₂ diffuser was used as necessary to ensure pH was within acceptable surface water quality guidelines (pH 6.5 – 9). No discharge from the treatment ponds occurred during this reporting period (Photo 11); therefore, the IEM did not collect WQ results.

Photo 11 – Settling ponds and pH treatment at BDRHEF tunnel portal (September 6, 2014)

- Settling ponds at the downstream portal should be continually monitored to ensure appropriate treatment of seepage from tunnelling activities is occurring. Although dry weather persists, rain events typical of the changing season may result in increased water volumes and current infiltration rates may result in discharge from the ponds. The IEM will continue to monitor the effectiveness of the treatment systems to ensure water meets the approved guidelines prior to discharge.

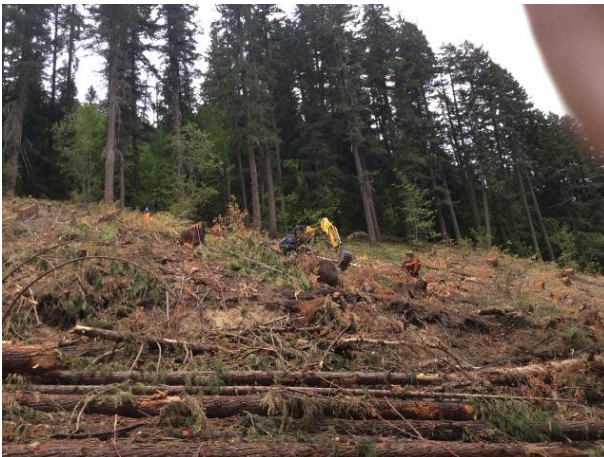
- Machine works on steep slopes to construct pole foundation (Photo 12).
- Pole structure placement and associated groundwork (including blasting). Structure 81 is in close proximity to the RVMA associated with stream 80b.
- Merchantable timber yarding and decking in the vicinity of structures 81-83.

Photo 12 – Segment 5 machine works (spider hoe) at structure locations (August 31, 2014).

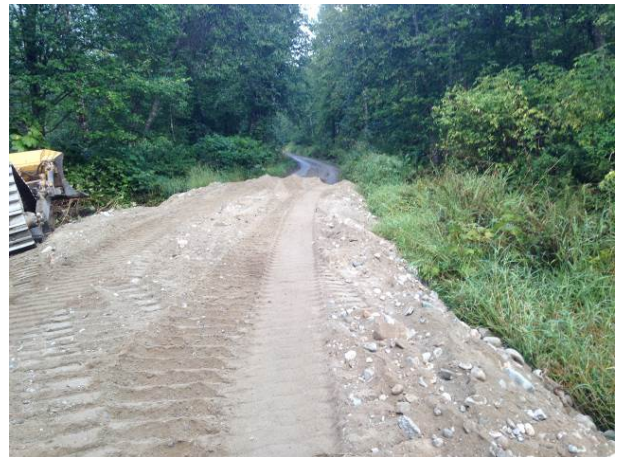
- Continued RoW clearing.
- Road ballasting continued along the Lillooet South FSR (Photo 13) during this reporting period. The purpose of the road upgrades was to improve construction vehicle access along the FSR through the low lying wetland areas and gain access to pole structures locations near the Lillooet River Tx line crossing, without fording fish bearing waters or introducing sediment to adjacent wetlands.

Photo 13 – Lillooet South FSR road ballasting near KM 7 (September 3, 2014).

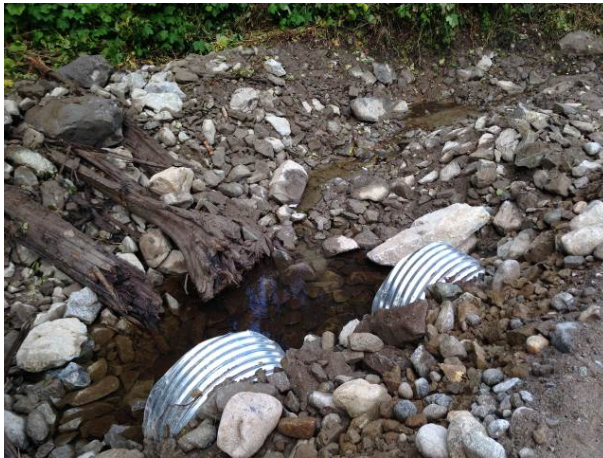
- Road ballasting works along the Lillooet South FSR adjacent to wetlands on either side of the road were completed in the dry during this reporting period. A beaver exclusion fence surrounding the inlet of the two 1000mm culverts (Photo 14) at approximately 6km of the FSR, remains to be installed and will be completed prior to September 15, 2014. Contractors were completing road works in an appropriate manner and sufficiently isolated from the adjacent wetlands to the satisfaction of the IEM. No environmental issues were observed.

Photo 14 – Two 1000 mm culverts installed at 6km on the Lillooet South FSR (September 3, 2014).

- Continued road works (approximately one week remaining) along the Lillooet South FSR. Beaver exclusion fencing will be installed on culvert inlets prior to the end of the ISW window.
- The majority of works described in the construction activities section described above will continue. Construction activities are tentatively scheduled to continue within RVMAs (Segment 5 & 14), as well as within 100m CTF (Segment 5) and 150m western toad breeding pond (Segment 3 & 5) buffers.
- Road upgrades in Segment 8 will continue towards Blacks Creek at the beginning of road 197.1.

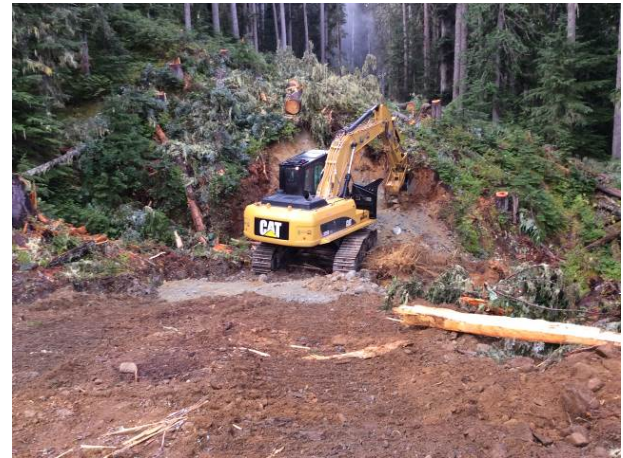
- Continued RoW clearing (hand-falling) and road works.
- Construction commenced along road 371.1 and at the first of the proposed box culverts over stream 347a which is currently dry (Photo 15).

Photo 15 – Construction commenced along access road 371.1, excavator grubbing area for box culvert near dry creek bed (September 2, 2014)

- Road upgrades will continue in Segment 14 past the end of Pemberton Main FSR along road 371.1 including continued box culvert construction in dry stream bed (stream 347a).
