# Upper Lillooet Hydro Project

## Weekly Environmental Monitoring Report #39

**Reporting Period: September 14 – September 20, 2014**

Upper Lillooet River Hydroelectric Facility (Water File No. 2002561, Water licence No. C130613),  
Boulder Creek Hydroelectric Facility (Water File No. 2003049, Water licence No. C129969) &  
Transmission Line (TX Line)

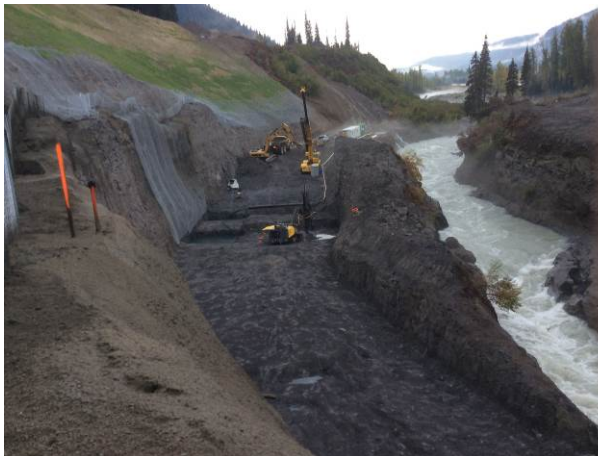
**Photo 1 – Continued excavation of ULRHEF intake diversion channel, within the Obermeyer weir footprint (September 20, 2014).**

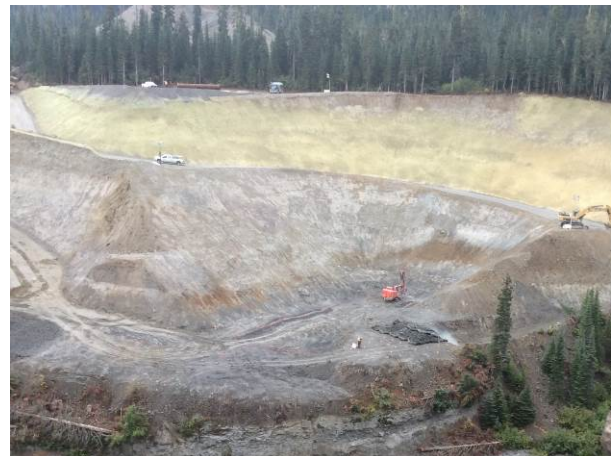
**Photo 2 – ULRHEF north side tunnel portal excavation below elevation 666m (September 18, 2014).**

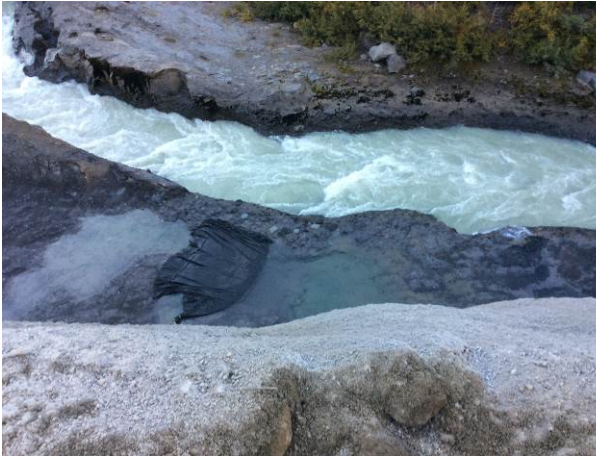
**Photo 3 – ULRHEF intake diversion channel, dewatering bag for seepage control during grouting works (September 20, 2014).**

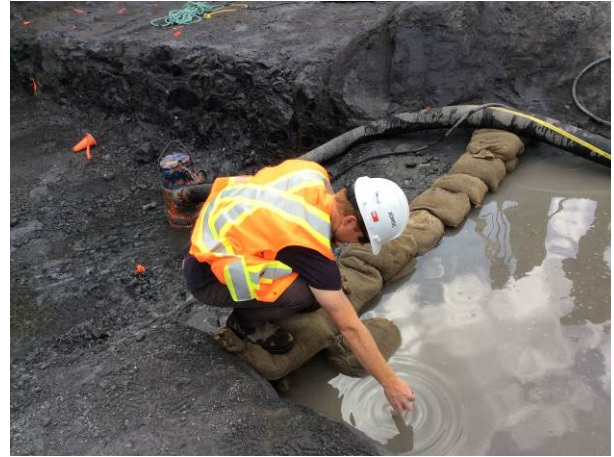
- On September 19, the IEM recommended that grouting of the rebar-rock anchors within the Obermeyer weir excavation cease as no pH adjustment equipment was onsite and grouting works were in direct contact with seepage water. Although no exceedance of BCWQGs was noted (pH remained below 9) the IEM determined that insufficient pH mitigation measures were in place should a rise in pH occur. CE's

Environmental Manager halted works until a CO<sub>2</sub> diffuser was brought to site to treat water in contact with grouting works. Seepage water within the Obermeyer weir excavation was managed in two separate cells. In the first cell, seepage water was conveyed directly back to the river via a dewatering bag (Photo 3). The seepage water in contact with grouting works were isolated (Photo 4) and treated with a CO<sub>2</sub> diffuser in one half of the 2<sup>nd</sup> cell before mixing with neutral pH seepage water in the other half of the 2<sup>nd</sup> cell. The treated and diluted water was then directed through a dewatering bag place on the lower section of the diversion channel (Photo 3). The IEM was onsite full-time to monitor turbidity and pH during the grouting works. When pH levels within the 2<sup>nd</sup> cell began to approach pH = 9 the pumps were shut-off until the pH dropped below 8.5. The grouting activities were successfully managed in this way and no environmental incidents of elevated pH discharge to the Lillooet River were recorded.

**Photo 4 – Measuring pH in isolated section of Obermeyer weir excavation. This water was treated with a CO<sub>2</sub> and confirmed to be below pH 9 prior to reaching the pump (September 19, 2104).**

- On September 19, the IEM met with the contractor's Environmental Manager at the ULRHEF intake to discuss pH management concerns with the grouting works in the Obermeyer Weir foundation. The IEM recommends that a static mixer type manual pH adjustment system be sourced and used for the remainder of the grouting activities. It was agreed that the Environmental Manager would discuss potential options and communicate back to the IEM.

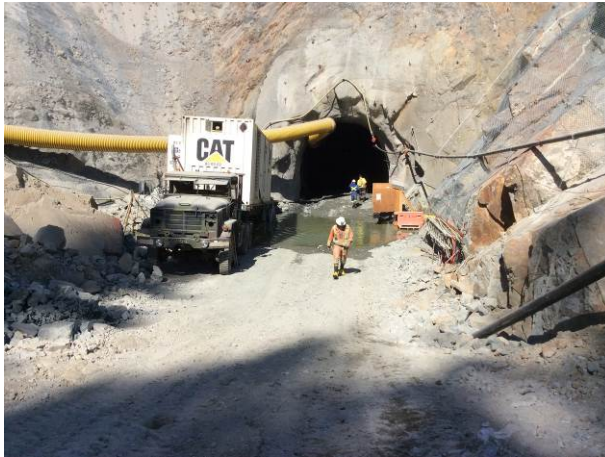
- Drilling, blasting, mucking and stabilization (anchoring and shotcrete application) continued within the tunnel (Photo 5). Seepage water from the tunnel portal was conveyed effectively to the settling ponds for treatment and storage. Pooling of water at the tunnel portal entrance was observed on September 16, and maintenance of the sump and tunnel ditch was completed on September 17.
- Restoration planting of the temporary haul road and auditory berm within the Mountain Goat migration corridor was completed from September 17-19 (Photo 6).

**Photo 5 – ULRHEF downstream tunnel portal (September 16, 2014).**

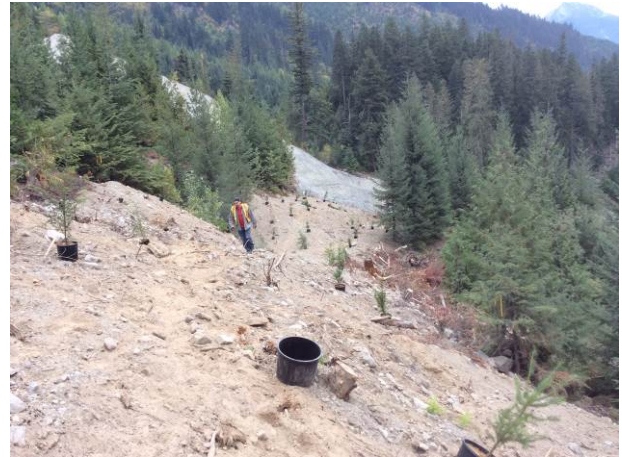
**Photo 6 – Restoration planting along the temporary haul road near the ULRHEF downstream tunnel portal (September 17, 2014).**

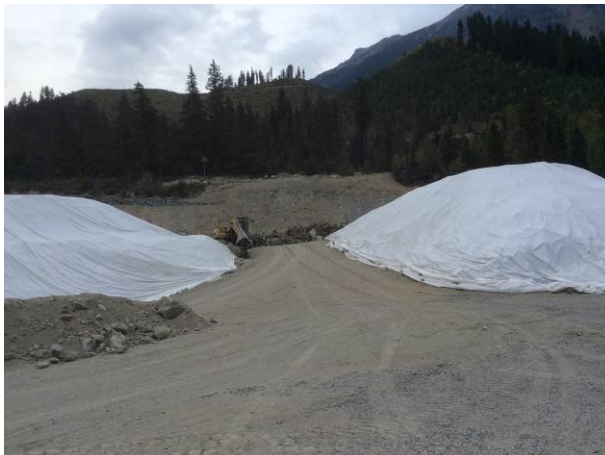
- The temporary PAG stockpiles located near the ULRHEF lower tunnel portal were covered with an impermeable tarp to prevent rain water infiltration according to the ARD/ML Monitoring and Control Plan (Photo 7). This material will be temporarily stored in its current location until a final storage plan is presented for review and approval.
- The settling ponds (Photo ) installed adjacent to Truckwash Creek were used to treat the seepage and process water emanating from the tunnel. No surface discharge from the sediment ponds was observed this week; therefore no WQ measurements were taken by the IEM.
- Blast rock was hauled to the lower spoil area and managed according to the ULRHEF ARD/ML Monitoring and Control Plan.

**Photo 7 – Temporary PAG stockpiles located near the ULRHEF downstream tunnel portal were covered with impermeable plastic tarps (September 15, 2014).**

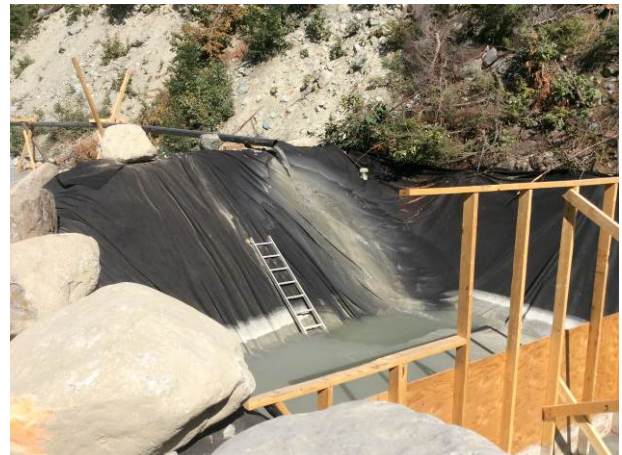
**Photo 8 – Inlet of the ULRHEF settling ponds, no discharge observed (September 16, 2014).**

- Settling ponds at the downstream portal should be continually monitored to ensure appropriate treatment of seepage from tunnelling activities is occurring. Although dry weather persists, rain events typical of the changing season may result in increased water volumes and current infiltration rates may result in discharge from the ponds. The pH treatment measures proposed for the grouting works at the ULRHEF intake diversion channel could be used for the downstream portal dewatering in the event that the treatment ponds begin to overflow and require treatment.

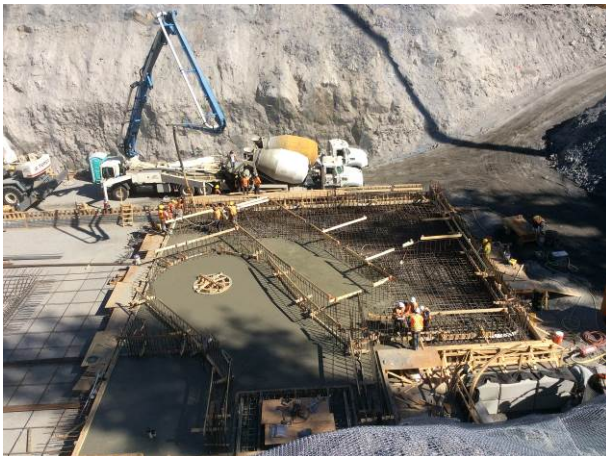
- Rebar installation and form works for the powerhouse foundation continued throughout the reporting period.
- A portion of the concrete powerhouse foundation was poured on the 16<sup>th</sup> of September (Photo 9).
- Two pumps (6" and 10") previously installed in the sump draining seepage waters in the powerhouse excavation continued to convey water to the existing settling ponds.

**Photo 9 – Concrete pour for ULRHEF powerhouse foundation (September 16, 2014).**

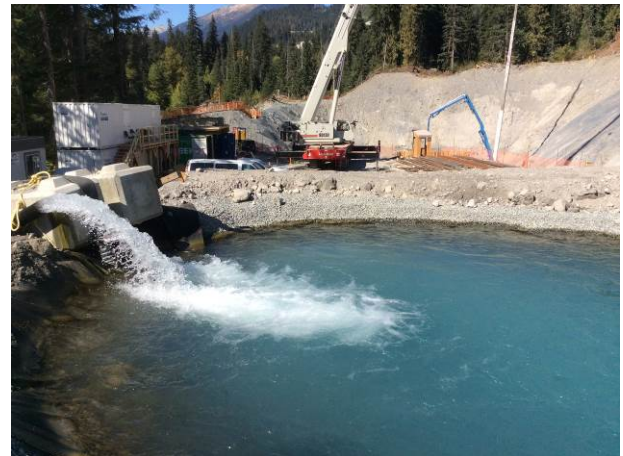
**Photo 10 – Settling ponds at ULRHEF powerhouse, dewatering from excavation remains isolated from concrete works (September 16, 2104).**

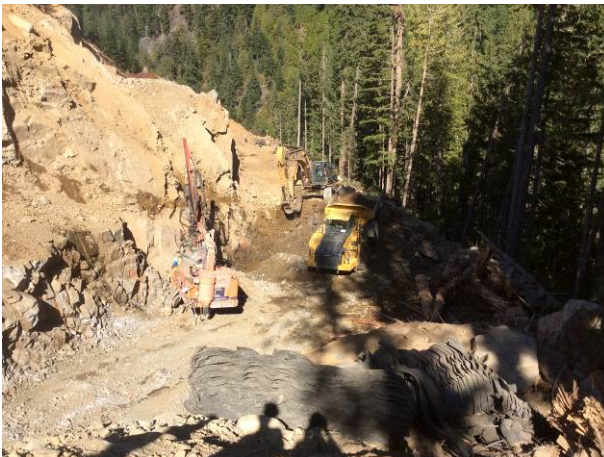
- Sequences of drilling, small controlled blasts, and blast rock excavation proceeded on the first bench of the crane pad throughout the reporting period (Photo 12). Care was taken to prevent material from escaping down the slope adjacent to the excavation.
- Intake access road construction, including bulk excavation (Photo 11); material spoiling; slope contouring; drilling and blasting; and road fill/grading (Photo 11) continued throughout the reporting period.

Photo 11 – BDRHEF Intake access road construction (September 16, 2014).

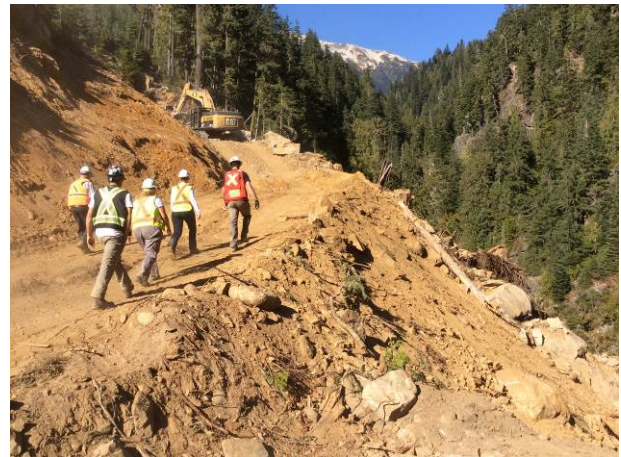
Photo 12 – BDRHEF crane pad excavation at upper pad (September 16, 2014).

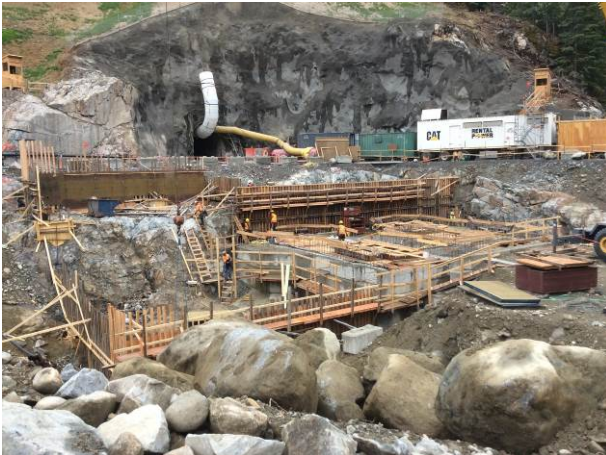
Photo 13 – BDRHEF downstream tunnel portal and powerhouse rebar/formworks (September 18, 2014).

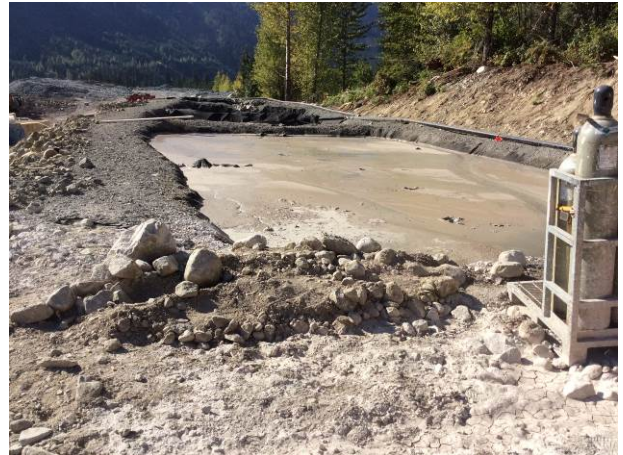
Photo 14 – BDRHEF powerhouse settling pond, no discharge observed; however pond #1 is now full of sediment and requires maintenance. (September 16, 2014).

- Settling ponds at the downstream portal should be continually monitored to ensure appropriate treatment of seepage from tunnelling activities is occurring. Although dry weather persists, rain events typical of the changing season may result in increased water volumes and current infiltration rates may result in discharge from the ponds. The maintenance of these ponds was discussed with the Environmental Coordinator and it was agreed that confirmatory samples would be taken to characterize whether the sediment/slurry (mostly rock fines from the tunnel drilling activities) should be treated as PAG or non-PAG.

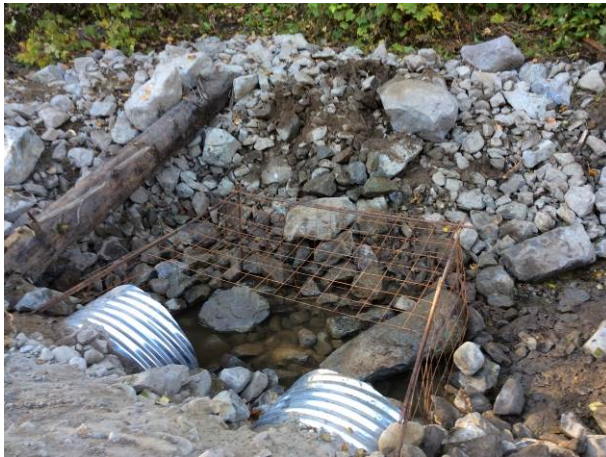
- Continued RoW clearing via helicopter access throughout segment
- Installation of beaver exclusion fencing around newly installed culvert inlets near 6km of the Lillooet South FSR (Photo 15)

- Beaver exclusion fencing surrounding the inlets of the two 1000mm culverts (Photo ) at approximately 6km of the Lillooet South FSR was installed prior to September 15 which coincides with the end of the 2014 ISW window for the works area. No environmental issues were observed.
- The IEM was present as required when clearing activities occurred within 150m of wetlands, 15m RVMAs (30m for CTF streams), 100m of Coastal Tailed Frog Streams, Class 1 & 2 suitable Grizzly Bear WHA and/or suitable forage habitat, moose and deer UWR, and within legally designated Old Growth Management Areas (OGMAs). All flagged boundaries were respected during clearing activities. No environmental issues were observed.

**Photo 15 – South Lillooet FSR – Beaver exclusion fencing installed at the inlet of the doubled 1000mm culverts (September 15, 2014).**

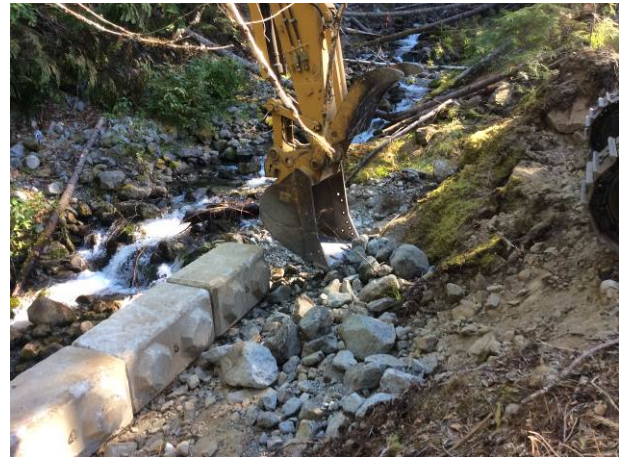
- The Blacks Creek temporary bridge installation was monitored by the IEM on September 15<sup>th</sup>, following a pre-work meeting. The installation did not involve any instream works and no fording of machinery was required (Photo 16). Water quality remained visually unaffected throughout the work activities and no environmental concerns were noted.

**Photo 16 – Excavator installing temporary bridge footing at Blacks Creek Temporary Bridge. No instream works were required (September 15, 2014).**
