Upper Lillooet Hydro Project

Weekly Environmental Monitoring Report #40

Reporting Period: September 21 – September 27, 2014

Upper Lillooet River Hydroelectric Facility (Water File No. 2002561, Water licence No. C130613),
Boulder Creek Hydroelectric Facility (Water File No. 2003049, Water licence No. C129969) &
Transmission Line (TX Line)

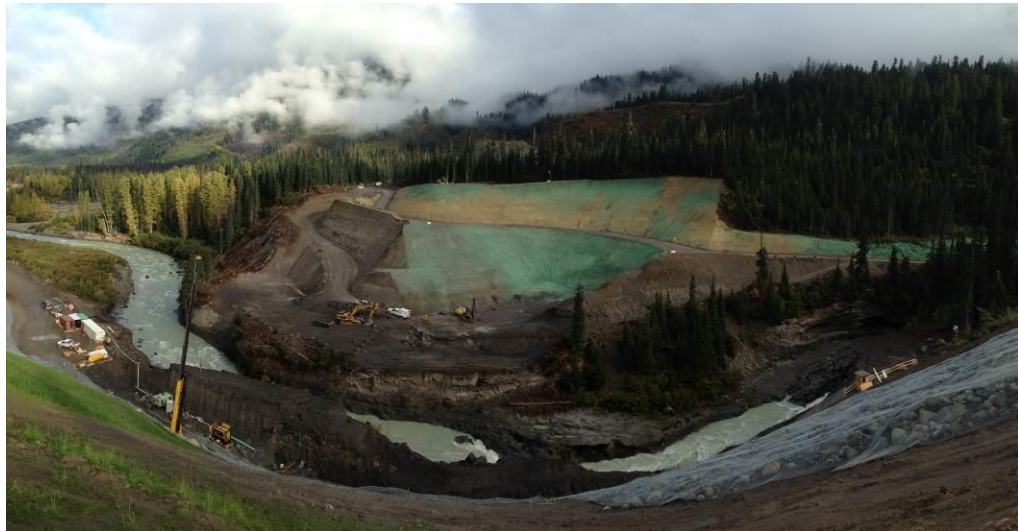
- No environmental issues were observed on the north side of the Lillooet River during bulk excavation works.
- Dust control along the ULRHEF intake access roads and Lillooet River FSR continued as necessary.
- Hydro-seed was applied (and re-applied in some areas) to slopes on the north side of the ULRHEF intake as a temporary ESC protection measure (Photo 1).

Photo 1 – Overview of the north side of the ULRHEF intake. Hydro-seed was applied to slopes as a temporary ESC measure (September 27, 2014).

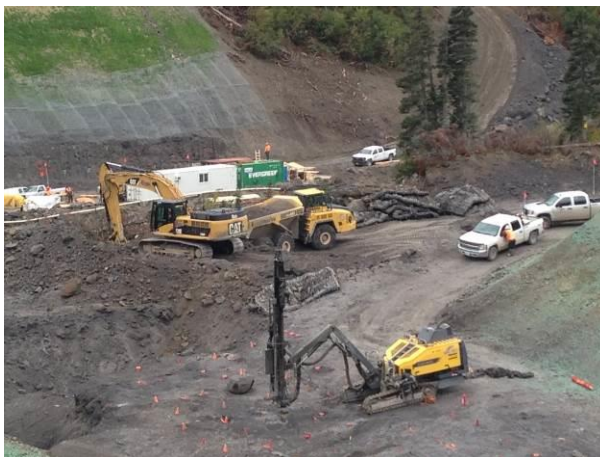
- Drilling and blasting activities continued for bulk excavation of the ULRHEF upstream tunnel portal below elevation 666m throughout this reporting period on the north side (Photo 1 & 2) of the Lillooet River.
- Grouting of the rebar-rock anchors for the Obermeyer Weir continued throughout the reporting period. CE used a combination of two CO₂ injection/static mixer pH treatment systems, dewatering bags and pumping/trucking water to an infiltration/wash pit (Photo 3) as means to ensure that water directed to the Lillooet River remained within BCWQG.

Photo 2 – ULRHEF north side tunnel portal excavation below elevation 666m (September 26, 2014).

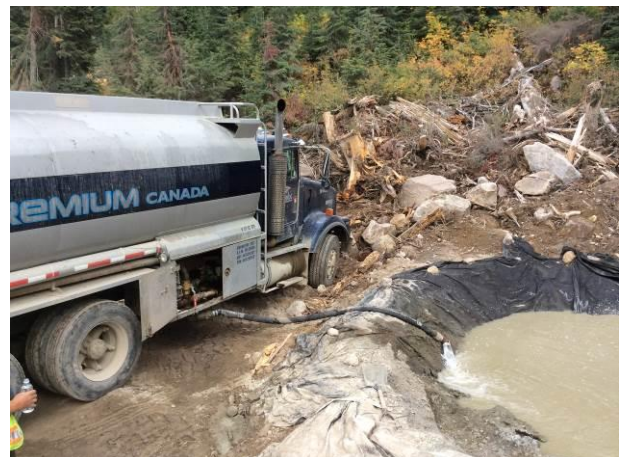
Photo 3 – Hauling water to infiltration pit during grouting works within the Obermeyer weir footprint (September 22, 2014).

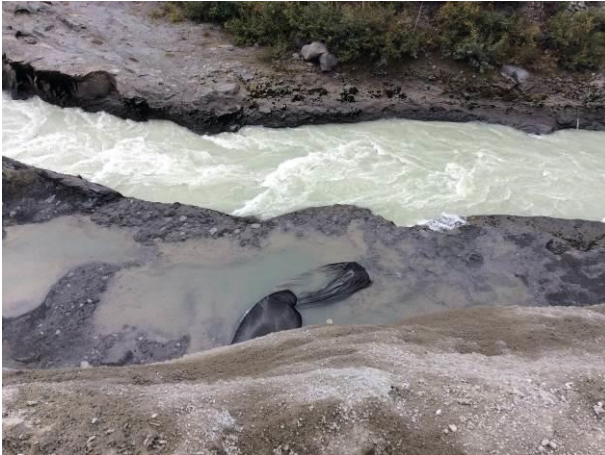
Photo 4 – ULRHEF intake diversion channel, dewatering bag for seepage control during grouting works (September 23, 2014).

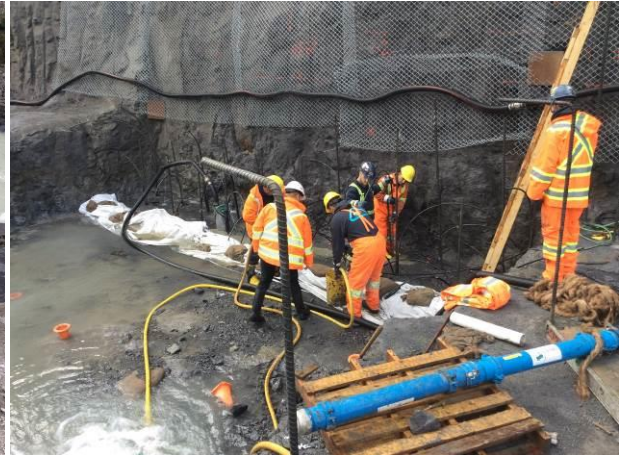
- On September 23, the IEM and CE Environmental Coordinator met onsite to review water quality management during the Obermeyer weir rebar/rock anchor grouting works due to concerns with increased seepage volumes observed in the excavation, and to review the setup of two CO₂ injection/static mixer pH adjustment systems. The CO₂ injection/static mixer systems were installed (Photo 5) to replace the less efficient CO₂ diffuser system as recommended during the previous reporting period. As an additional treatment option the IEM recommended pumping to a water tank and trucking water to a geotextile lined infiltration pit for disposal in the event that the CO₂ injection/static mixer systems pH were not able to treat water to below pH 9. Construction of a lined infiltration pit was completed on September 24, and when pH levels within the second cell began to approach pH 9, water was pumped to a water tank and trucked to the infiltration pit for disposal. The grouting activities were successfully managed in this way from September 24 to 27 and no environmental incidents of elevated pH discharge to the Lillooet River were recorded.

Photo 5 – Water management during grout work in isolated section of Obermeyer weir excavation. The blue pipe is the CO₂ injection/static mixer used for pH adjustment. Water as tested and confirmed to be below pH 9 prior to reaching the pump (September 24, 2104).

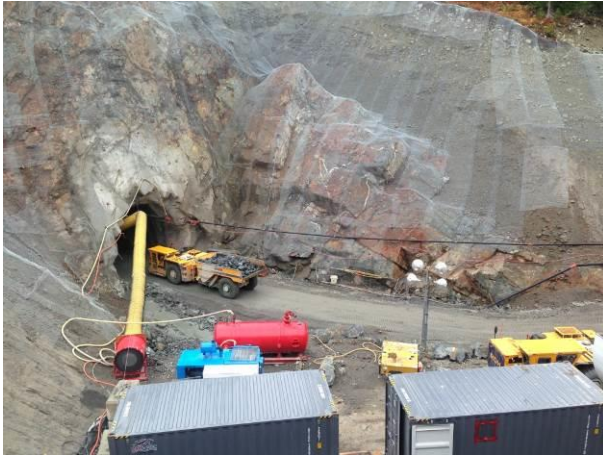
- Drilling, blasting, mucking and stabilization (anchoring and shotcrete application) continued within the tunnel (Photo). Seepage water from the tunnel portal was conveyed effectively to the settling ponds for treatment and storage.

Photo 6 – ULRHEF downstream tunnel portal (September 16, 2014).

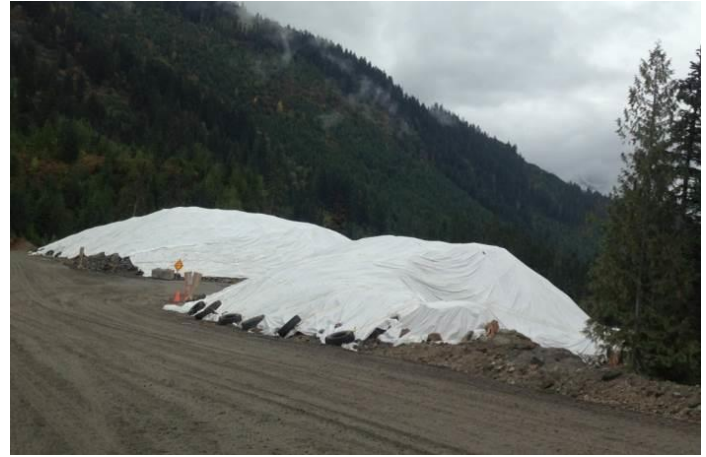
- The temporary PAG stockpiles located near the ULRHEF lower tunnel portal remained covered with an impermeable tarp to prevent rain water infiltration according to the ARD/ML Monitoring and Control Plan (Photo 7). This material will be temporarily stored in its current location until a final storage plan is presented for review and approval.

Photo 7 – Temporary PAG stockpiles located near the ULRHEF downstream tunnel portal remained covered with impermeable plastic tarps (September 26, 2014).

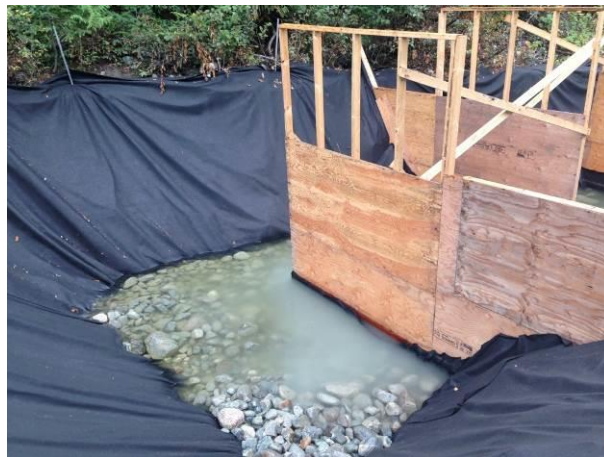
- The settling ponds (**Error! Reference source not found.**) installed adjacent to Truckwash Creek were used to treat the seepage and process water emanating from the tunnel. No surface discharge from the sediment ponds was observed this week; therefore no WQ measurements were taken by the IEM.

Photo 8 – The second ULRHEF settling pond, no discharge observed (September 26, 2014).

- Settling ponds at the downstream portal should be continually monitored to ensure appropriate treatment of seepage from tunnelling activities is occurring. With rain forecast for the upcoming reporting period, increased water volumes in the form of increased infiltration rates within the tunnel excavation may result in discharge from the ponds. The pH treatment measures currently being used for the grouting works at the ULRHEF intake diversion channel could be used for the downstream portal dewatering in the event that the treatment ponds begin to overflow and require treatment.

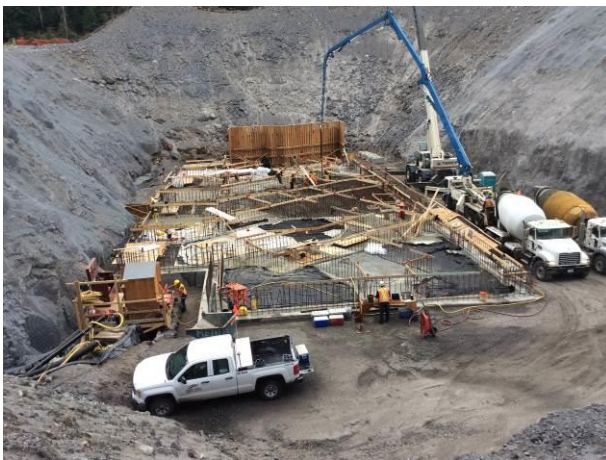
- Rebar installation and form works for the powerhouse foundation continued throughout the reporting period.
- A portion of the concrete powerhouse foundation was poured on September 22 (Photo 9).
- Two pumps (6" and 10") previously installed in the sump draining seepage waters in the powerhouse excavation continued to convey water to the existing settling ponds. No flowing surface water was observed within the excavation and pump capacity appears to be adequate to maintain isolation from active work areas.

Photo 9 – Concrete pour for ULRHEF powerhouse foundation (September 22, 2014).

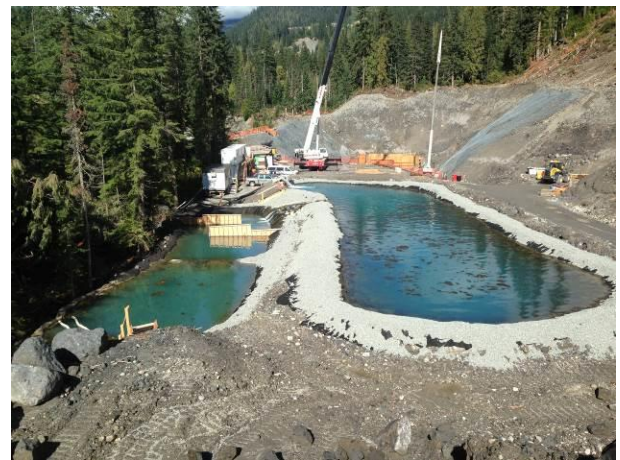
- Turbidity was visually monitored during periodic visits to the ULRHEF powerhouse by the IEM. Water entering the Lillooet River from the discharge (through vegetation) of the settling ponds remained within water quality guidelines during each inspection and concrete poured for the mud slabs and powerhouse foundation did not come in contact with the seepage water during this reporting period, as no leak in the form work were observed (Photo 10). Future opportunistic WQ sampling will be conducted at the discretion of the IEM.

Photo 2 – Settling ponds at ULRHEF powerhouse, dewatering from excavation remains isolated from concrete works (September 27, 2104).

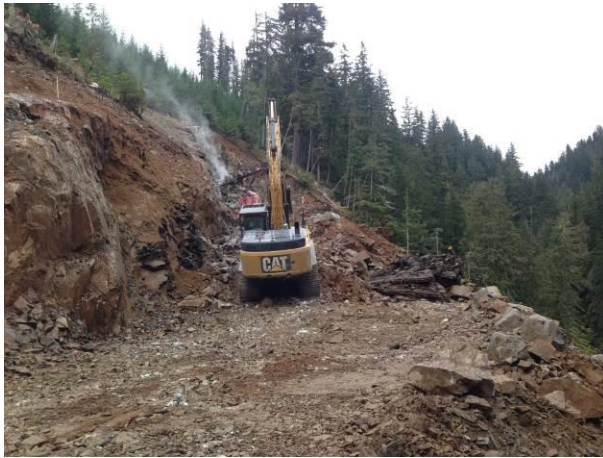
- Sequences of drilling, small controlled blasts, and blast rock excavation proceeded on the top bench of the crane pad throughout the reporting period (Photo 11). Care was taken to prevent material from escaping down the slope adjacent to the excavation.
- Intake access road construction at ~4.2km, included bulk excavation (Photo 12); material spoiling; slope contouring; drilling and blasting; and road fill/grading.

Photo 11 – BDRHEF crane pad excavation at upper pad (September 26, 2014).

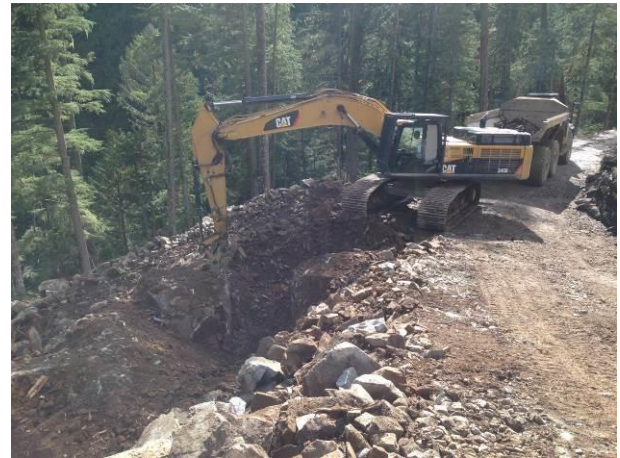
Photo 12 – BDRHEF Intake access road construction at ~4.2km (September 27, 2014).

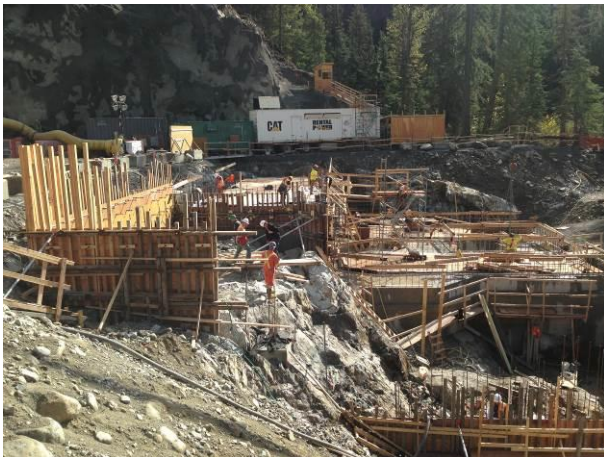
- Rebar installation and formworks (Photo) at the powerhouse continued throughout the reporting period.
- Concrete works – Powerhouse foundation pour occurred on September 26, 2014.
- Drilling, blasting, mucking and stabilization (anchoring and shotcrete application) continued within the tunnel.

Photo 13 – BDRHEF downstream tunnel portal and powerhouse rebar/formworks (September 27, 2014).

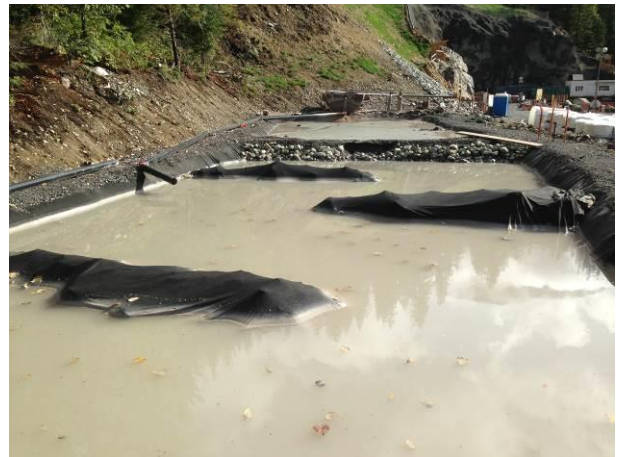
- Seepage flowing out of the tunnel continues to be collected at the portal tunnel entrance in a sump and this water is then pumped from the sump to the oil/water separator, pH adjustment holding tank, and settlement ponds for treatment. No discharge from the treatment ponds occurred during this reporting period; therefore, the IEM did not collect WQ results. The first pond is now completely full of sediment and the second pond is at full capacity (Photo 14). The maintenance of these ponds is pending the results of confirmatory samples taken to determine whether the sediment (mostly rock fines from the tunnel drilling activities) should be treated as PAG or non-PAG, as discussed with the Environmental Manager.

Photo 14 – BDRHEF powerhouse settling pond, no discharge observed; however pond #1 is now full of sediment and requires maintenance. (September 27, 2014).

- Settling ponds at the downstream portal should be continually monitored to ensure appropriate treatment of seepage from tunnelling activities is occurring. With rain forecast for the upcoming reporting period, increased water volumes in the form of increased infiltration rates within the tunnel excavation may result in discharge from the ponds. The maintenance of the ponds was discussed with CE's Environmental Coordinator and it was agreed that confirmatory samples would be taken to characterize whether the sediment/slurry (mostly rock fines from the tunnel drilling activities) should be treated as PAG or non-PAG.

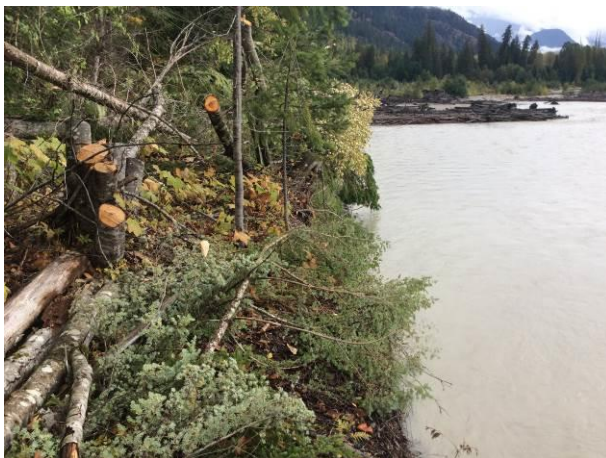
- Hand falling and slashing occurred in Segment 9, within the Lillooet River RVMA (Photo 15; Segments 5 & 6) and Pemberton Creek RVMA (Segment 14) during this reporting period.
- On September 23, Feller-Buncher clearing was performed at the crossing of the ROW and Lillooet South FSR (~ KM 7.5) within Grizzly Bear WHA 2-399 (Segment

Photo 15 – Lillooet River RVMA clearing (September 25, 2014).

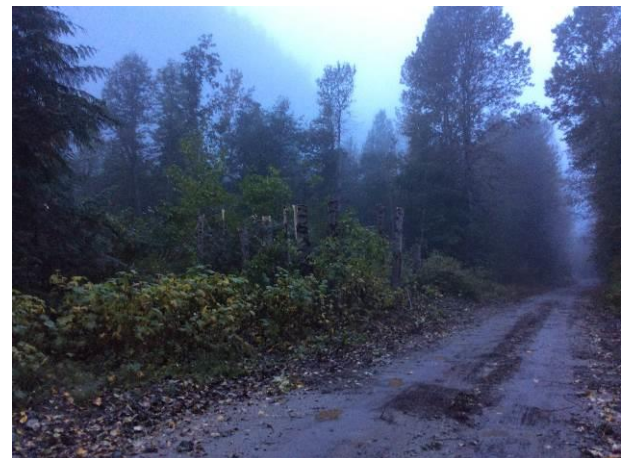
6). A Grizzly Bear Vegetated Screen was left undisturbed to the extent possible on either side of the Lillooet South FSR within Grizzly Bear WHA 2-399 (Photo 16).

Photo 16 – A Grizzly Bear Vegetated Screen adjacent to the Lillooet South FSR within Grizzly Bear WHA 2-399 (September 23, 2014).

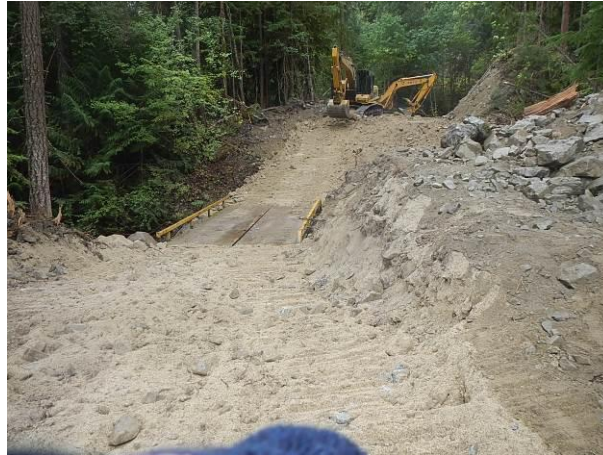
- Transmission line access road works were completed in Segments 7 – 9 and 14 during this reporting period.
- The work on the approaches (Photo 17) to the permanent bridge location and improvements to the abutment of the Blacks Creek temporary bridge installed during the previous reporting period, occurred from September 22 – 24.

Photo 17 – Work on the right bank approach for the permanent Black Creek Bridge (September 23, 2014).
