Upper Lilloet Hydro Project

Weekly Environmental Monitoring Report #41

Reporting Period: September 28 – October 4, 2014

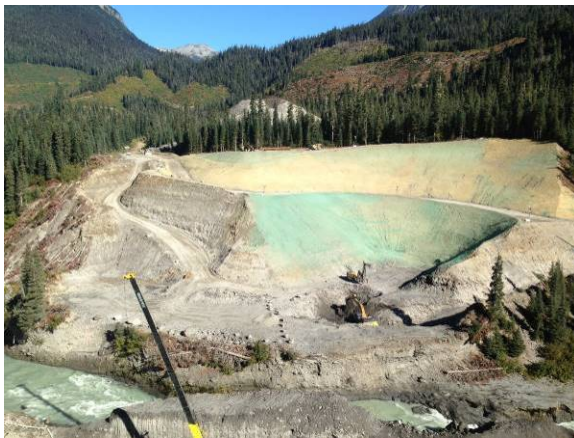
Photo 1 – Overview of the north side of the ULRHEF intake (September 28, 2014).

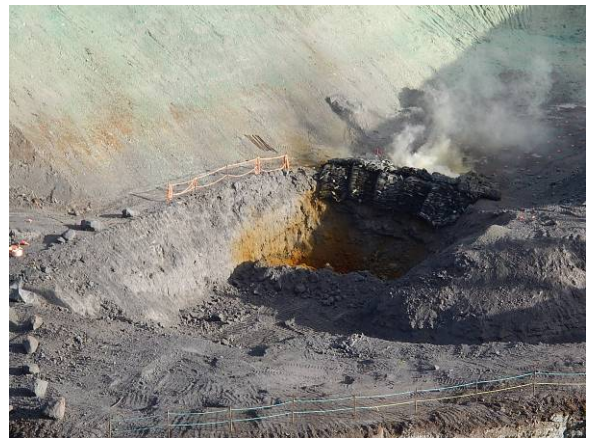
Photo 2 – ULRHEF north side tunnel portal drilling/blasting for tunnel portal (September 30, 2014).

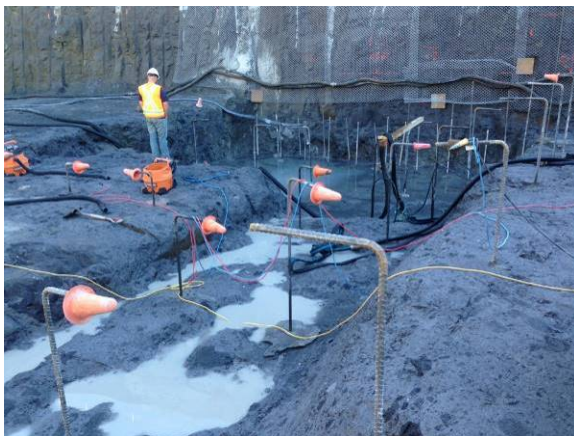
Photo 3 – ULRHEF intake diversion channel, Obermeyer weir anchors (September 28, 2014).

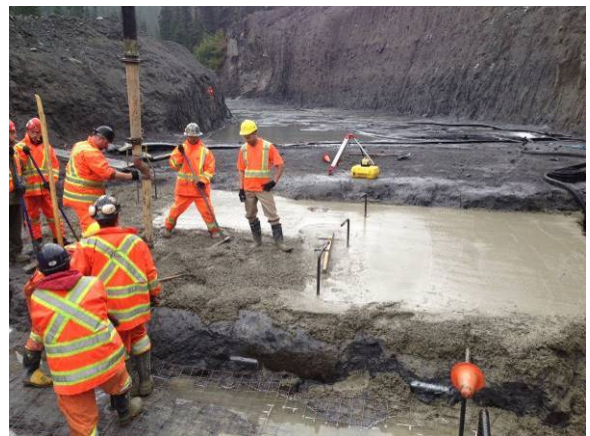
- Throughout concrete activities (anchor grouting and mud slab pours) at the Obermeyer weir, CE used used a combination of two CO₂ injection/static mixer pH treatment systems, dewatering bags and pumping/trucking of alkaline water to an infiltration/wash pit as means to ensure that water directed to the Lillooet River remained within BCWQG. The IEM was onsite full-time to monitor turbidity and pH during grouting and concrete pours, and activities were successfully managed to mitigate the potential for environmental incidents due to alkaline discharge.

Photo 4 – Obermeyer weir mud slab pour, alkaline water was treated with CO₂ injection as required system prior to discharge (September 29, 2014).

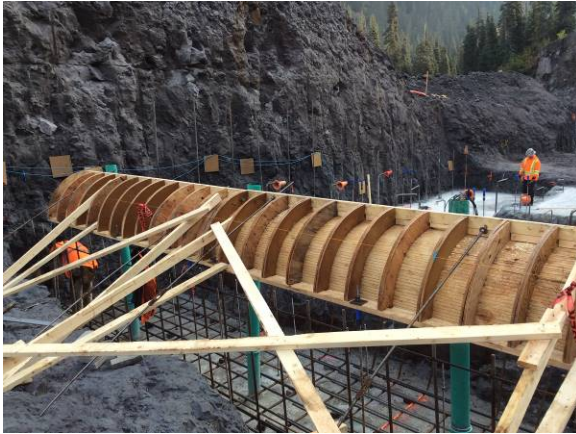
Photo 5 – ULRHEF intake diversion channel, rebar and formworks at Obermeyer weir (October 2, 2104).

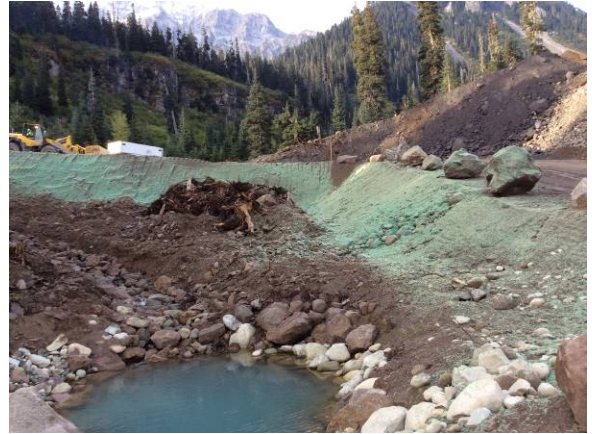
Photo 6 – Hydroseeding and drainage works near south side spoil area at ULRHEF intake (October 2, 2014).

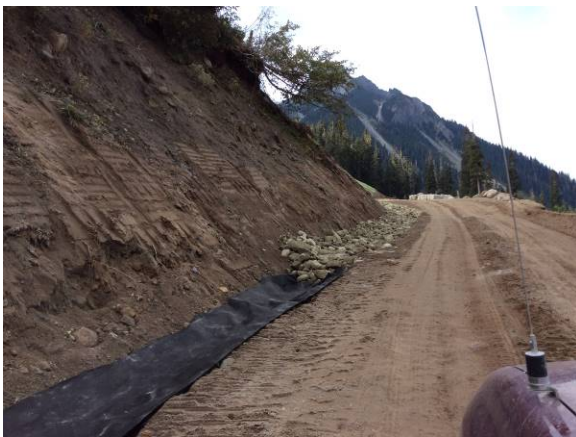
Photo 7 – Ditch lining and armoring of Lillooet River FSR on south side of ULRHEF intake (October 3, 2014).

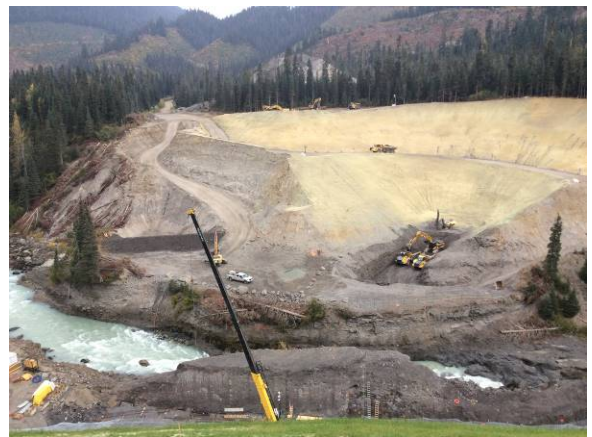
Photo 8 – ULRHEF north side drilling/blasting for tunnel portal bulk excavation and construction of settling pond (October 3, 2014).

- Bulk excavation at the north side ULRHEF intake open cut below elevation 666m will continue and is expected to come in contact with seepage water. Construction of a proposed settling pond is to be completed during the next reporting period.
- Concrete works ULRHEF intake Obermeyer weir will continue for the structure foundation and walls.
- Grubbing and bulk excavation to commence along the ULRHEF penstock alignment following completion of clearing and issuance of the LTC.

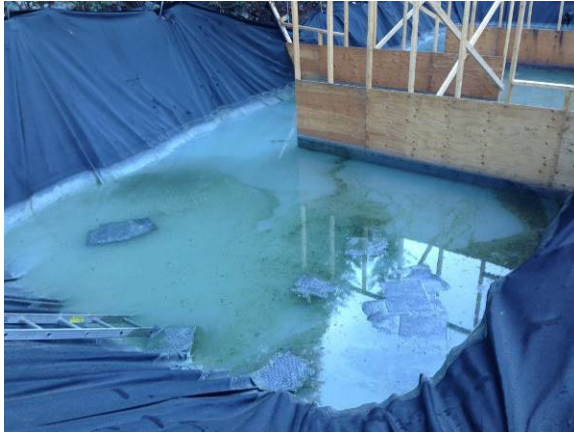
- On September 27 a mining scoop working within the ULRHEF downstream spilled hydraulic oil from a failed hose. Due to the nature of tunnel activities and the management of wastewater the oil was conveyed to the water treatment system. The majority of contaminants was captured in the oil/water separator, however due to heavy sediment load and modifications undertaken by the contractor to the separator, a small portion (IEM estimated it to be <5L) of the hydraulic fluid was

Photo 9 – ULRHEF downstream portal settling ponds following spill within tunnel, no discharge from ponds (September 28, 2014)

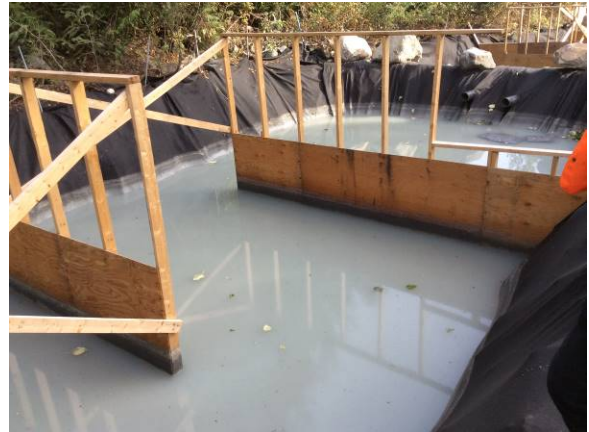
Photo 10 – ULRHEF downstream portal settling ponds following cleanup efforts, no visual or olfactory signs of hydrocarbons remained (October 2, 2014).

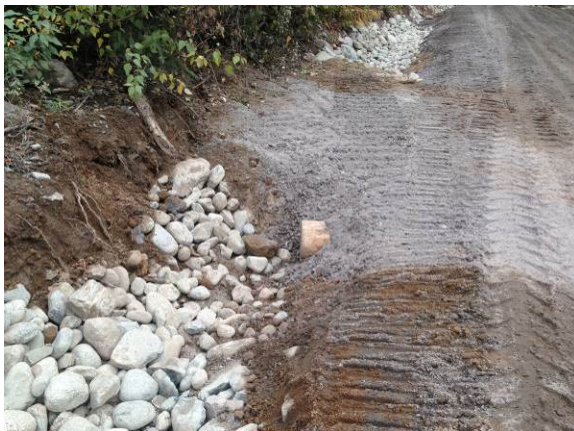
- On September 29, the IEM issued *FAM04* (attached) to address ESC concerns at the ULRHEF downstream portal access road regarding road surface run-off and ineffective ditching. Further discussion took place in the field and general recommendations were made by the IEM that included disbursement of flows from within the high-side ditch line via ditch blocks and drainage culverts to convey water during rain events and spring melt to vegetation on the low side of the permanent access road, and road capping. CE implemented a series of mitigations (Photo 11 and Photo 12) during this reporting period and the IEM will continue to monitor the effectiveness.

Photo 11 – ULRHEF downstream tunnel portal access road, drainage works included ditch block and culvert installation (October 1, 2014).

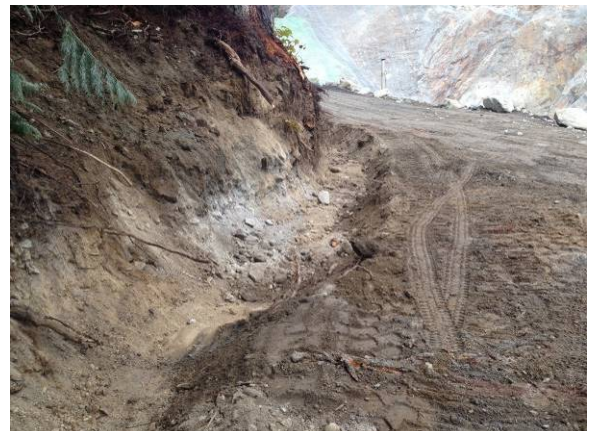
Photo 12 – French drain installation of ULRHEF downstream tunnel portal access road, woods side (October 1, 2014).

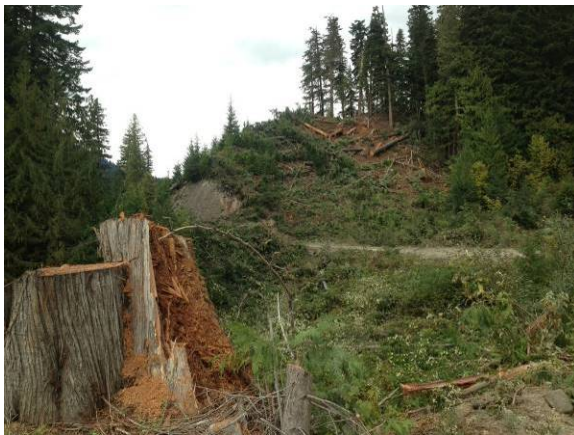
Photo 13 – ULRHEF penstock clearing (October 1, 2014).

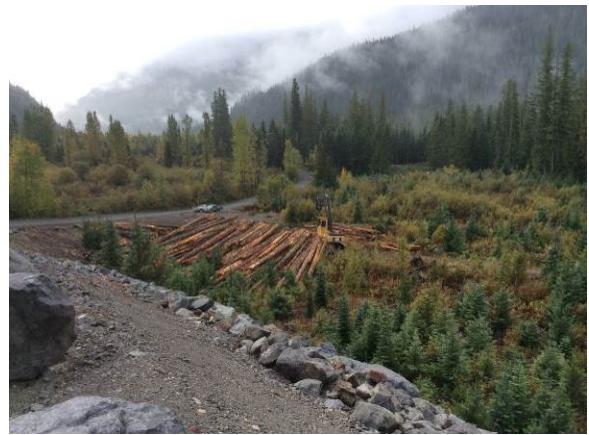
Photo 14 – Yarding and roadside decking at KM 42.5 (October 4, 2014).

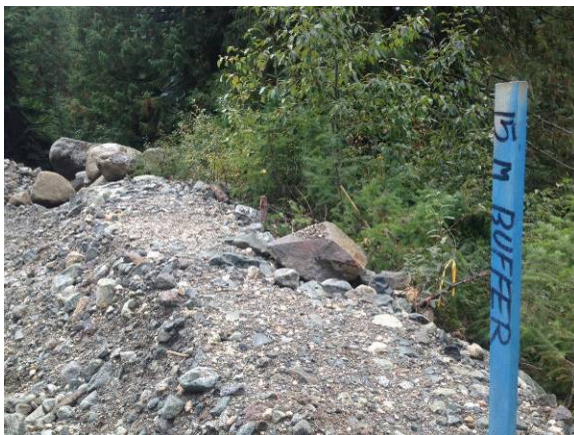
- The IEM was onsite to monitor clearing activities within 15m of non-CTF watercourses (Photo 15) and 30m of CTF watercourses. No environmental issues were observed.
- On September 30, Ecofish performed a survey/sweep for CTF within 30m of ULL-ASTR04 prior to clearing activities. During the survey/sweep some sediment deposition was noted within the watercourse. The sediment source was determined to be road drainage from the old Lillooet River FSR alignment. Following identification of the source CE repaired the silt fence at the input location and added rock blast to the road to prevent further erosion of the road surface and sediment transport to the creek.

Photo 15 – Surveyed 15m buffer on Truckwash Creek in preparation for ULRHEF penstock clearing (September 28, 2014).

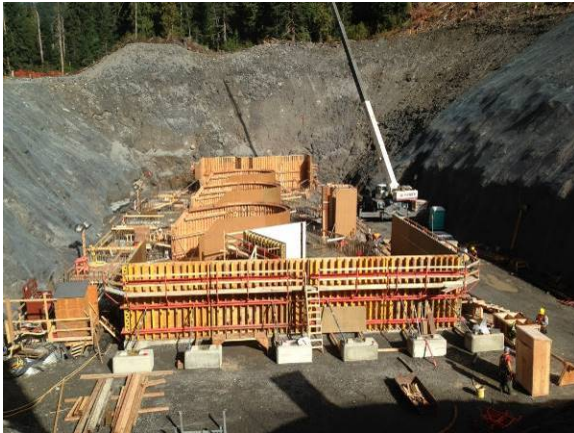
- Rebar installation and form works for the powerhouse foundation continued throughout the reporting period (Photo 16 and Photo 17).
- Two pumps (6" and 10") previously installed in the sump draining seepage waters in the powerhouse excavation continued to convey water to the existing settling ponds. No flowing surface water was observed within the excavation and pump capacity appears to be adequate to maintain isolation from active work areas.

Photo 16 – Current conditions at ULRHEF powerhouse (September 30, 2014).

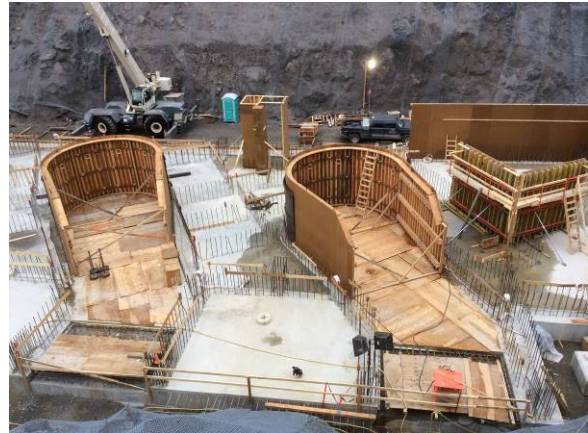
Photo 17 – Continued rebar and formworks at ULRHEF powerhouse (October 3, 2014).

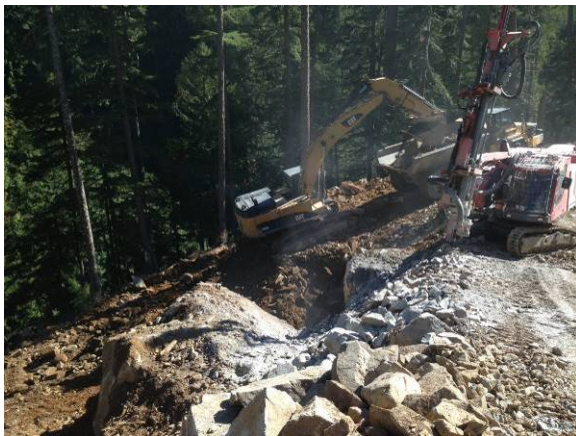
Photo 18 – BDRHEF crane pad excavation and drilling/blasting at top level of crane pad (September 28, 2014).

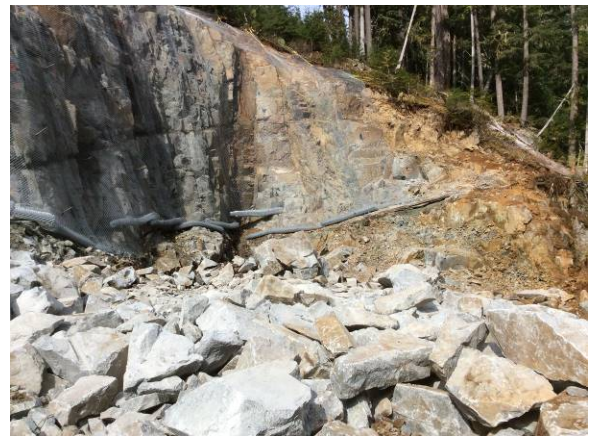
Photo 19 – BDRHEF crane pad wire mesh installation for slope stabilization (October 2, 2014).

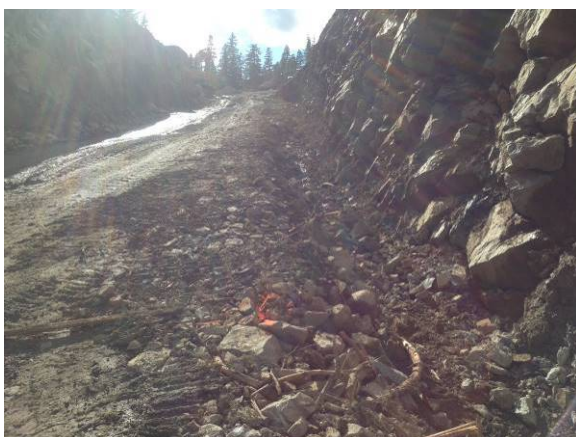
Photo 20 – BDRHEF Intake access road construction including ditching (September 30, 2014).

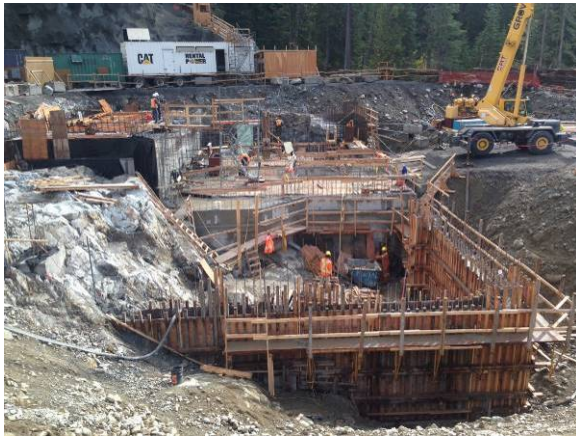
Photo 21 – Current conditions at BDRHEF powerhouse, continued rebar/formworks (September 30, 2014).

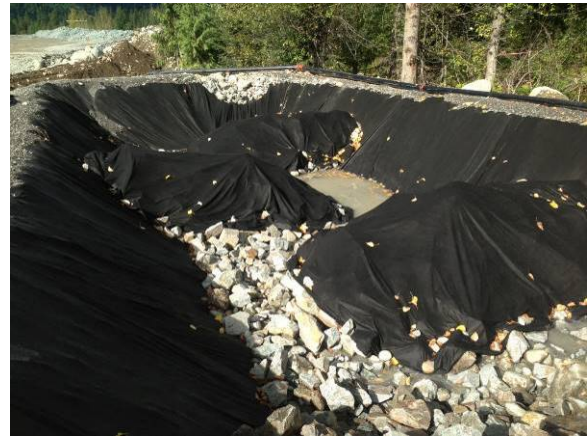
Photo 22 – BDRHEF powerhouse settling pond, no discharge observed; however pond #1 remains full of sediment and requires maintenance. (September 30, 2014).

- Settling ponds at the downstream portal should be continually monitored to ensure appropriate treatment of seepage from tunnelling activities is occurring. With rain forecast for the upcoming reporting period, increased water volumes in the form of increased infiltration rates within the tunnel excavation may result in discharge from the ponds. The maintenance of the ponds was discussed with CE's Environmental Coordinator and it was agreed that confirmatory samples would be taken to characterize whether the sediment/slurry (mostly rock fines from the tunnel drilling activities) should be treated as PAG or non-PAG. Results are expected in the next reporting period.

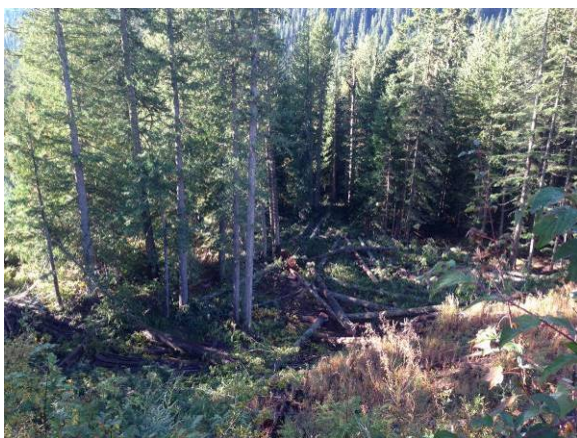
Photo 23 – Segment 7 RVMA clearing (September 30, 2014).

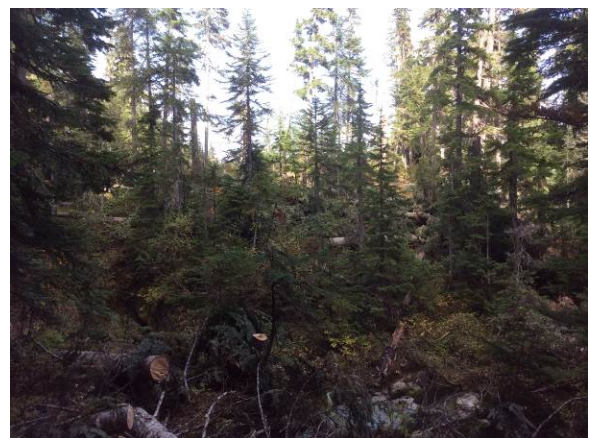
Photo 24 – Segment 14 RVMA clearing (October 3, 2014).

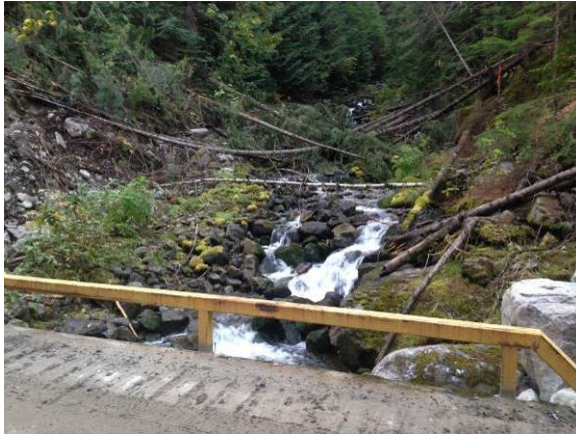
Photo 25 – Segment 8, Black Creek looking upstream from temporary bridge crossing to permanent location during pre-work meeting (October 1, 2014).

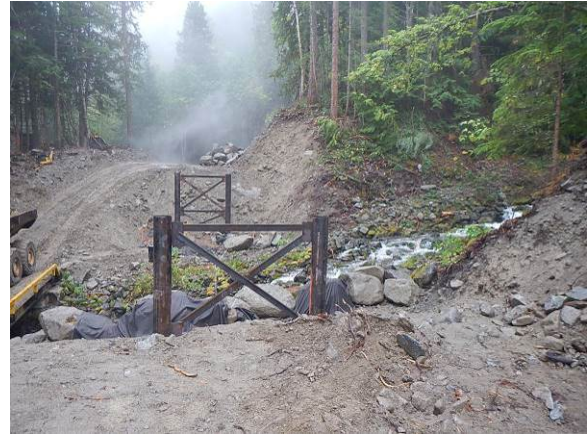
- Construction activities for the installation of the permanent bridge over Black Creek were monitored fulltime during the reporting period. The installation did not involve any instream works and no fording of machinery was required. Water quality remained visually unaffected throughout the work activities and no environmental concerns were noted.
- The IEM was present as required when clearing activities occurred within 150m of wetlands, 15m RVMAs (30m for CTF streams), 100m of Coastal Tailed Frog Streams, Class 1 & 2 suitable Grizzly Bear WHA and/or suitable forage habitat, moose and deer UWR, and within legally designated Old Growth Management Areas (OGMAs). All flagged boundaries were respected during clearing activities. No environmental issues were observed.

Photo 26 – Segment 8, construction of Black Creek permanent bridge (October 4, 2014).

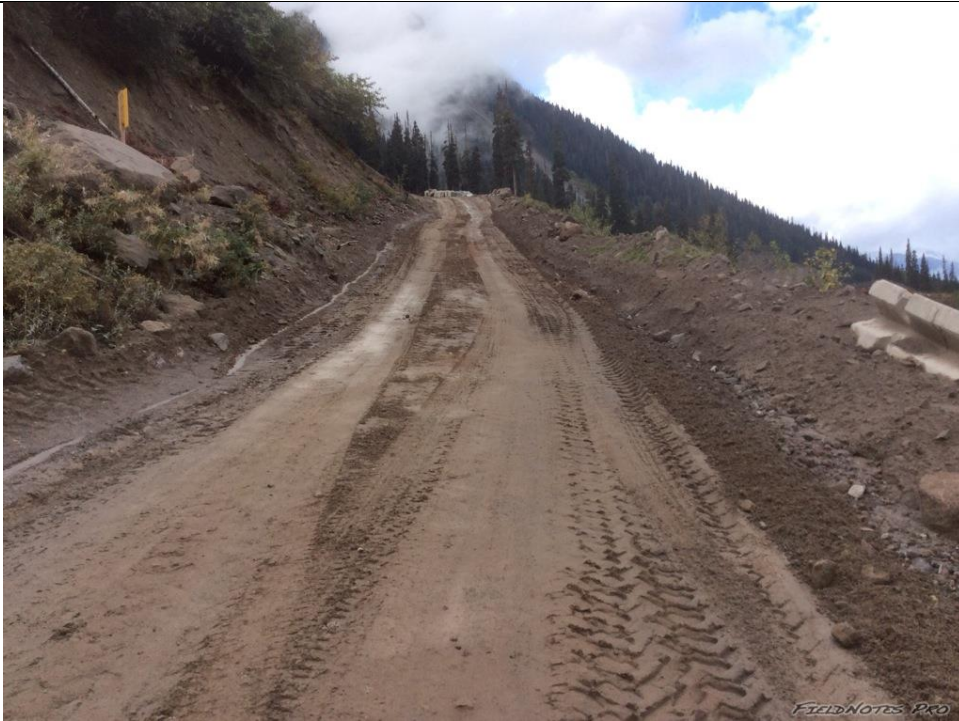
Photo 1. South side access road surface runoff causing erosion must be mitigated. Ditching and check dam installation is recommended.

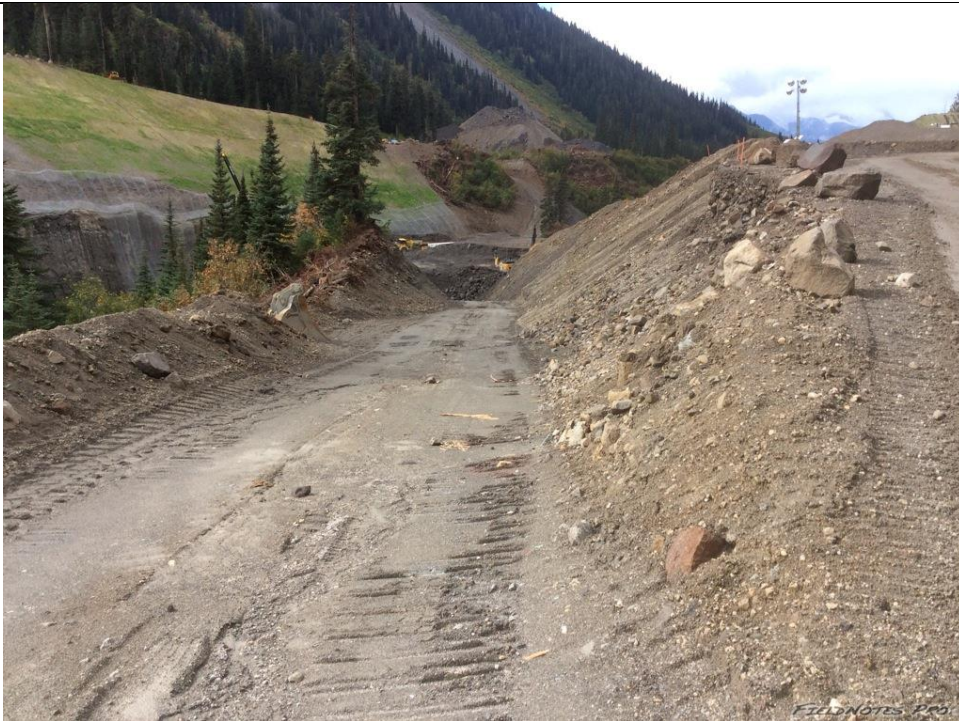
Photo 2. North side upstream portal access road surface runoff causing erosion must be mitigated. Ditching and check dam installation is recommended.

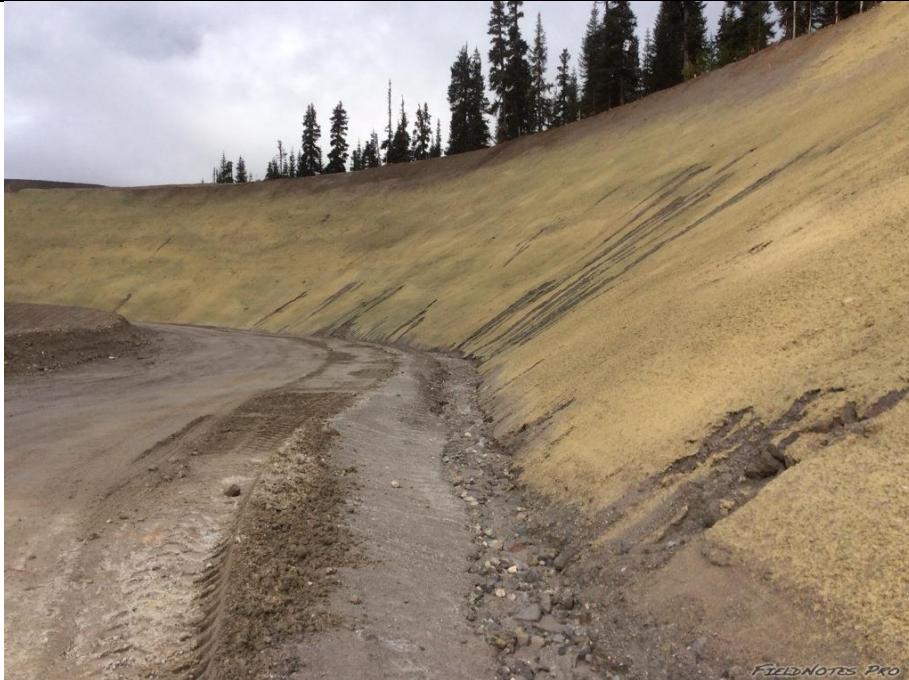
Photo 3. Rilling and gully erosion forming on the north side/upstream portal excavation cut slopes. The installation of velocity dissipation slope breaks to slow surface runoff or the application of a hydro-mulch better suited to the slopes (BFM or FGM) is recommended. Ditches should be cleaned and check dams installed/maintained as required. Erosion of the ditch line is not currently achieving intended ESC goals.

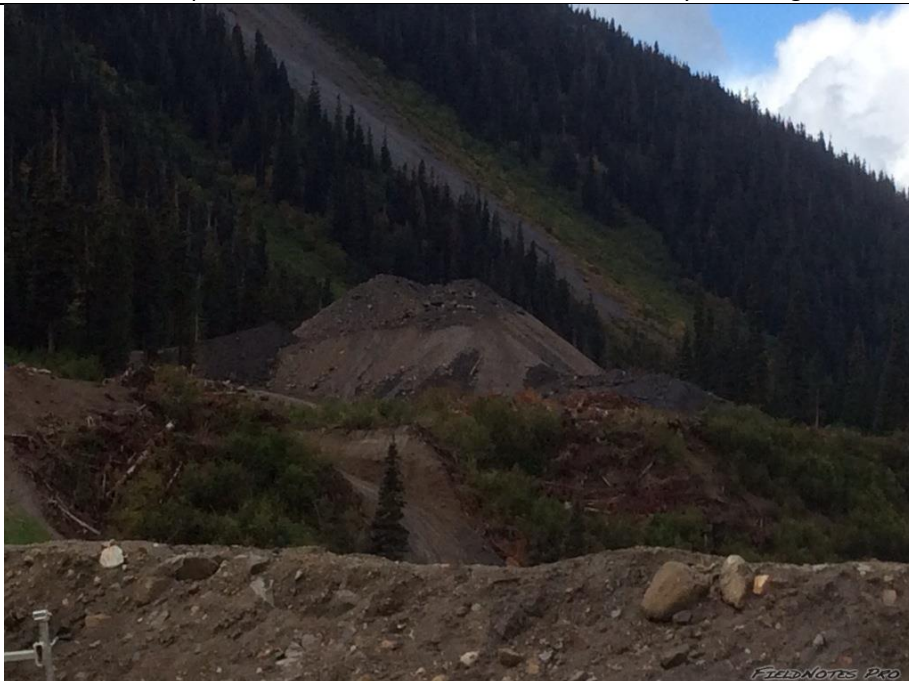
Photo 4. The south spoil area at the ULRHEF intake requires material consolidation, erosion protection and drainage installation to prevent further erosion and the generation of sediment laden runoff. Recommend contouring to final design slopes, capping final slopes with organic material and hydro-seeding as a temporary ESC protection measure (with slope appropriate mulch type), until the final reclamation prescription is presented and approved.

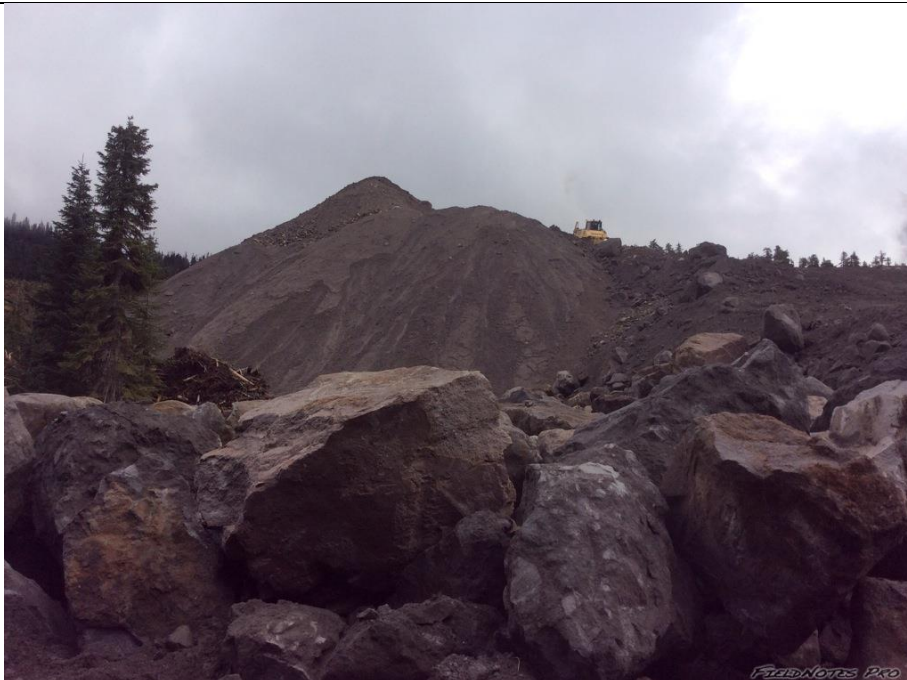
Photo 5. The north spoil area at the ULRHEF intake requires material consolidation, erosion protection and drainage installation to prevent further erosion and the generation of sediment laden runoff. Recommend contouring to final design slopes, capping final slopes with organic material and hydro-seeding as a temporary ESC protection measure (with slope appropriate mulch type), until the final reclamation prescription is presented and approved.

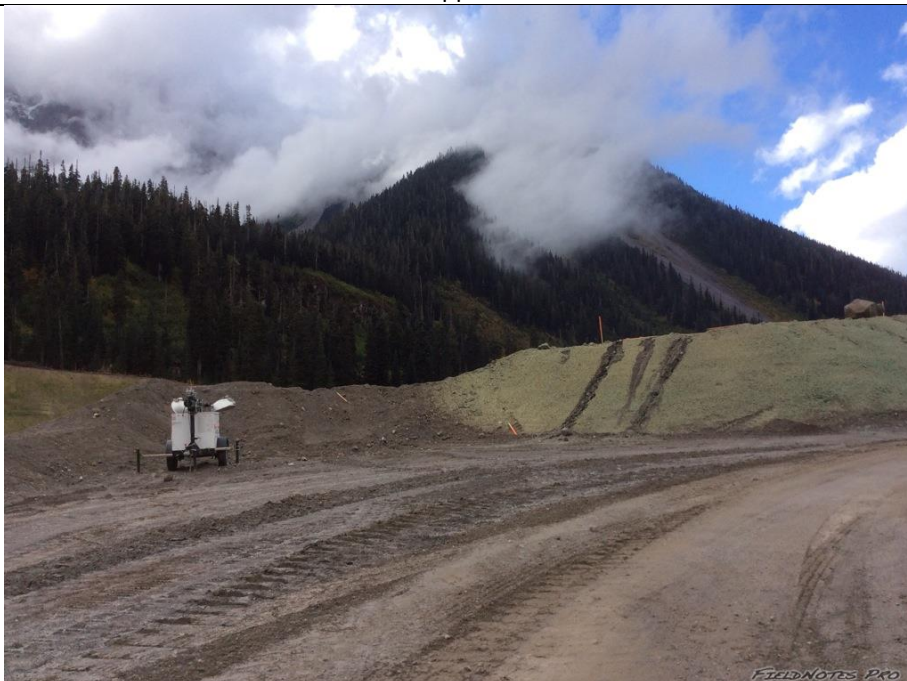
Photo 6. Rilling and gully erosion forming on the north side/upstream portal excavation cut slopes. The installation of velocity dissipation slope breaks to slow surface runoff or the application of a hydro-mulch better suited to the slopes (BFM or FGM) is recommended. Ditches should be cleaned and check dams installed/maintained as required. Erosion of the ditch line is not currently achieving intended ESC goals.

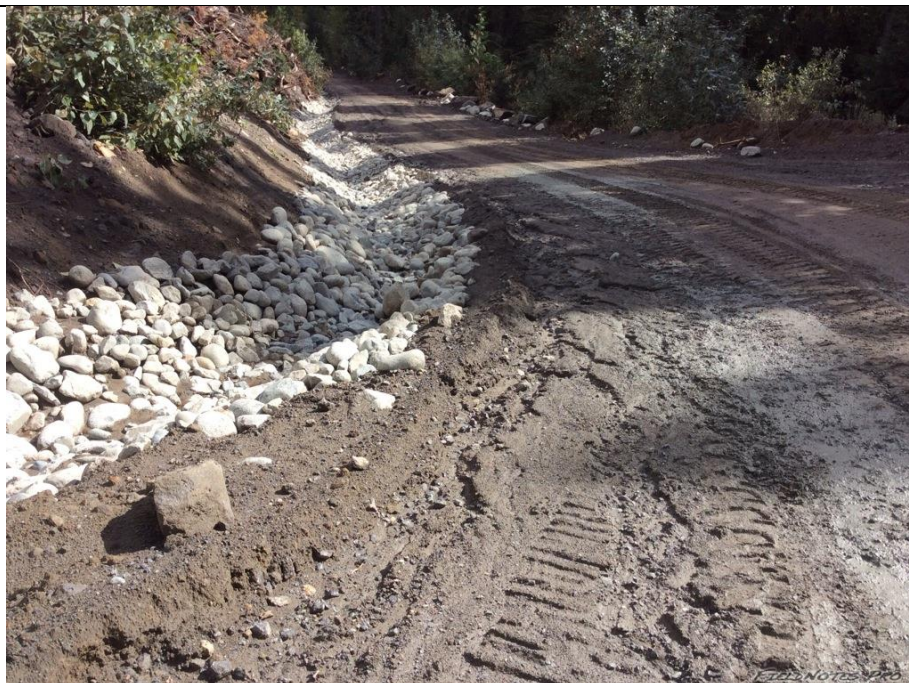
Photo 7. Ditches are not collecting and transporting road runoff as intended due to the road grading along the lower ULRHEF tunnel portal access road. Regrading of the road surface is recommended to direct runoff to the road side ditch and check dam installation is recommended to slow water velocities along the steep sections and permit sediments to drop out of suspension in the ditch line.

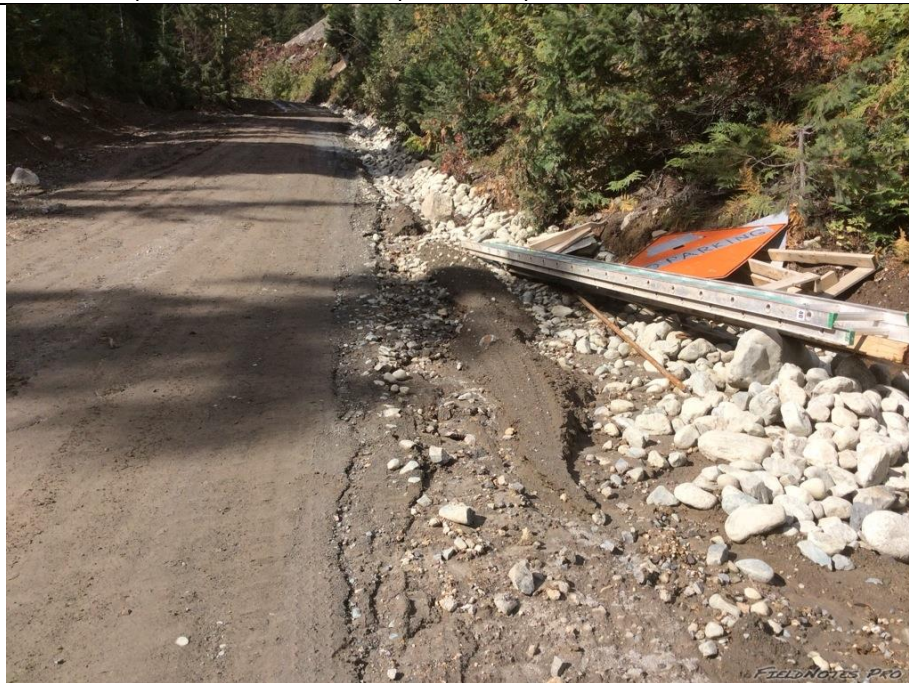
Photo 8. . Ditches are not collecting and transporting road runoff as intended due to the road grading along the lower ULRHEF tunnel portal access road. Regrading of the road surface is recommended to direct runoff to the road side ditch and check dam installation is recommended to slow water velocities along the steep sections and permit sediments to drop out of suspension in the ditch line.

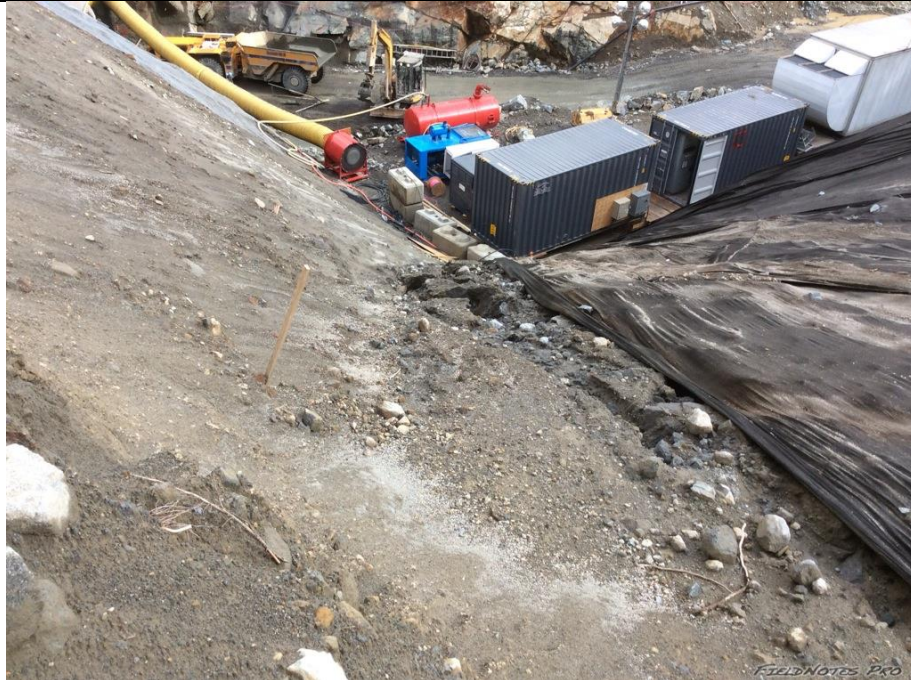
Photo 9. Gully erosion forming where road runoff flows over the edge of the slope into the ULRHEF lower portal work area. Directing road runoff away from this slope and installing slope protection to prevent further erosion is recommended.

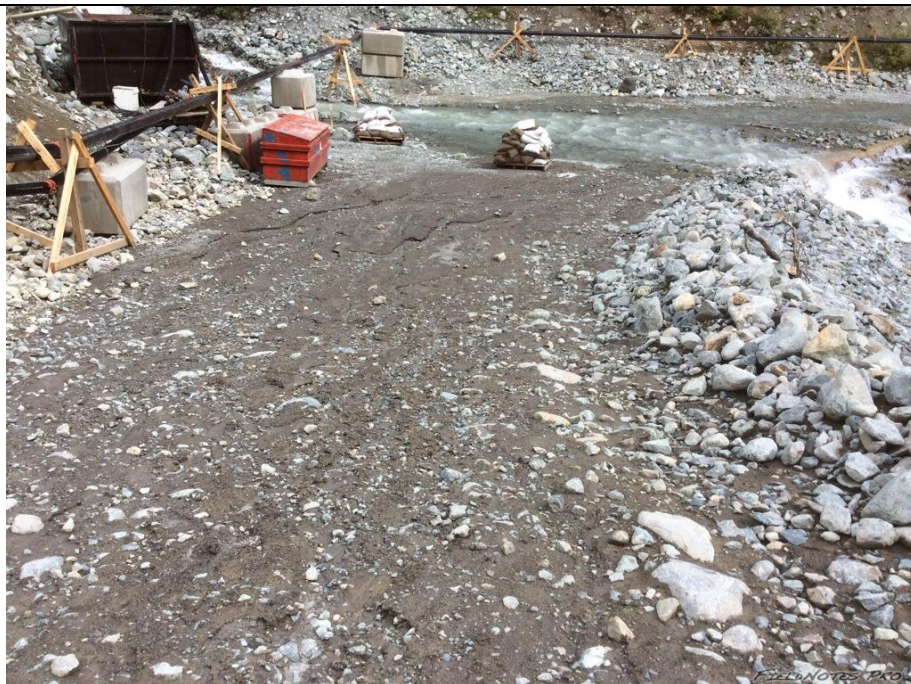
Photo 10. The ULRHEF lower tunnel portal access road drainage discharges directly to Truckwash Creek. Ditch improvements and road grading is required to protect surface water quality.

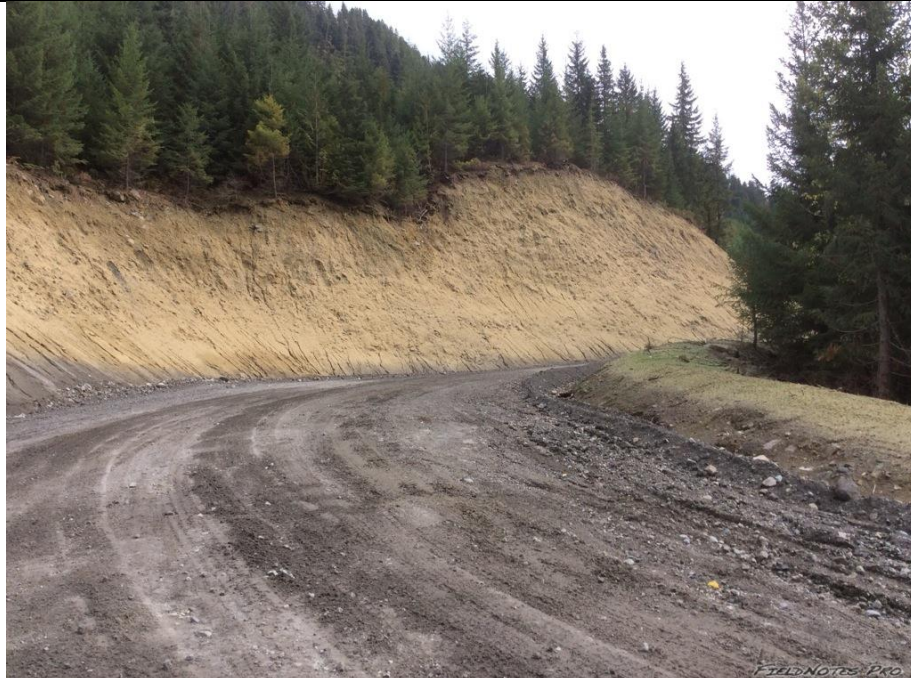
Photo 11. Ditch improvement, road grading to direct surface runoff to the ditch line, and slope erosion protection (to prevent further rill erosion) is recommended at the start of the Truckwash Creek FSR realignment (~42.75 km).

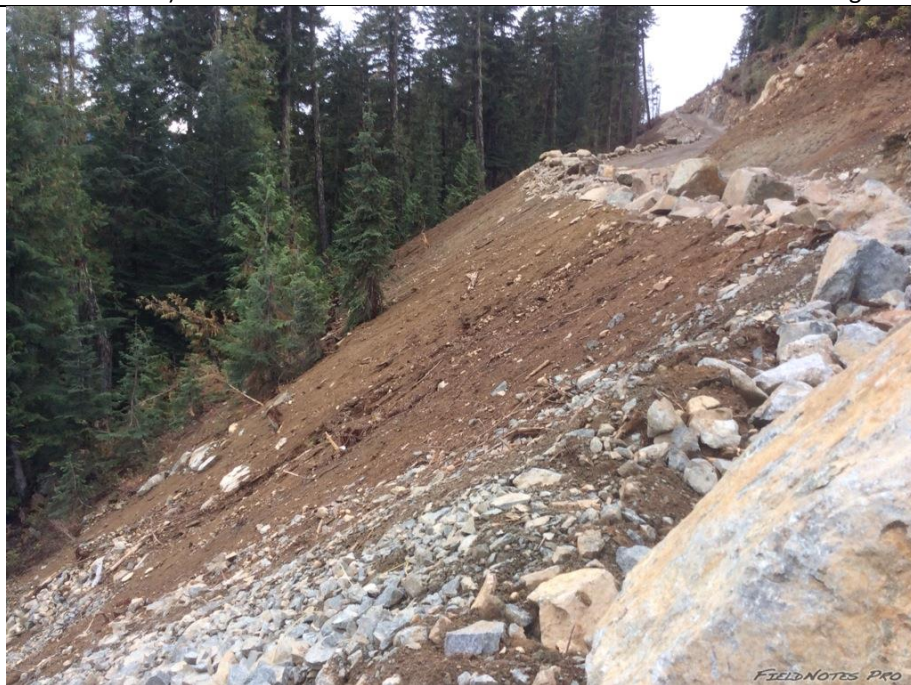
Photo 12. Newly contoured/completed slopes along the BDRHEF intake access road required erosion protection (example 1)

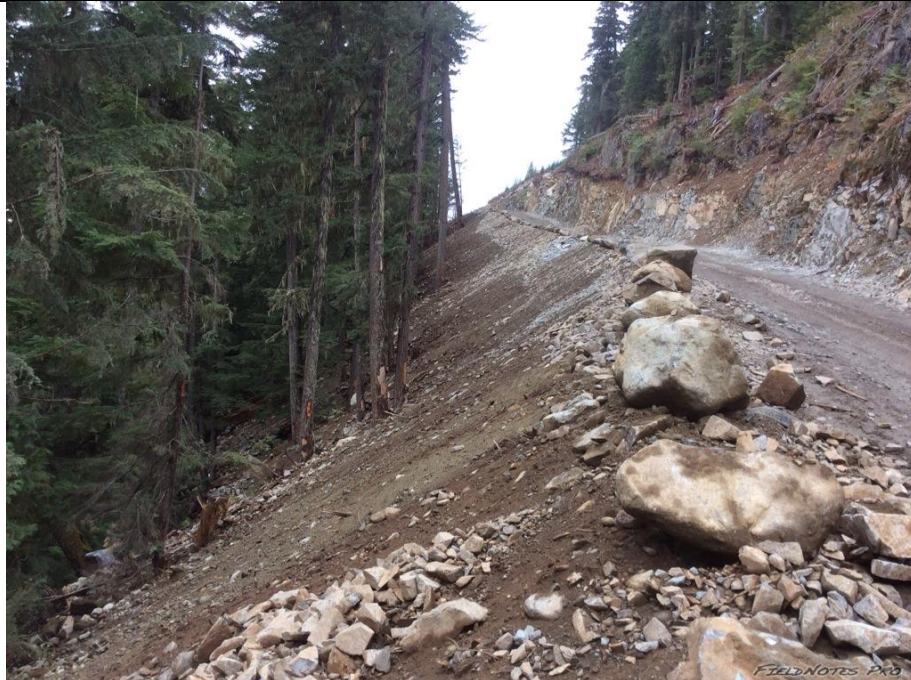
Photo 13. Newly contoured/completed slopes along the BDRHEF intake access road required erosion protection (example 2)

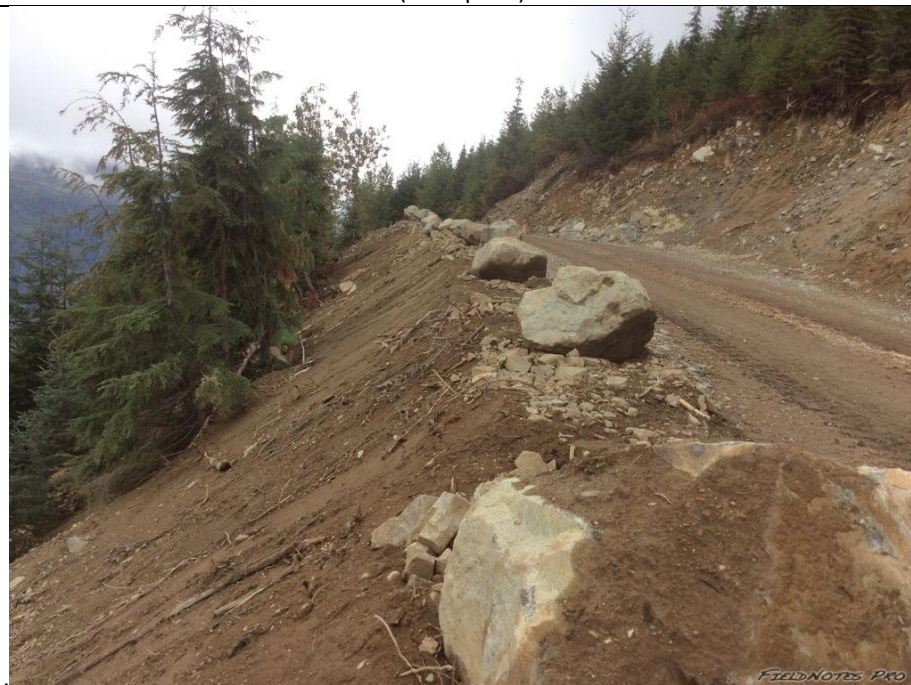
Photo 14. Newly contoured/completed slopes along the BDRHEF intake access road required erosion protection (example 3)

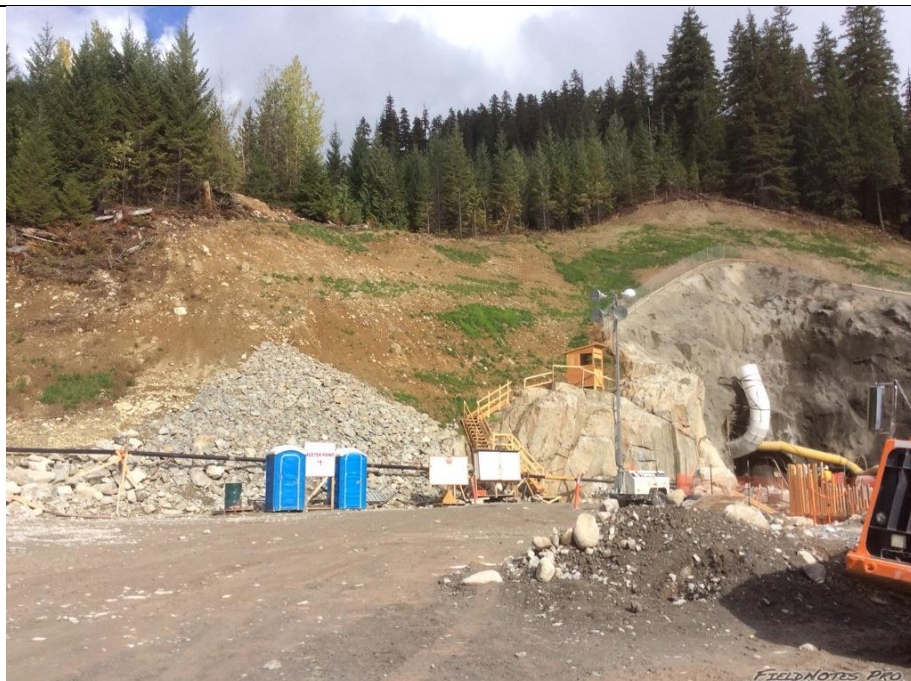
Photo 15. Slope stabilization measures required at the BDRHEF lower tunnel portal where hydro-seeding has been unsuccessful.

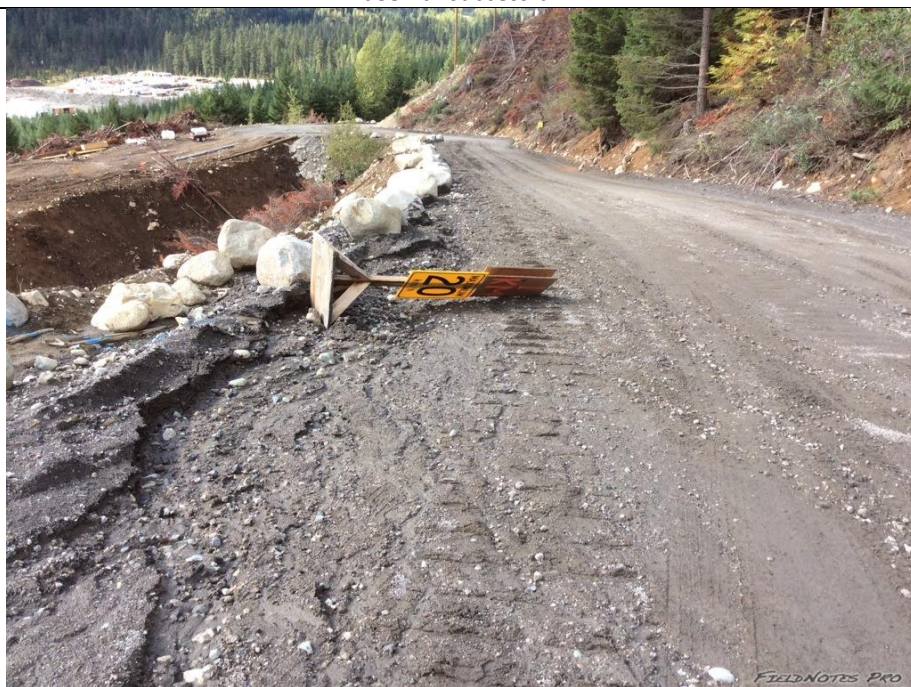
Photo 16. Road grading and ditch installation along the length of the camp access road/pebble main (~1.25km) is required to direct and convey road surface runoff to prevent further erosion. Check dams installation is recommended in steeper sections to prevent ditch line erosion and permit sediments to drop out of suspension.

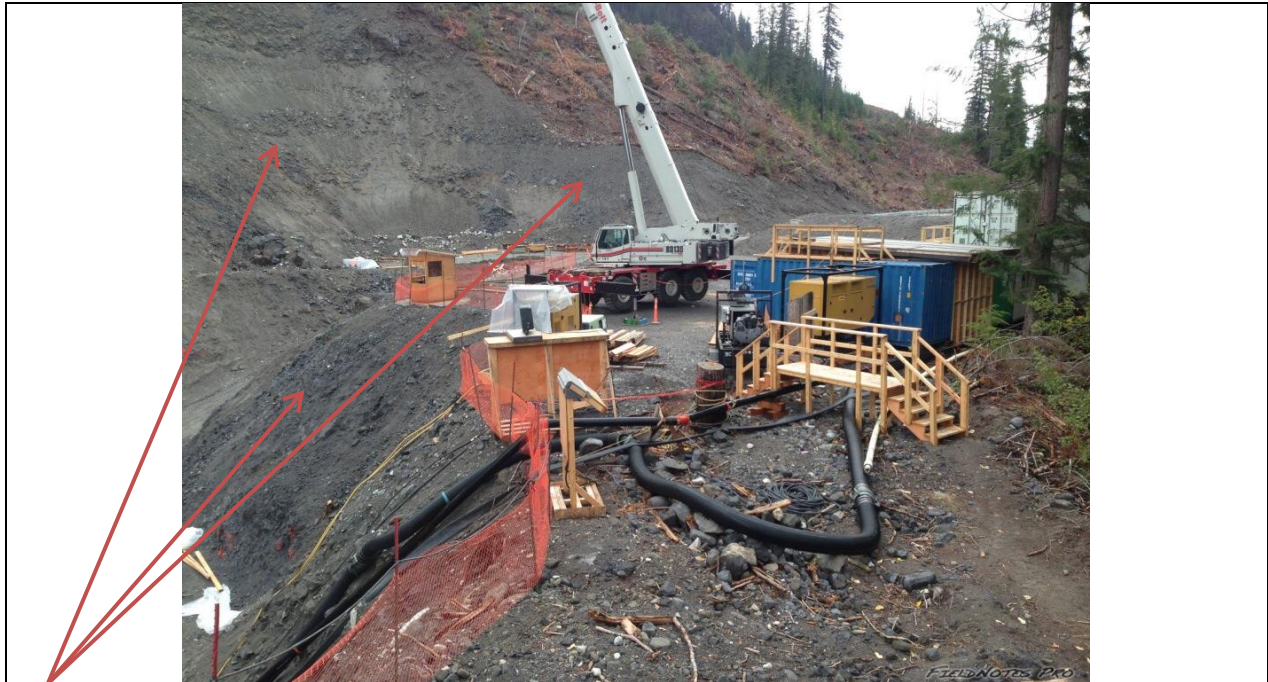
Photo 17. Slope stabilization measures required at the ULRHEF powerhouse cut slopes to protect against erosion. Recommendations include the application of hydro-seed with appropriate mulch product (BFM or FGM) for the upper (final slopes) and covering temporary slopes (below powerhouse backfill elevation) with poly-sheeting.

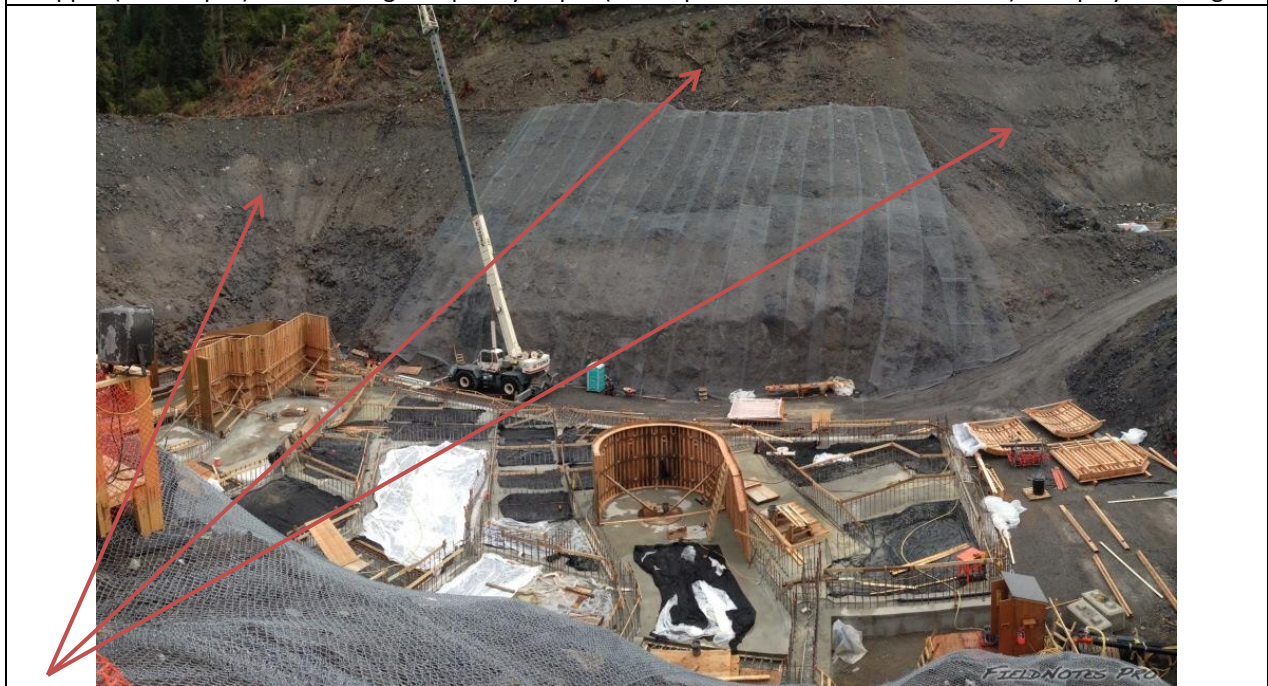
Photo 18. Slope stabilization measures required at the ULRHEF powerhouse cut slopes to protect against erosion. Recommendations include the application of hydro-seed with appropriate mulch product (BFM or FGM) for the upper (final slopes) and covering temporary slopes (below powerhouse backfill elevation) with poly-sheeting.
