# Upper Lillooet Hydro Project

## Weekly Environmental Monitoring Report #42

Reporting Period: October 5 – October 11, 2014

Upper Lillooet River Hydroelectric Facility (Water File No. 2002561, Water licence No. C130613),  
Boulder Creek Hydroelectric Facility (Water File No. 2003049, Water licence No. C129969) &  
Transmission Line (TX Line)

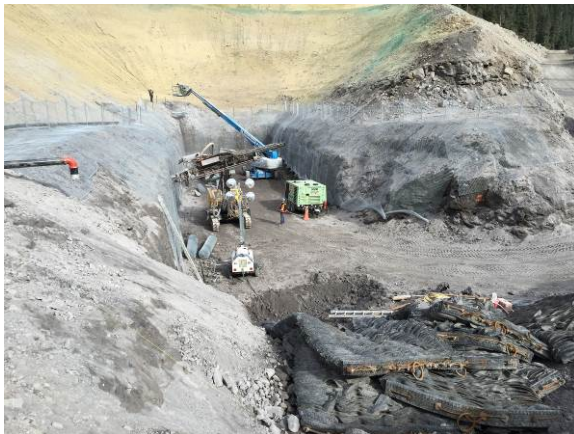
**Photo 1 – Overview of wire mesh and rock anchor installation at the north side of the ULRHEF intake (October 9, 2014).**

- Rock anchor and wire mesh installation occurred throughout this reporting period on the vertical walls of the tunnel portal excavation (Photo 1).
- Construction of a settling pond began at the intake (north side) on October 5, and was completed and commissioned on October 10 (Photo 2). Prior to beginning construction the IEM expressed concerns with the pond’s ability to treat sediment laden seepage from the tunnel portal excavation. No discharge from the sediment ponds was observed on October 10 or October 11. The IEM will continue to monitor any discharge to the Lillooet River to document adherence to Surface Water Quality Guidelines.

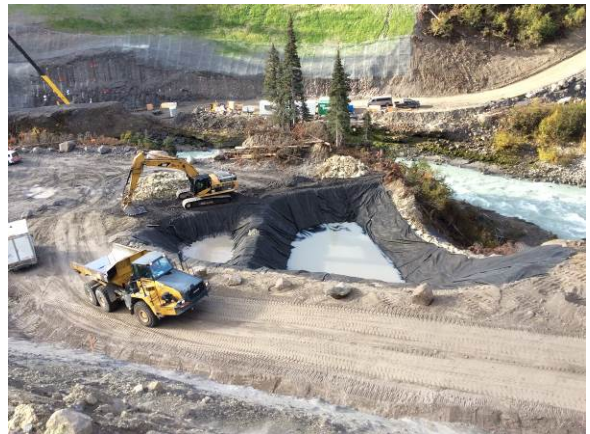
**Photo 2 – ULRHEF north side sediment pond (October 10, 2014).**

- Bulk excavation (including drilling and blasting) continued at the ULRHEF upstream tunnel portal below elevation 666m once the sediment pond installation was completed. (Photo 2 and 8).

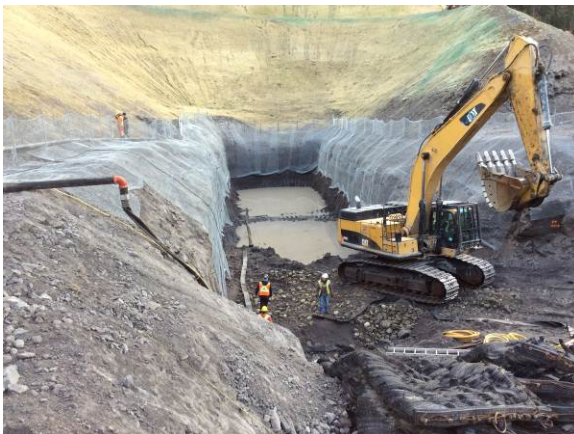
**Photo 3 – ULRHEF intake tunnel portal excavation, once seepage was encountered (October 10, 2014).**

- ULRHEF intake north side bulk excavation – Communications continued in regards to ongoing treatment of potentially sediment laden water when drilling/blasting activities (and subsequent tunnel activities) reach elevations where seepage water entering into the excavation needs to be actively managed (via pump) and treated prior to discharge to the Lillooet River. Following an alteration to the Work Plan pertaining to the location and usage of a sediment pond, the IEM reinforced the importance of adequately treating water to within acceptable BCWQG prior to discharge and recommended that if proposed/implemented treatment could not maintain BCWQG then a more robust system would be required.

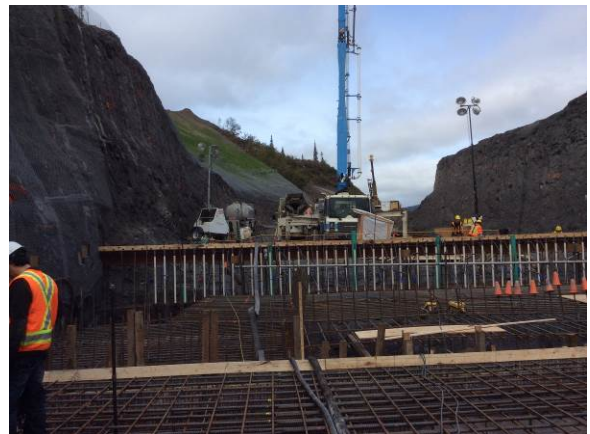
**Photo 4 – Obermeyer weir structure pour, alkaline water was treated with CO<sub>2</sub> injection as required system prior to discharge (October 5, 2014).**

- Throughout concrete activities (concrete pour, and concrete curing) at the Obermeyer weir, CE used a combination of two CO<sub>2</sub> injection/static mixer pH treatment systems, dewatering bags and pumping/trucking of alkaline water to an infiltration/wash pit as means to ensure that water directed to the Lillooet River remained within BCWQG. The IEM was onsite full-time to monitor turbidity and pH during the concrete pour and concrete wet curing, and activities were successfully managed to mitigate the potential for environmental incidents due to alkaline discharge.
- On September 29, the IEM issued *FAM04* to address ESC concerns at the ULRHEF intake. Primary concerns included slope protection and ditch

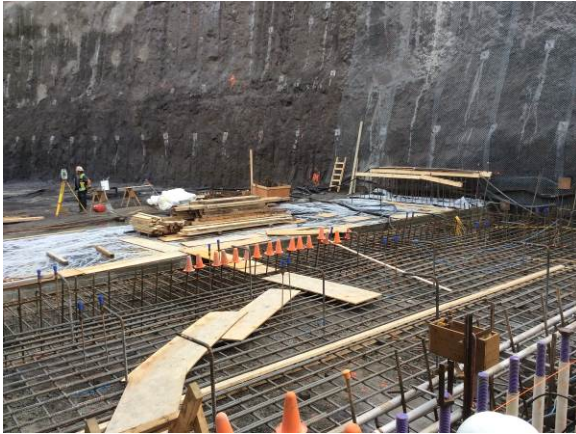
**Photo 5 – ULRHEF intake diversion channel, rebar and formworks at Obermeyer weir (October 7, 2014).**

- ULRHEF intake diversion channel (south side) activities focused on construction of the Obermeyer Weir. Concrete for the base of the weir structure was poured on October 5 (Photo 4). Following the pour, wet curing of the concrete proceeded. Once the concrete sufficiently set, rebar and formworks (Photo 5) resumed for the weir structure and continued throughout the remainder of the week.

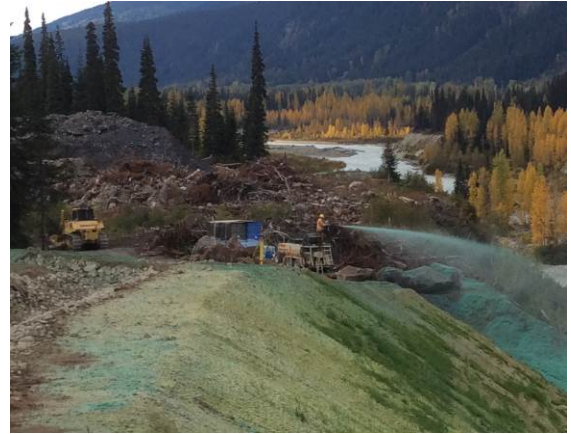
**Photo 6 – Hydroseeding and drainage ditch works above the south side cut slope at ULRHEF intake (October 7, 2014).**

- Installation of cut-off ditch above the south side cut slope and hydroseeding of the area once the ditching was completed (Photo 6)
- Maintenance of ditches along the north and south side intake access road and Lillooet River FSR (Photo 7)
- Construction of a sediment pond on the north side of the Upper Lillooet River adjacent to the upstream tunnel portal excavation (Photo 2)
- Outstanding issues from *FAM04* pertaining to slope stabilization and spoil pile winterization at the ULRHEF intake have been included in the Project's ITM as *ULR#20 – open*. The IEM continues to monitor construction activities within 30m of the Lillooet River during day and night shifts.

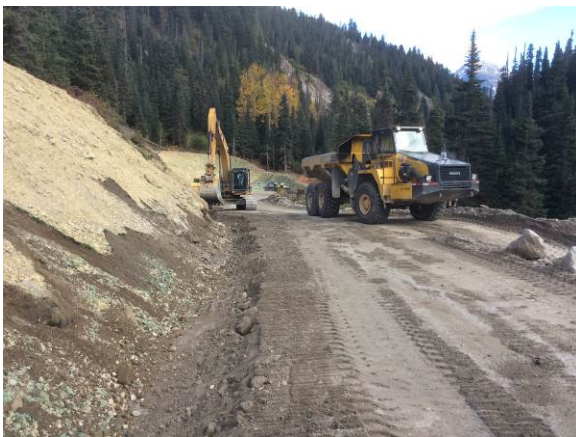
**Photo 7 – Ditch improvements along the north side intake access road (October 8, 2014).**

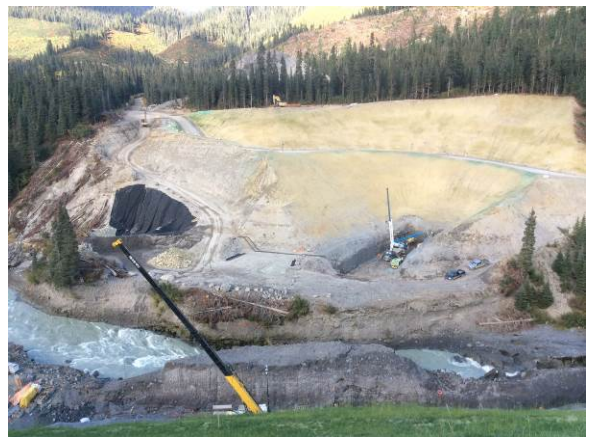
**Photo 8 – ULRHEF north side overview (October 8, 2014).**

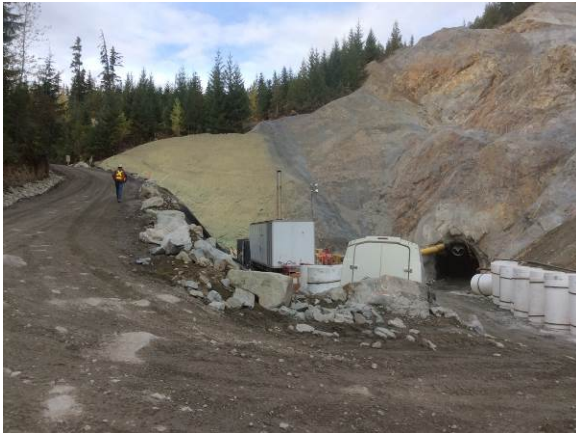
**Photo 9 – ULRHEF downstream portal work area (October 9, 2014)**

- Drilling, blasting, mucking and stabilization (anchoring and shotcrete application) continued within the tunnel (Photo 9). Seepage water from the tunnel portal was conveyed effectively to the settling ponds for treatment and storage.
- The remaining ditch improvement work along the downstream portal access road was completed this week (Photo 10)

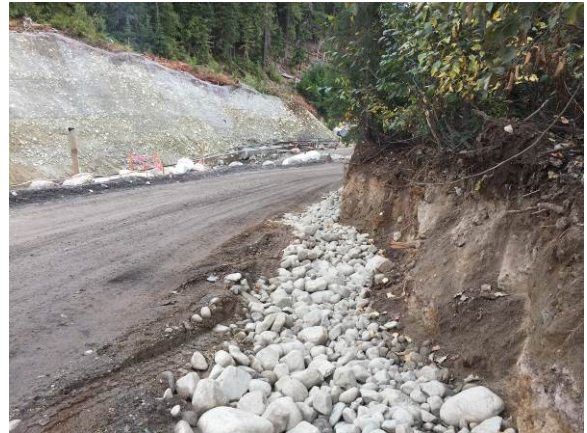
**Photo 10 – French drain installation of ULRHEF downstream tunnel portal access road completed on the woods side (October 9, 2014).**

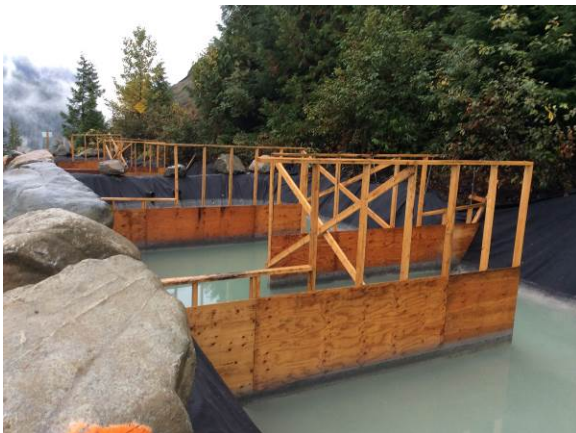
- The settling ponds installed adjacent to Truckwash Creek were used to treat the seepage and process water emanating from the tunnel. No surface discharge from the sediment ponds was observed this week (Photo 11); therefore no WQ measurements were taken by the IEM.

**Photo 11 – ULRHEF downstream portal sediment ponds. No discharge was observed (October 11, 2014).**

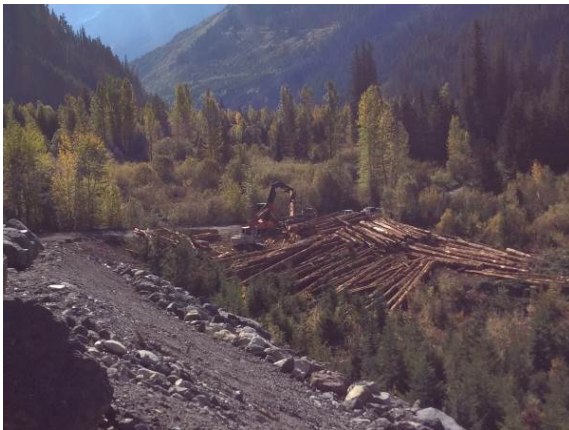
**Photo 12 – Loading decked timber at the 42.5 km of the Lillooet River FSR (October 8, 2014).**

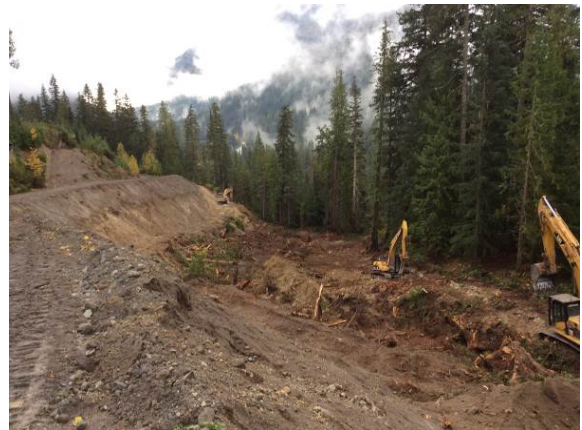
**Photo 13 – Stripping and grubbing activities between stations 2+725 to 3+025 (October 11, 2014).**

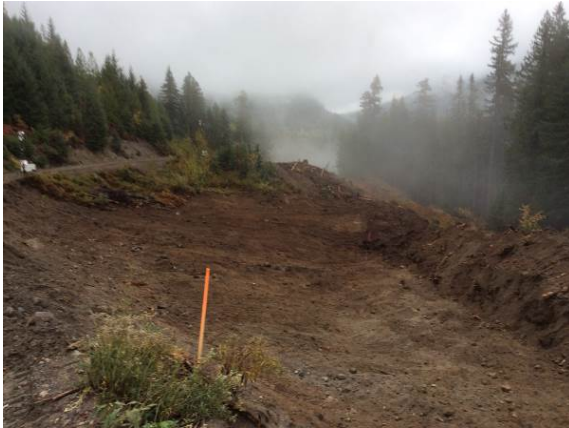
**Photo 14 – Stripping and grubbing activities between stations 3+090 to 4+095 (October 11, 2014).**

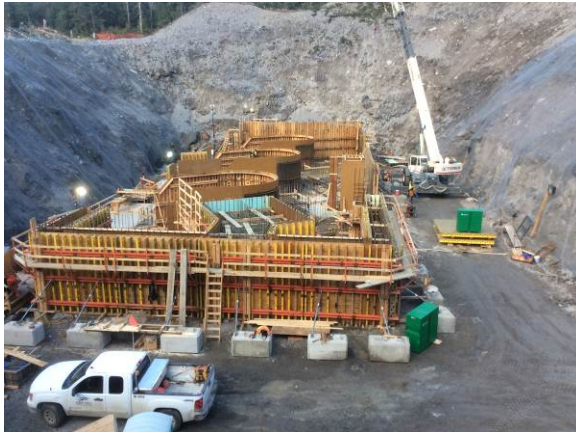
- Rebar installation and form works for the powerhouse foundation continued throughout the reporting period (Photo 15). Another stage of the concrete foundation was poured on October 8.
- Two pumps (6" and 10") previously installed in the sump draining seepage waters in the powerhouse excavation continued to convey water to the existing settling ponds. No flowing surface water was observed within the excavation and pump capacity appears to be adequate to maintain isolation from active work areas.

**Photo 15 – Current conditions at ULRHEF powerhouse (October 8, 2014).**

- Slope protection on cut slopes above the ULRHEF powerhouse via hydroseeding/engineered fiber matrix application remains outstanding. This item is tracked in the in the Project's ITM as *ULR#20 – open*.
- Dewatering of the ULRHEF powerhouse continued without environmental concerns (Photo 16). The IEM will continue to monitor the works area to confirm that future concrete pours are adequately isolated from flowing waters and protected from precipitation during curing.

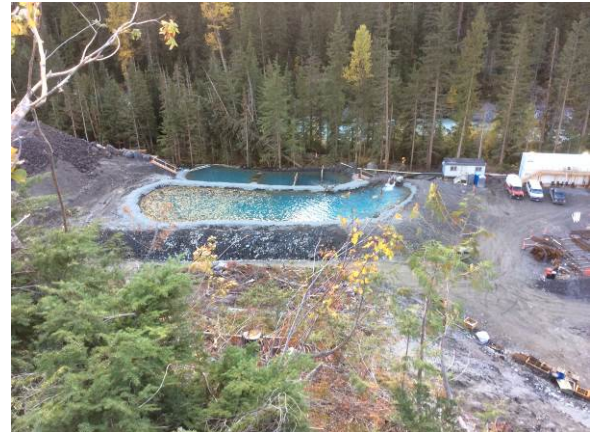
**Photo 16 – Condition of the sediment ponds used for ULRHEF powerhouse dewatering (October 8, 2014).**

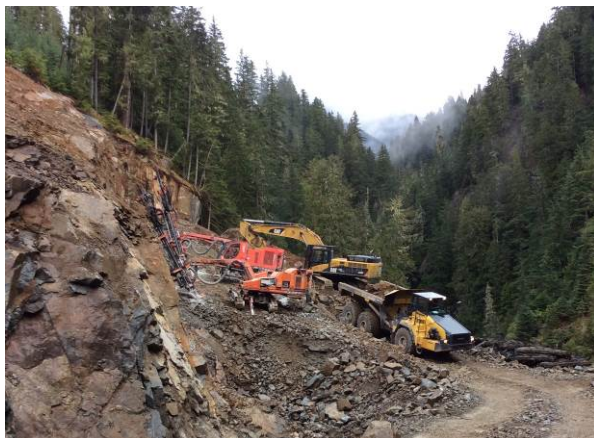
- Sequences of drilling, small controlled blasts, and blast rock excavation proceeded on the top bench of the crane pad throughout the reporting period (Photo 17). Care was taken to prevent material from escaping down the slope adjacent to the

excavation; however some large boulders were lost to Boulder Creek during this monitoring period.

Photo 17 – BDRHEF crane pad excavation and drilling/blasting at top level of crane pad (October 11, 2014).

- On October 5, a large boulder escaped down the embankment of Boulder Creek during excavation activities at the BDRHEF intake crane pad. The IEM understands that all practical measures are being taken to mitigate the potential for material to enter Boulder Creek, and communicated to the contractor the expectation that lost material (including blasting mats) should be tracked and once the crane is installed and access is feasible, be removed to the extents possible.

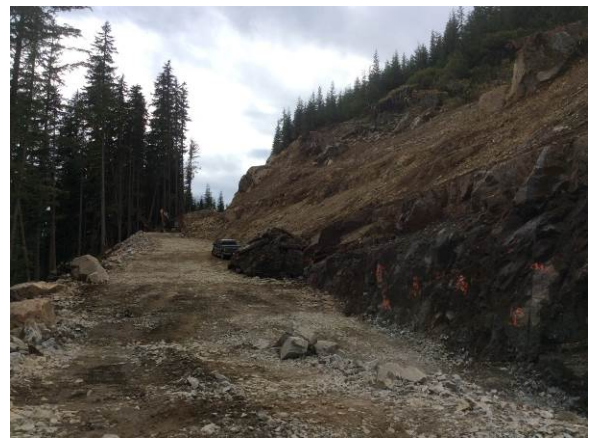
Photo 18 – BDRHEF Intake access road construction (October 9, 2014).

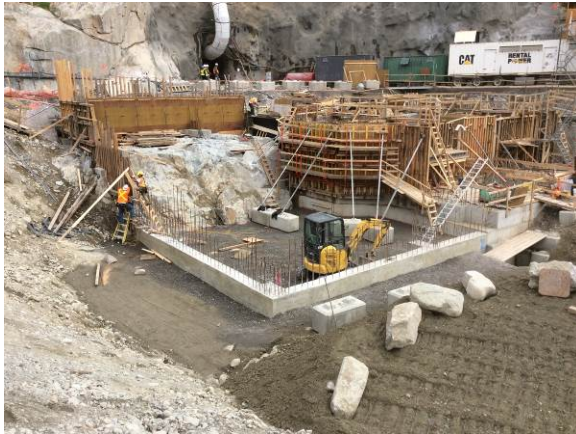
- Rebar installation and formworks (Photo 19) at the powerhouse continued throughout the reporting period.

Photo 19 – Current conditions at BDRHEF powerhouse, continued rebar/formworks (October 9, 2014).

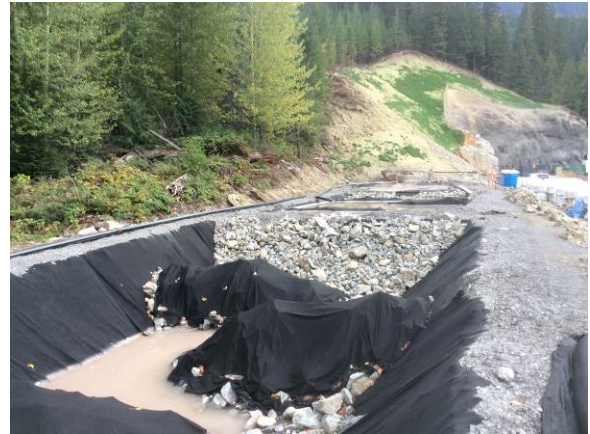
Photo 20 – BDRHEF powerhouse settling pond, no discharge observed; however pond #1 remains full of sediment and requires maintenance (September 30, 2014).

- Settling ponds at the downstream portal should be continually monitored to ensure appropriate treatment of seepage from tunnelling activities is occurring. With rain forecast for the upcoming reporting period, increased water volumes in the form of increased infiltration rates within the tunnel excavation may result in discharge from the ponds. The maintenance of the ponds was discussed with CE's Environmental Coordinator and it was agreed that confirmatory samples would be taken to characterize whether the sediment/slurry (mostly rock fines from the tunnel drilling activities) should be treated as PAG or non-PAG. Results are pending.

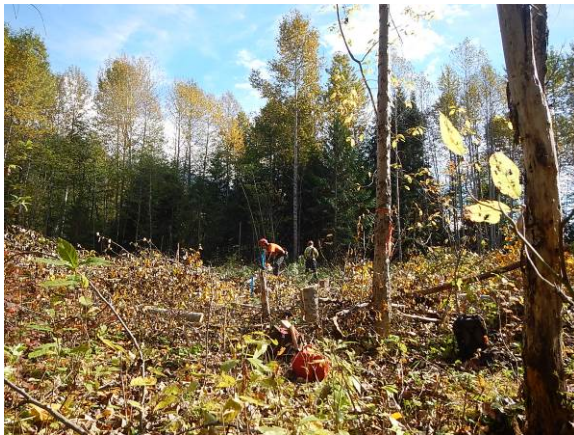
**Photo 21 – Segment 6 RVMA clearing on the Lillooet river island (October 7, 2014).**

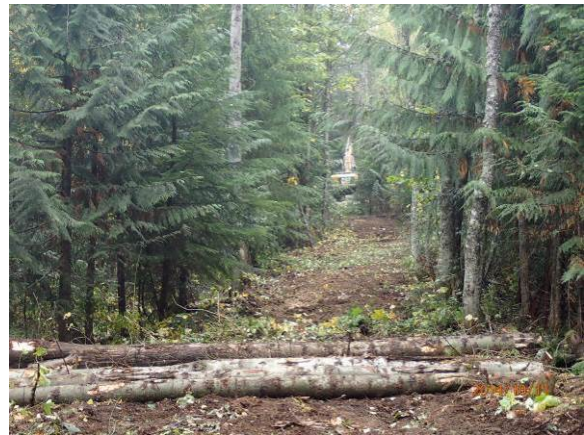
**Photo 22 – Segment 8 road upgrading (October 11, 2014)**

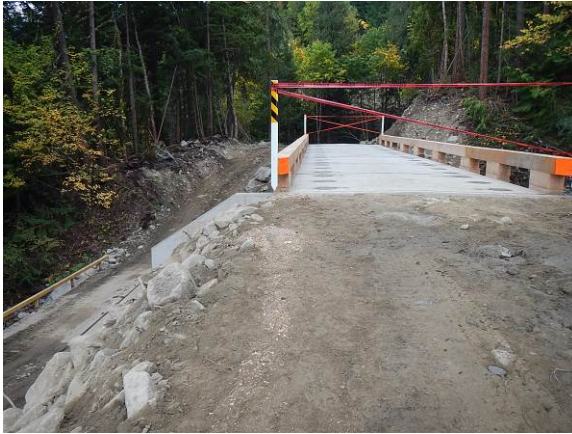
- Construction activities for the installation of the permanent bridge over Black Creek were monitored fulltime during the reporting period. The installation did not involve any instream works and no fording of machinery was required. Water quality was closely monitoring during grouting works but remained visually unaffected as no grout escaped the form work. No environmental concerns were noted.
- The IEM was present as required when clearing activities occurred within 150m of wetlands, 15m RVMAs (30m for CTF streams), 100m of Coastal Tailed Frog Streams, Class 1 & 2 suitable Grizzly Bear WHA and/or suitable forage habitat, moose and deer UWR, and within legally designated Old Growth Management Areas (OGMAs). All flagged boundaries were respected during clearing activities. No environmental issues were observed.

**Photo 23 – Segment 8, Black Creek permanent bridge approach final backfill and grading (October 9, 2014).**

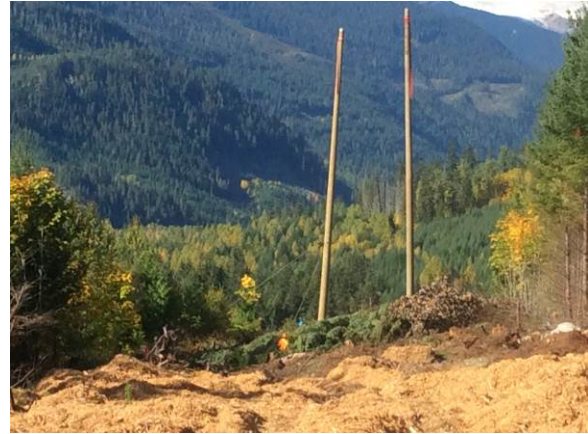
- Foundation construction (ground works including blasting and use of heavy machinery) was conducted in Segments 6 – 7.
- Structure framing and conductor line stringing occurred in Segments 3 and 4 (Photo 24).

**Photo 24 – Segment 4, structure framing works (October 8, 2014).**
