Upper Lillooet Hydro Project

Weekly Environmental Monitoring Report #43

Reporting Period: October 12 – October 18, 2014

Upper Lillooet River Hydroelectric Facility (Water File No. 2002561, Water licence No. C130613),
Boulder Creek Hydroelectric Facility (Water File No. 2003049, Water licence No. C129969) &
Transmission Line (TX Line)

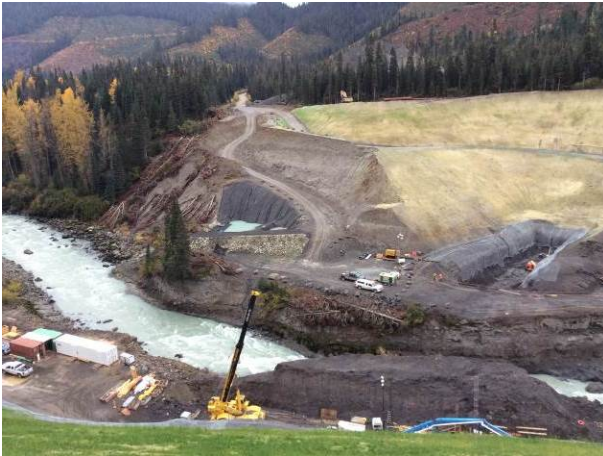
- Bulk excavation, including drilling and blasting, continued at the ULRHEF upstream tunnel portal (north side) below elevation 666m (Photo 1).
- Continued rebar and formworks (Photo 2) at the Obermeyer Weir (south side diversion channel). Concrete works included two structure pours occurring on October 12 and 17 (Photo 3).

Photo 1 – Overview of the north side of the ULRHEF intake (October 12, 2014).

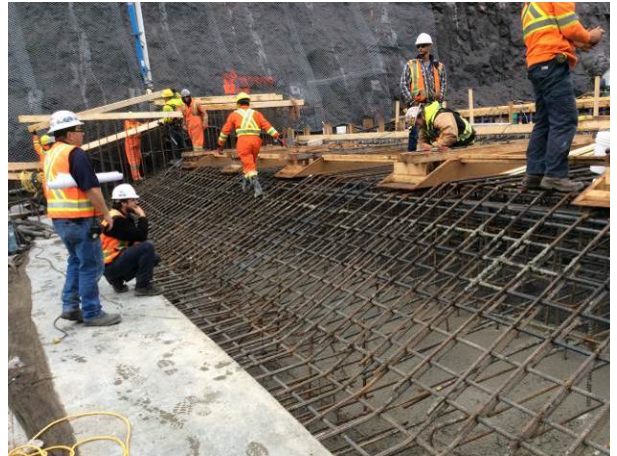
Photo 2 – ULRHEF intake diversion channel, Obermeyer weir formworks (October 12, 2014).

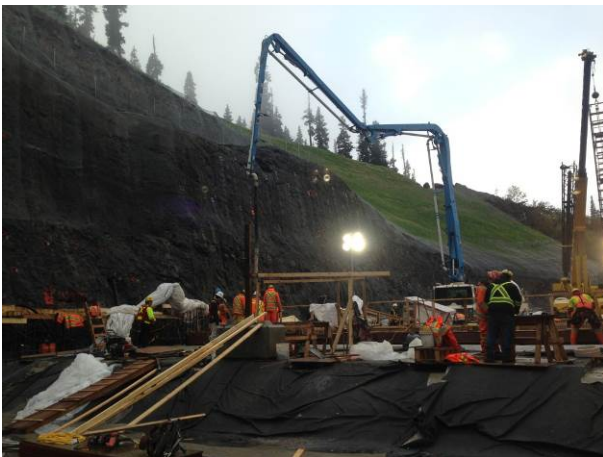
Photo 3 – ULRHEF Obermeyer weir concrete pour (October 17, 2014).

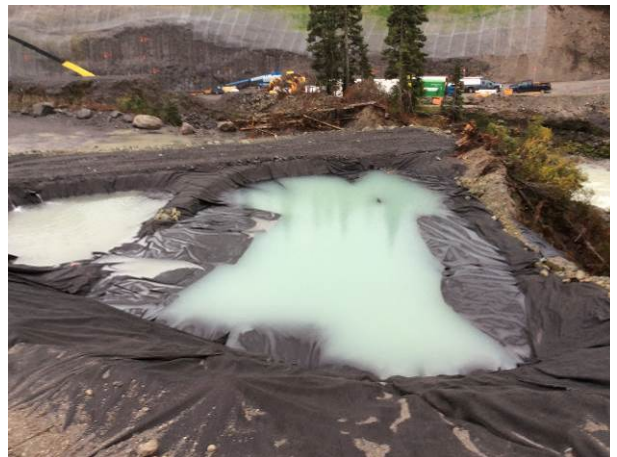
- ULRHEF intake north side settling pond adjacent to cofferdam access road (Photo 4) – Increasing precipitation events and seepage into the ULRHEF upstream tunnel portal works area led to increased volumes of sediment laden water requiring treatment. Although no WQ exceedances were observed within the Lillooet River, it is the opinion of the IEM that the settling pond should be closely monitored to ensure adequate treatment.

Photo 4 – ULRHEF intake north side settling pond adjacent to cofferdam access road (October 14, 2014).

- As a follow up to *FAM04* (issued September 29, 2014) and additional ESC issues identified in this reporting period, the IEM continues to recommend that all necessary measures be implemented to mitigate sediment mobilization and provide for adequate treatment capacity and efficiency prior to conveyance towards the Upper Lillooet River.

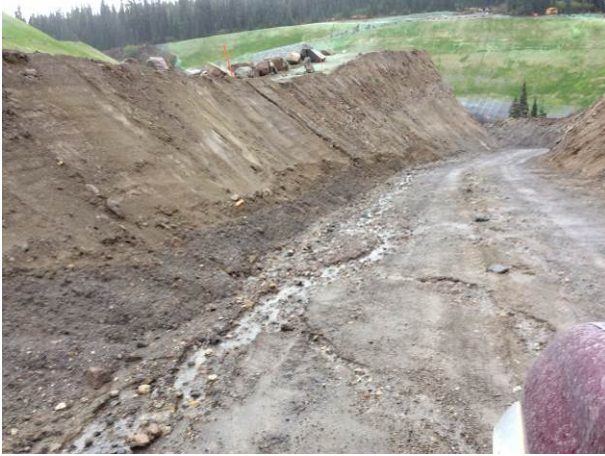
- ULRHEF intake north side cofferdam access road (Photo 5) – Ditching is currently inadequate and is leading to increased sediment inputs to the above mentioned settling pond.

Photo 5 – ULRHEF intake north side cofferdam access road, ditching requires attention (October 14, 2104).

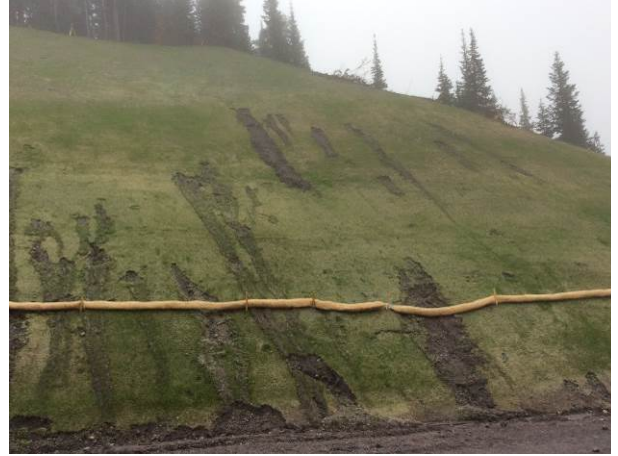
- ULRHEF intake north side cut slopes above the Lillooet River FSR (Photo 6) – Initial Curlex installation has been completed along a portion of the slope, however inadequate coverage is leading to further rilling.

Photo 6 – ULRHEF intake north side cut slopes with hydroseed and initial Curlex log installation, requires further attention (October 14, 2014).

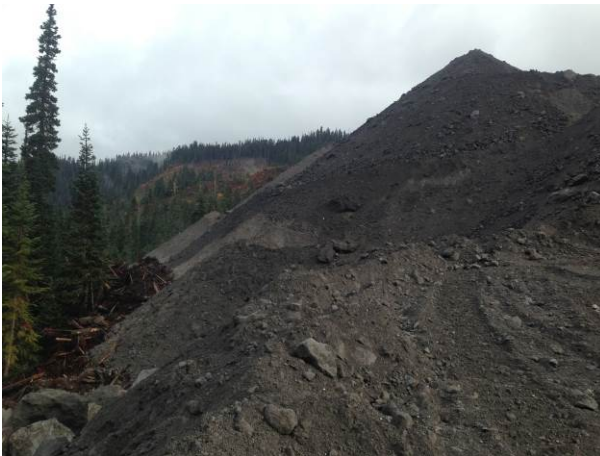
- ULRHEF north side spoil area (Photo 7) – Spoil area requires attention prior to the onset of winter as slopes are unconsolidated and no ESC measures are currently in place. A winterization plan for the ULRHEF spoil area was submitted to the IEM on October 17, however the ITM will remain open until works are complete and slopes are stabilized.

Photo 7 – ULRHEF intake spoil are (north side) requiring additional mitigation prior to winter shutdown (October 16, 2014).

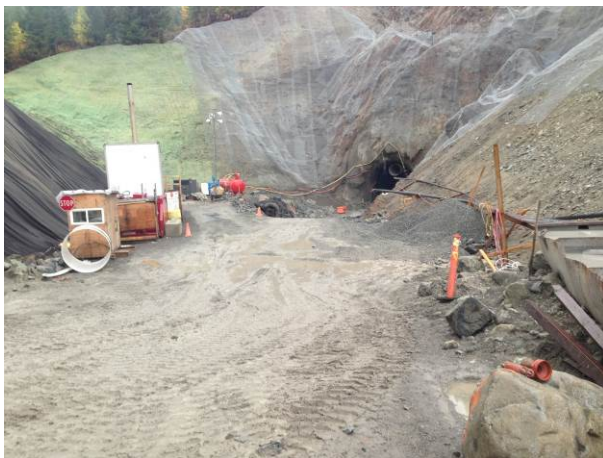
- Drilling, blasting, mucking and stabilization (anchoring and shotcrete application) continued within the tunnel (Photo 8). Seepage water from the tunnel portal was conveyed effectively through an oil water separator (Photo 9) and into the settling ponds for treatment and storage.
- Exploratory borehole drilling for the ULRHEF tunnel near KM 46.5 on the Lillooet River FSR was completed on October 15 and 16 (Photo 10).

**Photo 8 – ULRHEF downstream tunnel portal
(October 16, 2014)**

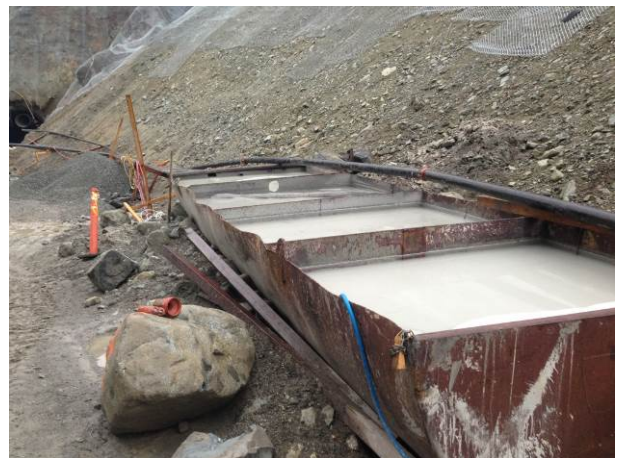
**Photo 9 – ULRHEF downstream portal oil water separator
(October 16, 2014)**

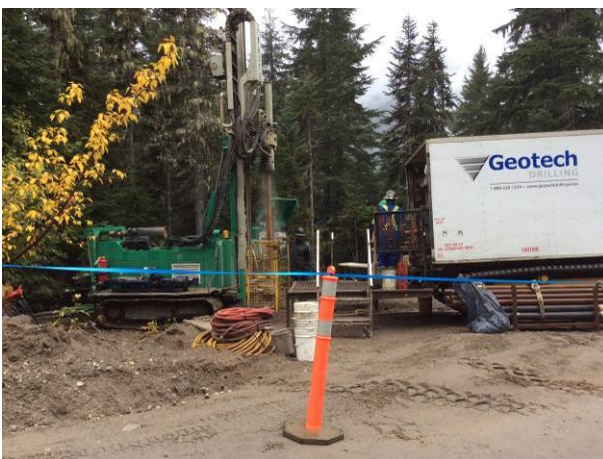
Photo 10 – ULRHEF tunnel exploratory borehole drilling at KM 46.5 on the Lillooet River FSR (October 15, 2014).

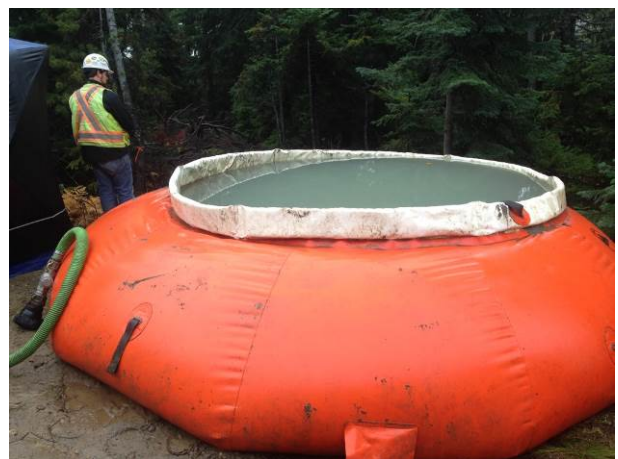
Photo 11 – Water bladder for ULRHEF tunnel exploratory borehole drilling at KM 46.5 on the Lillooet River FSR (October 16, 2014).

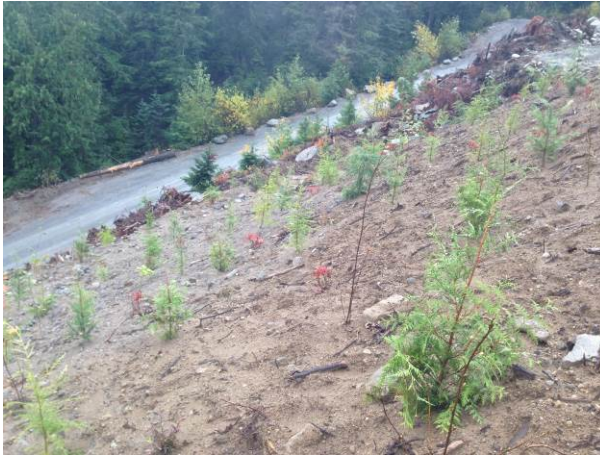
- No environmental issues were observed at the ULRHEF downstream tunnel portal during this reporting period. The settling ponds installed adjacent to Truckwash Creek were used to treat the seepage and process water emanating from the tunnel. No surface discharge from the sediment ponds was observed this week; therefore no WQ measurements were taken by the IEM.
- A gravity fed water extraction system was used for drilling activities according to the conditions of the Short Term Water Use Approval (No.A2006123).
- Exploratory borehole drilling was completed with no ESC issues. Water required for drilling was contained within a bladder (Photo 11).
- Planting of the ULRHEF downstream tunnel portal temporary access road was completed as per the Truckwash Creek Revegetation Plan (Photo 12).

Photo 12 – Truckwash Creek Mountain goat migration corridor temporary access road revegetation (October 16, 2014).

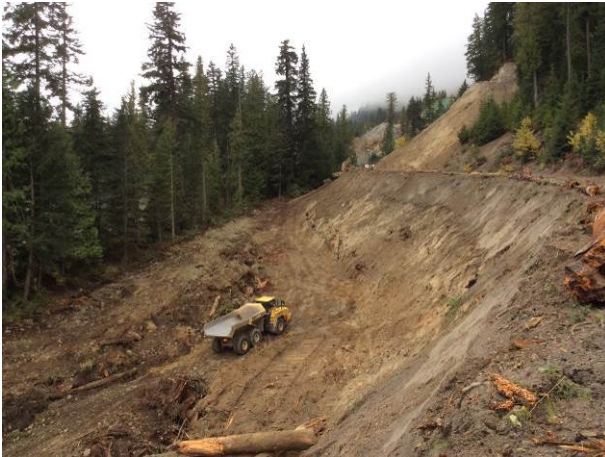
- Grubbing and bulk excavation/fill continued from penstock station 2+725 to 3+025m (Photo 13 and Photo 14) and from 3+090 to 4+095m.

Photo 13 – ULRHEF penstock grubbing and bulk excavation from 2+725 to 3+090m (October 12, 2014).

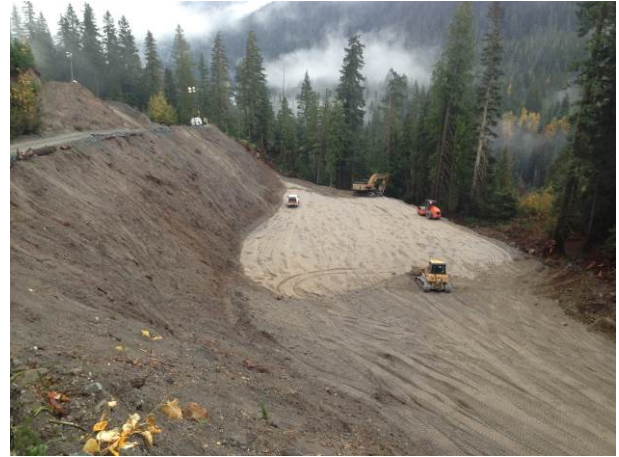
Photo 14 – ULRHEF penstock fill from 2+725 to 3+090m (October 15, 2014).

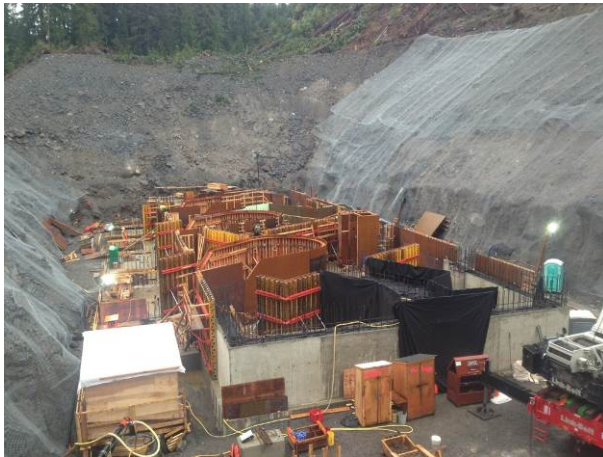
- Continued rebar installation and formworks for the powerhouse structure (Photo 15). A structure pour was completed on October 18.
- Two pumps (6" and 10") previously installed in the sump draining seepage waters in the powerhouse excavation continued to convey water to the existing settling ponds. No flowing surface water was observed within the excavation and pump capacity appears to be adequate to maintain isolation from active work areas.

Photo 15 – Continued rebar and formworks at ULRHEF powerhouse (October 3, 2104).

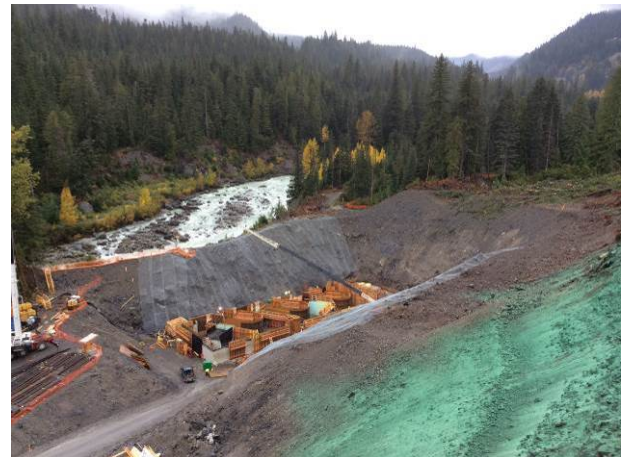
- A portion of the slopes above the ULRHEF powerhouse were hydroseeded (Photo 16) to address ESC concerns outlined in FAM#04 and tracked in *ULR#20 – open*.
- Dewatering of the ULRHEF powerhouse continued without environmental concerns. The IEM will continue to monitor the works area to confirm that future concrete pours are adequately isolated from flowing waters and protected from precipitation during curing.

Photo 16 – Current conditions at ULRHEF powerhouse, hydroseeding commenced on upper slopes (October 12, 2014).

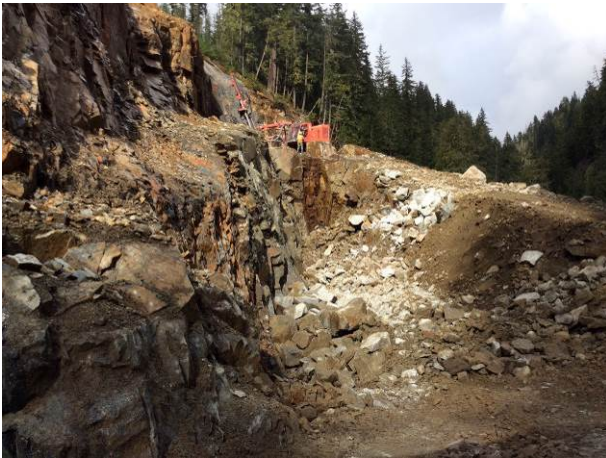
- Sequences of drilling, small controlled blasts, and blast rock excavation continued on the top bench of the crane pad throughout the reporting period (Photo 17). Care was taken to prevent material from escaping down the slope adjacent to the excavation; however some large boulders were lost to Boulder Creek during this monitoring period.
- Intake access road construction continued.

Photo 17 – BDRHEF crane pad excavation and drilling/blasting at top level of crane pad (October 14, 2014).

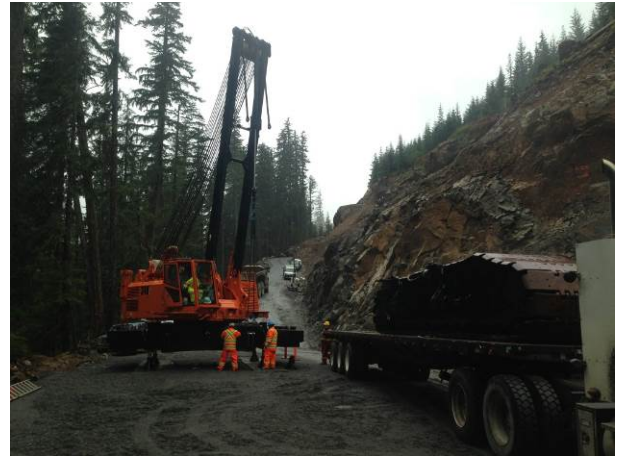
- Mobilization of 300 tonne crane to the BDRHEF intake occurred on October 17 (Photo 18).

Photo 18 – 300 tonne crane mobilization at BDRHEF intake (October 17, 2014).

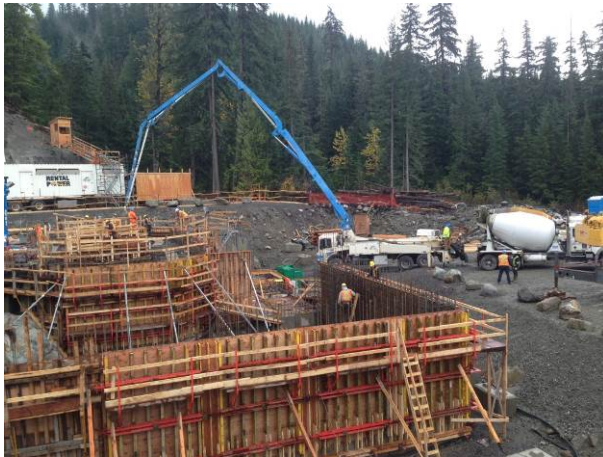
- Rebar installation and formworks at the powerhouse continued throughout the reporting period. Concrete works include a structure pour on October 16 (Photo 19)
- Drilling, blasting, mucking and stabilization (anchoring and shotcrete application) continued within the tunnel (Photo 20).

Photo 19 – Current conditions at BDRHEF powerhouse, continued rebar/formworks and concrete structure pour (October 16, 2014).

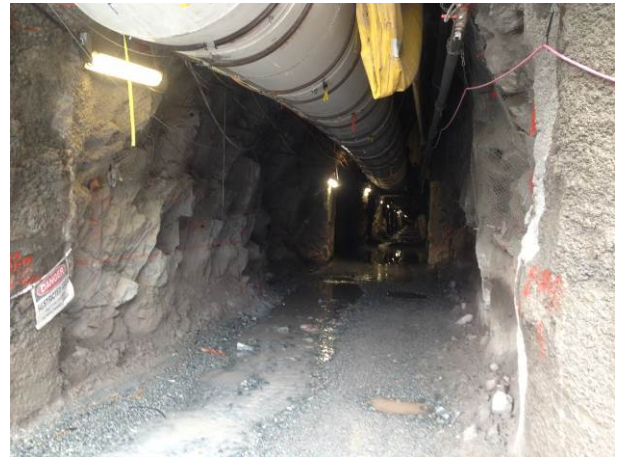
Photo 20 – BDRHEF downstream tunnel portal (October 16, 2014).

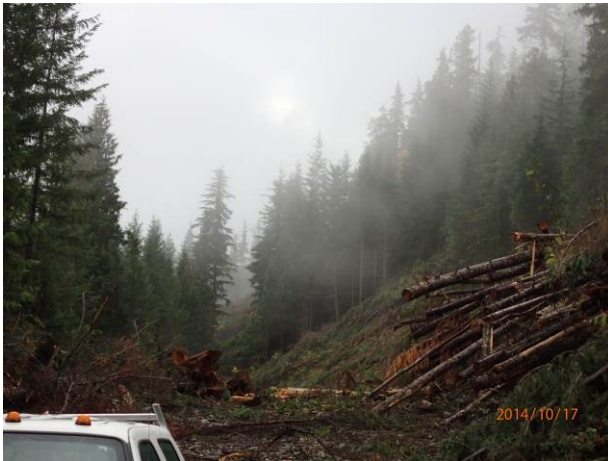
- ROW occurred in Segment 6, Segment 8 (Photo 21), Segment 9, and Segment 14 (south side of Pemberton Creek).
- RVMA clearing in Segment 7.
- A grinder continued processing slash in Segment 5 (KM 21 – 23 and 25.5 – 26.0 of the Lillooet River FSR).

**Photo 21 – Segment 8 ROW timber management
(October 17, 2014).**

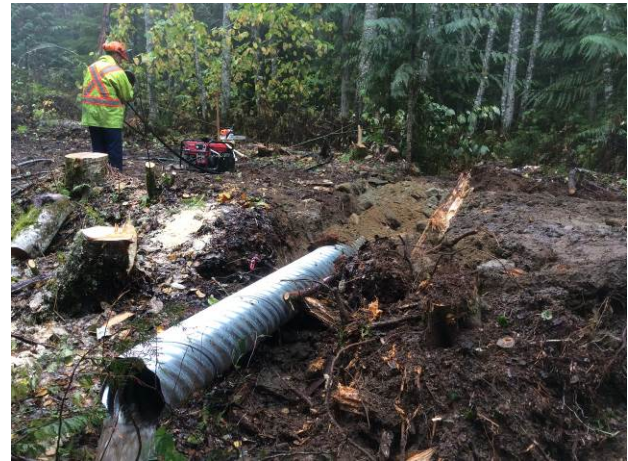
- The IEM was onsite during the installation of two cross drain culverts in Segment 8 along access road 197.2. Pumps were used to divert water around the work area during the culvert installations (Photo 22). Following the culvert installations, the existing road surface was raised with ballast rock across the low lying area. Water quality was monitored by the IEM during the installations and no environmental issues were observed.
- The IEM was present as required when clearing activities occurred within 150m of wetlands, 15m RVMAs (30m for CTF streams), 100m of Coastal Tailed Frog Streams, Class 1 & 2 suitable Grizzly Bear WHA and/or suitable forage habitat, moose and deer UWR, and within legally designated Old Growth Management Areas (OGMAs). All flagged boundaries were respected during clearing activities. No environmental issues were observed.

**Photo 22 – Segment 8 cross drain culvert installation
(October 15, 2014)**
