Upper Lillooet Hydro Project

Weekly Environmental Monitoring Report #48

Reporting Period: November 16 – November 22, 2014

Upper Lillooet River Hydroelectric Facility (Water File No. 2002561, Water licence No. C130613),
Boulder Creek Hydroelectric Facility (Water File No. 2003049, Water licence No. C129969) &
Transmission Line (TX Line)

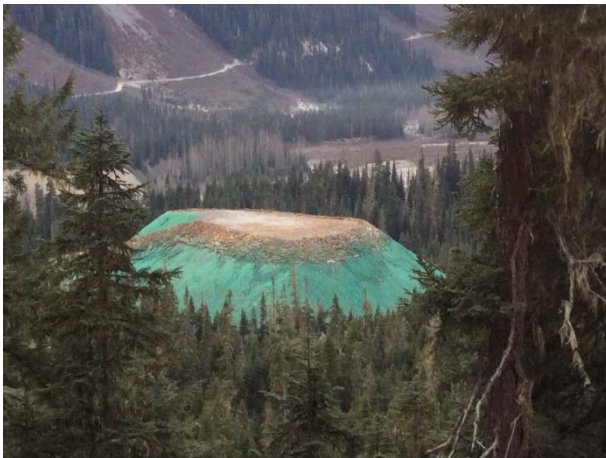
- Winterization of the ULRHEF north side spoil area (Photo 1) was completed on November 17, 2014. The winterization strategy included the reshaping of the spoil pile to reduce its overall height and the application of standard hydro mulch and EFM in the hydro-seed mix. It should be noted that the manufacturer specifications for ProMatrix™ EFM outline that it is designed to be applied on slopes less than 1H to 1V (with an application rate of 4500kg/ha) and that slope interruption devices or water diversion techniques are recommended when slope lengths exceed 15m. Based on the IEM's inspection of the application it appears that the EFM product has been heavily applied; however application has not been completed to manufacturer specifications. The IEM recommends that the spoil pile slopes are closely monitored during the spring melt for signs of erosion to prevent additional material from

Photo 1 – Re-shaping and hydro-seeding of the north side spoil area at the ULRHEF intake (November 17, 2014).

- The IEM recommends that the north intake spoil pile slopes are closely monitored for signs of erosion to prevent additional material from extending beyond the OLTC limits. A final reclamation prescription for this spoil pile should be developed by a qualified professional.

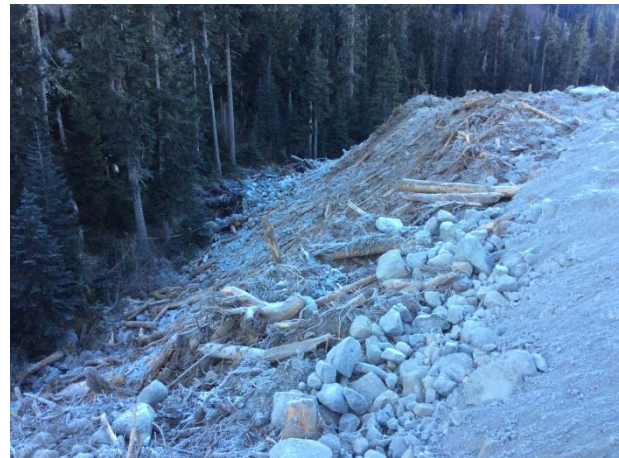
extending beyond the OLTC limits. Winterization of the ULRHEF south side spoil area (Photo 2) was also performed during this reporting period, and involved reshaping the slopes and application of organic material. With these winterization measures complete, *ULR#20* has now been closed. The inspection and regular maintenance of ESC installations is an ongoing Project requirement and CE should ensure that the intake works area is winterized prior to site demobilization.

Photo 2 – Slopes of the south side spoil area at the ULRHEF intake have been shaped and covered with organic material (November 16, 2014).

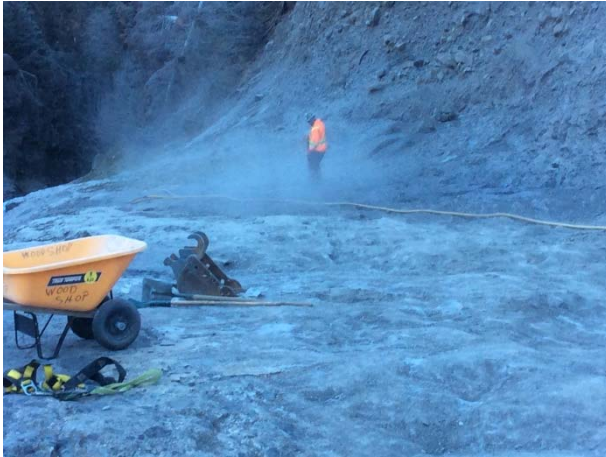
Photo 3 – Cleaning of the diversion channel with pressurized air and collection of the material with hand tools (November 16, 2014).

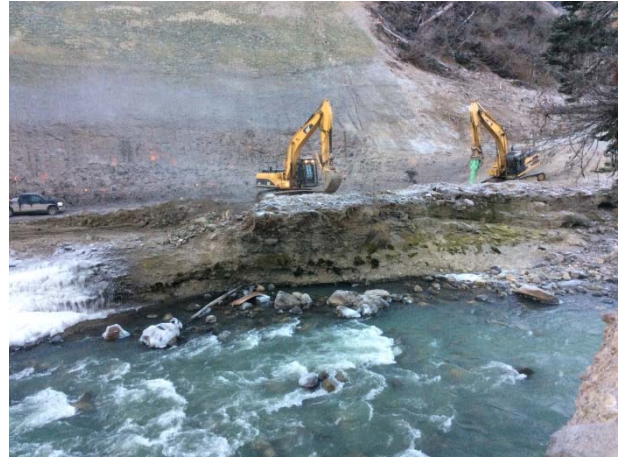
Photo 4 – ULRHEF intake diversion channel upstream plug excavation. No work occurred instream (November 16, 2014).

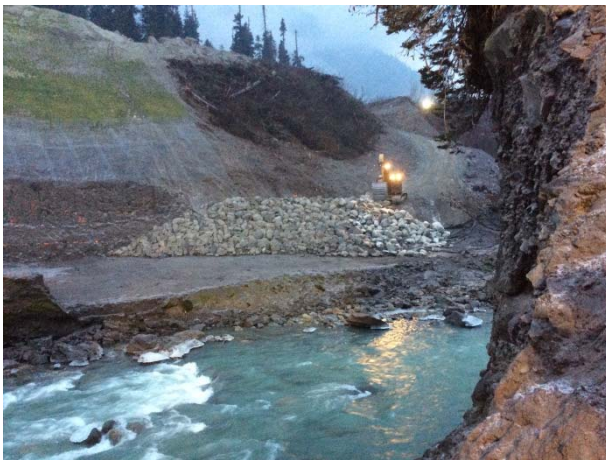
Photo 5 – Armoring of the ULRHEF diversion channel upstream slope (November 20, 2014).

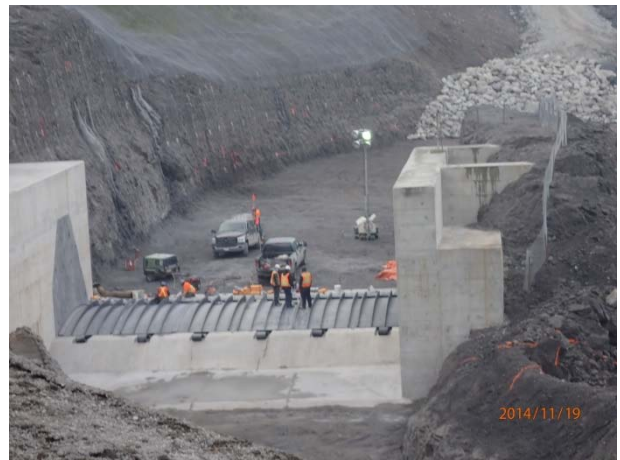
Photo 6 – Final testing of the Obermeyer weir (November 19, 2014).

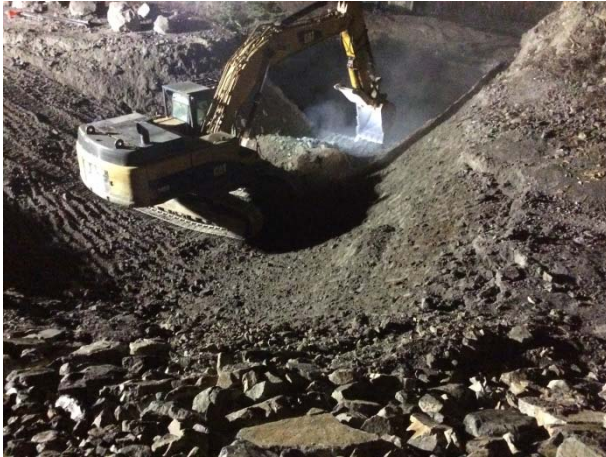
Photo 7 – ULRHEF intake north side cofferdam access ramp excavation (November 18, 2104).

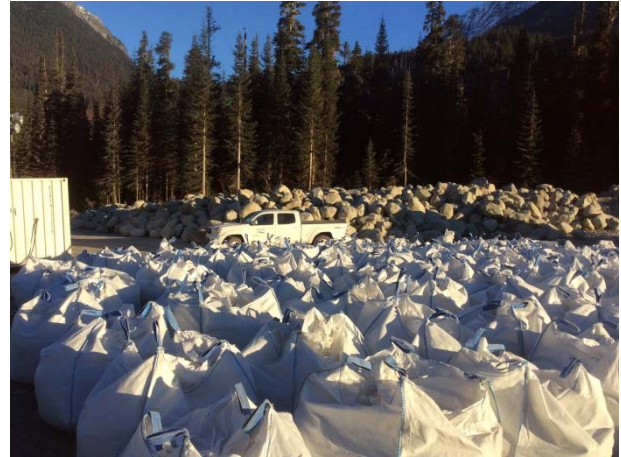
Photo 8 – Stockpiled material near the ULRHEF intake (November 16, 2014).

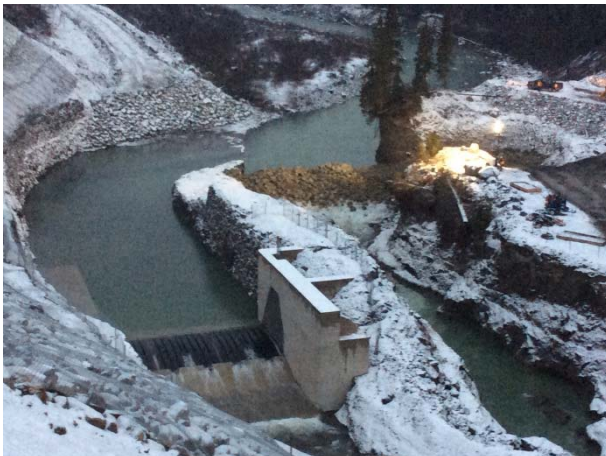
- Placement of pre-washed 500 – 1500mm rock proceeded from the north bank across the natural channel over the course of approximately 4 hours, during which time a gradual filling of the headpond was observed. Impacts to downstream turbidity was not visually perceptible for extended periods of time (> 5 minutes) during placement of the first 75% of the 500 – 1500mm material. Turbidity generation became more apparent during placement of the final 25% of the washed rock dam as flows were concentrated and commissioning of the diversion channel occurred. The turbidity peak was short lived and was caused by the first flush of the diversion channel (visual turbidity increase downstream at Keyhole Bridge observed to have lasted approximately 0.5 hours). Placement of the washed rock was completed to elevation 662m and it was estimated that 50% of the flows were diverted through the diversion channel at the end of day 1.

Photo 9 – Washed rock cofferdam and flooding of the diversion channel (November 20, 2014).

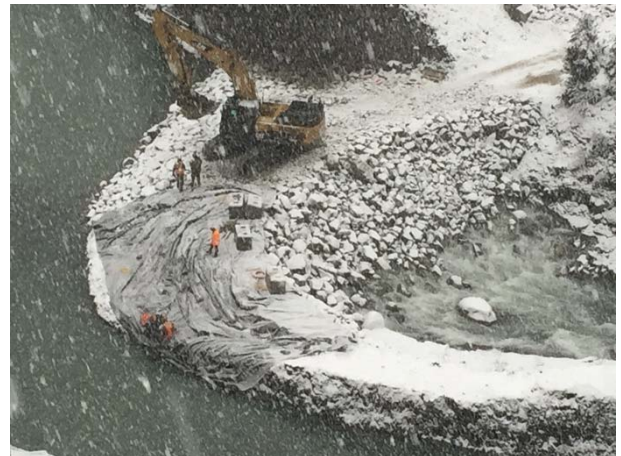
- Cofferdam height was increased by the placement of additional clean rock above the wetted area.
- Geo-membrane (liner) was installed on the upstream side of the cofferdam with the intent of reducing seepage through the cofferdam. Limitations of the equipment reach and depth of the headpond made the installation of the geo-membrane to the base of the cofferdam difficult. Modifications to the excavator (Photo 11) were made on Day 3 to extend its reach and geo-membrane installation was attempted. CE also installed several heavy bags (1m³) filled with clean crushed rock to the upstream side of the cofferdam to attempt to stem the seepage. At the end of Day 3 the goal of significantly reducing seepage volume through the cofferdam was not achieved and further geo-membrane installation will continue during the next reporting period.

Photo 10 – Placement of the geo-membrane on the front face of the cofferdam (November 21, 2014).

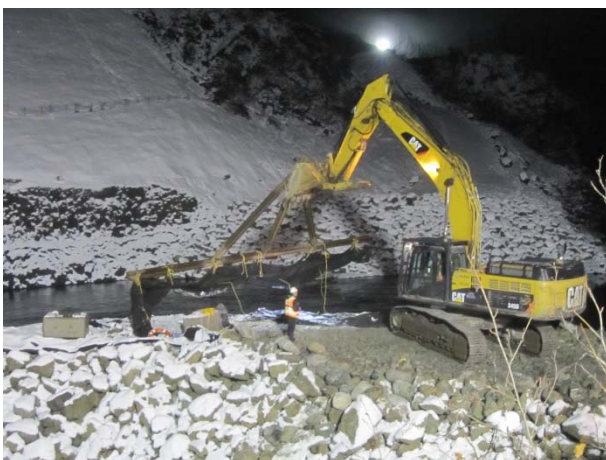
- On Day 3, the IEM authorized the use of a second excavator (not equipped with bio-oil) to place cobble on top of the geo-membrane as the modified excavator (equipped with bio-oil) held the geo-membrane in place during the installation. The approval was granted as CE demonstrated that appropriate spill response equipment (spill booms, spill pads, poly-sheeting, spill kit, etc.) were available onsite. The excavator was pre-inspected and continuously monitored for leaks while operating on the cofferdam and within 30m of the Lillooet River. The second excavator was only needed for a short time and was removed from within 30m of the Lillooet River once it was no longer required.

Photo 11 – Excavator modification for placement of the geo-membrane (November 22, 2014).

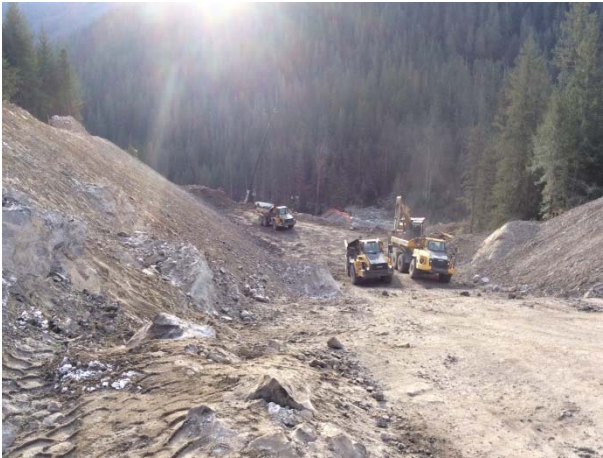
- ESC stabilization and repair of the outside fill slope from penstock station 2+725 to 3+025m was completed outside of the daily mountain goat migration corridor shutdown periods.
- Bulk excavation continued from penstock station 3+090 to 4+095 (Photo 12).

Photo 12 – ULRHEF penstock excavation near station 4+095m (November 17, 2014).

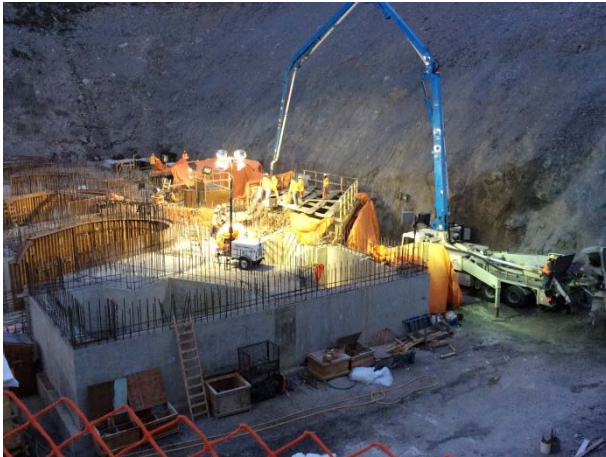
- The final structure pour for 2014 was completed on November 16 (Photo 13). During the remainder of the reporting period CE removed concrete form work, and demobilization equipment from site in preparation for the winter shutdown (Photo 14).
- Two pumps (6" and 10") previously installed in the sump draining seepage waters in the powerhouse excavation continued to convey water to the existing settling ponds. No flowing surface water was observed within the excavation and pump capacity appears to be adequate to maintain isolation from active work areas.

Photo 13 – Structural concrete pour at ULRHEF powerhouse (November 16, 2014).

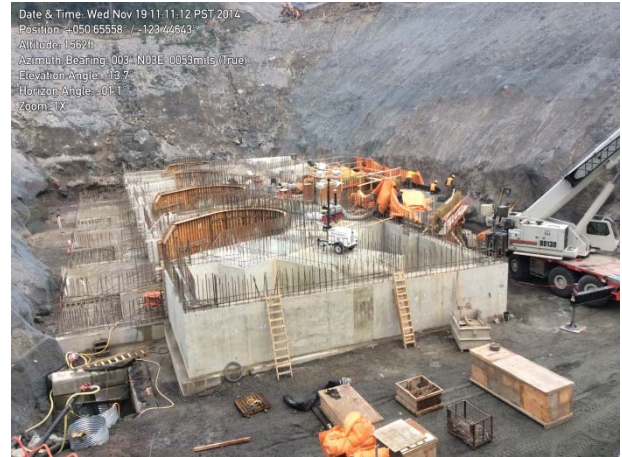
Photo 14 – Continued rebar and formworks at ULRHEF powerhouse (November 19, 2014).

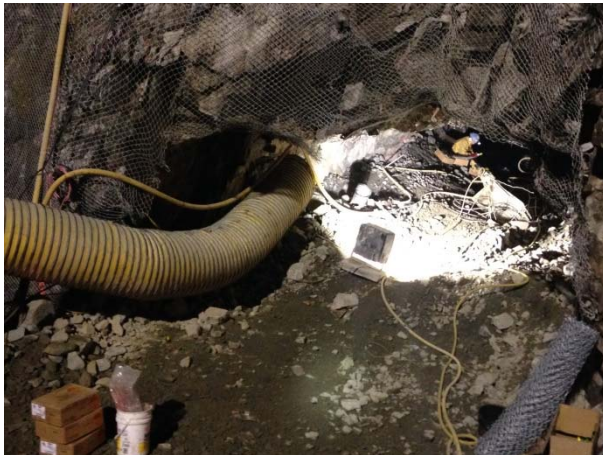
- Sequences of drilling, controlled blasts, and blast rock excavation continued on the top bench of the diversion tunnel throughout the reporting period (Photo 15). The blast rock was placed in a crane bucket and hoisted to the crane pad for stockpiling (Photo 16). Care was taken to prevent material from entering Boulder Creek and no environmental or water quality concerns were noted during this reporting period.

Photo 15 – Conditions inside the BDRHEF diversion tunnel excavation (November 19, 2014).

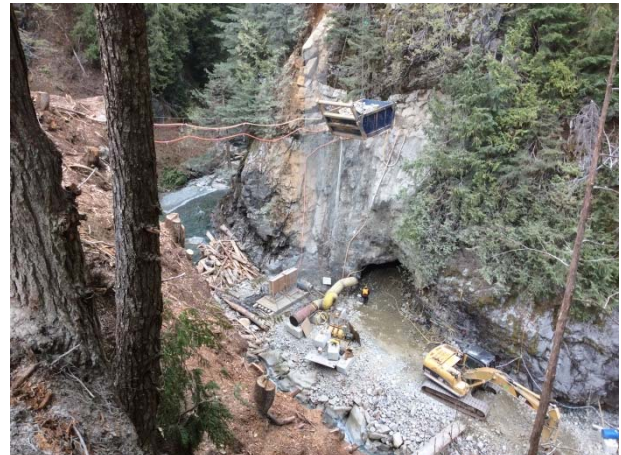
Photo 16 – Continued mucking of blast material (November 18, 2014).

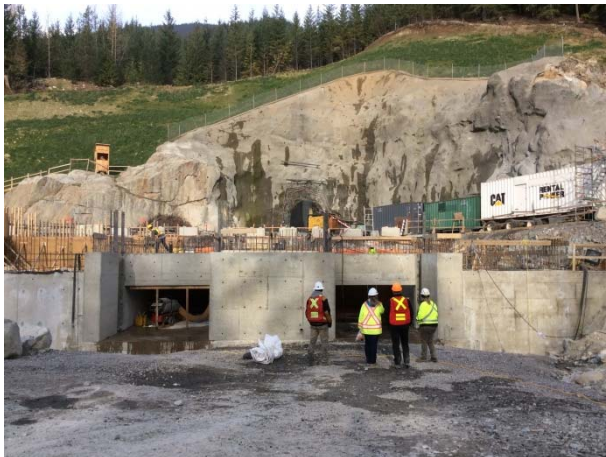
- The removal of form works and winterization of the powerhouse site continued during this reporting period (Photo 17).
- All construction activities associated with the tunnel excavation were completed on November 16, 2014. CE installed a wire mesh closure to the tunnel portal entrance

Photo 17 – Current conditions at BDRHEF powerhouse, continued rebar/formworks and concrete structure pour (November 17, 2014).

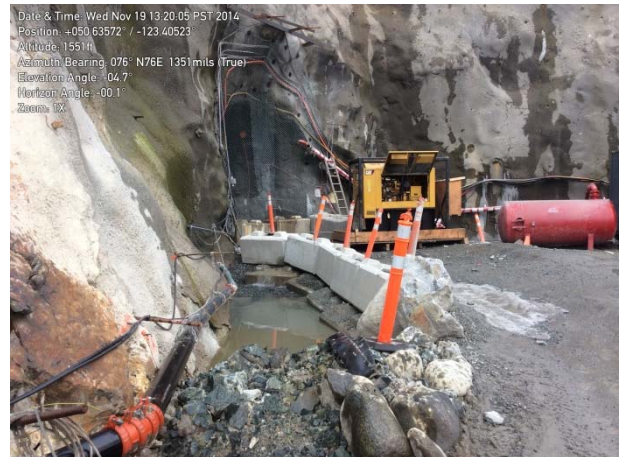
to prevent unwanted entry into the tunnel during the winter shutdown period (Photo 18).

Photo 18 – BDRHEF downstream tunnel portal with wire mesh installed to prevent access (November 19, 2014).

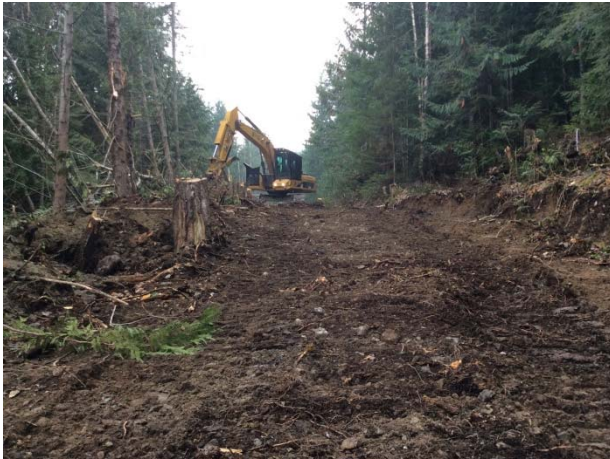
**Photo 19 – Segment 8 road construction works
November 19, 2014).**

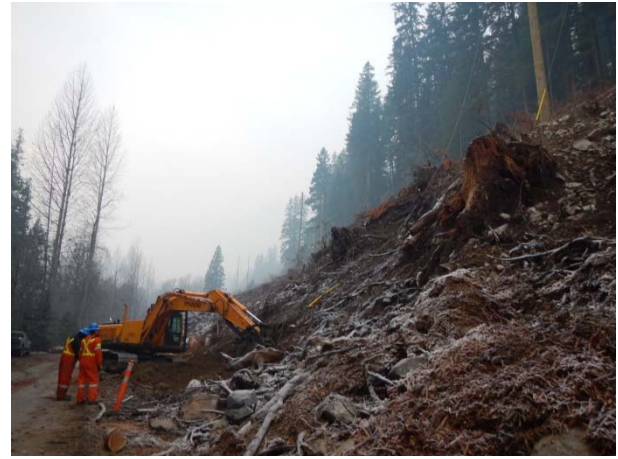
- Foundation construction (ground works including blasting and use of heavy machinery) and structure framing works were completed in Segments 5 & 7 (Photo 20).

**Photo 20 – Segment 5 pole anchor installation
(November 18, 2014).**
