# Upper Lillooet Hydro Project

## Weekly Environmental Monitoring Report #46

Reporting Period: November 2 – November 8, 2014

Upper Lillooet River Hydroelectric Facility (Water File No. 2002561, Water licence No. C130613), Boulder Creek Hydroelectric Facility (Water File No. 2003049, Water licence No. C129969) & Transmission Line (TX Line)

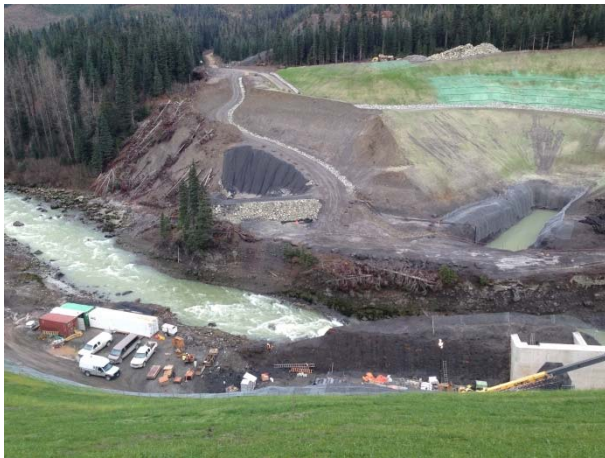
**Photo 1 – Current conditions at ULRHEF intake (November 8, 2014).**

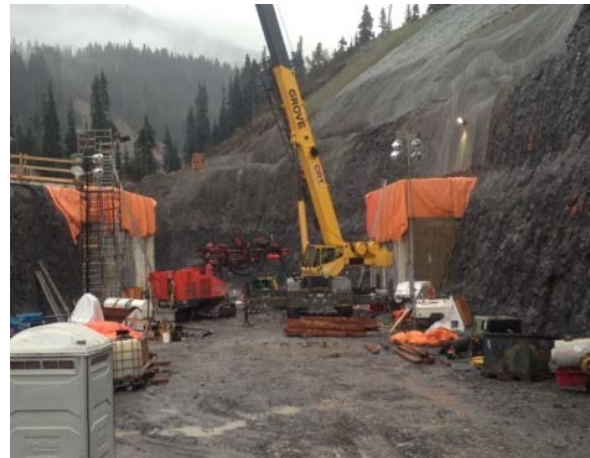
**Photo 2 – Current conditions in the ULRHEF intake diversion channel (November 8, 2014).**

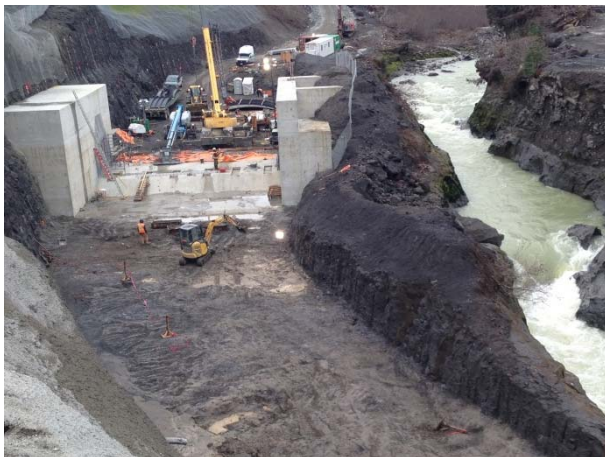
- Cleaning occurred in the downstream end of the diversion channel in preparation for upcoming diversion works (Photo 3). A mini-excavator was used to load material into crane baskets and out of the diversion channel excavation.

**Photo 3 – ULRHEF intake diversion channel cleaning (November 6, 2014).**

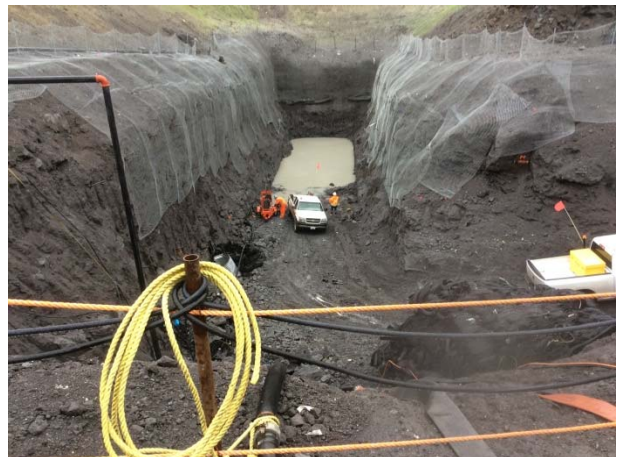
- Continued rebar and formworks at the Obermeyer Weir (south side diversion channel) (Photo 1 and Photo 2).
- Installation of final Obermeyer Weir components (Photo 2).
- Cleaning of downstream end of diversion channel (Photo 3).
- Demobilization and winterization at the upstream portal excavation. Excavation works did not continue during this reporting period (Photo 4).

**Photo 4 – Demobilization works at the ULRHEF upstream portal excavation (November 4, 2014).**

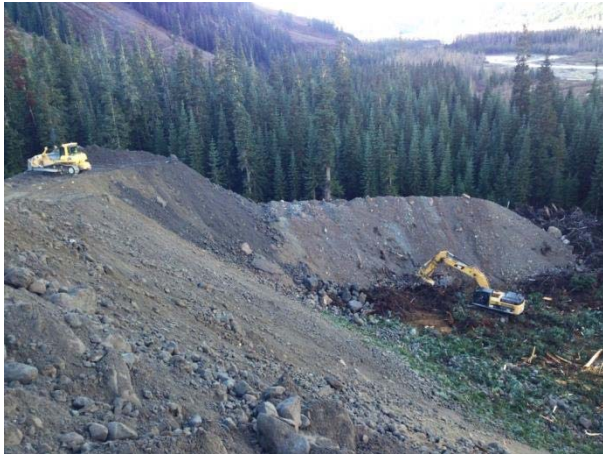
- ULRHEF spoil areas – A winterization plan for the ULRHEF spoil areas was submitted to the IEM on October 17. Re-contouring of the north and south side spoil areas began in this reporting period (Photo 5 and Photo 6). Woody debris and organic material was applied to the upper portion of the north side spoil pile slopes and sediment fencing was installed around the perimeter of the pile (Photo 7). This action item will remain open until works are complete and slopes are stabilized.

**Photo 5 – Re-contouring of south side spoil piles (November 7, 2014).**

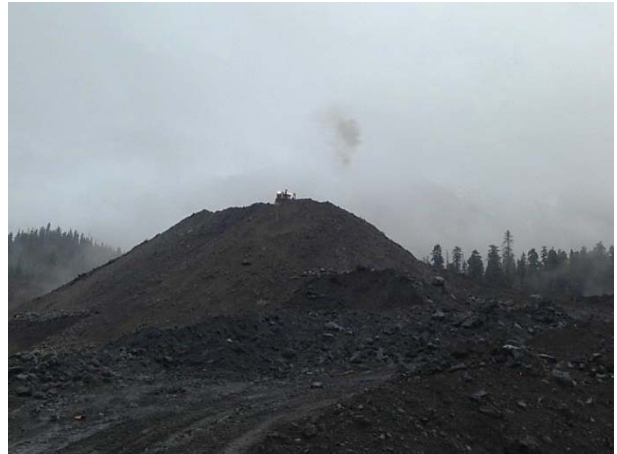
**Photo 6 – Bulldozer re-contouring north side spoil pile (November 7, 2014).**

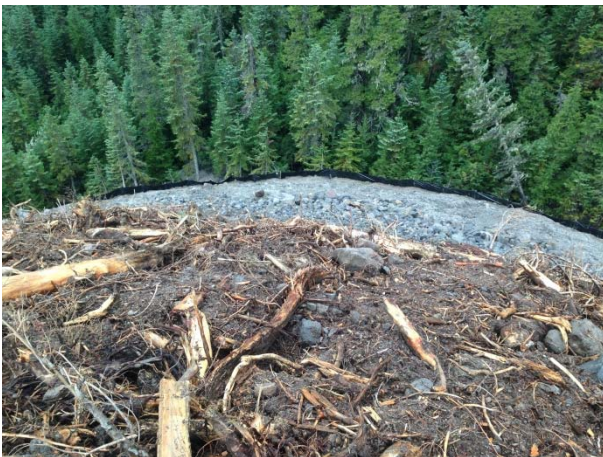
**Photo 7 – Silt fence installed at toe of slope and organic material placed on north side spoil pile (November 8, 2014).**

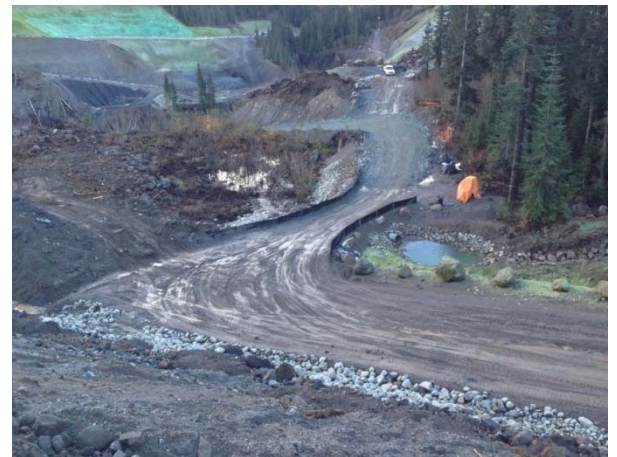
**Photo 8 – Silt fencing installed around tributary and ditching completed on ULRHEF intake south side access road (November 7, 2014).**

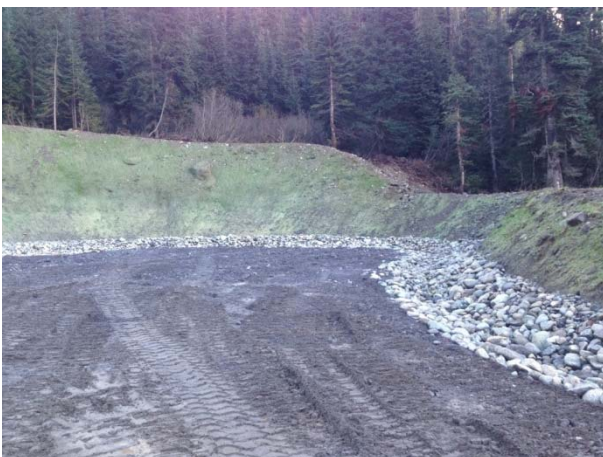
**Photo 9 – Re-grading and ditching completed on north side of Keyhole Falls bridge (November 7, 2014).**

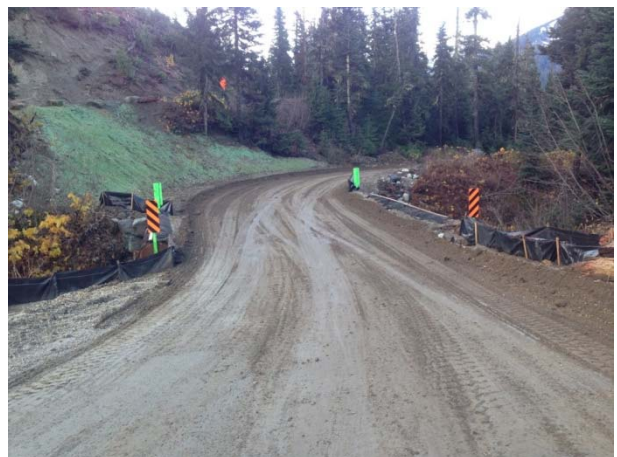
**Photo 10 – Silt fencing installed and road grading completed at the KM 48 box culvert (November 7, 2014).**

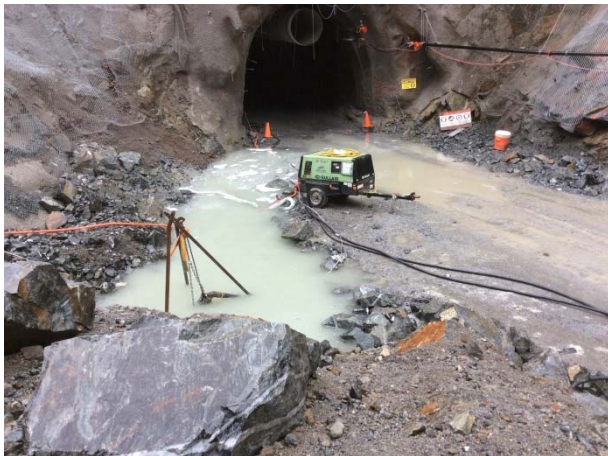
- Demobilization of tunnelling equipment and winterization of portal area (Photo 11 and Photo 12).

Photo 11 – Conditions at ULRHEF downstream tunnel portal (November 3, 2014)

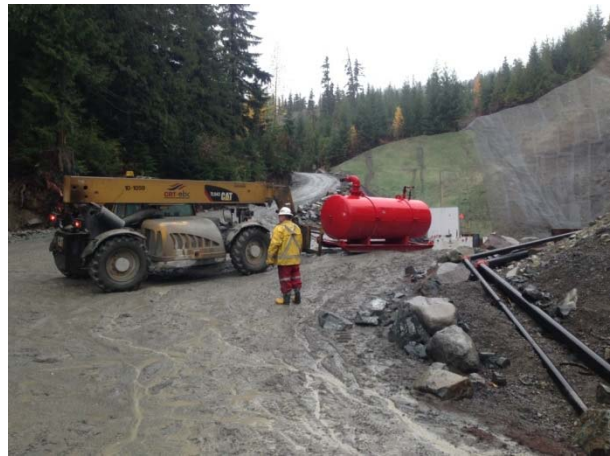
Photo 12 – Crews demobilizing tunnelling equipment (November 3, 2014)

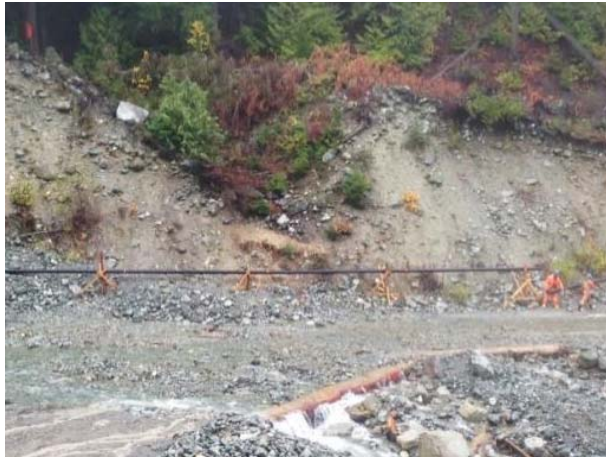
- The downstream tunnel portal water treatment system was dismantled as part of winterization works (Photo 13). The IEM was onsite to monitor works within 30m of Truckwash Creek and works were completed without incident.

**Photo 13 – Dismantling of downstream portal dewatering system (November 3, 2014).**

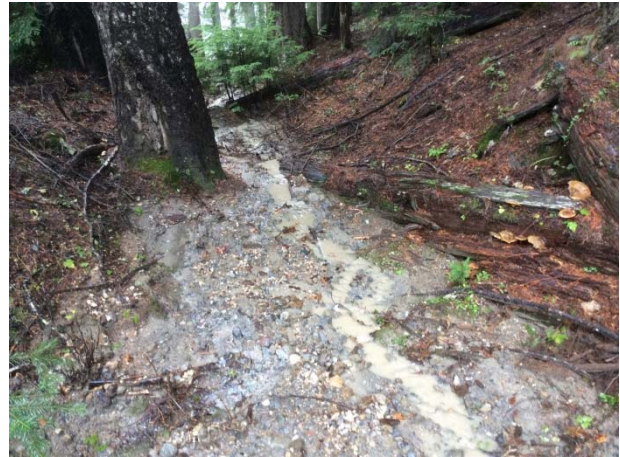
- During a significant rain event on November 3, the IEM observed turbid road runoff entering Truckwash Creek and runoff and deposited sediment in the forested area below the bottom of the downstream tunnel portal access road (Photo 14). The IEM conducted water quality sampling at the Truckwash Creek road crossing and measured it to be within BCWQG (see WQ results below). Truckwash Creek was not safely accessible downstream of all turbid inputs. The IEM contacted CE to discuss the ESC measures necessary to prepare the site for winter shutdown. Following discussion, ditching was completed, the access road and pad were re-graded and a berm was built at the bottom of the access road (Photo 15).

**Photo 14 – Mobilizing and deposited sediment observed below downstream portal access road (November 3, 2014).**

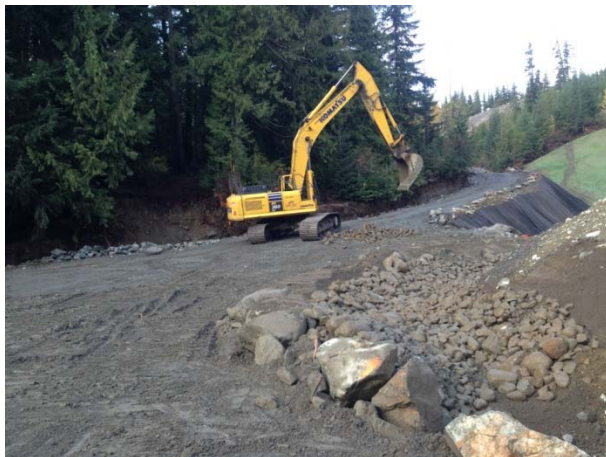
**Photo 15 – Works to improve drainage at bottom of ULRHEF downstream portal access road (November 7, 2014).**

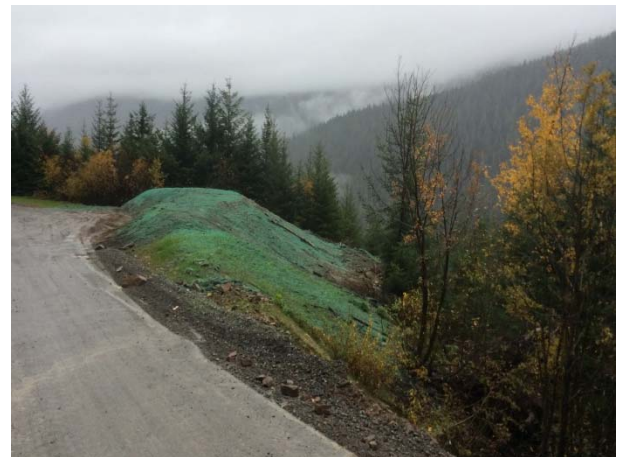
**Photo 16 – Re-contouring of failing material at KM 43.5 on the Lillooet River FSR (November 3, 2014).**

- Re-contouring works were completed to stabilize failing material at KM 43.5 on the Lillooet River FSR (Photo 16). This action item has been completed to the satisfaction of the IEM and marked accordingly in the Project's ITM.

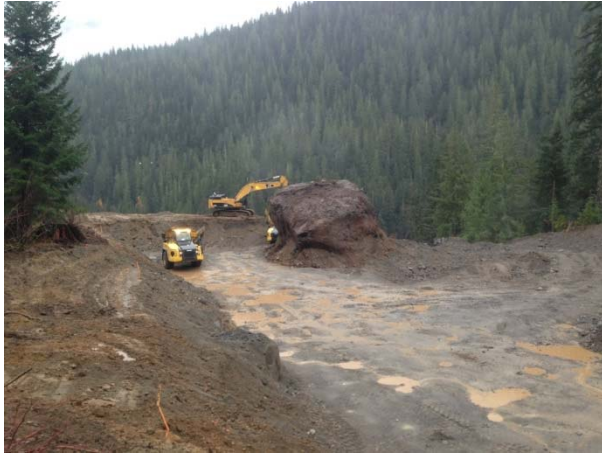
- Bulk excavation and fill works were suspended at station 2+800 to allow for slope stabilization works (see environmental summary below).
- Grubbing and bulk excavation/fill continued from 3+090 to 4+095m (Photo 17).

**Photo 17 – ULRHEF penstock bulk excavation from station 3+090m – 4+095 (November 3, 2014).**

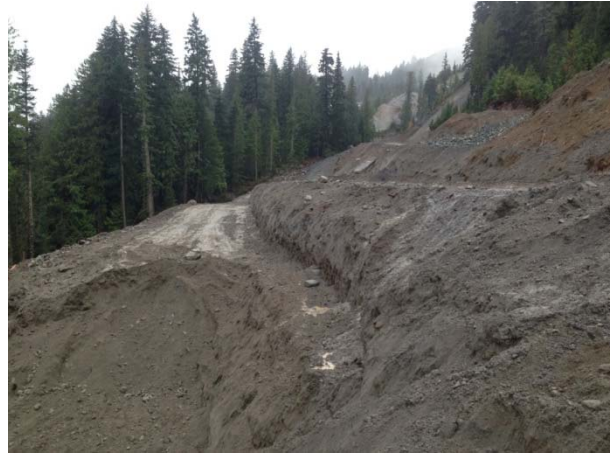
- On November 3 the IEM observed slope failures and mobilization of sediment outside of Project boundaries at the 2+800 fill slope following a significant rain event (Photo 18 and Photo 19). The IEM contacted CE and initiated a site tour to assess the situation and plan remediation works to prevent further ESC issues. Excavation and fill activities were suspended and slope stabilization works began on November 5. Works included re-grading, benching, rock armouring and installation of Curlex wattles at toe of slope (Photo 20 and Photo 21).

**Photo 18 – Sloughing and failures observed at station 2+800 fill slope (November 3, 2014).**

- As a follow up to *FAM04* (issued September 29, 2014) and additional ESC issues identified in this reporting period, the IEM continues to recommend that all necessary measures be implemented to mitigate sediment mobilization and provide for adequate treatment capacity and efficiency prior to conveyance towards the Upper Lillooet River.
- The IEM recommends that works continue to stabilize the slope at 2+800 on the penstock alignment in order to prevent further sloughing and mobilization of sediment outside project boundaries.

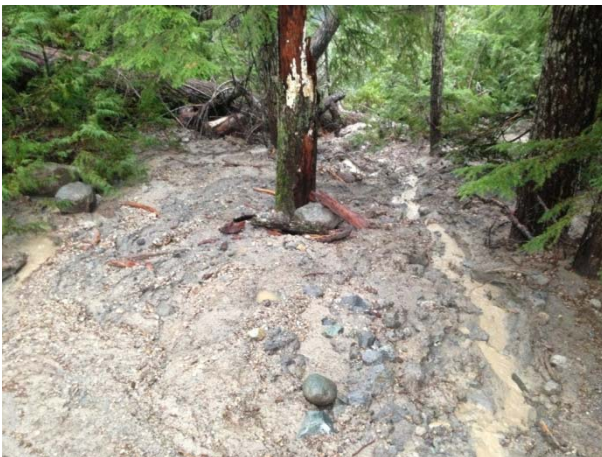
**Photo 19 – Material mobilizing beyond project boundaries below toe of 2+800 fill slope (November 3, 2014).**

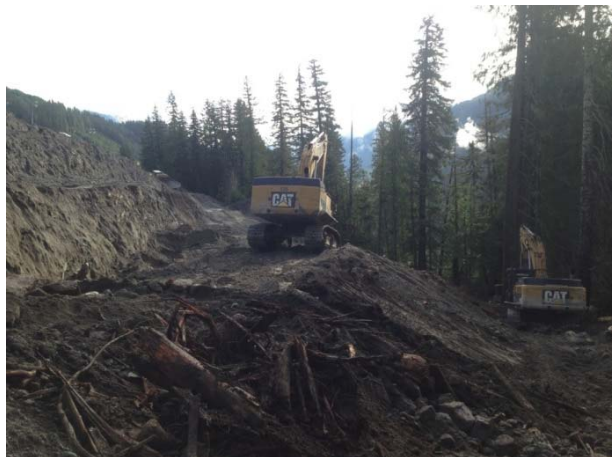
**Photo 20 – Stabilization works at 2+800 fill slope (November 7, 2014).**

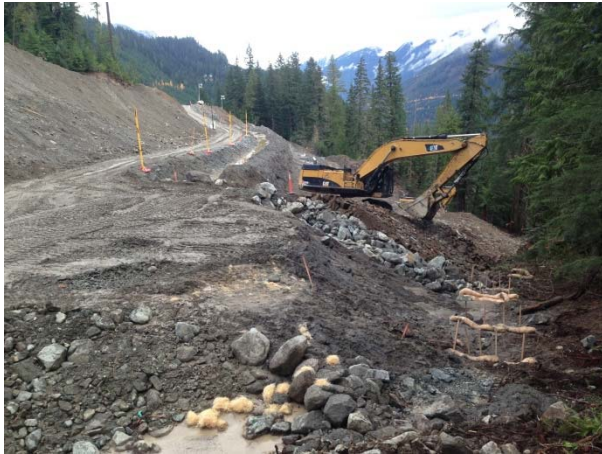
Photo 21 – Stabilization works and erosion and sediment control measures at 2+800 fill slope (November 8, 2014).

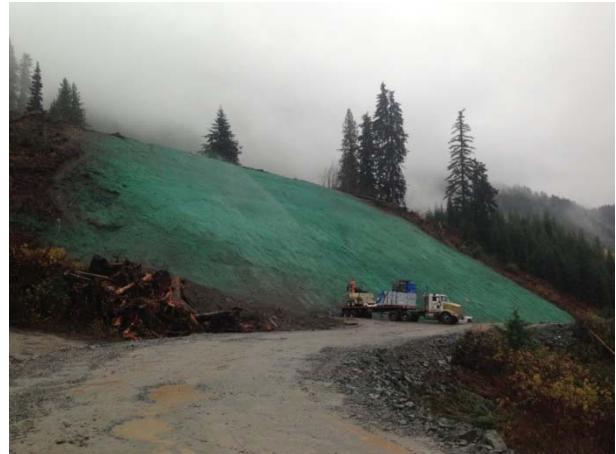
- Hydroseeding occurred on slopes near station 3+100 (Photo 22).

Photo 22 – Hydroseeding slopes near station 3+100 (November 3, 2014).

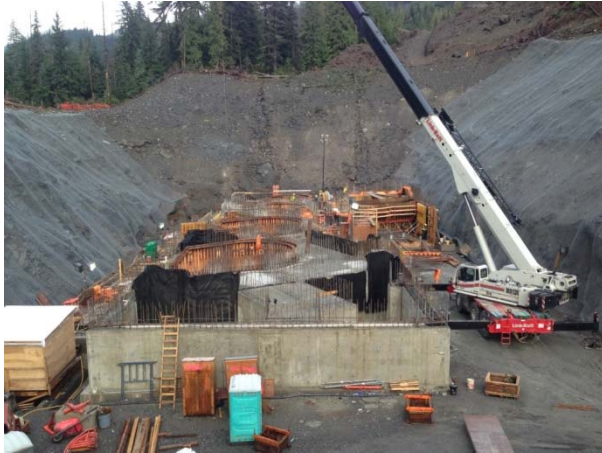
- Continued rebar installation and formworks for the powerhouse structure (Photo 23 and Photo 24). A structure pour was completed on November 8 (Photo 25).
- Two pumps (6" and 10") previously installed in the sump draining seepage waters in the powerhouse excavation continued to convey water to the existing settling ponds (Photo 26). No flowing surface water was observed within the excavation and pump capacity appears to be adequate to maintain isolation from active work areas.

**Photo 23 – Current conditions at ULRHEF powerhouse (November 7, 2014).**

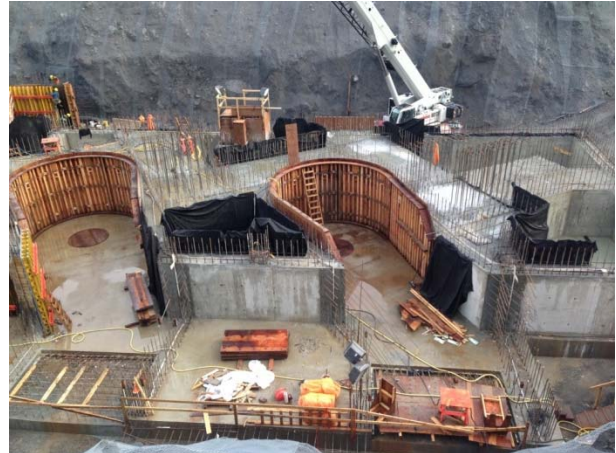
**Photo 24 – Current conditions at ULRHEF powerhouse (November 7, 2014).**

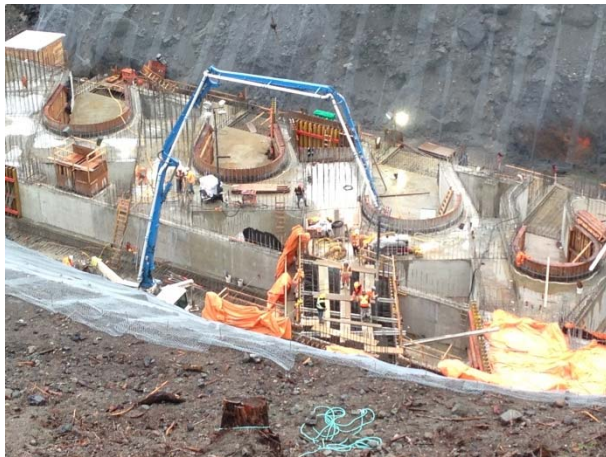
**Photo 25 – Continued concrete works at ULRHEF powerhouse (November 8, 2014).**

- Dewatering of the ULRHEF powerhouse continued without environmental concerns. The IEM will continue to monitor the works area to confirm that future concrete pours are adequately isolated from flowing waters and protected from precipitation during curing.

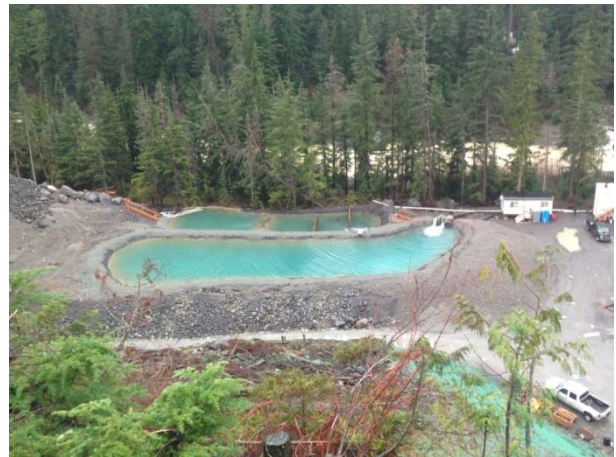
**Photo 26 – Current conditions at ULRHEF powerhouse settling ponds (November 7, 2014).**

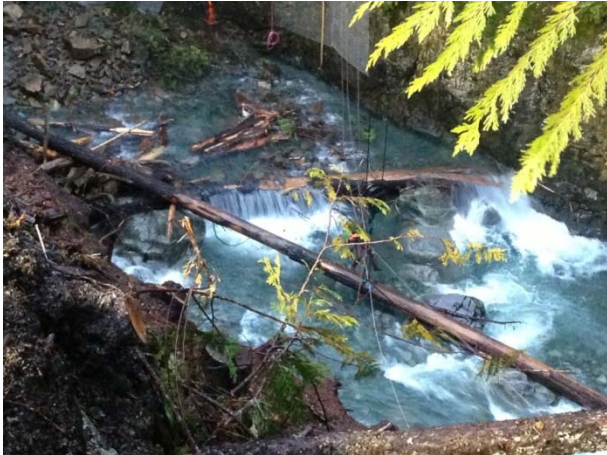
- Rope access technicians conducted scaling and stabilization works below the crane pad and above the diversion tunnel site.
- Log removal with 300 tonne crane near diversion tunnel site (Photo 27).
- Hoisting and transporting CAT 320 excavator to diversion tunnel site (Photo 28).
- Log jam dismantling with excavator near diversion tunnel site (Photo 29 and Photo 30).
- Blasting to prepare diversion tunnel platform area (Photo 31).
- BDRHEF intake diversion tunnel platform installation (Photo 32) and rock pad construction (Photo 33).
- BDRHEF diversion tunnelling works (drilling, blasting and mucking) (Photo 34).

**Photo 27 – Rope access crews choke log for crane removal (November 3, 2014).**

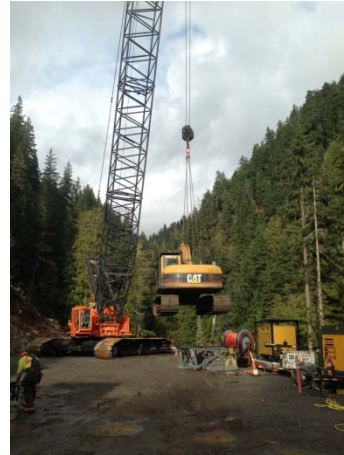
**Photo 28 – CAT 320 excavator lifted with crane and mobilized to left bank for diversion tunnel works (November 4, 2014).**

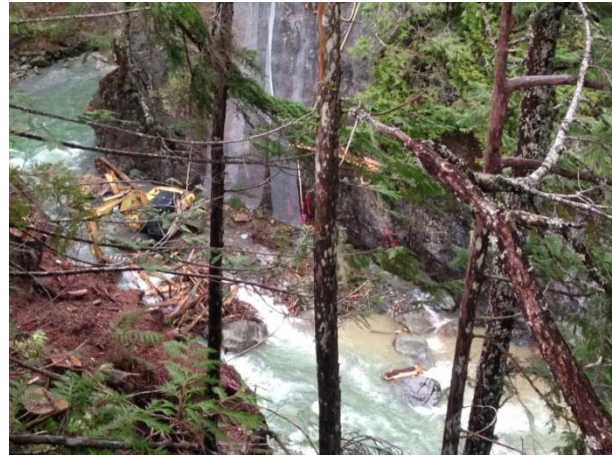
- On November 4, the dismantling of a log jam located in front of the diversion tunnel location resulted in sediments being introduced to Boulder Creek. A plume of sediment was visible for approximately 20 minutes and was observed to be diluted 15m downstream of works. The IEM was on site to monitor works and conduct water quality sampling (see WQ results below).

**Photo 30 – Excavator used for log jam removal; sediment plume visible downstream of works (November 4, 2014).**

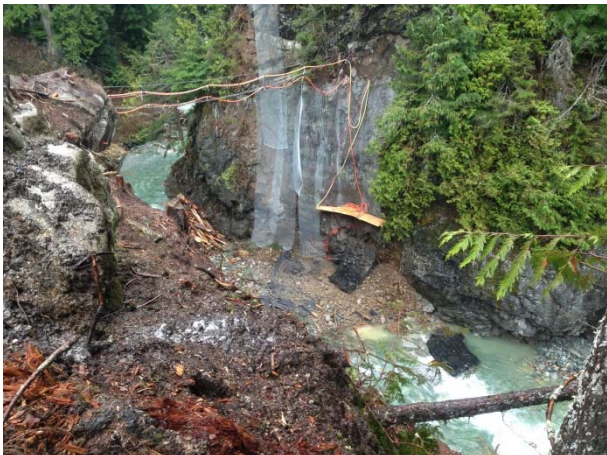
**Photo 31 – Blast mat hung during diversion tunnel platform preparation blast (November 5, 2014).**

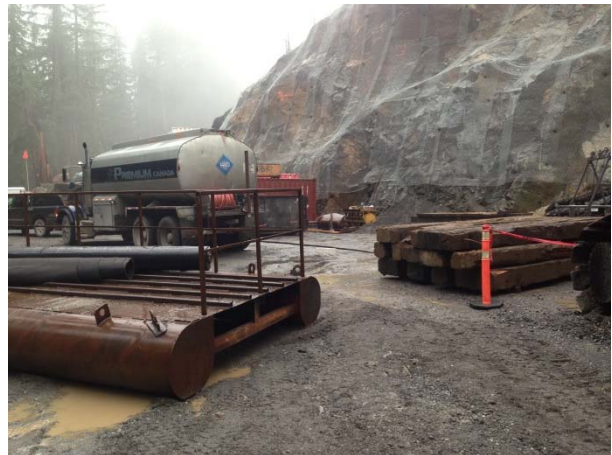
- Prior to installation, the metal and wood platforms used for the diversion tunnel pad were washed on the crane pad (Photo 32).
- A water containment system was installed at the diversion tunnel to capture and contain all tunnelling construction wastewater. A half-culvert is being utilized to convey wastewater to a barrel where it is then pumped to a containment tote. When full, the tote is transported to the BDRHEF downstream portal sediment ponds (Photo 34 and Photo 35).

**Photo 32 – Platforms cleaned on crane pad prior to being installed at diversion tunnel site (November 5, 2014).**

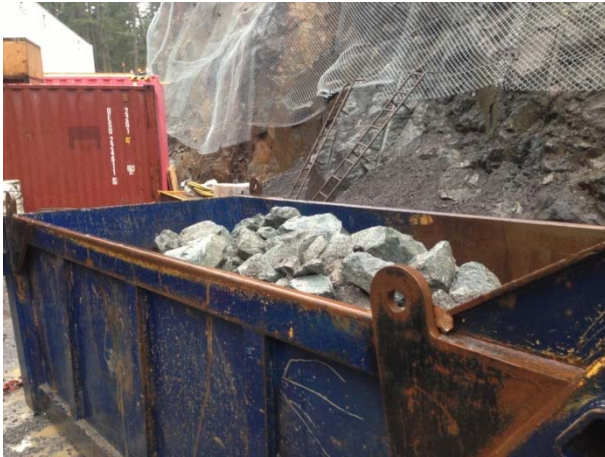
**Photo 33 – Clean rock for pad construction at diversion tunnel (November 6, 2014).**

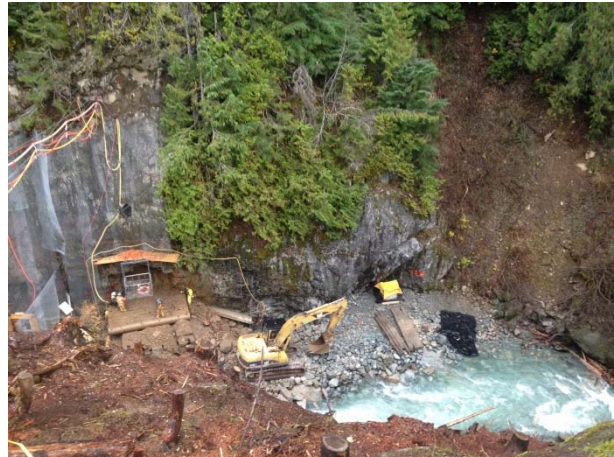
**Photo 34 – Conditions at BDRHEF intake diversion tunnel following first blast (November 8, 2014).**

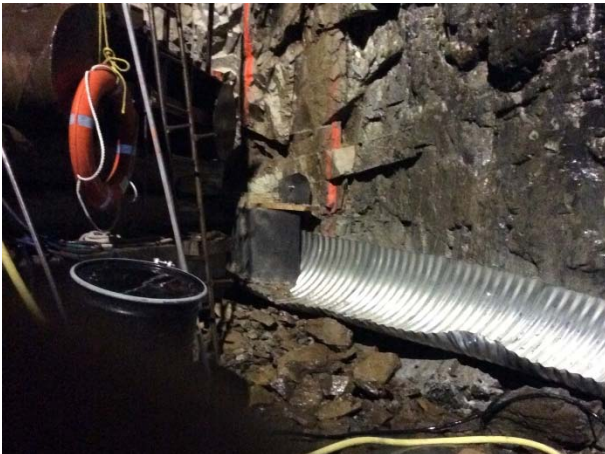
**Photo 35 – Half-culvert utilized to convey tunnelling wastewater for containment and disposal (November 6, 2014).**

- The IEM recommends that all wastewater related to the BDRHEF intake diversion tunnel works continues to be contained and transported to the BDRHEF downstream portal sediment ponds for treatment.

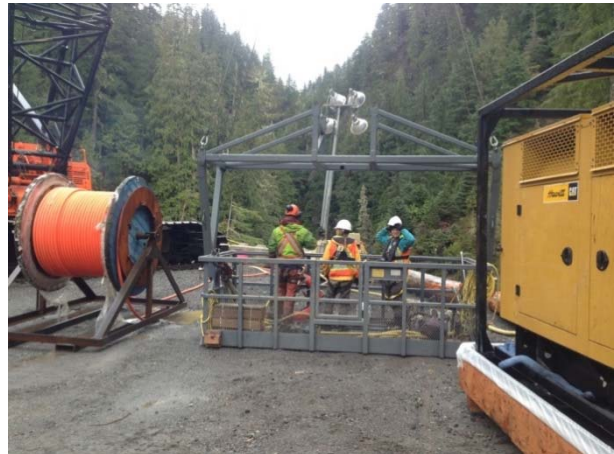
- Ecofish salvage crew conducted Coastal Tailed Frog salvage (Photo 36 and Photo 37) prior to log jam dismantling and diversion tunnel platform installation.

**Photo 36 – Ecofish salvage crew being transported in man-basket to left bank for Coastal Tailed Frog salvage (November 4, 2014).**

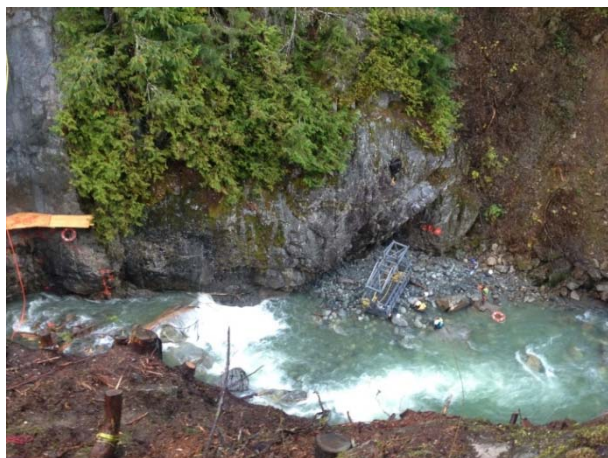
**Photo 37 – Ecofish crew conducts Coastal Tailed Frog salvage downstream of BDRHEF intake diversion tunnel site (November 4, 2014).**

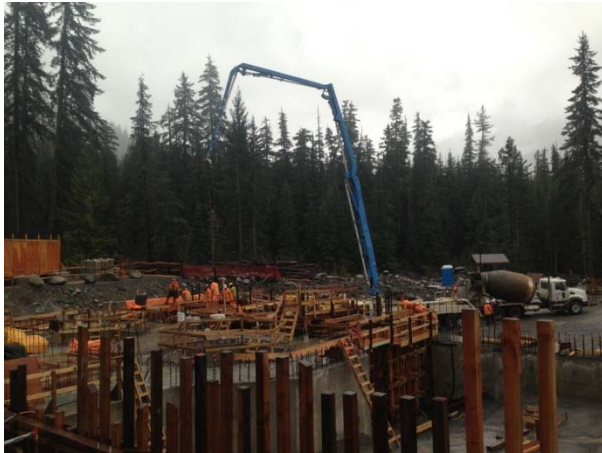
- Rebar installation, formworks and concrete works continued at the powerhouse throughout the reporting period (Photo 38).
- Drilling, blasting, mucking and stabilization (anchoring and shotcrete application) continued within the tunnel.

Photo 38 – Concrete works at BDRHEF powerhouse (November 6, 2014).

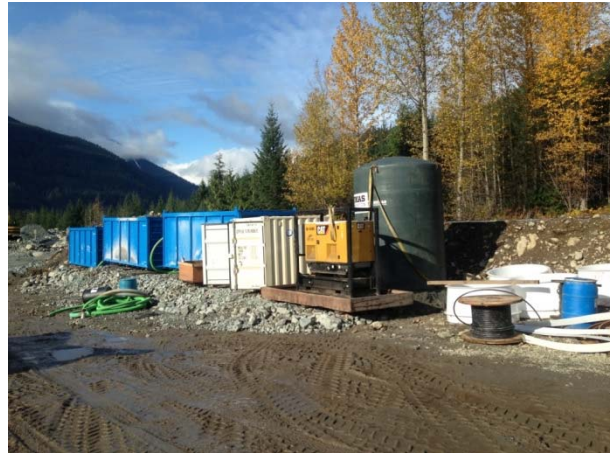
- The active water treatment system previously used at the ULRHEF intake was transported to the BDRHEF downstream portal sediment ponds (Photo 39 and Photo 40). The system began treating tunnel wastewater on November 8 (Photo 41).
- The silt fence was repaired on either side of the box culvert at KM 39.7 on the Lillooet River FSR. This action item has been completed to the satisfaction of the IEM and marked accordingly in the Project's ITM.
- No environmental issues were observed during this reporting period at the BDRHEF powerhouse or downstream tunnel portal.

Photo 39 – Active water treatment transported to BDRHEF portal settling ponds (November 7, 2014).

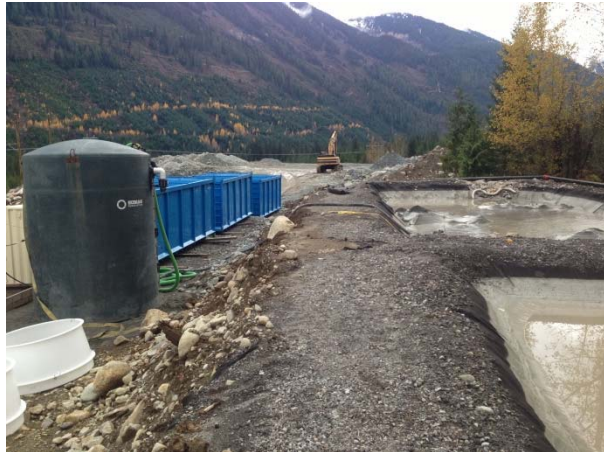
**Photo 40 – Active water treatment system installed at BDRHEF portal settling ponds (November 8, 2014).**

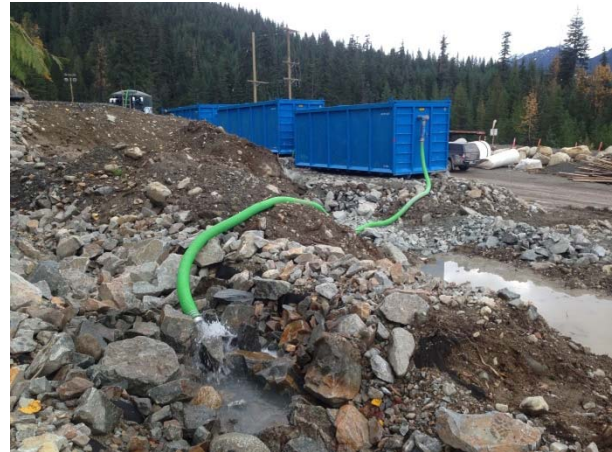
**Photo 41 – Active water treatment system activated at BDRHEF portal settling ponds (November 8, 2014).**

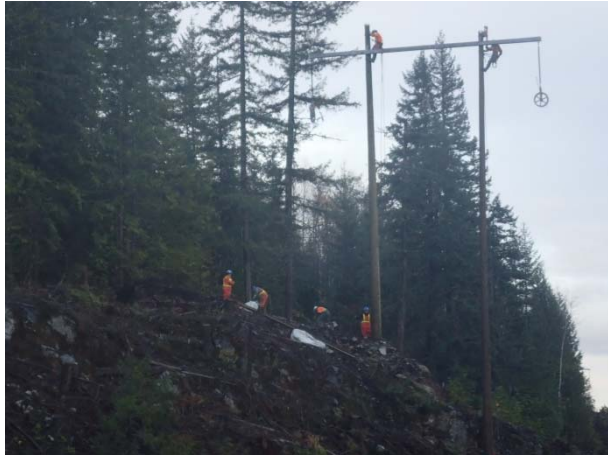
Structure framing, steel hanging and stringing occurred in Segment 5 (Photo 42 and Photo 43).

Photo 42 – Segment 5 pole stringing (November 7, 2014)

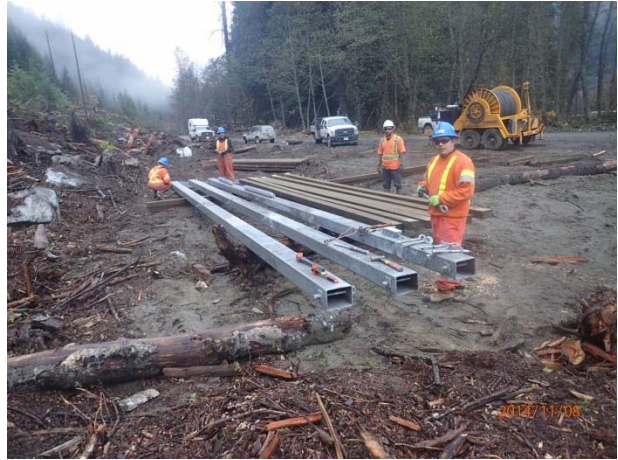
Photo 43 – Segment 5 structure framing (November 8, 2014).
