Upper Lillooet Hydro Project

Weekly Environmental Monitoring Report #50

Reporting Period: December 1 – December 31, 2014

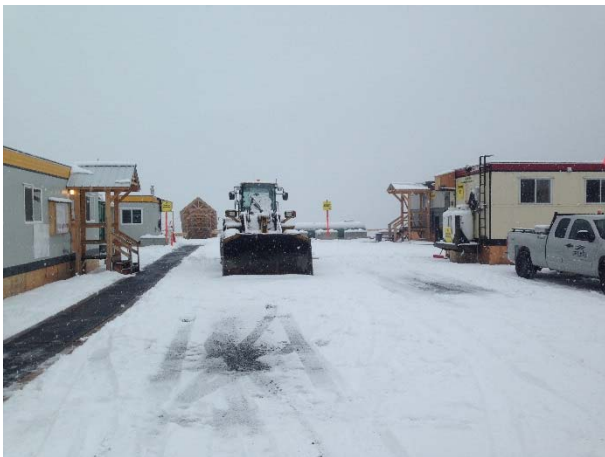
Photo 1 – Conditions at the construction camp pad #3 (December 18, 2014).

- All CE winter operations are restricted to the Construction Camp (Photo 1) and 38 km laydown (Photo 2) areas. Works included snow removal (e.g., maintaining electric fence and gates, clearing roof tops, driving surfaces and access paths), and routine maintenance of construction equipment within the mechanic shop at the 38 km laydown.
- Signs have been posted at all construction areas where works have been closed for the winter to notify the public of the dangers of entering closed construction sites (Photo 3).

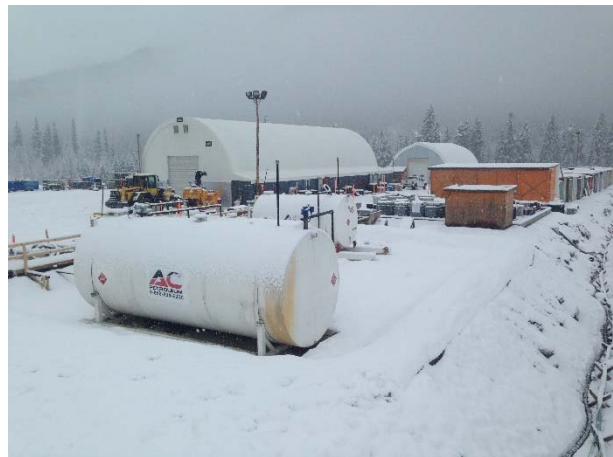
Photo 2 – Conditions at fuel storage area at the 39 km laydown (December 18, 2014).

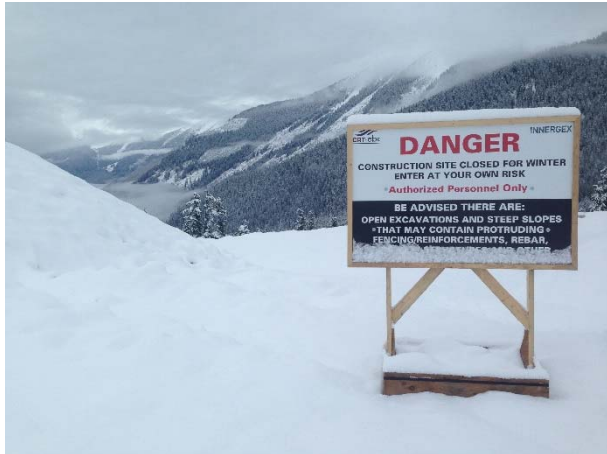
Photo 3 – Example of sign boards posted at all closed construction areas (December 18, 2014).
