# Upper Lillooet Hydro Project

## Weekly Environmental Monitoring Report #50

Reporting Period: December 1 – December 31, 2014

Upper Lillooet River Hydroelectric Facility (Water File No. 2002561, Water licence No. C130613), Boulder Creek Hydroelectric Facility (Water File No. 2003049, Water licence No. C129969) & Transmission Line (TX Line)

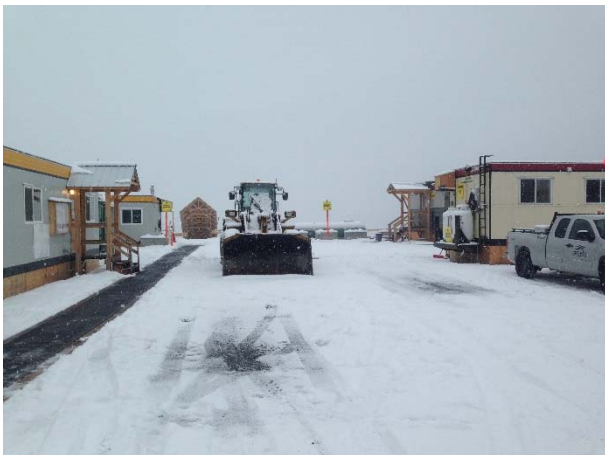
Photo 1 – Conditions at the construction camp pad #3 (December 18, 2014).

- All CE winter operations are restricted to the Construction Camp (Photo 1) and 38 km laydown (Photo 2) areas. Works included snow removal (e.g., maintaining electric fence and gates, clearing roof tops, driving surfaces and access paths), and routine maintenance of construction equipment within the mechanic shop at the 38 km laydown.
- Signs have been posted at all construction areas where works have been closed for the winter to notify the public of the dangers of entering closed construction sites (Photo 3).

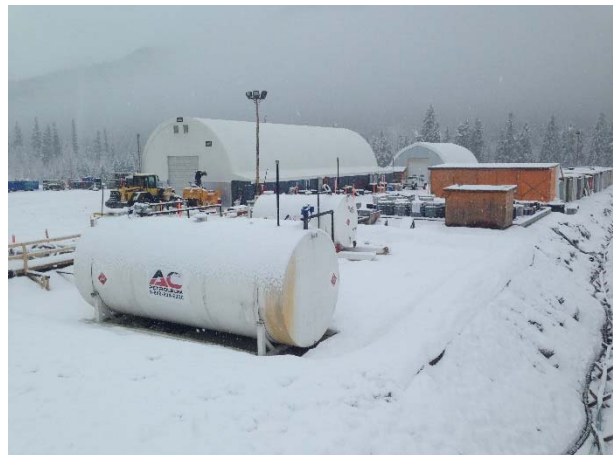
Photo 2 – Conditions at fuel storage area at the 39 km laydown (December 18, 2014).

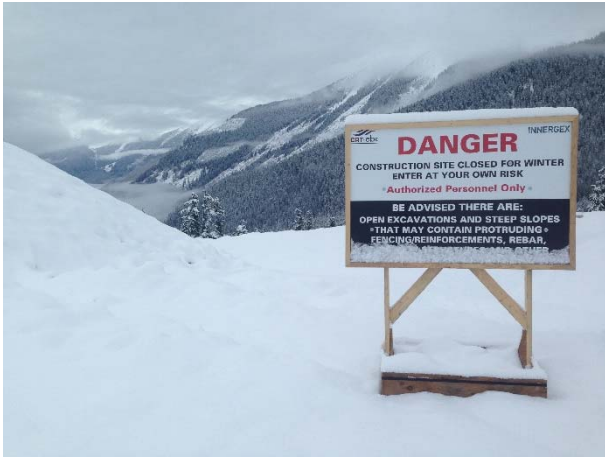
Photo 3 – Example of sign boards posted at all closed construction areas (December 18, 2014).

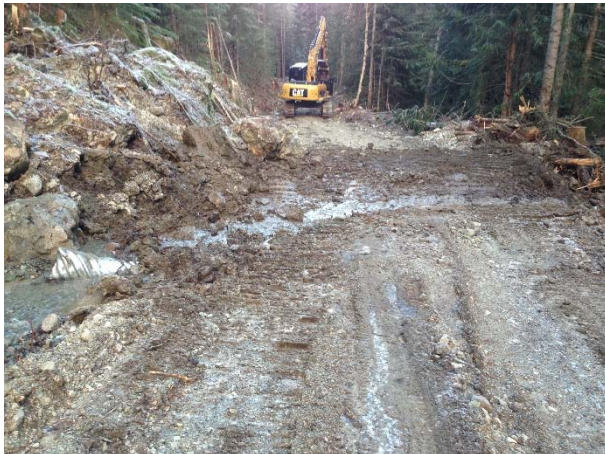
- Water quality was also monitored during seasonal deactivation/winterization of access road 197.2 in Segment 8. Two temporary turbidity pulses were noted by the IEM during the road deactivation works, including a peak of 15.1 NTU in Stream 185a and a peak of 26.9 NTU in Hillaby Creek. Temporarily elevated turbidity lasted for less than 25 minutes in both instances. The cross ditch excavations were performed through the dry sections of the access road prior to connecting the road side drainage to the newly installed cross ditch. The elevated turbidity pulses were observed to be caused by the washing of the bottom of the new cross ditches. Water quality results are presented in Section 5.2.

Photo 4 – Segment 8 crossing ditching above Hillaby Creek (December 15, 2014).

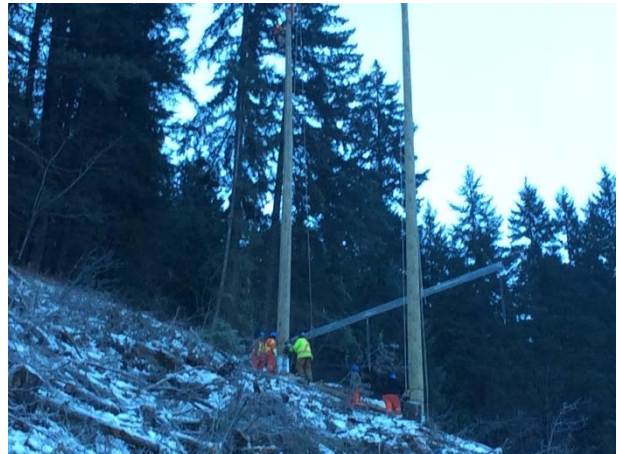
- Construction of the Stringer Line pole foundations began during this reporting period. All excavation within RVMAs and CTF stream buffers was monitoring by the IEM.
- Foundation construction and structure framing works were performed in Segments 5 (Photo 5) & 7, and in Segment 9 at structure 202.

Photo 5 – Segment 5 pole dressing works (December 2, 2014).

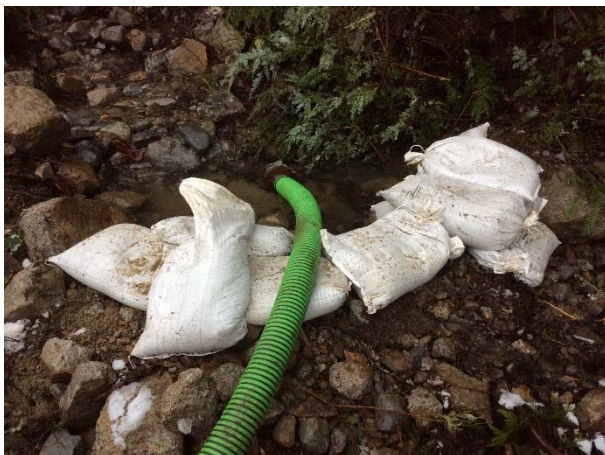
Photo 6 – Example of a sand bag berm and pump diversion installed to divert water around the work area during culvert installations along the Salmon main road (December 19, 2014).

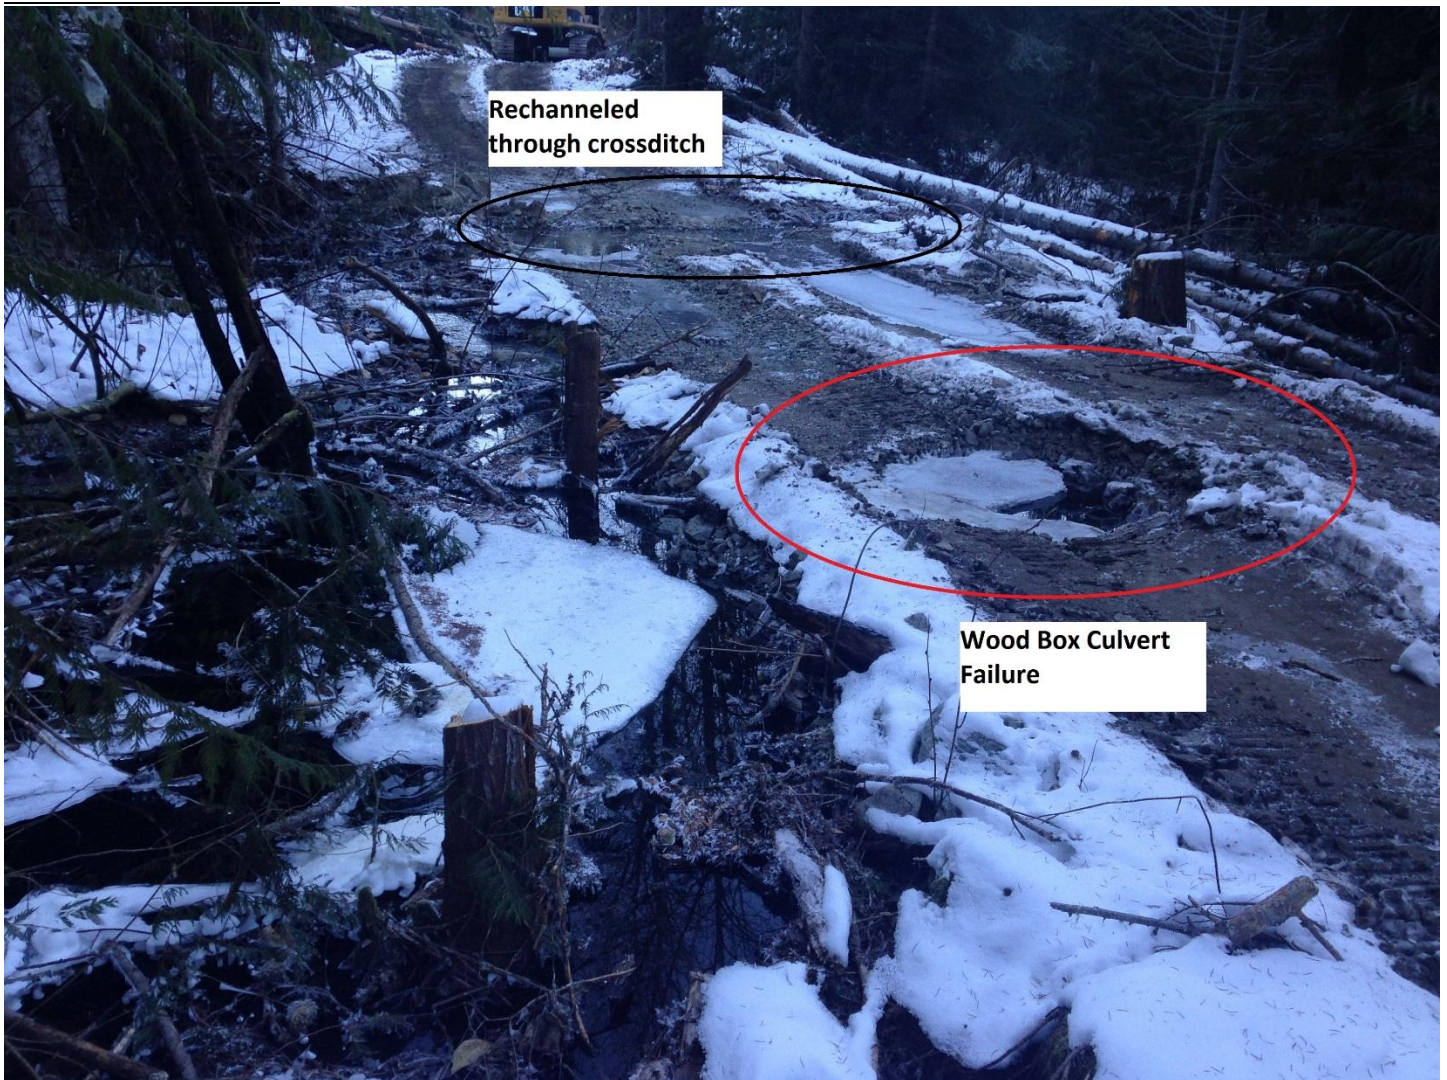
- Wood box culvert failed during road resurfacing works. The stream flow was partially blocked causing the stream to back water. The excavator operator dug a cross ditch (in the dry) parallel to the culvert through the road surface to channel flow over the road without eroding the running surface.
- The rock truck was able to drive away from the WBC.
- Works were halted, equipment was parked and workers left the site once they were confident the site was stable.
- The work site is out of a mobile service area. Once the workers were in communication range, they were not able to contact the supervisor due to the power outage issues in Pemberton from the extreme weather occurrences.
- The IEM was notified late in the day due to the break in communication between the workers and the appropriate supervisors.

- Rock truck tire punched through the wood box culvert while traveling unloaded along road.

- There was a plume of sediment introduced into the stream when the culvert collapsed and again once the stream redirected through the cross-ditch.
- No hydrocarbon spills occurred.

Collapsed WBC in foreground, cross-ditch in background.

The excavator operator built a cross ditch to allow stream flow to continue across the road and back into the channel downstream. Works were halted once the area was stabilized.  
 Workers travelled to a location within mobile service, however, due to the extreme weather conditions Pemberton's power was sporadically in and out. This caused a delay with communications between workers and supervisors. The incident notification was not issued until after 6pm.

- Improvement with efficiency in communication.
- A satellite phone is issued to the on-site first aid attendant and workers will be advised to use the sat-phone to attempt contacting the supervisor and/or the IEM.

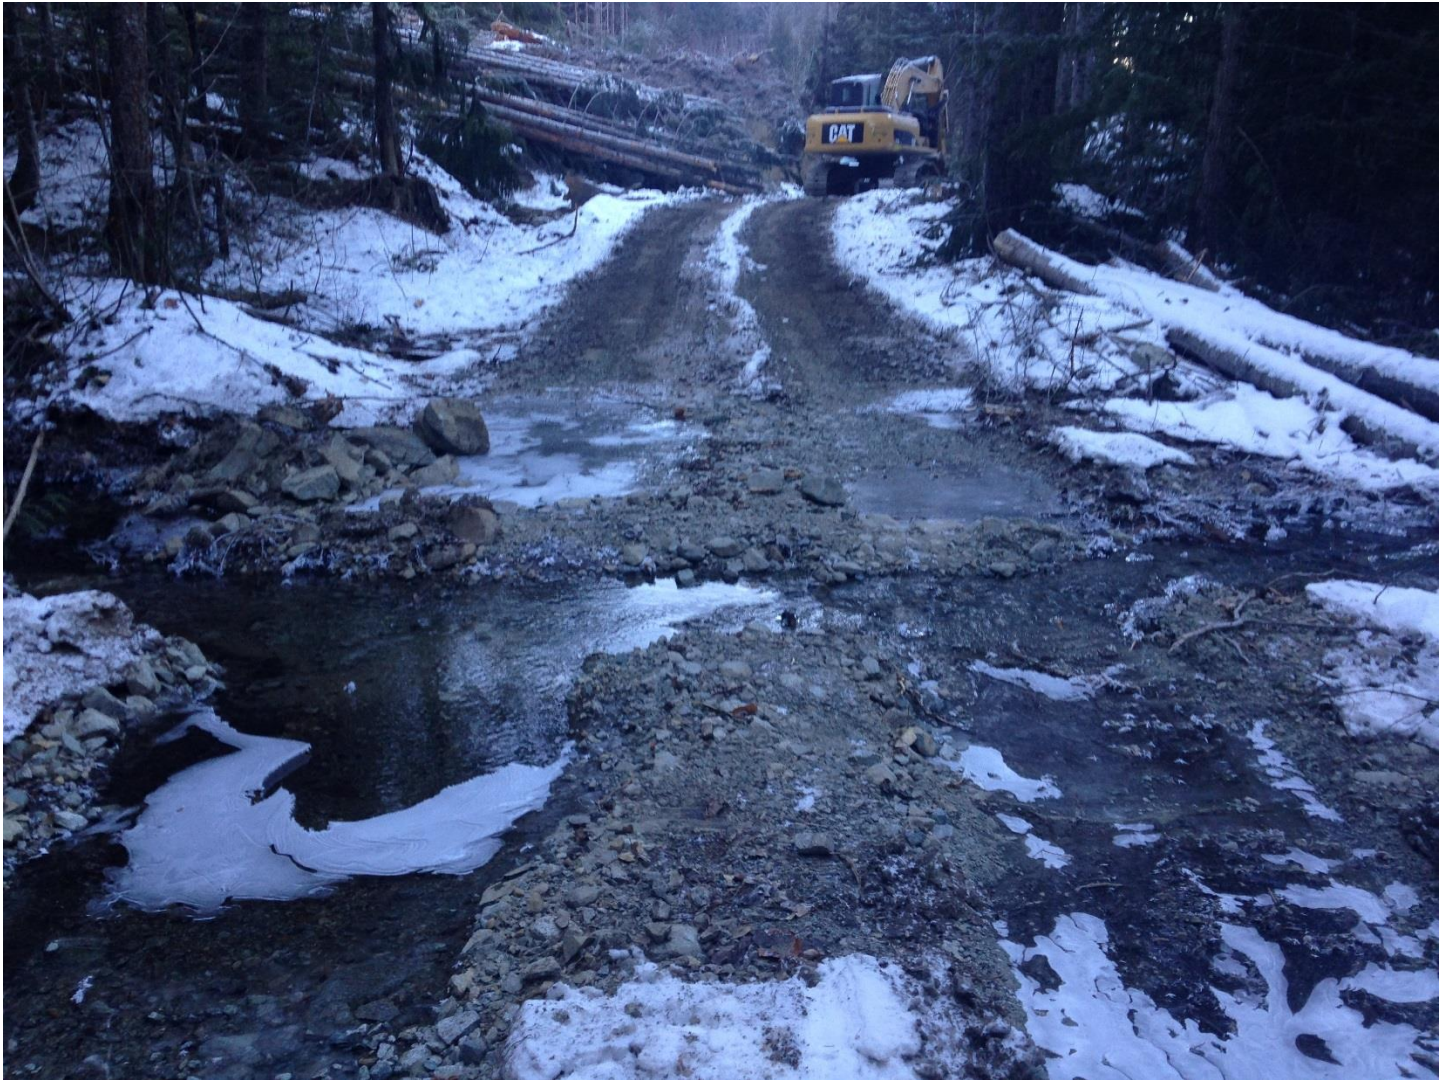
Cross-ditch
