Upper Lillooet Hydro Project

Weekly Environmental Monitoring Report #51

Reporting Period: January 1 – January 31, 2015

Upper Lillooet River Hydroelectric Facility (Water File No. 2002561, Water licence No. C130613), Boulder Creek Hydroelectric Facility (Water File No. 2003049, Water licence No. C129969) & Transmission Line

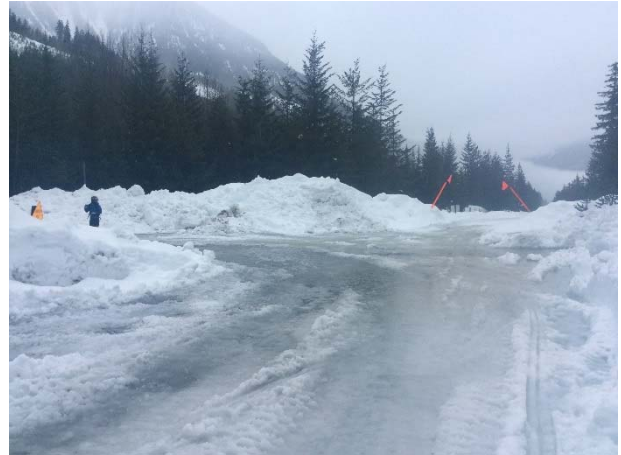
- The transitions between the Lillooet River FSR and the winter works area (at 37.5 km and 38.5 km) were marked and passable by snowmobile during both inspections (January 9 and 23, 2015). The running surface of the Lillooet River FSR was snow covered during the January 9 inspection (Photo 1); however, the rain and warm weather on January 23 resulted in snow melt, exposing patches of the gravel running surface (Photo 2). CE informed the IEM that they were attempting to keep a portion of the running surface of the Lillooet River FSR snow covered to the extent possible despite the warm conditions.

Photo 2 – Transition into winter work area at 37.5km (January 23, 2015).

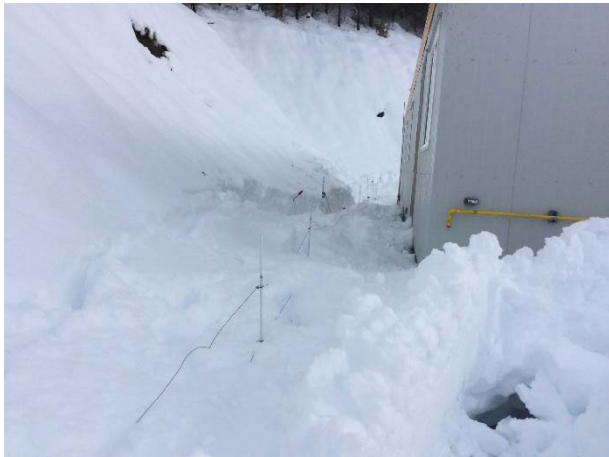
- The electric fence was observed to be buried on January 9. CE was actively in the process of clearing snow and repairing the electric fence (Photo 3). During the follow-up inspection on January 23 the electric fence was fully operational and clear of snow (Photo 4).

- The IEM performed an inspection of the active ULRHEF and BDRHEF sites on January 9 and January 23, 2015. On January, 9 the IEM observed that the electric fence was under repair and non-operational due to recent heavy snow falls. The gates of each of the four levels of the construction camp were also left open. The IEM asked that the electric fence be repaired and that the gates be closed at all times to prevent wildlife from entering the construction camp area. No wildlife sightings within the construction camp area were reported in January 2015. During the follow-up inspection on January 23 the electric fence was found to be fully operational and clear of snow.

Photo 3 – The electric fence was being repaired and cleared of snow during the January 9, 2015 inspection.

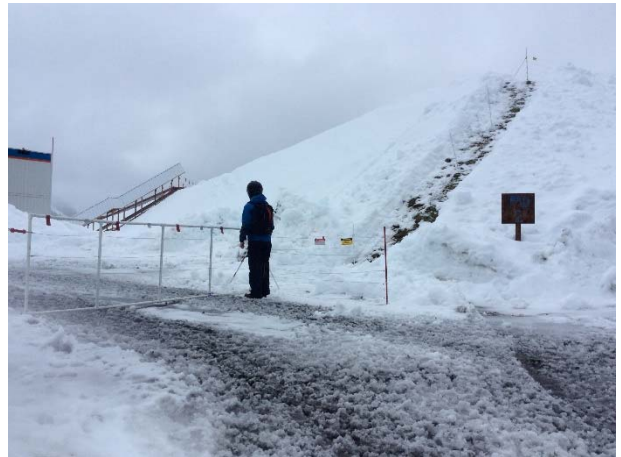
Photo 4 – The electric fence was operational and snow free during the January 23, 2015 inspection.

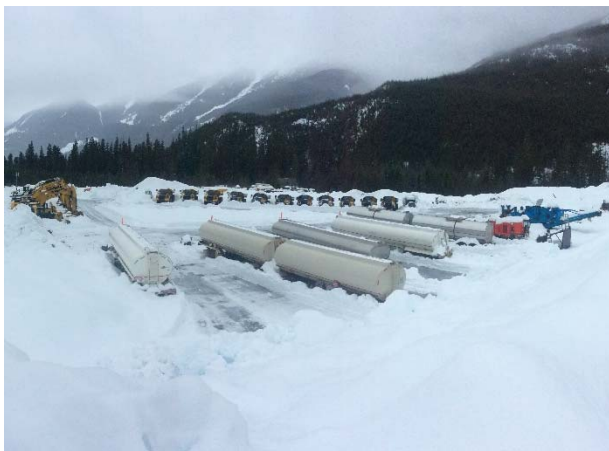
- All CE winter operations are restricted to the Construction Camp and 38 km laydown (Photo 5) areas. Works included snow removal (e.g., maintaining electric fence and gates, clearing roof tops, driving surfaces and access paths), and routine maintenance of construction equipment within the mechanic shop at the 38 km laydown.

Photo 5 – Conditions at fuel storage area within Pad 1 of the 38km laydown (January 23, 2015).

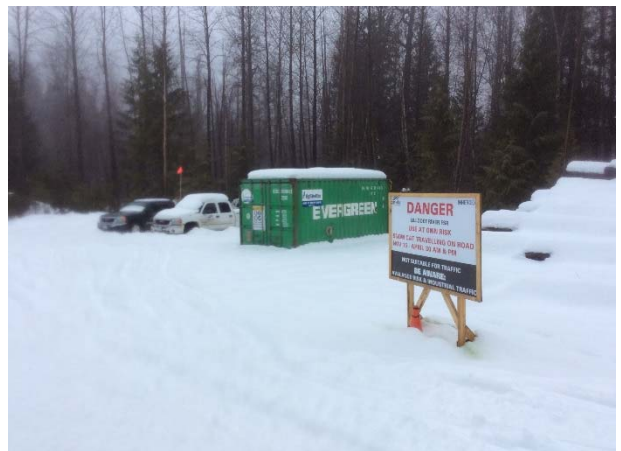
- Signs have been posted to notify the public of the dangers of entering closed construction sites (Photo 6).

Photo 6 – Example of sign boards posted to warn public of the dangers of entering closed construction areas (January 23, 2015).

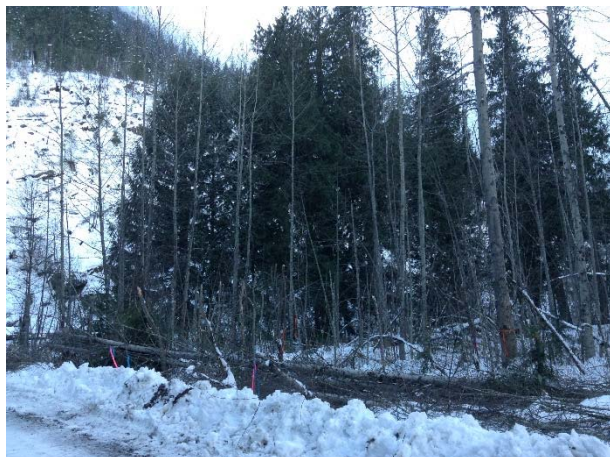
- Stringer Line RoW clearing occurred from pole 1 - 5 on January 14 – 16, 2015 (Photo 7). RVMA clearing of trees overhanging the Salmon Slough occurred on January 22. Minor branch limbing within the Salmon Slough RVMA occurred on January 28. The IEM was onsite to oversee clearing activities within 150m of wetland habitat associated with the Salmon Slough.
- Clearing of the Segment 16 RoW began on January 26 following a pre-work meeting. The IEM monitored hand falling and tree topping within RVMAs and clearing within 100m of CTF streams.

Photo 7 – Hand falling near pole 5 of the Stringer Line alignment (January 13, 2015).

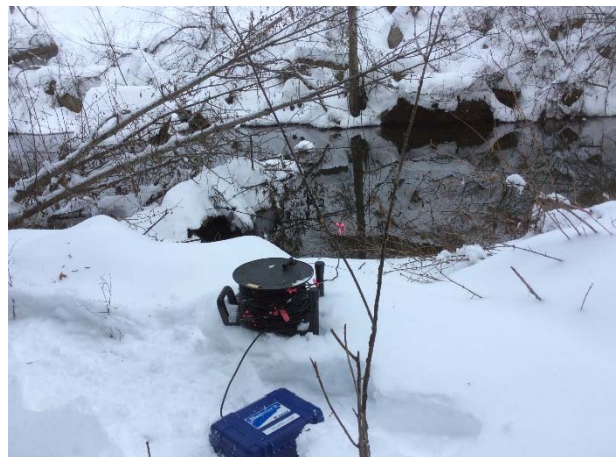
- On January 10, 2015 the IEM was onsite to conduct instream acoustic monitoring during blasting works in proximity to the Salmon Slough (Photo 8). The hydrophone trigger

Photo 8 – Instream acoustic pressure monitoring during blasting within 30 m of the Salmon Slough (January 10, 2015).

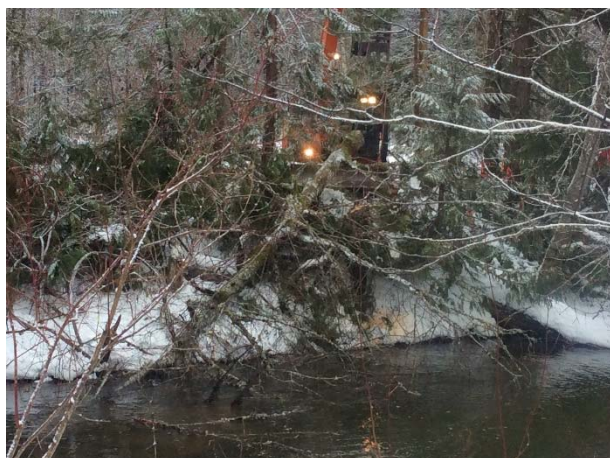
Photo 9 – Removing a tree from the Salmon Slough with ropes attached to an excavator (January 22, 2015).

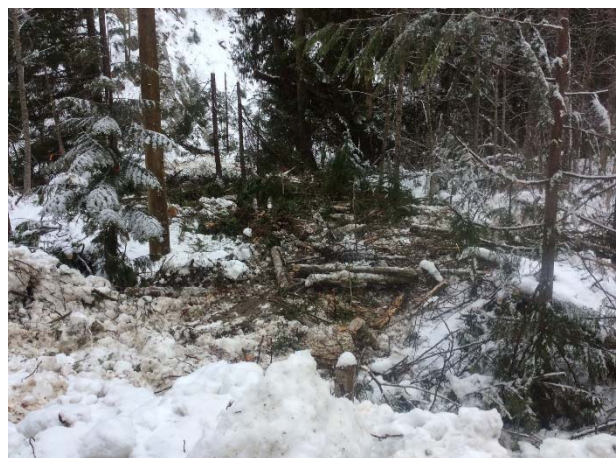
Photo 10 – Conditions following the operation of an excavator with 30m of the Salmon Slough (January 22, 2015).
