# Upper Lillooet Hydro Project

## Weekly Environmental Monitoring Report #53

Reporting Period: March 1 – March 14, 2015

Upper Lillooet River Hydroelectric Facility (Water File No. 2002561, Water licence No. C130613), Boulder Creek Hydroelectric Facility (Water File No. 2003049, Water licence No. C129969) & Transmission Line

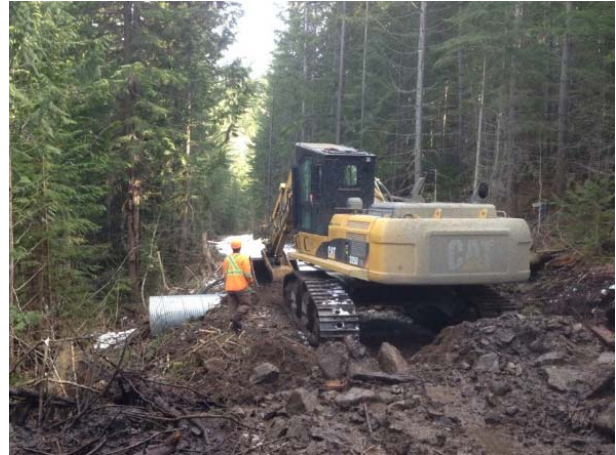
**Photo 2 – Culvert installation works at 1+911 on road 197.2 (March 3, 2015).**

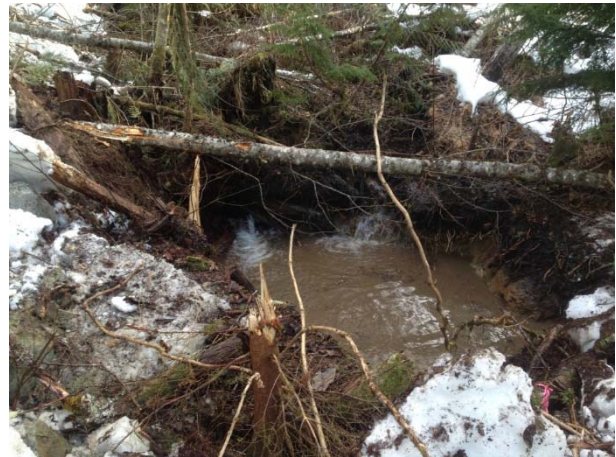
- On March 4, the diversion at 1+335 on road 197.2 (Segment 8) required the excavator dig a sump for the pump inlets due to subsurface flow and large amounts of coarse woody debris covering the watercourse (Photo 4). The sump excavation caused a temporary pulse of suspended sediment in watercourse 185A. The sump was excavated at 13:50 and the turbid pulse was observed at its peak ~100m downstream of works within stream 185A at 14:05 (192NTU). The IEM continued water quality monitoring 10m upstream of Black's water intake where peak turbidity was observed to be 18.3NTU and returned to within 8NTU of background within 20 minutes. Another turbid pulse was observed at 1+335 when water was released into the new culvert. Peak turbidity was measured 100m downstream of works in stream 185A to be 83.3NTU at 15:39. Monitoring continued 10m upstream of Black's water intake where peak turbidity was 10.9NTU at 16:10 and became 4.88NTU at 16:20. See Section 5.2 Water Quality Results.

**Photo 4 – Sump excavated to allow water to be pumped for worksite isolation during culvert installation at 1+335 on road 197.2 (March 4, 2015).**

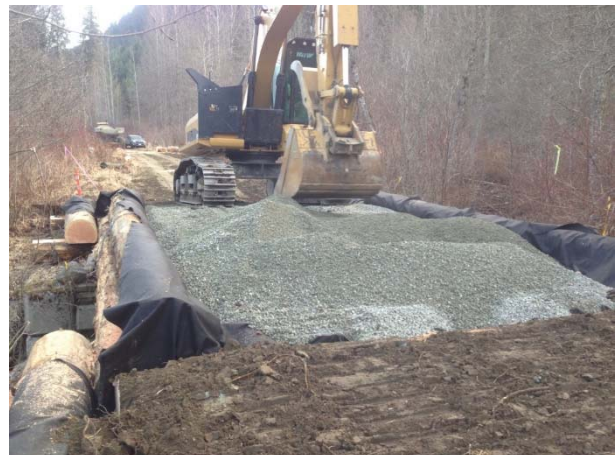
- The IEM was onsite to monitor the three temporary crossing upgrades on the Miller Bench FSR (Segment 12; Photo 6 and Photo 7). The high water mark was clearly flagged at all crossings and works were completed in the dry with no effect on the surrounding watercourse.

**Photo 6 – Bridge installation works at MB59 on the Miller Bench FSR (March 3, 2015).**

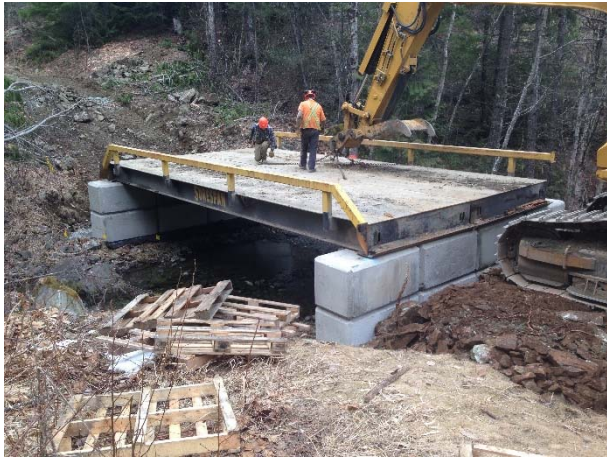
Photo 7 – Bridge installation works at MB53 on the Miller Bench FSR (March 6, 2015).

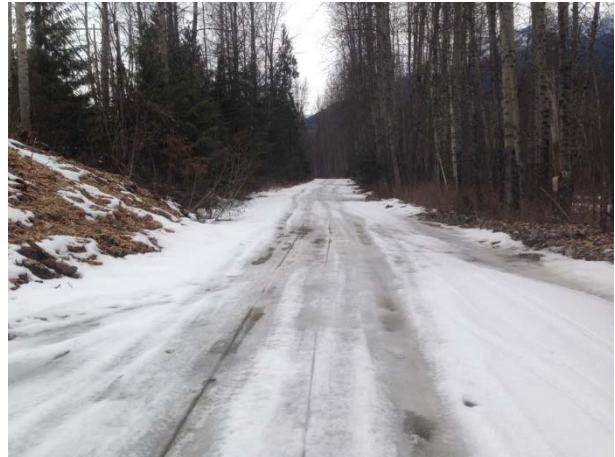
Photo 8 – Conditions at KM 2.5 on the South Lillooet FSR prior to snow clearing (March 6, 2015).

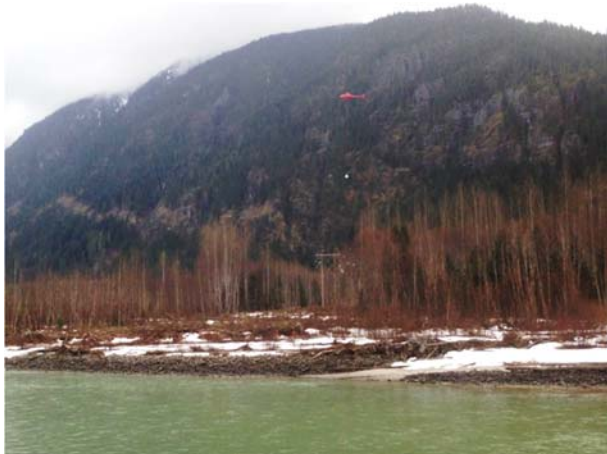
- River crossing works were completed in Segment 5 and 6 from March 8-13. The crossing works included the installation of pole 140 and 141, framing, stringing and clipping (Photo 9 and Photo 10).

Photo 9 – A-Star B3 helicopter dropping equipment at pole 140 location (March 11, 2015).

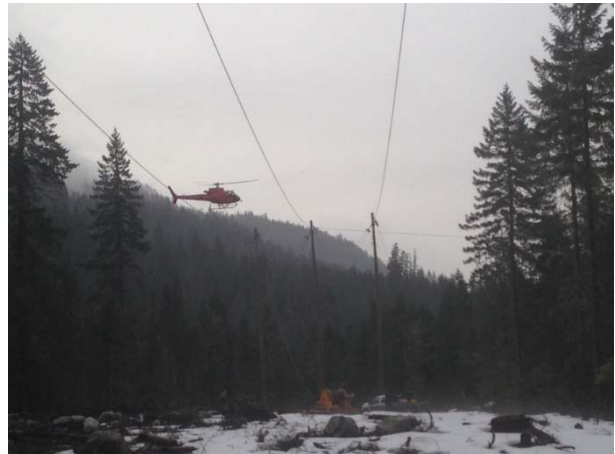
Photo 10 – A-Star B3 helicopter flying pilot line at pole 136 (March 11, 2015).
