Upper Lillooet Hydro Project

Weekly Environmental Monitoring Report #53

Reporting Period: March 1 – March 14, 2015

Upper Lillooet River Hydroelectric Facility (Water File No. 2002561, Water licence No. C130613), Boulder Creek Hydroelectric Facility (Water File No. 2003049, Water licence No. C129969) & Transmission Line

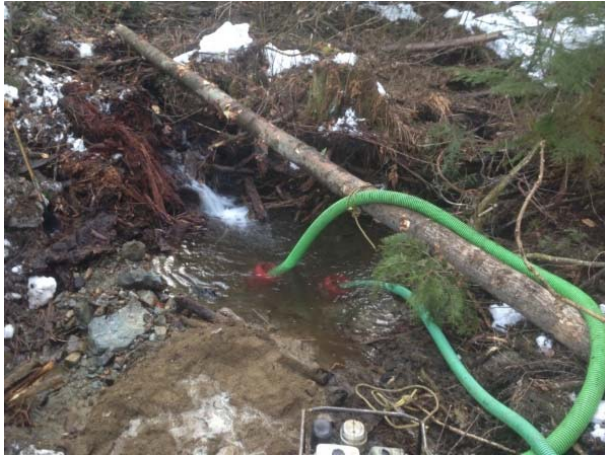
Photo 1 – Two pumps used to complete worksite isolation for culvert installation at 2+700 on road 197.2 (March 10, 2015).

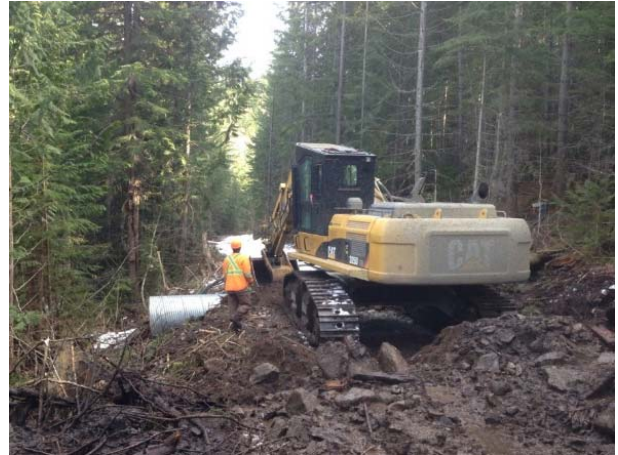
Photo 2 – Culvert installation works at 1+911 on road 197.2 (March 3, 2015).

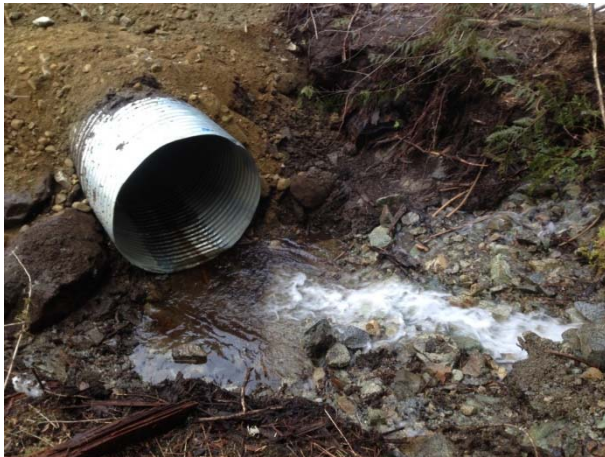
Photo 3 – A temporary pulse of suspended sediment was observed when water was released through new culvert at 1+911 on road 197.2 (March 3, 2015).

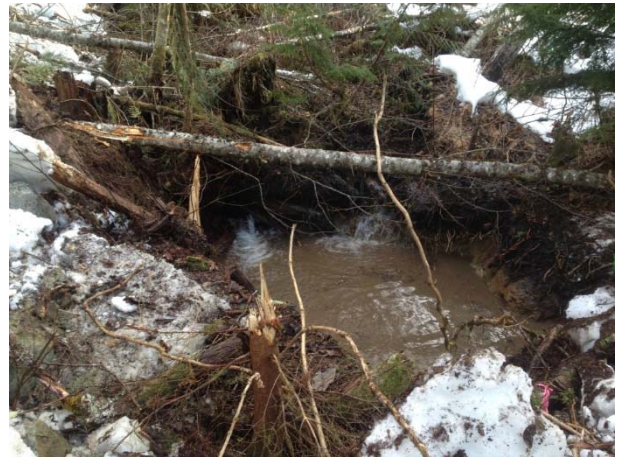
- On March 4, the diversion at 1+335 on road 197.2 (Segment 8) required the excavator dig a sump for the pump inlets due to subsurface flow and large amounts of coarse woody debris covering the watercourse (Photo 4). The sump excavation caused a temporary pulse of suspended sediment in watercourse 185A. The sump was excavated at 13:50 and the turbid pulse was observed at its peak ~100m downstream of works within stream 185A at 14:05 (192NTU). The IEM continued water quality monitoring 10m upstream of Black's water intake where peak turbidity was observed to be 18.3NTU and returned to within 8NTU of background within 20 minutes. Another turbid pulse was observed at 1+335 when water was released into the new culvert. Peak turbidity was measured 100m downstream of works in stream 185A to be 83.3NTU at 15:39. Monitoring continued 10m upstream of Black's water intake where peak turbidity was 10.9NTU at 16:10 and became 4.88NTU at 16:20. See Section 5.2 Water Quality Results.

Photo 4 – Sump excavated to allow water to be pumped for worksite isolation during culvert installation at 1+335 on road 197.2 (March 4, 2015).

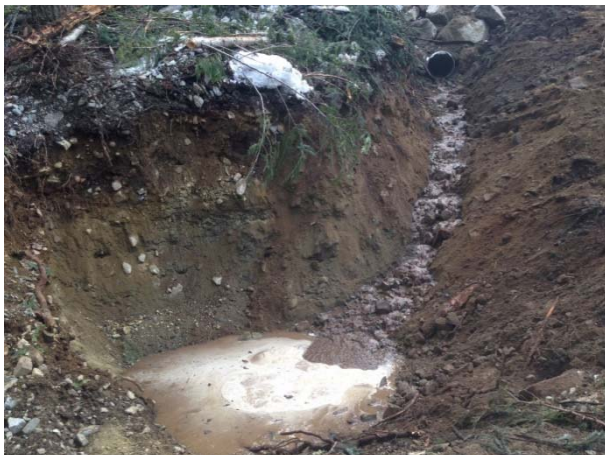
- On March 5, the culvert installed on the access road at 1+890 on road 197.2 (Segment 8) required a new ditch to convey flow to the watercourse at 1+911. Turbid flows were anticipated due to the unconsolidated material in the new ditch. A settling pond was excavated to allow suspended sediment to settle prior to entering watercourse 186A (Photo 5). The flows conveyed by the new culvert slowly filled the settling pond and new ditch. The IEM was unable to stay onsite until flows reached the confluence with 186A. Due to low volume of water and settlement in pond there was little risk of impact to watercourse 186A. The IEM returned to site on the morning of March 6 and measured water quality below the culvert, and found turbidity levels to be similar to background conditions. See Section 5.2 Water Quality Results.

Photo 5 – Settling pond used to improve water quality following culvert installation on access road at 1+890 on road 197.2 (March 5, 2015).

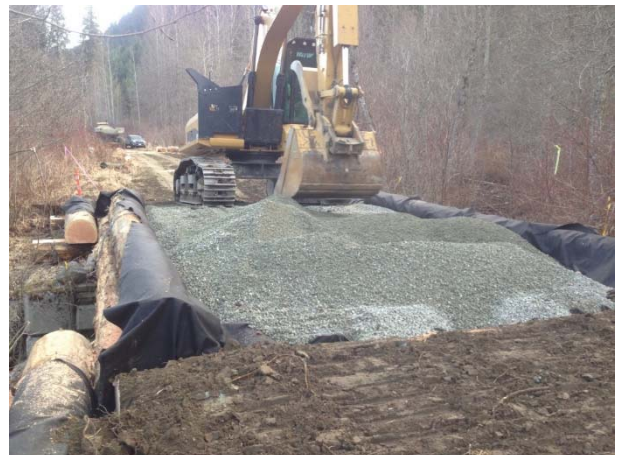
- The IEM was onsite to monitor the three temporary crossing upgrades on the Miller Bench FSR (Segment 12; Photo 6 and Photo 7). The high water mark was clearly flagged at all crossings and works were completed in the dry with no effect on the surrounding watercourse.

Photo 6 – Bridge installation works at MB59 on the Miller Bench FSR (March 3, 2015).

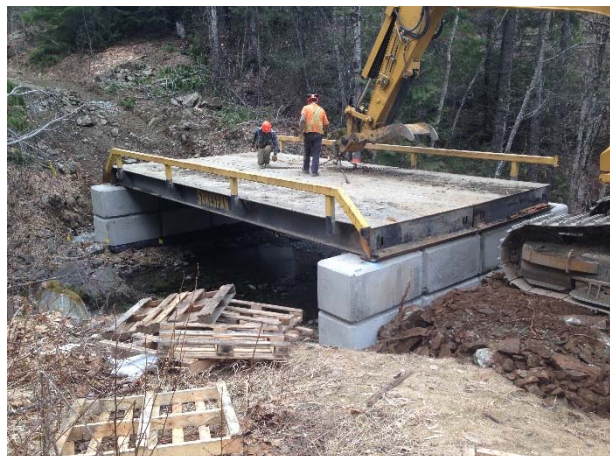
Photo 7 – Bridge installation works at MB53 on the Miller Bench FSR (March 6, 2015).

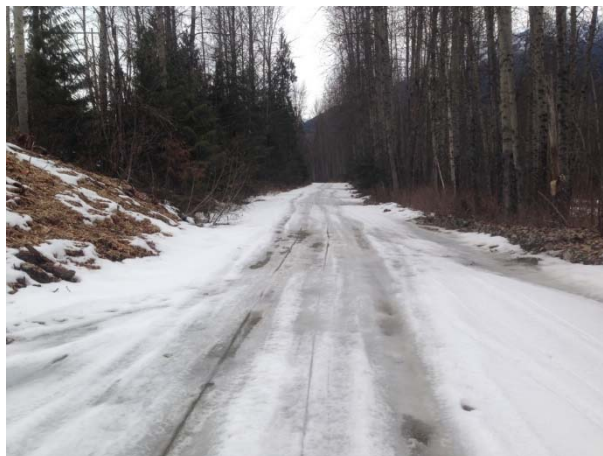
Photo 8 – Conditions at KM 2.5 on the South Lillooet FSR prior to snow clearing (March 6, 2015).

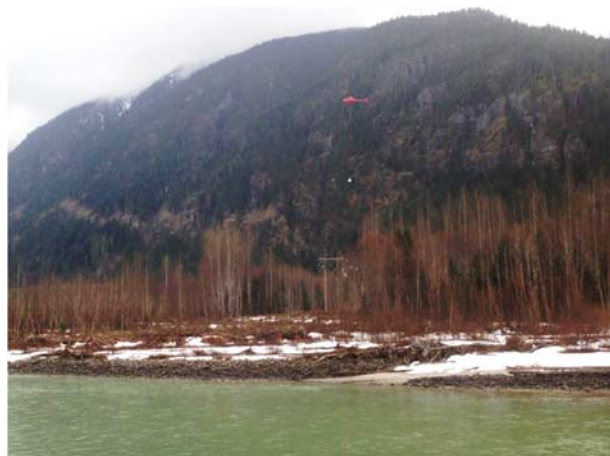
- River crossing works were completed in Segment 5 and 6 from March 8-13. The crossing works included the installation of pole 140 and 141, framing, stringing and clipping (Photo 9 and Photo 10).

Photo 9 – A-Star B3 helicopter dropping equipment at pole 140 location (March 11, 2015).

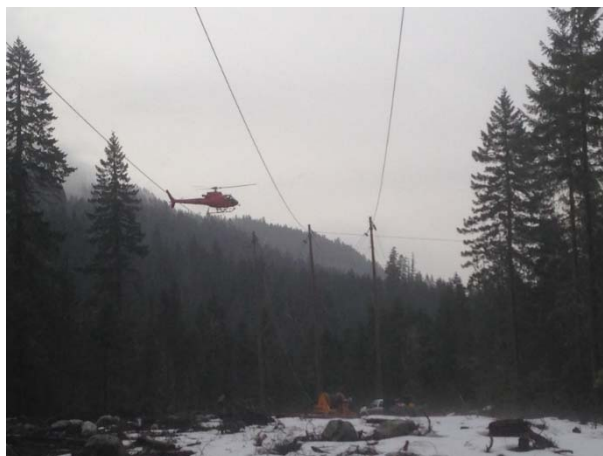
Photo 10 – A-Star B3 helicopter flying pilot line at pole 136 (March 11, 2015).
