Upper Lillooet Hydro Project

Weekly Environmental Monitoring Report #57

Reporting Period: April 12 – April 18, 2015

Upper Lillooet River Hydroelectric Facility (Water File No. 2002561, Water licence No. C130613), Boulder Creek Hydroelectric Facility (Water File No. 2003049, Water licence No. C129969) & Transmission Line

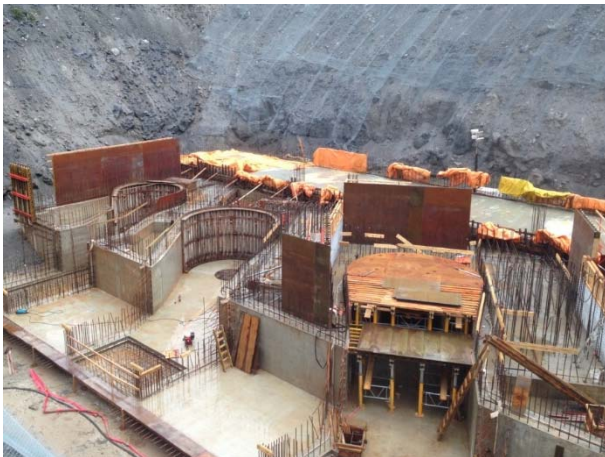
- Formwork and rebar installation.
- Structural concrete pour occurred on April 13 (Photo 1 and Photo 2).
- Dewatering to settling ponds (Photo 3).

Photo 1 – ULRHEF powerhouse with recently poured concrete in background (April 13, 2015).

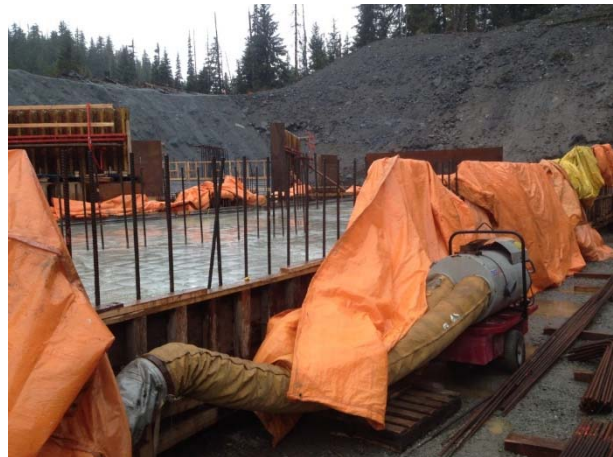
- On April 13, the IEM was onsite to inspect the ULRHEF powerhouse following a concrete pour. Rain contacting uncured concrete resulted in alkaline runoff and pooling found in the northeast portion of the powerhouse excavation. The IEM conducted water quality sampling in the powerhouse sump and in the settling ponds. All water samples were measured to have a pH <9 and suitable for discharge to the surrounding environment as per the Surface Water Quality Protection Plan (See Section 4.4 for Water Quality Results).

Photo 2 – Concrete poured at ULRHEF powerhouse (April 13, 2015).

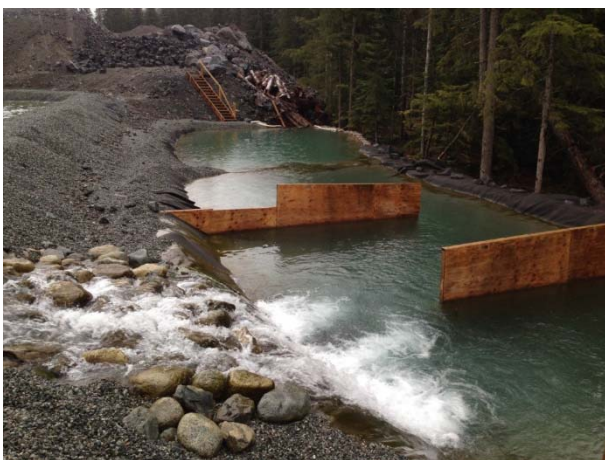
Photo 3 – ULRHEF powerhouse settling ponds (April 13, 2015).

- The IEM recommends that the BDRHEF and ULRHEF sediment ponds continue to be utilized and are closely monitored to ensure that they are effectively promoting infiltration/ and treating water quality prior to discharging water offsite.
- Once the ULRHEF and BDRHEF intake sites can be accessed the IEM recommends that the effectiveness of installed winterization and ESC measures be assessed to ensure that regular maintenance is performed as needed.

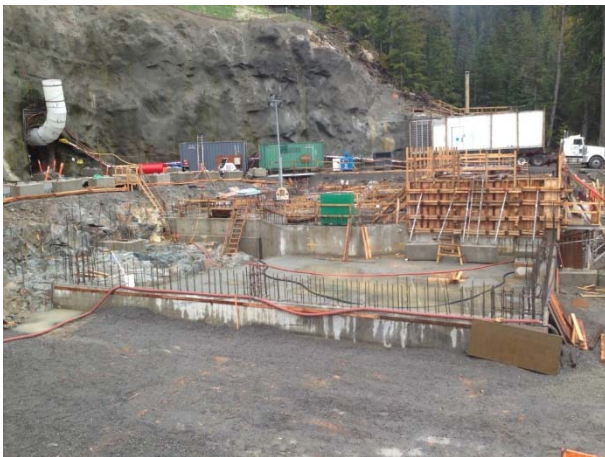
- Formwork, rebar installation and backfill works (Photo 4).
- Structural concrete pour occurred on April 15 (Photo 5).
- Drill and blast works in tunnel.
- Tunnel portal and powerhouse dewatering to oil water separator and settling ponds (Photo 6).

Photo 4 – Current conditions at BDRHEF powerhouse (April 13, 2015).

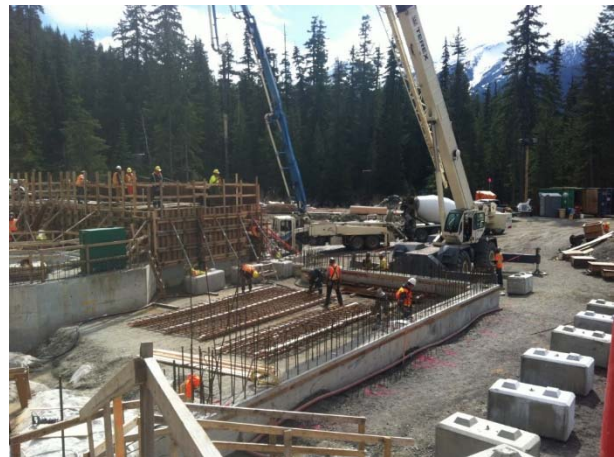
Photo 5 – Concrete pour in progress at BDRHEF powerhouse (April 15, 2015).

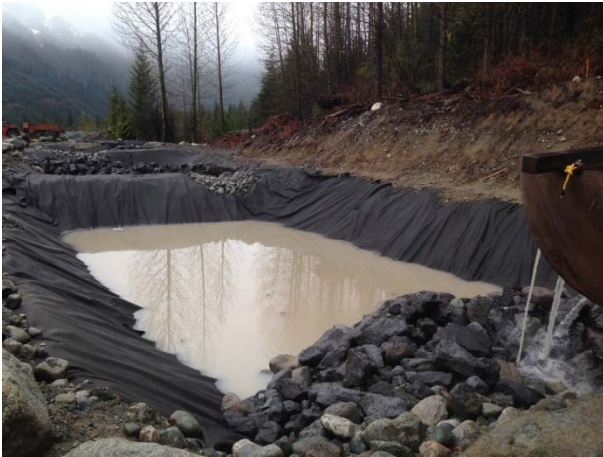
- All dewatering of the powerhouse excavation and tunnel was directed to the reconstructed settling ponds (Photo 6). All water introduced to the settling ponds was observed to be infiltrating to ground in the first cell of the ponds throughout this reporting period.
- New spill kits were placed at the tunnel portal site (Photo 7).

Photo 6 – BDRHEF powerhouse settling ponds
(April 13, 2015).

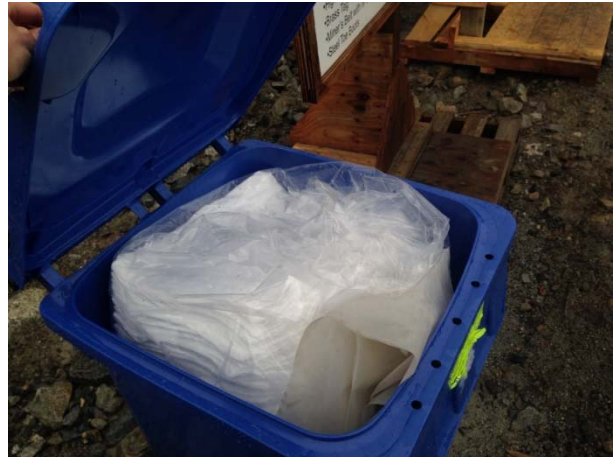
Photo 7 – New spill kit at the BDRHEF tunnel portal
(April 13, 2015).

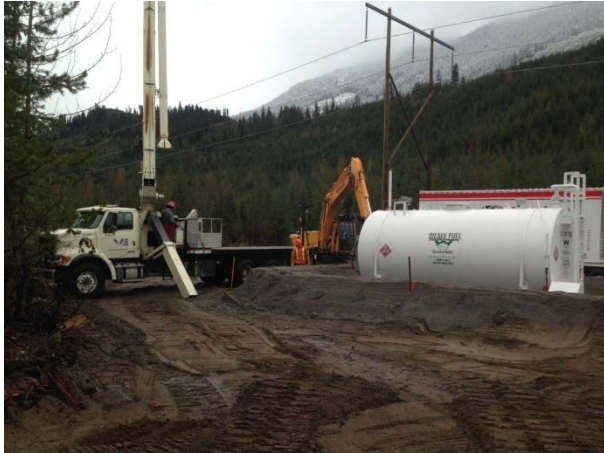
- Construction of temporary generator site in Segment 2 near 39km of Lillooet River FSR (Photo 8).
- Road upgrades (including culvert installations) continued in Segment 12 on Miller Bench FSR (Photo 9, Photo 10, Photo 11 and Photo 12).
- Hand falling in Segment 13 from structure 319 – 322.5 (Photo 13).
- Hoe chucking and log decking in Segment 16 (Photo 14).

Photo 8 – Construction of temporary generator site in Segment 2 (April 13, 2015).

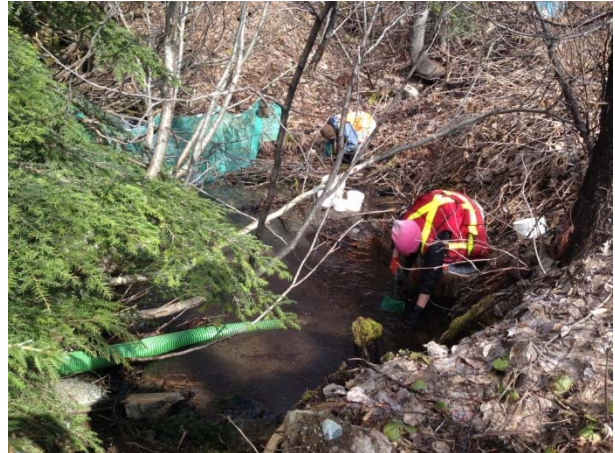
- On April 14 and 15 the IEM was present for seven non-fish bearing culvert installations at MB23, MB24, MB30, MB32, MB33, MB34 and MB38 on the Miller Bench FSR. The culvert installations at MB30 and MB32 were at identified Coastal Tailed Frog (CTF) streams. An Ecofish crew conducted CTF salvages prior to works and during dewatering (Photo 9). The MB38 location was observed to have intermittent flow and the culvert installation was completed while no flow was present. For all wet culvert installations worksite isolation was achieved with dam, sump and pump methods and works were completed in the absence of flowing water (Photo 10, Photo 11 and Photo 12). Crews took care to minimize downstream sedimentation by minimizing disturbance to surrounding soil. The IEM conducted water quality sampling during all wet culvert installations (See Section 5.2 for Water Quality Results).

Photo 9 – CTF salvage conducted by Ecofish crew at MB30 (April 15, 2015).

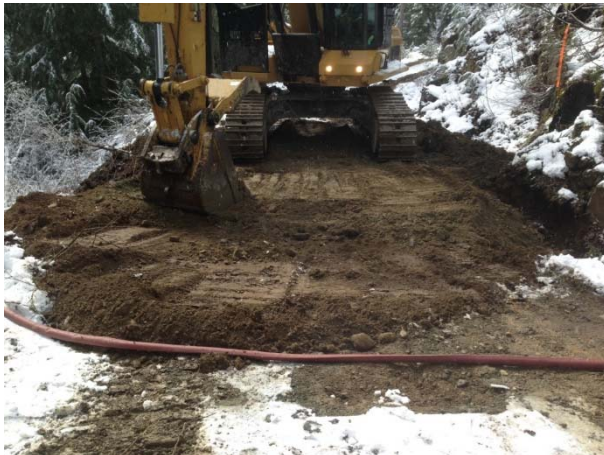
Photo 10 - Culvert installation with diversion in place at MB24 in Segment 12 (April 14, 2015).

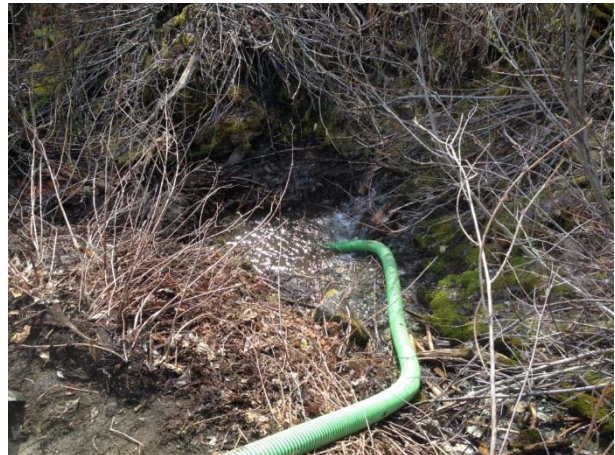
Photo 11 – Sump and 3" pump used to divert water at MB34 (April 15, 2015).

Date	Time	Sample Location Description	pH	Turbidity (NTU)	Cond (uS)	Temp (°C)
	12:00	10m downstream following MB30 works	-	1.82	-	-
MB34						
	12:25	Background above MB34	-	1.73	-	-
	12:35	100m downstream during MB34 works	-	24.4	-	-
	12:55	100m downstream during MB34 works		8.84		
	13:00	100m downstream following MB34 works		4.55		
MB32						
	14:20	Background above MB32		1.69		
	14:30	10m downstream during MB32 works		2.07		
	14:40	10m downstream during MB32 works		1.71		
	14:50	10m downstream following MB32 works		1.73

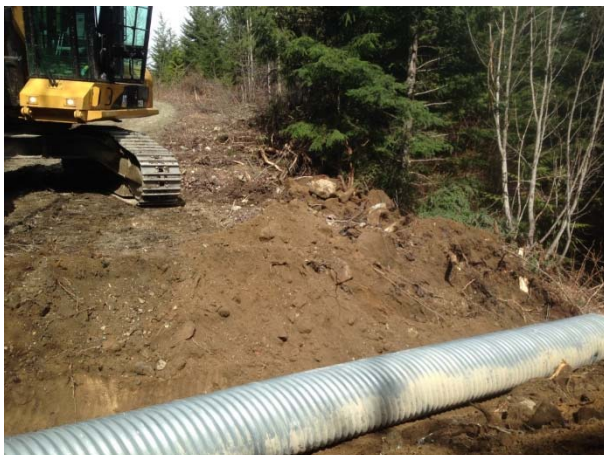
Photo 12 – Culvert installation in progress at MB32 (April 15, 2015).

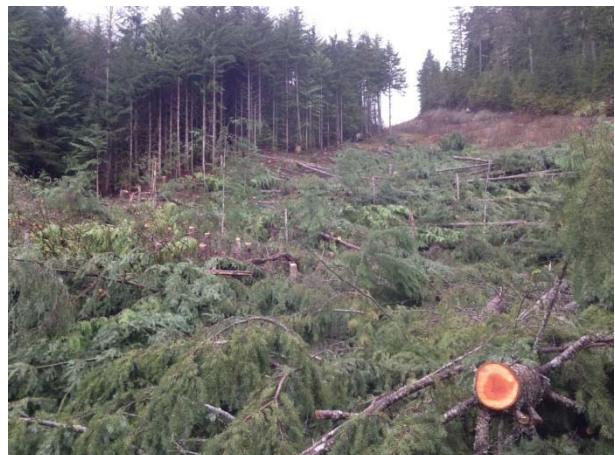
Photo 13 – Falling completed near structure 120 (April 15, 2015).

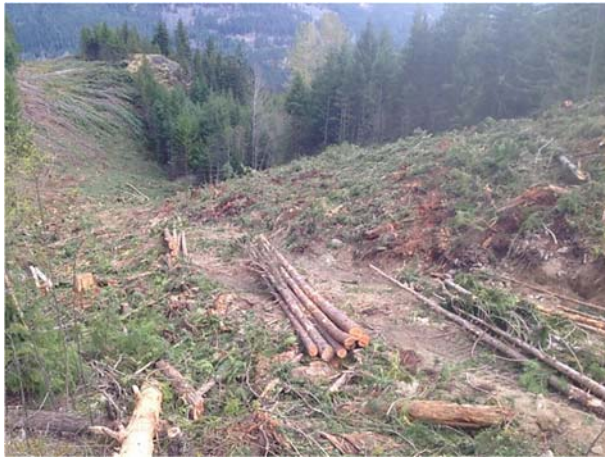
Photo 14 – Hoe chucking and log decking completed in Segment 16 (April 15, 2015).

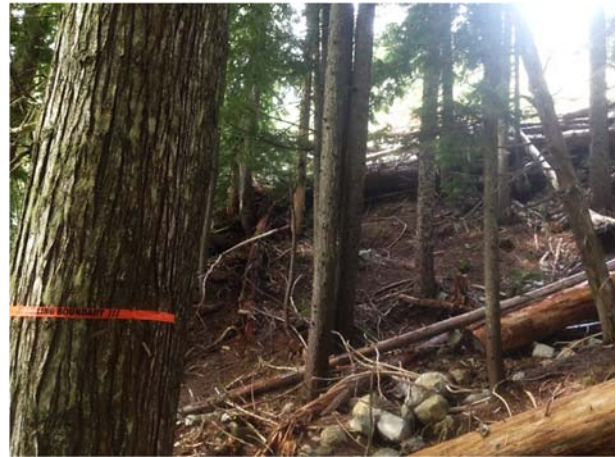
- On April 16, the IEM conducted a modified survey to detect presence/absence of Spotted Owl and Northern Goshawk nesting activity within the Segment 13 ROW clearing boundaries. The IEM conducted playback surveys and visual assessments at stations starting at structure 316 and ending southeast of structure 318 (Photo 15). The IEM did not detect any nests or signs of nesting activity.

Photo 15 – SPOW and NOGO habitat in Segment 13 (April 16, 2015).
