Upper Lillooet Hydro Project

Weekly Environmental Monitoring Report #59

Reporting Period: April 26 – May 2, 2015

Upper Lillooet River Hydroelectric Facility (Water File No. 2002561, Water licence No. C130613), Boulder Creek Hydroelectric Facility (Water File No. 2003049, Water licence No. C129969) & Transmission Line (TX Line)

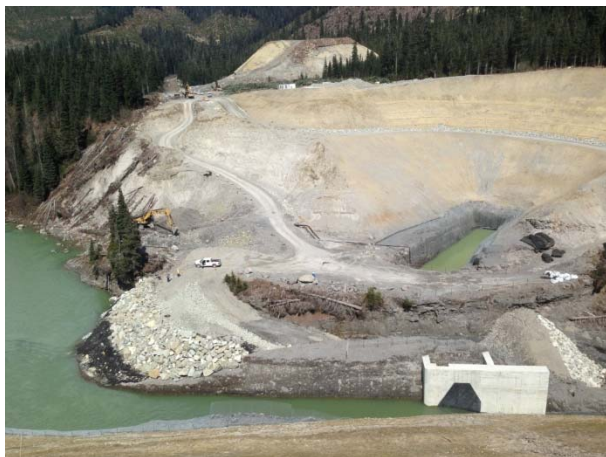
- Sump excavation for intake dewatering and wastewater treatment system (Photo 1 and Photo 2).
- Hand falling, machine clearing and grubbing for north-side spoil enlargement and sediment basins (Photo 3 and Photo 4).

Photo 1 – Current conditions at ULRHEF intake
(May 2, 2015).

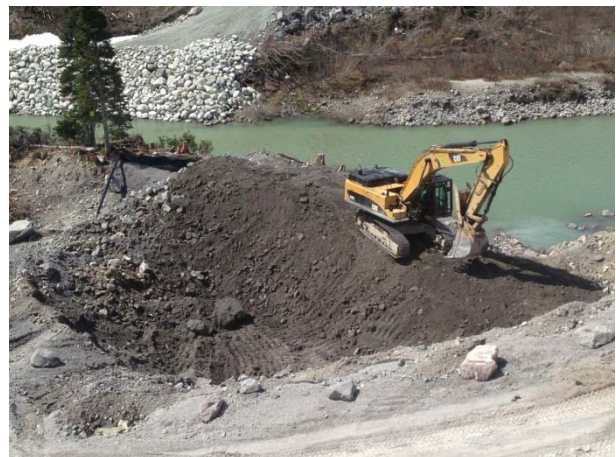
- On May 1, a kick-off meeting was held to discuss site conditions, safety concerns and environmental issues.
- Construction of the ULRHEF intake dewatering and wastewater treatment system commenced during this reporting period (Photo 2).

Photo 2 – Sump excavation for wastewater treatment system
(May 2, 2015).

- Following completion of the intake dewatering and wastewater treatment system, all seepage water in the upstream tunnel portal excavation should be conveyed to the sediment basins unless approved for discharge directly to the Lillooet River by the IEM.
- The ULRHEF powerhouse sump water should be monitored regularly and if the risk of turbid or alkaline water exists it should be pumped to the remaining settling pond for treatment.

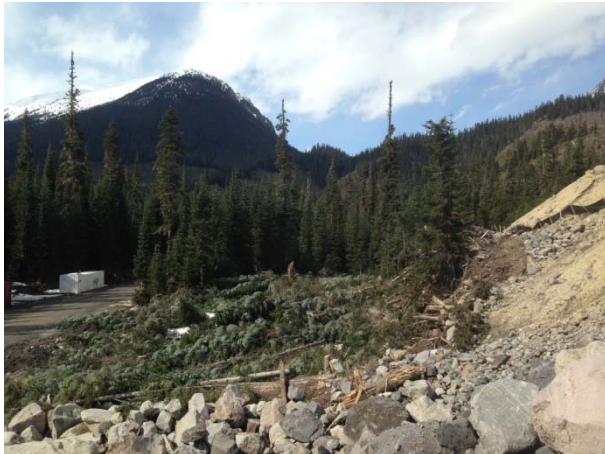
Photo 3 – Hand falling for spoil pile enlargement (May 2, 2015).

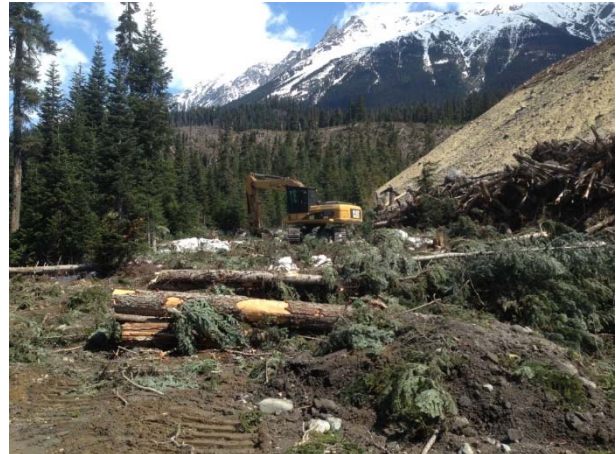
Photo 4 – Machine clearing for spoil pile enlargement (May 2, 2015).

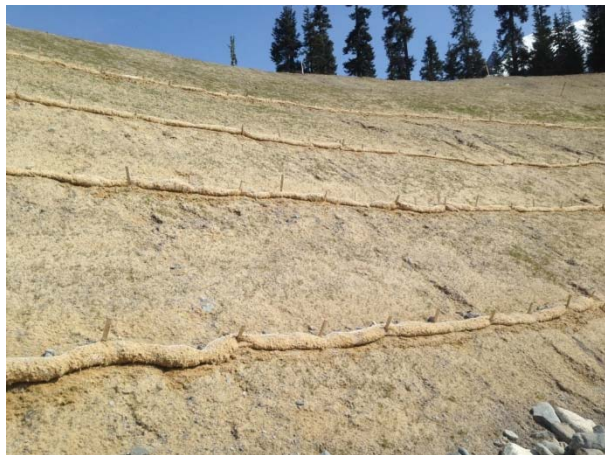
- The IEM observed that the erosion and sediment control measures (including hydroseeding) conducted in the fall and winter of 2014 appear to have been effective in preventing slope failure and mobilization of sediment during the spring snowmelt and rains (Photo 5).

Photo 5 – Intake left bank slope with curlex logs and hydroseeding to prevent rilling and erosion; hydroseeded grass sprouting on top of bank (May 2, 2015).

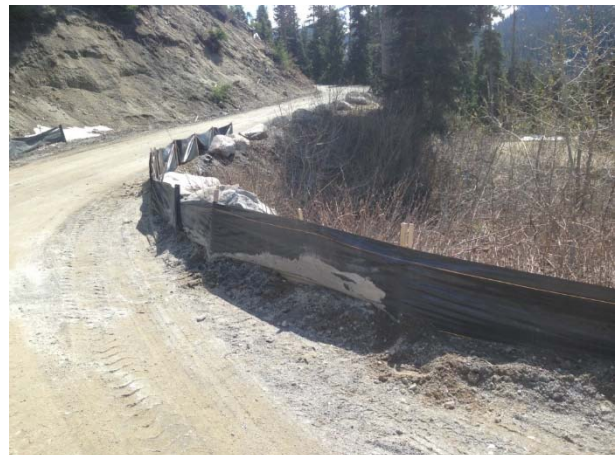
- The IEM was onsite to monitor construction activities within 30 metres of the Lillooet River.
- Silt fencing was repaired at the 47.5km tributary to prevent sediment-laden runoff from entering the fish-bearing watercourse (Photo 6).

Photo 6 – Silt fencing repaired at 47.5km tributary (May 2, 2015).

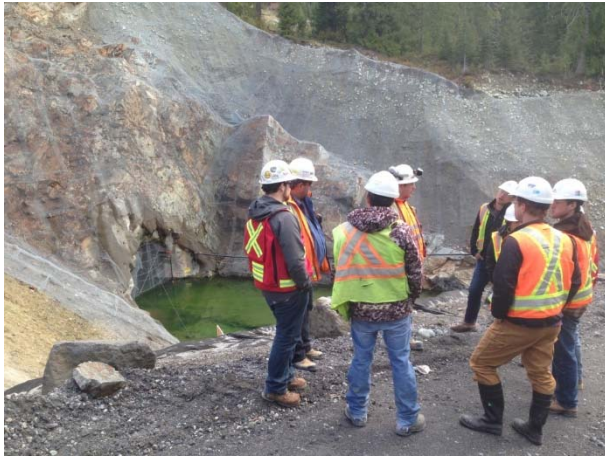
- On May 1, a kick-off meeting was held to discuss site conditions, safety concerns and environmental issues (Photo 7 and Photo 8).
- During the May 1 kick-off meeting, the IEM and CE discussed the downstream portal dewatering requirements (Photo 7). CE requested that a generator be allowed to operate during the Mountain Goat migration corridor sunrise/sunset shutdown periods to power a pump for dewatering. The IEM agreed under the conditions that the generator was used only for the pumps and access to the generator was restricted during the shutdown periods.

Photo 7 – Kick-off meeting held at ULRHEF downstream tunnel portal (May 1, 2015)

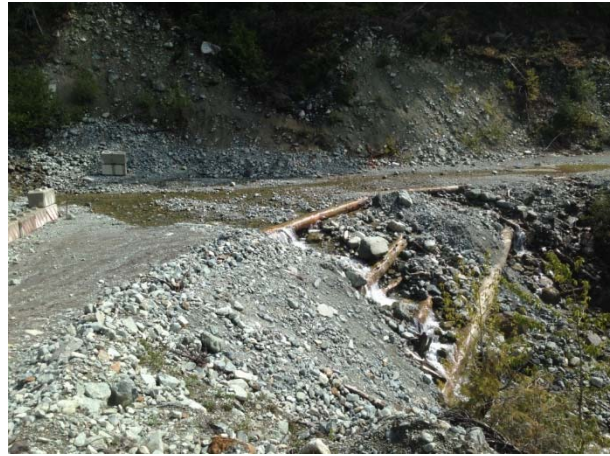
Photo 8 – Conditions at Truckwash Creek (May 1, 2015)

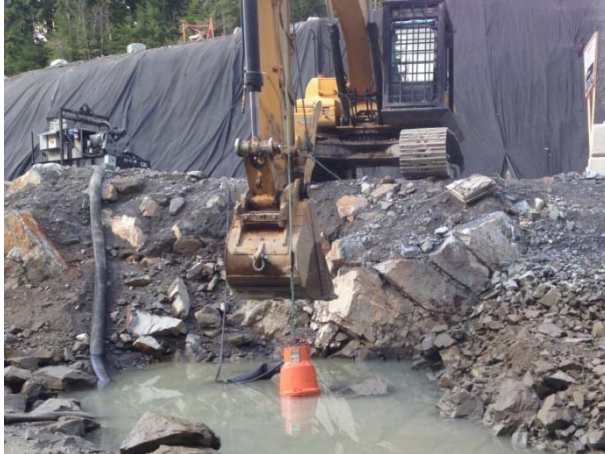
- Dewatering of downstream tunnel portal (Photo 9 and Photo 10).

- On May 2, the downstream tunnel portal was dewatered directly to Truckwash Creek with a 6" pump and hose. The pump was suspended from an excavator bucket to ensure that the intake did not convey sediment-laden water to Truckwash Creek (Photo 9). The hose outlet was secured in a position that would not cause erosion to the stream bank (Photo 10). The IEM conducted water quality sampling prior to pumping and measured the portal water to be 1.46NTU with a pH of 7.85.

Photo 9 – Pump suspended from excavator at ULRHEF downstream tunnel portal (May 1, 2015).

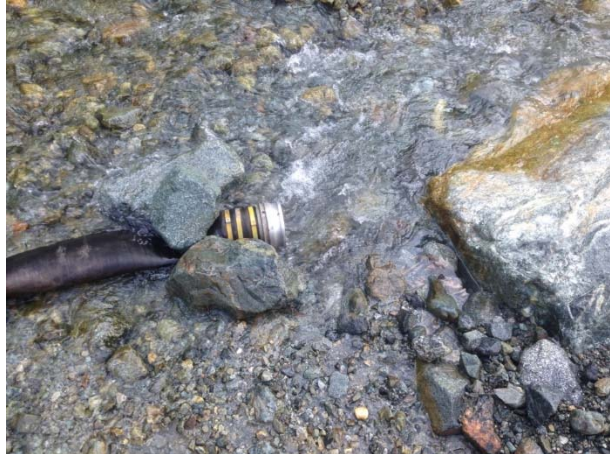
Photo 10 – Hose positioned in Truckwash Creek for dewatering of ULRHEF downstream tunnel portal (May 1, 2015).

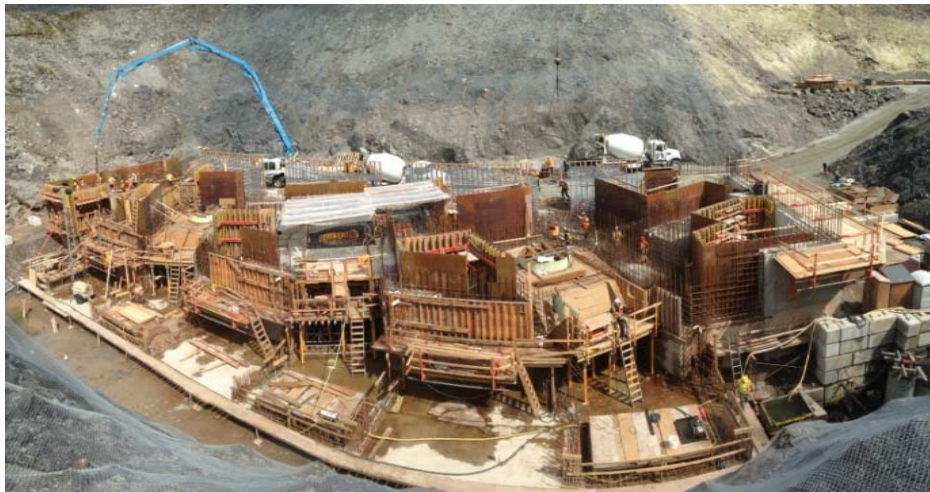
- Continued rebar installation and formworks for the powerhouse structure.
- Structural concrete pours were completed on April 27 and May 1 (Photo 11).
- Dewatering of powerhouse sump to the Lillooet River continued (Photo 12 and Photo 13).

Photo 11 – Current conditions at ULRHEF powerhouse with concrete pour in progress (May 1, 2015).

- Dewatering of the ULRHEF powerhouse continued without environmental concerns. The IEM will continue to monitor the works area to confirm that future concrete pours are adequately isolated from flowing waters and protected from precipitation during curing.

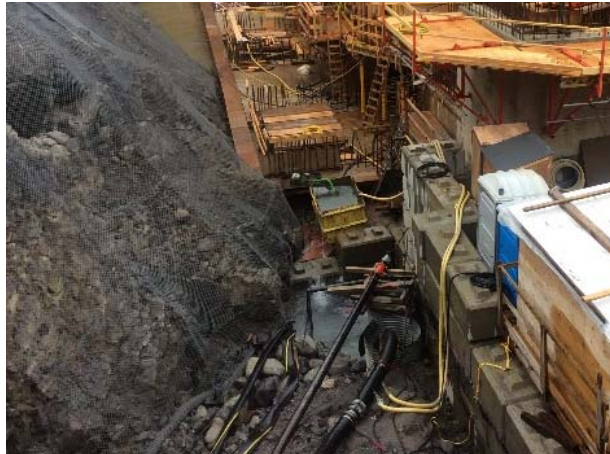
Photo 12 – ULRHEF powerhouse sump (May 1, 2015).

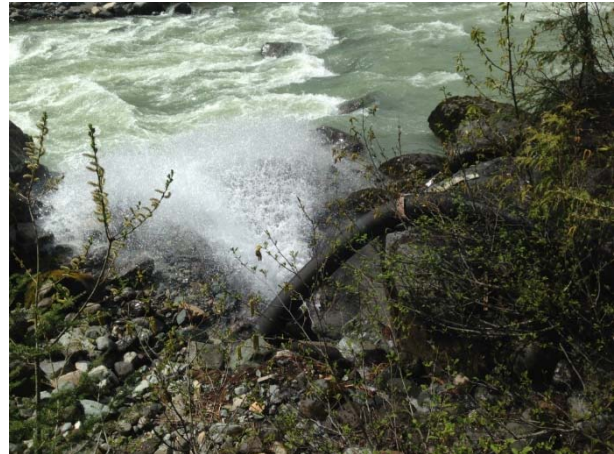
Photo 13 – Dewatering of ULRHEF powerhouse sump to Lillooet River (May 1, 2015).

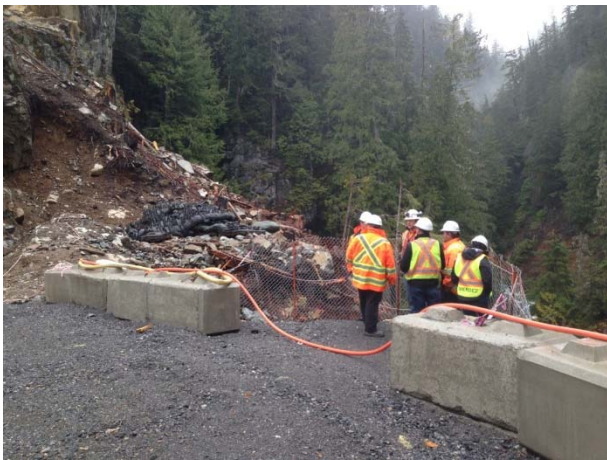
- On May 1, a kick-off meeting was held to discuss site conditions, safety concerns and environmental issues (Photo 14).
- On May 1, the IEM observed an excavator conducting road clearing and bank stabilization works within a wetted ditch without water management measures in place and without prior IEM notification (Photo 15). Works to remove debris from the ditch line caused the generation of turbid water that was discharged offsite without treatment. The IEM informed the CE environmental manager onsite that works were required to halt until pumps were in place to isolate the work area from flowing water. Works were halted a pump was brought in to divert the flow around the work area (Photo 16). The IEM requested that CE prepare and submit EIR#015 outlining the root cause of the incident and how it will be avoided in future.

Photo 14 – Kick-off meeting at BDRHEF intake crane pad (May 1, 2015).

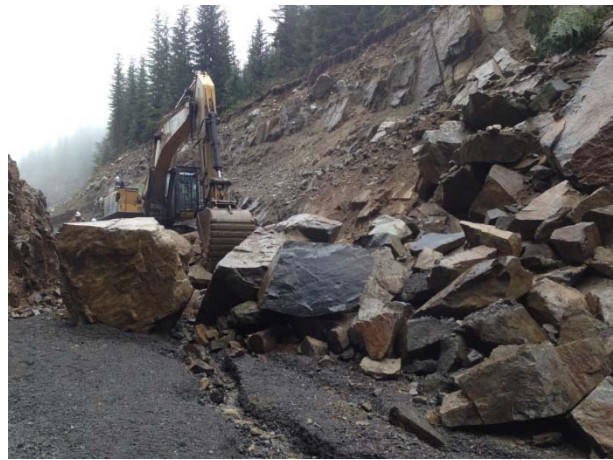
- Road clearing and bank stabilization works began on May 1, 2015 within UWR UL-11 on access road at 4.75km (Photo 15).
- Crane assembly works.

Photo 15 – Road clearing and bank stabilization works at 4.75km on BDRHEF intake access road (May 1, 2015).

- Works to restore the ditch line and stabilize the slope were completed on May 2 and the IEM was present to monitor the removal of the pump and release of water to the ditch line (Photo 17). The IEM conducted water quality sampling during works. Sampling at the culvert outlet was not possible due to access restraints. Please see Section 5.3 Water Quality Results.

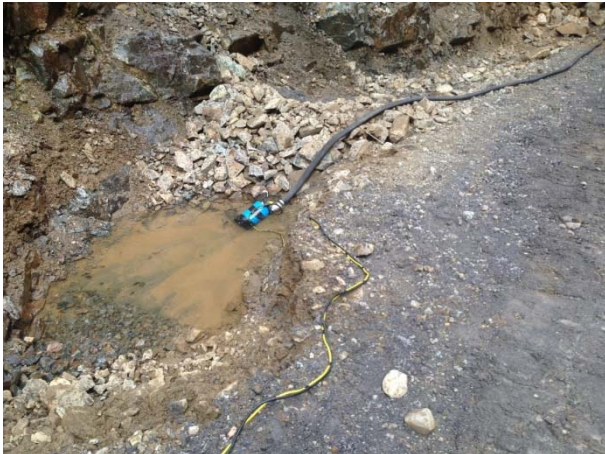
Photo 16 – 2" pump used to convey water around road clearing works at 3.75km on BDRHEF intake access road (May 1, 2015).

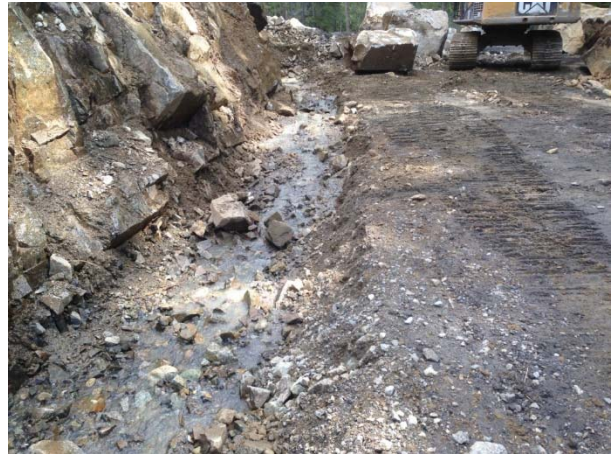
Photo 17 – Ditch water with clear flows at 3.75km on BDRHEF intake access road (May 2, 2015).

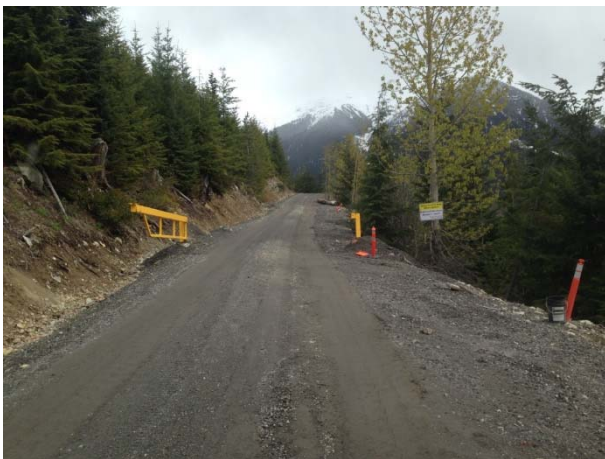
- On May 1, the IEM observed the gate to restrict public access on the BDRHEF intake access road within 500m of UWR to be unlocked and unmanned (Photo 18). The IEM communicated to CE's environmental management team that a gate attendant was required and CE responded by staffing the gate immediately (Photo 19). No public access occurred beyond the unmanned/unlocked gate.

Photo 18 – Gate at 3.5km on the BDRHEF intake access road (May 1, 2015).

- The unlocked/unmanned gate issue was added to the ITM as item ULR#23. The works within a wetted ditch on the BDRHEF access road issue was added to the ITM as item ULR#24 and an EIR was requested by SES. Please see the ITM in Section 9.1 for further details.

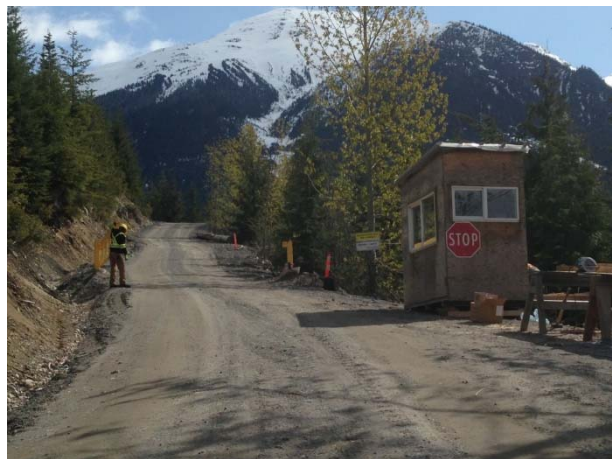
Photo 19 – Attendant stationed at gate at on the BDRHEF intake access road (May 2, 2015).

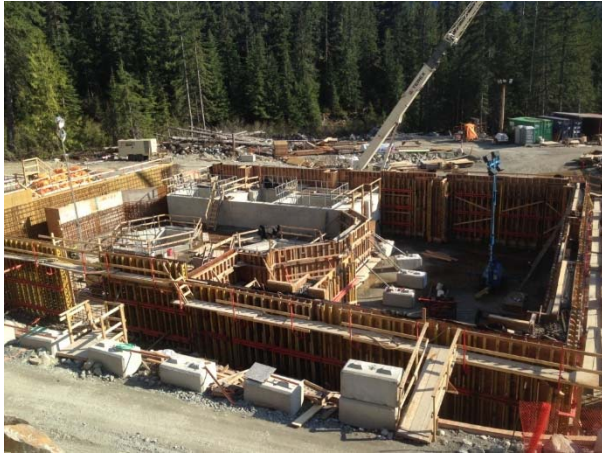
- Rebar installation and formworks for the powerhouse structure continued (Photo 20).
- A structural concrete pour was completed on April 29 (Photo 21).
- Drilling, blasting, mucking and stabilization works continued within the tunnel (Photo 22).
- Dewatering of the tunnel and powerhouse excavation to the oil water separator and settling ponds continued (Photo 23 and Photo 24).

Photo 20 – Current conditions at the BDRHEF powerhouse (May 2, 2015).

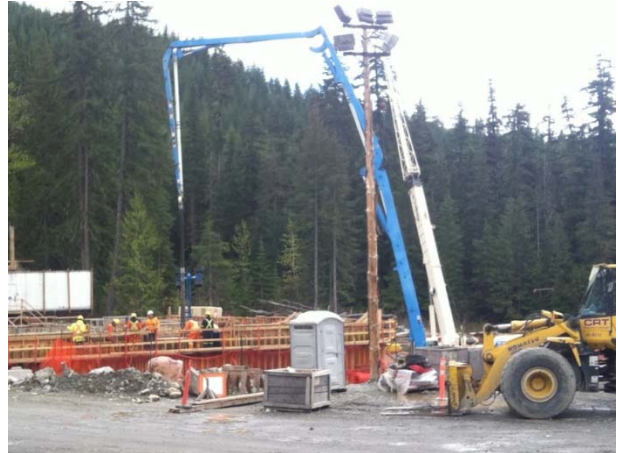
Photo 21 – Structural concrete pour at the BDRHEF powerhouse (April 29, 2015).

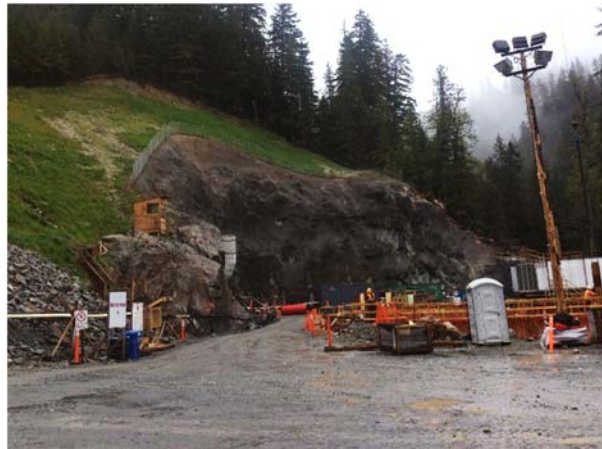
Photo 22 – Current conditions at BDRHEF tunnel portal (May 2, 2015).

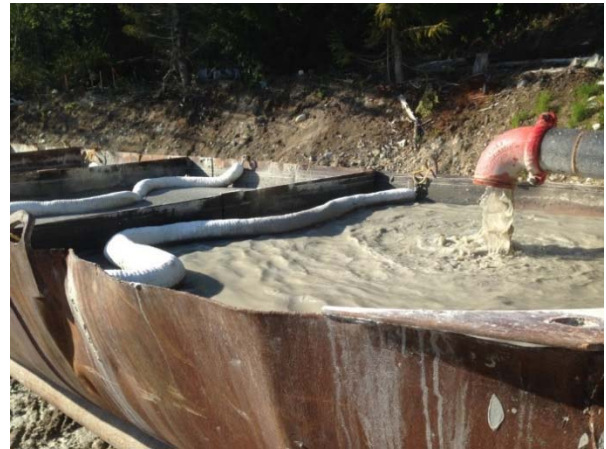
Photo 23 – Dewatering tunnel and powerhouse to oil water separator (May 2, 2015).

- The IEM recommends that the BDRHEF tunnel and powerhouse continue to be dewatered to the oil water separator and settling ponds. The settling ponds should be monitored to ensure water continues to infiltrate to ground and there is no discharge to the surrounding environment.

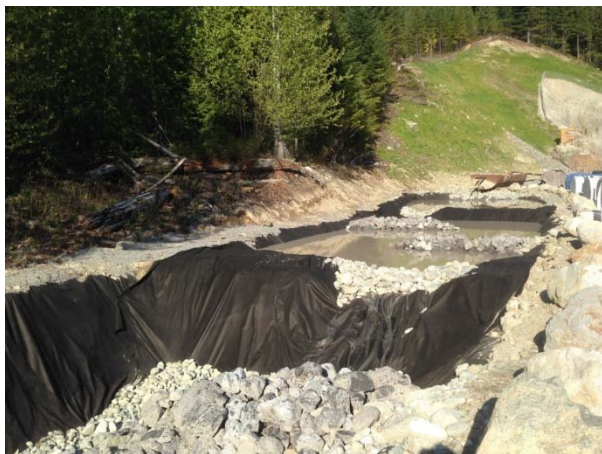
Photo 24 – BDRHEF portal/powerhouse settling ponds (May 2, 2015).

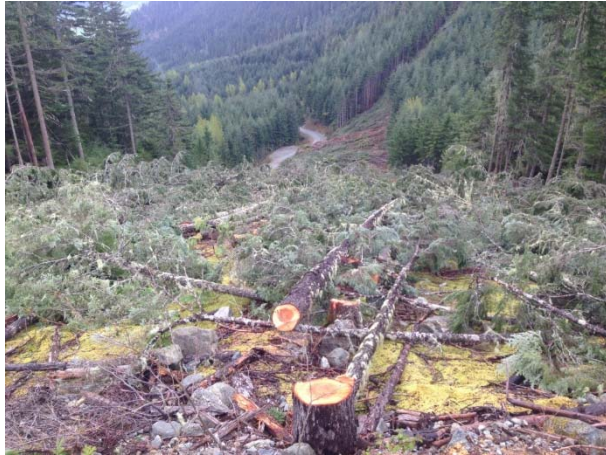
- Hand falling in Segment 12 from structures 281 – 283.
- Hand falling in Segment 13 from structures 316 – 318, 323 – 327 and for road 306.1 (Photo 25).

Photo 25 – Hand falling completed for spur road 306.1 in Segment 13 (April 30, 2015).

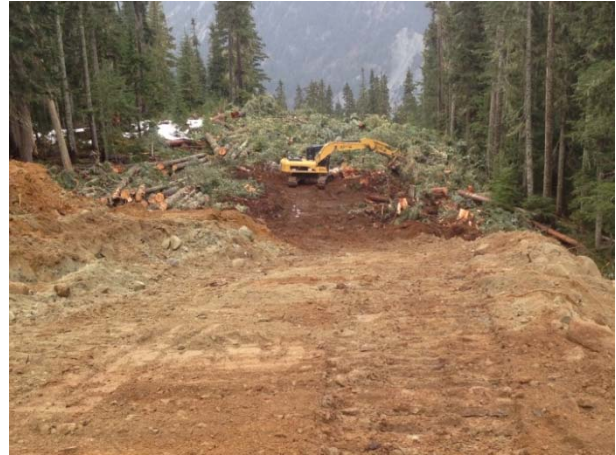
- Assembly of temporary generator site in Segment 2 near 39km on Lillooet River FSR.
- Building road 327.1 in Segment 14 between structures 330.5 – 327 (Photo 26).

Photo 26 – Building spur road 327.1 in Segment 14 (April 30, 2015).
