Upper Lillooet Hydro Project

Weekly Environmental Monitoring Report #61

Reporting Period: May 10 – May 16, 2015

Upper Lillooet River Hydroelectric Facility (Water File No. 2002561, Water licence No. C130613), Boulder Creek Hydroelectric Facility (Water File No. 2003049, Water licence No. C129969) & Transmission Line (TX Line)

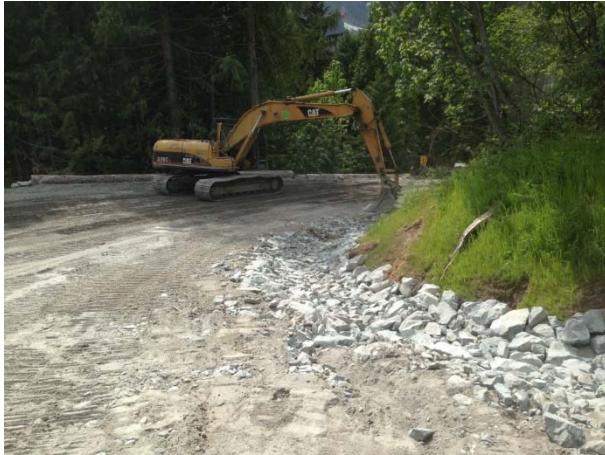
- Ditch maintenance (including rock lining) on the Lillooet River FSR from 42.5km to 44km (Photo 1).
- Silt fencing repair at tributary crossings on the Lillooet River FSR (Photo 2).
- Routine maintenance of construction equipment within the mechanic shop and fuel management continued at the 38km laydown.
- All electric fences were maintained and operational throughout this reporting period.

Photo 1 – Ditch maintenance near 43km on the Lillooet River FSR (May 12, 2015).

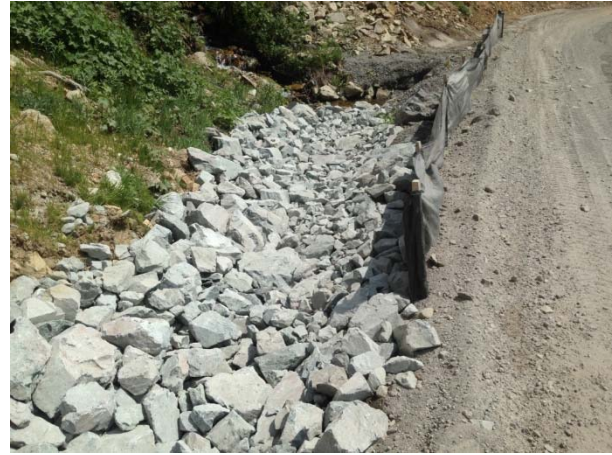
Photo 2 – Ditch maintenance and silt fencing repair at a tributary crossing near 43.5km on the Lillooet River FSR (May 12, 2015).

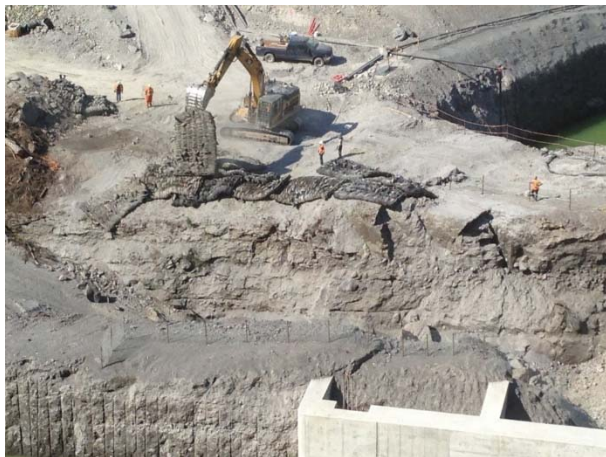
- The blast schedule was provided to the IEM to allow for goat monitoring to occur during the blasts.
- On May 11, the IEM was present to monitor blasting activity between the downstream cofferdam and the portal excavation (Photo 3 and Photo 4). The force of the blast propelled rock and material below the north side of the downstream cofferdam. Seepage water contacting the introduced material caused sediment-laden water to discharge from the downstream cofferdam culvert (Photo 5). Immediately following the blast CE mobilized a 6” pump to the cofferdam and began pumping the turbid water to the portal excavation for containment (Photo 6). The IEM conducted water quality sampling at the Keyhole Bridge. Downstream water quality remained within Project guidelines set out in the Surface Water Quality Protection Plan. Please see Section 4.5 Water Quality Results.

Photo 3 – Blast preparation between downstream cofferdam and portal excavation (May 11, 2015).

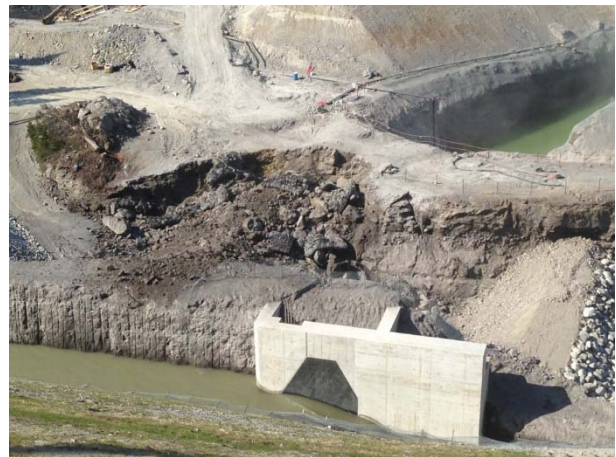
Photo 4 – Conditions after blast between downstream cofferdam and portal excavation (May 11, 2015).

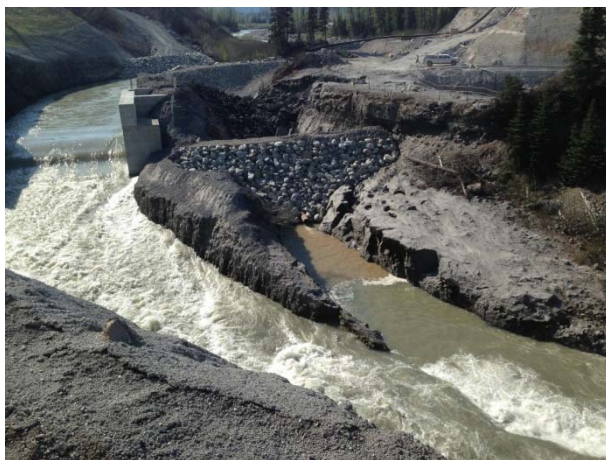
- Drilling, blasting and excavation between the downstream cofferdam and the tunnel portal excavation (Photo 3, Photo 4, Photo 5 and Photo 6).
- Dewatering of portal excavation to the intake dewatering and wastewater treatment system (Photo 7 and Photo 8).

Photo 5 – Sediment-laden water discharging from downstream cofferdam culvert following blast (May 11, 2015).

- Following completion of the intake dewatering and wastewater treatment system, all seepage water in the portal excavation should be conveyed to the sediment basins unless approved for discharge directly to the Lillooet River by the IEM.

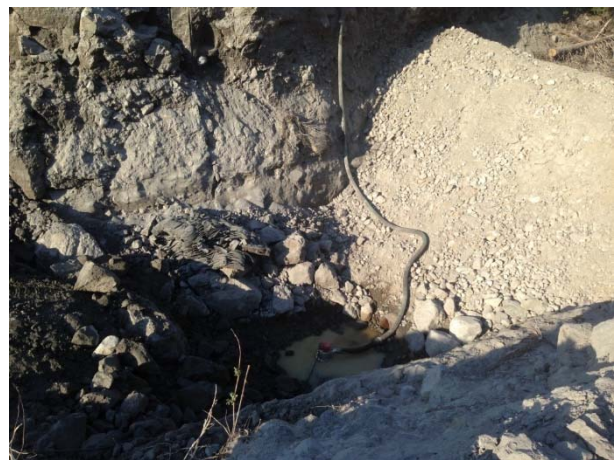
Photo 6 – Pumping sediment-laden water from downstream cofferdam to portal excavation (May 11, 2015).

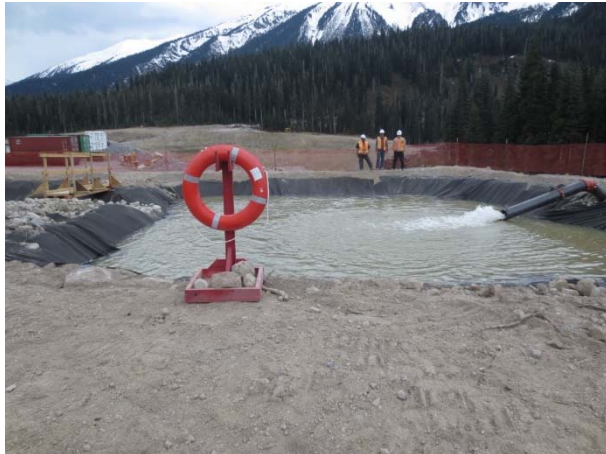
- Operation of the ULRHEF intake dewatering and wastewater treatment system commenced during this reporting period (Photo 7). Two pumps conveyed seepage water from the portal excavation to the dewatering system sump and then in to the sediment basins (Photo 8). Valves located at the sump location function to redirect water for discharge directly to the Lillooet River. The portal excavation water will be redirected to the river only after the IEM has confirmed it is suitable for discharge as per the Surface Water Quality Protection Plan.

Photo 7 – Dewatering upstream portal excavation to sediment basins (May 13, 2015).

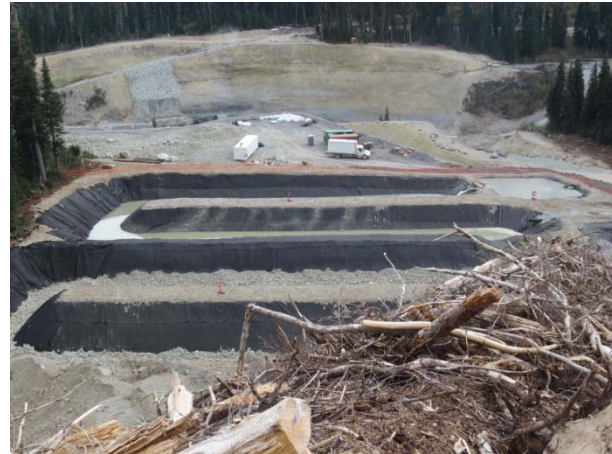
Photo 8 – Intake sediment basins (May 13, 2015).

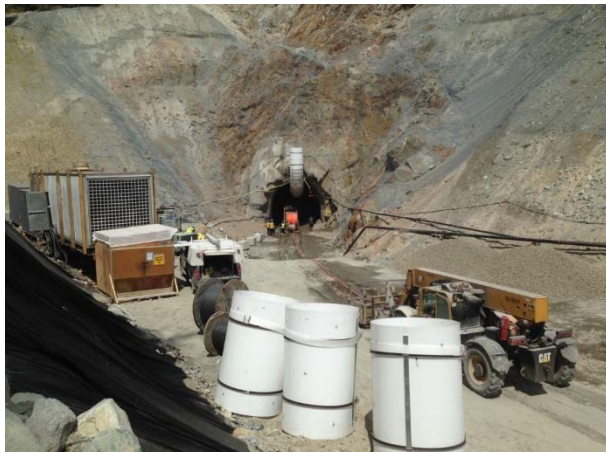
- Drilling, blasting, mucking and stabilization works within the tunnel (Photo 9).
- Dewatering to downstream portal settling ponds (Photo 10).

Photo 9 – Current conditions at the ULRHEF downstream tunnel portal (May 12, 2015).

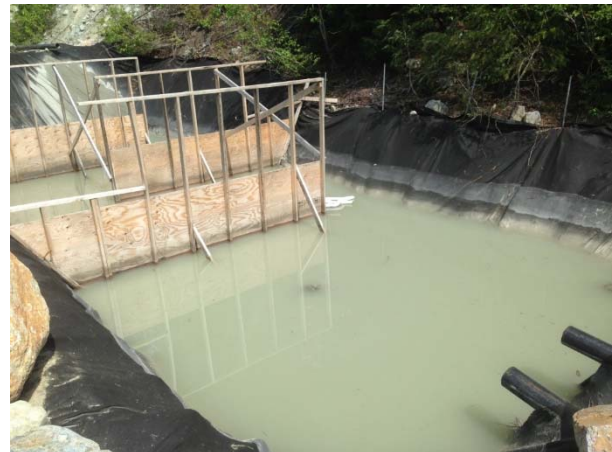
- Tunnelling works and dewatering to the downstream portal settling ponds commenced during this reporting period (Photo 10). The settling pond water infiltrated to ground in the first cell with no discharge to the surrounding environment.

Photo 10 – ULRHEF downstream tunnel portal settling ponds (May 12, 2015).

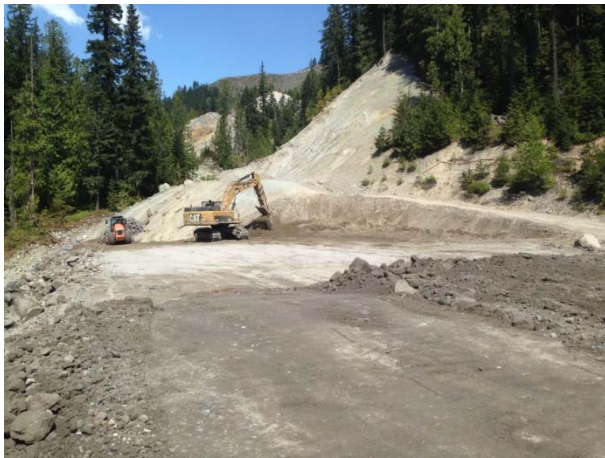
- Penstock fill and compaction works continued at 2+800 (Photo 11).
- Penstock excavation continued from 4+050 to 4+075 (Photo 12 and Photo 13).

**Photo 11 – Fill and compaction works at 2+800
(May 10, 2015).**

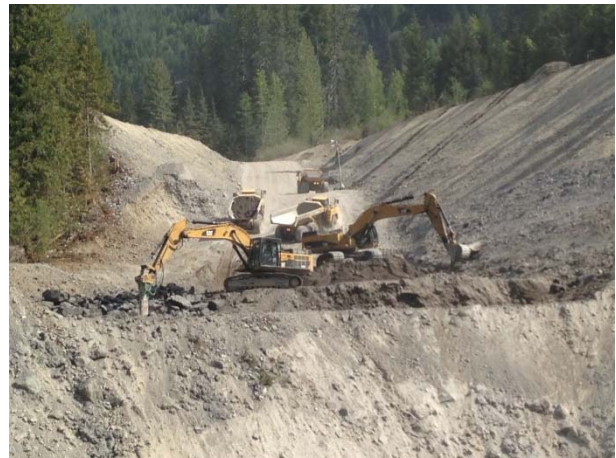
**Photo 12 – Penstock excavation at 4+060
(May 10, 2015).**

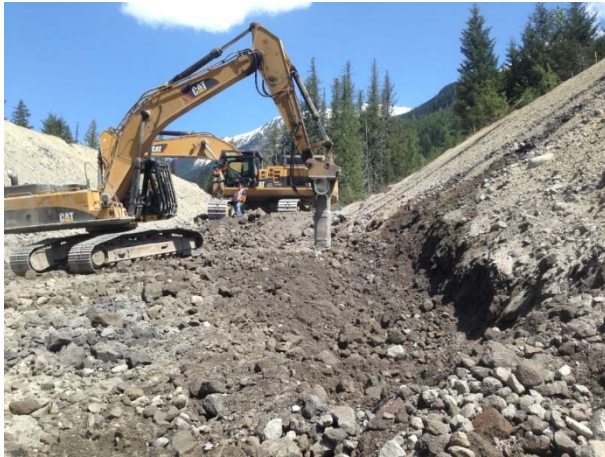
Photo 13 – Penstock excavation at 4+060 (May 12, 2015).

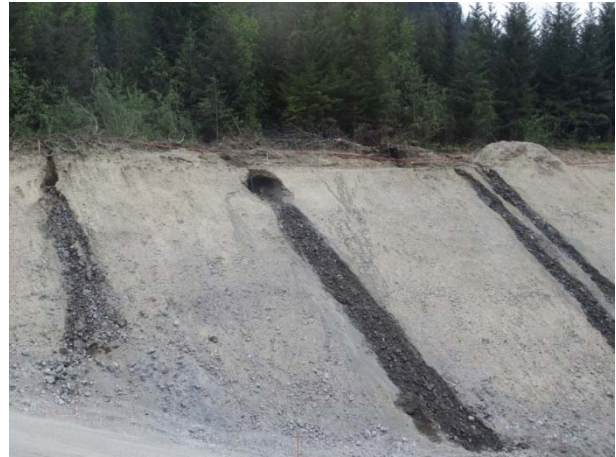
- High temperatures and snowmelt during this reporting period resulted in increased surface water flow on site. Multiple flows appeared on the slope above the penstock excavation between 4+000 and 4+075 (Photo 14). The emerging water was observed to infiltrate to ground at the toe of the slope. In order to prevent further erosion and to prevent water from entering the active worksite, CE intercepted the water flowing at 42.25km within a non-fish bearing, non-CTF ephemeral drainage before it entered the Lillooet River FSR culvert. A sandbag berm was built to contain the water and two pumps were installed to convey flows to a vegetated area southeast of 42.25km (Photo 15 and Photo 16). The IEM was onsite to conduct an amphibian sweep of all dewatered areas and to ensure that the discharged water infiltrated to ground in the vegetated area. No environmental concerns were noted.

Photo 14 – Runoff flowing down penstock excavation slope at 4+050 (May 13, 2015).

- The IEM recommends that the access roads and tributaries on the penstock alignment be monitored regularly to ensure that no erosion and sediment control issues develop with the continued excavation/fill works rock truck traffic. Temporary pumps installed at 42.25km of the Lillooet River FSR to divert water away from the penstock excavation should be monitored to ensure water continues to infiltrate to ground at the discharge location.
- The ULRHEF powerhouse sump water should be monitored regularly. Alkaline or turbid water should be pumped to the remaining settling pond for treatment.

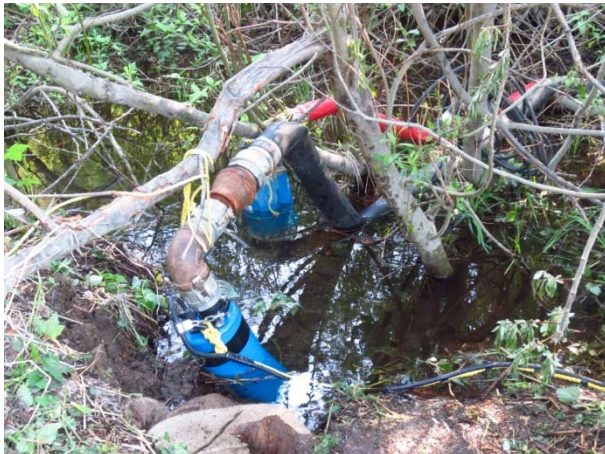
Photo 15 – Pumps installed above Lillooet River FSR at 42.25km (May 15, 2015).

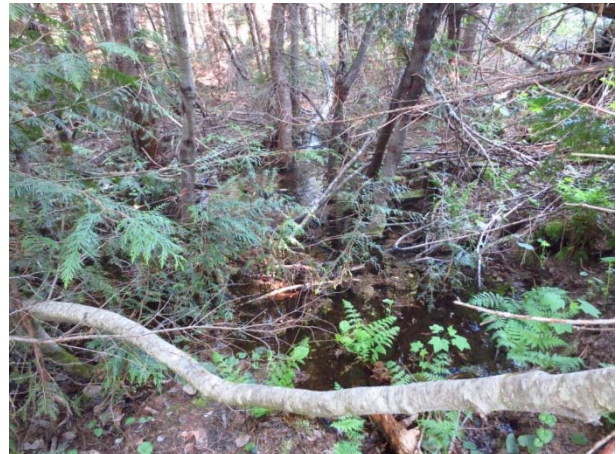
Photo 16 – Pumps discharging to vegetated area near 42.25km of Lillooet River FSR (May 15, 2015).

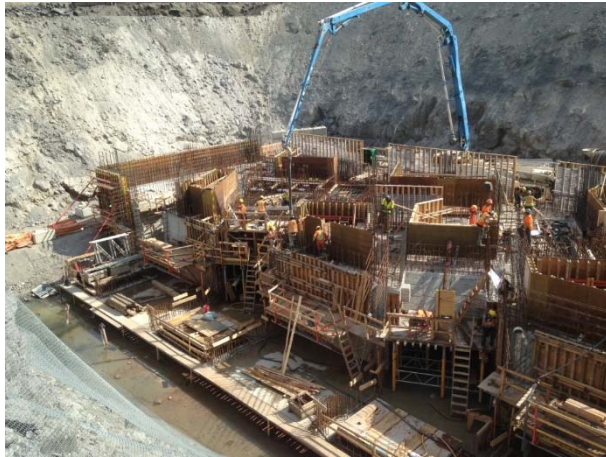
- Continued rebar installation and formwork for the powerhouse structure (Photo 17).
- Structural concrete pours were completed on May 10 and 14 (Photo 17).
- Dewatering of the powerhouse sump to the Lillooet River continued (Photo 18).

- On May 10 and 14, the IEM was onsite to inspect the ULRHEF powerhouse during a concrete pour (Photo 17). The IEM conducted water quality sampling of the powerhouse sump discharge (Photo 18 and Photo 19). All water samples were measured to have a pH <9 and suitable for discharge to the surrounding environment as per the Surface Water Quality Protection Plan (see Section 4.5 Water Quality Results).

Photo 17 – Concrete pour at the ULRHEF powerhouse (May 10, 2015).

- Dewatering of the ULRHEF powerhouse continued without environmental concerns. The IEM will continue to monitor the works area to confirm that future concrete pours are adequately isolated from flowing water and protected from precipitation during curing.

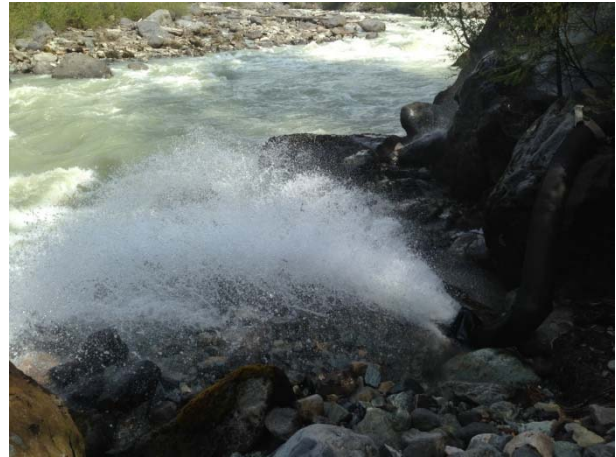
Photo 18 – Outlet of 10” powerhouse sump dewatering hose (May 10, 2015).

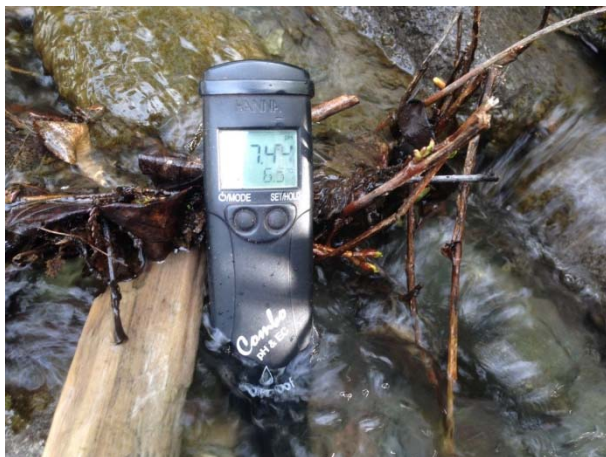
Photo 19 – pH measurement conducted at discharge point of powerhouse sump dewatering hose (May 10, 2015).

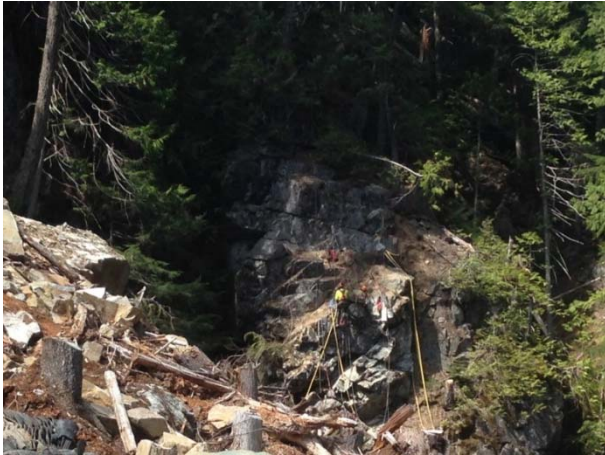
- Rope access scaling and slope stabilization works on the intake right bank (Photo 20).
- Rock hammering and excavation continued above the intake crane pad (Photo 21).

Photo 20 – Rope access crews conduct scaling works on right bank at BDRHEF intake (May 11, 2015).

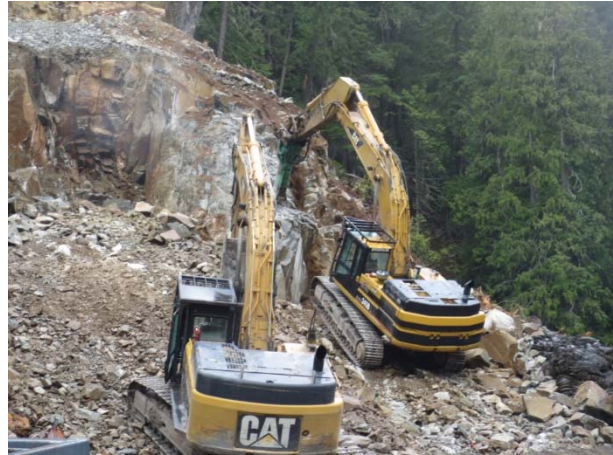
Photo 21 – Rock hammering and excavation continued at BDRHEF intake (May 11, 2015).

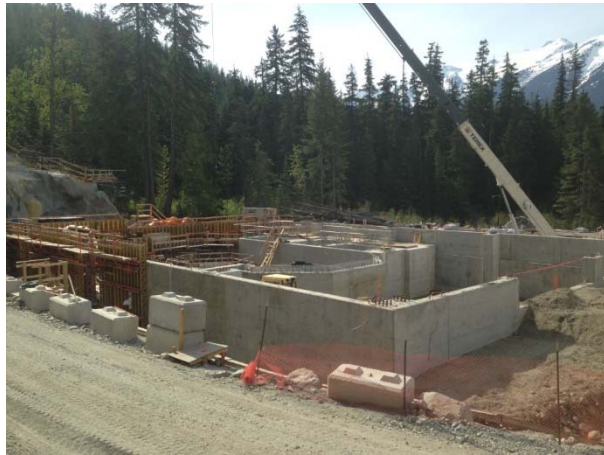
- Rebar installation and formworks for the powerhouse structure continued (Photo 22).
- Drilling, blasting, mucking and stabilization works continued within the tunnel.
- Dewatering of the tunnel and powerhouse excavation to the oil water separator and settling ponds continued (Photo 23).

Photo 22 – Current conditions at the BDRHEF powerhouse (May 7, 2015).

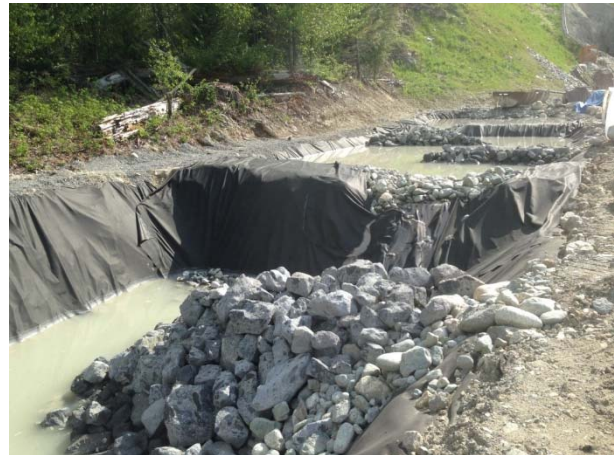
Photo 23 – Dewatering the BDRHEF tunnel to settling ponds (May 7, 2015).

- The IEM recommends that all wastewater related to the BDRHEF tunnelling works continues to be contained and conveyed to the downstream portal settling ponds for treatment.

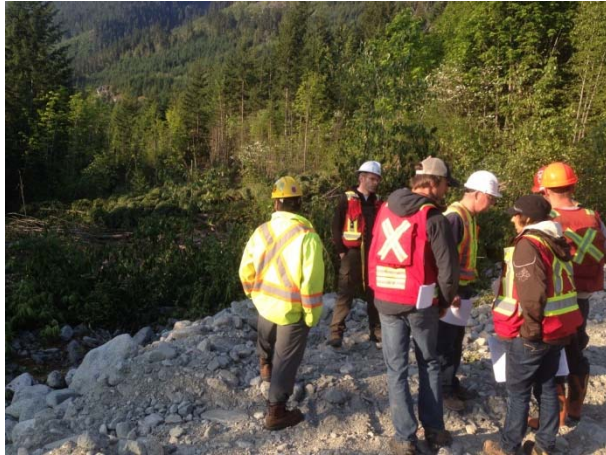
Photo 24 – Pre-work meeting held at stream 261a in Segment 11 (May 11, 2015).

- On May 11, pre-work meetings were held at stream 261a and at Vans Creek in Segment 11 (Photo 24). Discussions covered engineering, safety and environmental concerns related to the crossing and bridge installation works at both watercourses. Mitigations were considered for the removal of the log box culvert at Vans Creek (Photo 25). It was agreed that all necessary precautions will be taken to minimize downstream turbidity and the IEM will be present to monitor water quality.

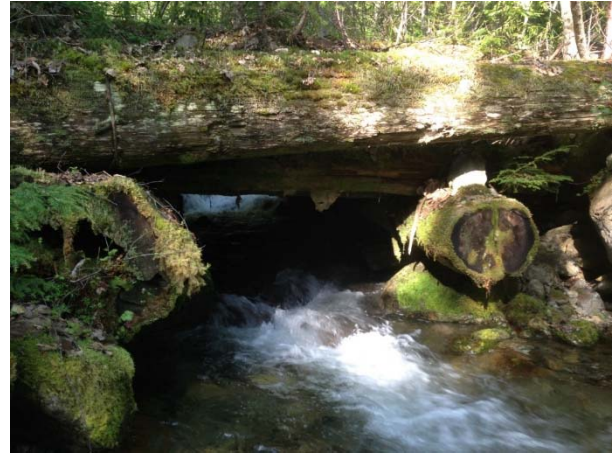
Photo 25 – Old log box culvert over Vans Creek (May 11, 2015).
