# Upper Lillooet Hydro Project

## Weekly Environmental Monitoring Report #66

Reporting Period: June 14 – June 20, 2015

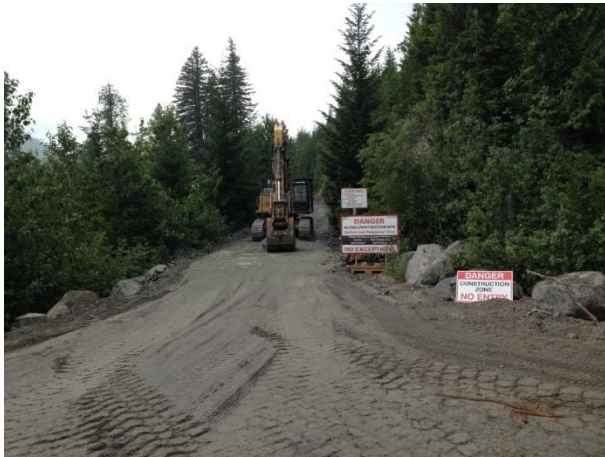
- Road capping and re-grading at the penstock access road (Photo 1).
- Water trucks applied water for dust suppression along project access roads and the Lillooet River FSR from KM 37.5 to KM 47, throughout the reporting period.
- Routine maintenance of construction equipment within the mechanic shop and fuel management continued at the KM 38 laydown.
- The electric fences were maintained and operational throughout this reporting period.

Photo 1 – Capping and re-grading at penstock access road (June 17, 2015).

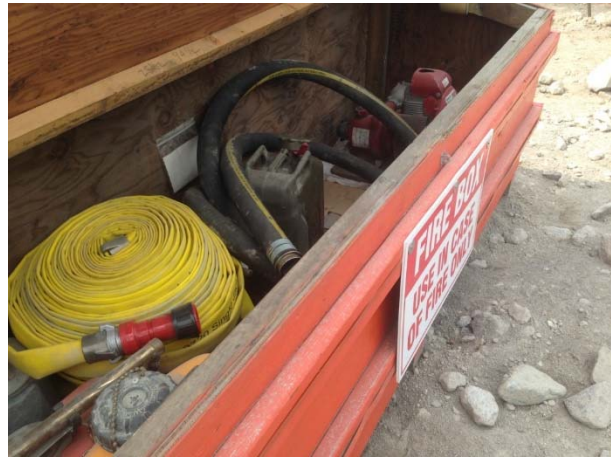
- Emergency fire suppression equipment was audited by the IEM during this reporting period. Supply boxes were found at all major work areas and the boxes were stocked as per the Fire Preparedness Plan (Photo 2).
- No environmental issues were observed during this reporting period at the construction camp, 38km laydown or on the Lillooet River FSR.

Photo 2 – Fire suppression supplies stored at the ULRHEF intake site (June 18, 2015).

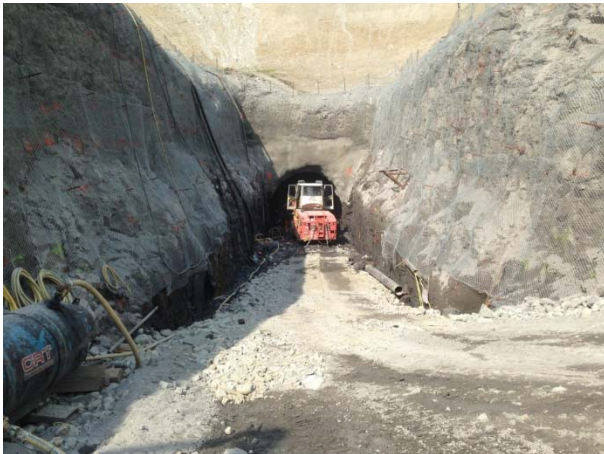
- Drilling, blasting, excavation and shotcrete stabilization at the upstream tunnel portal excavation (Photo 3 and Photo 4).
- Rebar preparation for intake structure (Photo 4).
- Dewatering of portal excavation to the intake dewatering and wastewater treatment system (Photo 5 and Photo 6).

**Photo 3 – ULRHEF upstream tunnel portal**  
(June 16, 2015).

- All seepage water in the portal excavation should be conveyed to the sediment basins unless approved for discharge directly to the Lillooet River by the IEM or CE environmental manager.

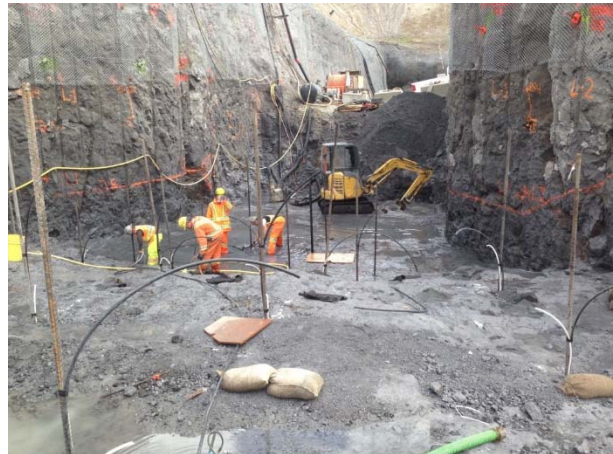
**Photo 4 – Applying resin to anchor bolts at ULRHEF intake**  
(June 19, 2015).

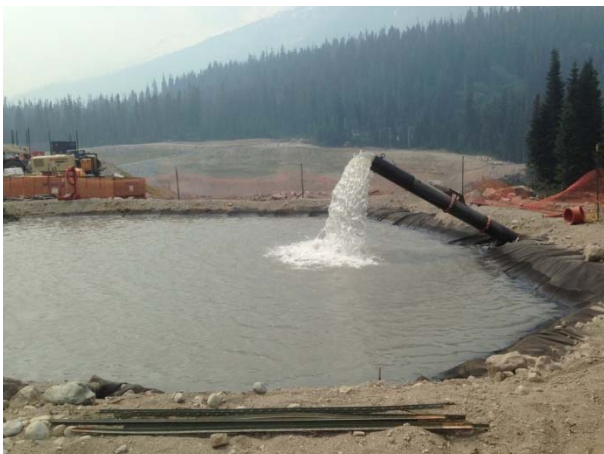
**Photo 5 – ULRHEF intake and upstream tunnel portal sediment basins**  
(June 17, 2015).

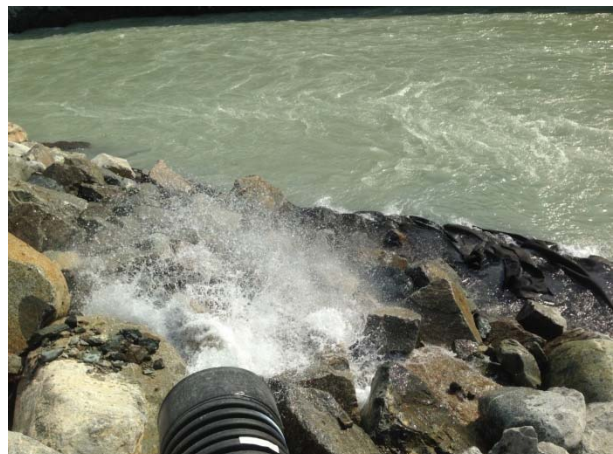
**Photo 6 – Discharging clean seepage water directly to Lillooet River**  
(June 17, 2015).

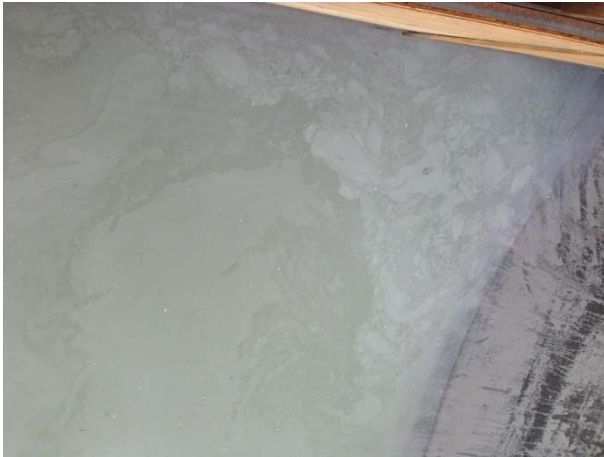
- On June 19, the IEM observed oil residue seepage at the oil water separator partition in the ULRHEF intake and upstream tunnel portal sediment basins (Photo 7). The IEM notified CE's environmental management team of the deficiency. On June 20 spill booms were added to the basins and the partition was repaired.
- On June 20, disposable baking pans on wooden stakes were installed around the first cell of the ULRHEF intake and upstream tunnel portal sediment basins as a bird deterrent measure (Photo 8). The IEM and CE's environmental management staff will monitor the site to ensure that the visual deterrents are effective in keeping birds away from the sediment basins.
- The IEM was onsite to monitor all blasts and construction activities within 30m of the Lillooet River.

Photo 7 – Oil residue visible in ULRHEF intake and upstream tunnel portal sediment basins (June 19, 2015).

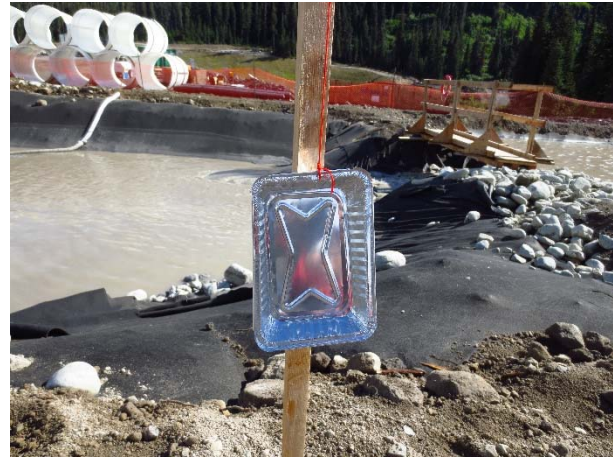
Photo 8 – Bird deterrent measures installed at ULRHEF intake and upstream tunnel portal sediment basins (June 20, 2015).

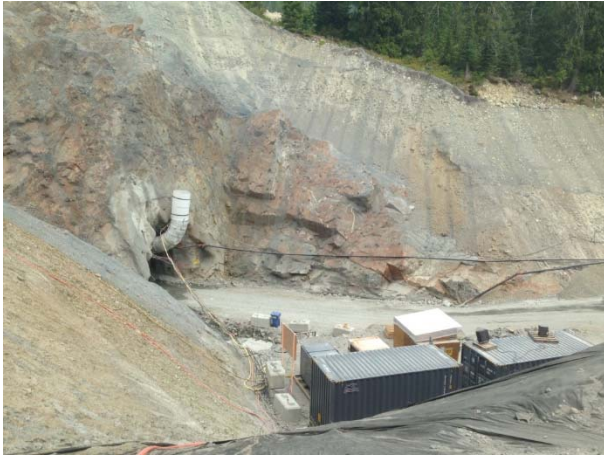
- Drilling, blasting, mucking and stabilization works within the tunnel (Photo 9).
- Dewatering to downstream tunnel portal settling ponds (Photo 10).
- Excavation for new downstream tunnel portal settling ponds at 2+800 (penstock chainage) (Photo 11).

**Photo 9 – Current conditions at the ULRHEF downstream tunnel portal (June 16, 2015).**

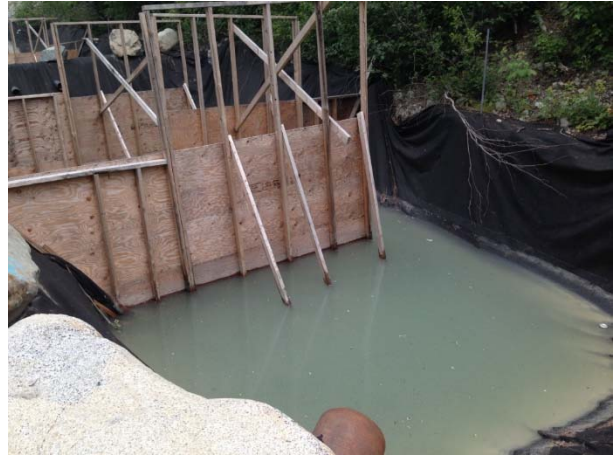
- Tunnelling works and dewatering to the downstream tunnel portal settling ponds continued during this reporting period. The settling pond water infiltrated to ground in the second cell with no discharge to the surrounding environment (Photo 10).
- On June 16, the IEM inspected the site (penstock chainage 2+800) for the new downstream tunnel portal settling ponds (Photo 11). The IEM observed that the ponds were visibly sloped and recommended that CE review the ponds prior to commissioning them. The ponds should be constructed to minimize flow velocity through the ponds, to increase particulate settling efficiency, and promote infiltration. The IEM notified CE's environmental management team who will review the recommendation prior to the commissioning of the ponds.

**Photo 10 – ULRHEF downstream tunnel portal settling ponds (June 16, 2015).**

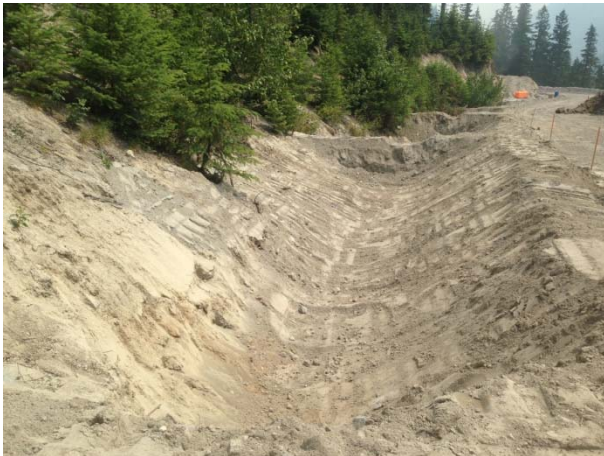
**Photo 11 – New downstream tunnel portal settling pond site on penstock alignment at 2+800 (June 17, 2015).**

- Recommend that CE review the gradient and elevations of the new infiltration ponds under construction at penstock chainage 2+800. Water velocity through the ponds should be minimized to the extent possible to improve suspended particulate settling ability and to promote infiltration. The IEM notified CE’s environmental management team who will review the recommendation prior to the commissioning of the ponds.

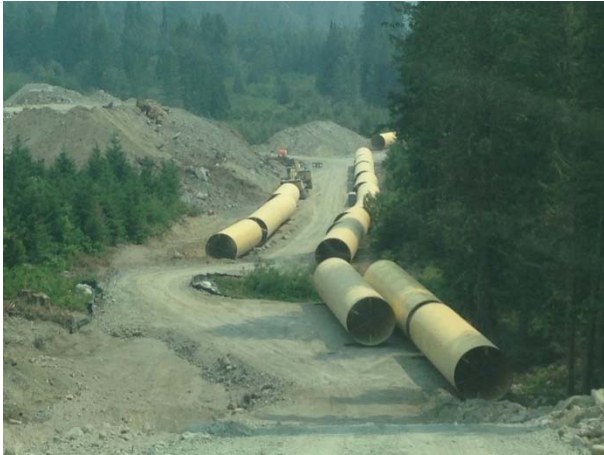
- Penstock staging continued (Photo 12).

**Photo 12 – Penstock staged near ASTR04  
(June 16, 2015).**

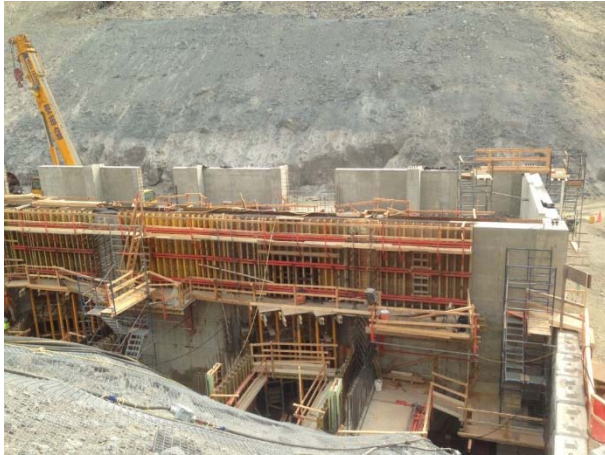
- Continued rebar installation and formwork for the powerhouse structure (Photo 13).
- Structural concrete pours occurred on June 14 and June 18 (Photo 14).
- Dewatering from the powerhouse sump to the Lillooet River continued (Photo 15).

**Photo 13 – Rebar installation and formwork at the ULRHEF powerhouse (June 17, 2015).**

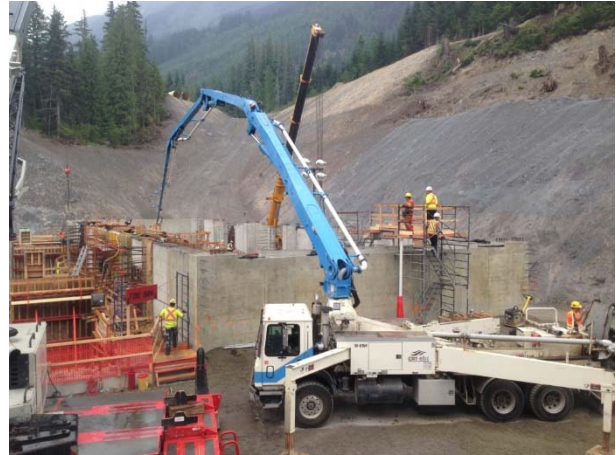
- On June 14 and 18, the IEM was onsite to inspect the ULRHEF powerhouse and verify WQ within the dewatering sump during a concrete pour (Photo 14). The IEM measured the water in the powerhouse sump to have a pH of 7.3 at 12:45 on June 14 and a pH of 6.9 at 14:30 on June 18. The water quality was suitable for discharge to the surrounding environment as per the Surface Water Quality Protection Plan.
- Dewatering of the ULRHEF powerhouse continued without environmental concern throughout the reporting period. The IEM will continue to monitor the works area to confirm that future concrete pours are adequately isolated from flowing water and protected from precipitation during curing.

**Photo 14 – Concrete pour at ULRHEF powerhouse (June 18, 2015).**

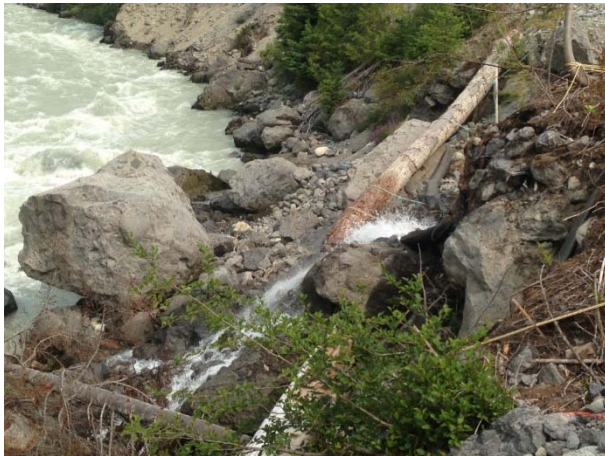
**Photo 15 – ULRHEF powerhouse sump discharging to the Lillooet River (June 18, 2015).**

- The ULRHEF powerhouse sump water should be monitored regularly. Alkaline or turbid water should be pumped to the remaining settling ponds for treatment.

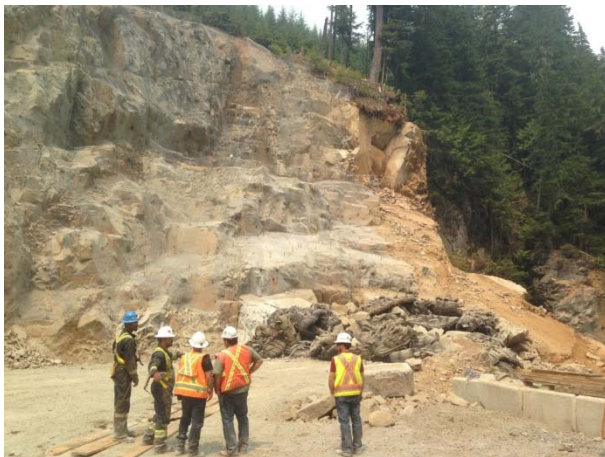
- Slope stabilization works continued at the BDRHEF intake and crane pad (Photo 16).

Photo 16 – Conditions at BDRHEF intake following blast above crane pad (June 16, 2015).

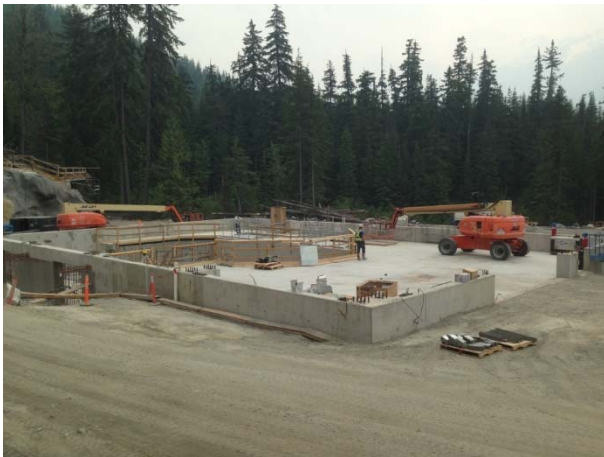
- Preparation and cleaning for superstructure construction (Photo 17).
- Drilling, blasting, mucking and stabilization works continued within the tunnel (Photo 18).
- Dewatering of the tunnel and powerhouse to the oil water separator and settling ponds continued (Photo 19).

**Photo 17 – Current conditions at the BDRHEF powerhouse (June 17, 2015).**

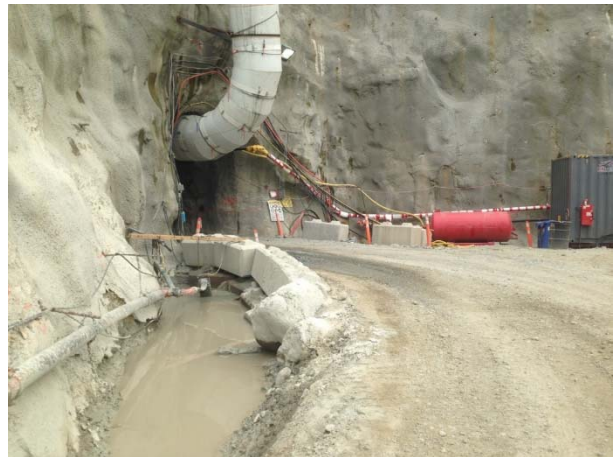
**Photo 18 – BDRHEF downstream tunnel portal (June 17, 2015).**

- All wastewater related to the BDRHEF tunnelling works should continue to be contained and conveyed to the downstream portal settling ponds for treatment. Regular inspections of the treatment ponds should be performed to ensure the necessary maintenance activities outlined in the work plan are performed.
- CE should continue to exercise caution when working at the BDRHEF crane pad and on slope consolidation to prevent excessive rock fall into Boulder Creek.

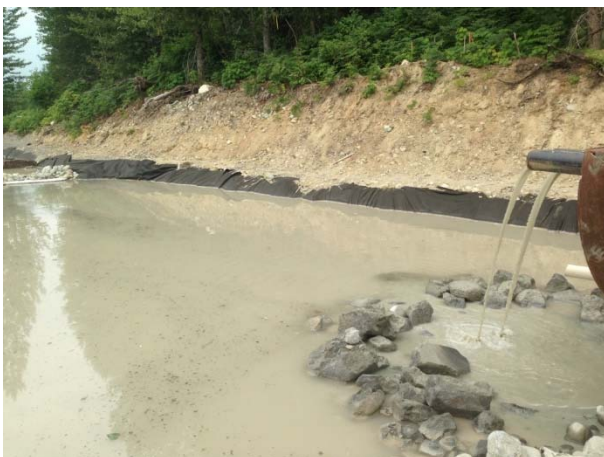
**Photo 19 – BDRHEF downstream tunnel portal and powerhouse settling ponds (June 17, 2015).**

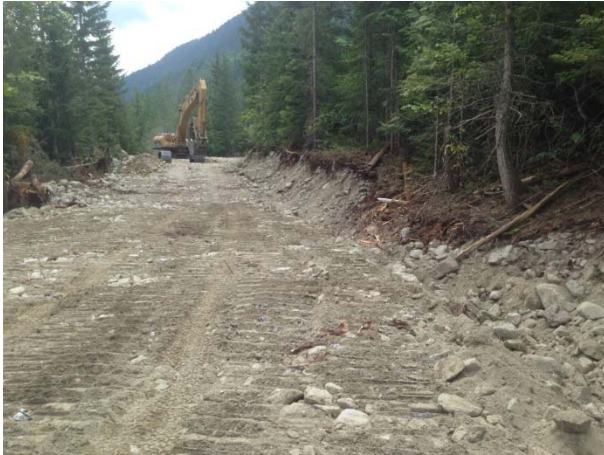
- Helipad clearing and construction in Segment 9b.
- Road construction in Segment 11 (Photo 20), 13 and 14.

Photo 20 – Ditching and road works on Ryan South Main near stream 261a (June 18, 2015).

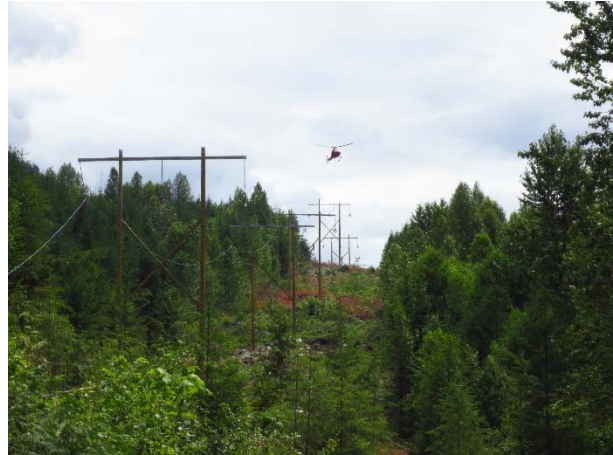
- Framing in Segment 4.
- Stringing, pulling and clipping conductors in Segment 7 (Photo 21).
- Groundworks for pole foundations in Segment 9a.

Photo 21 – Pole stringing in Segment 7 (June 20, 2015).

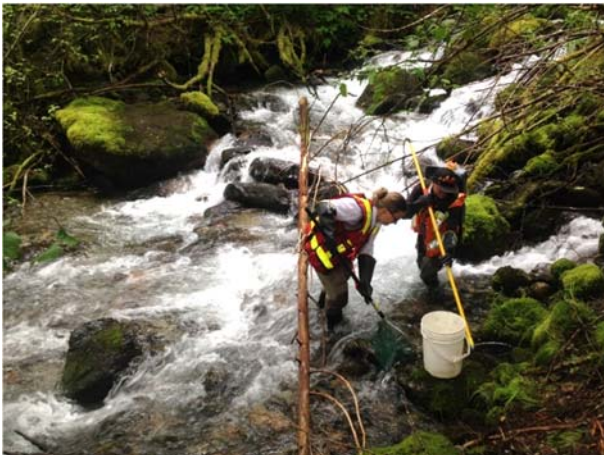
- On June 18, the IEM was present for a precautionary fish salvage conducted by Ecofish at Vans Creek. No fish were captured or observed during the salvage works. One CTF was observed but due to stream conditions (high velocity and volume), a frog salvage was deemed to be impractical and unsafe. Mitigation for the bridge removal works will involve minimizing sedimentation and IEM monitoring of all instream works.

Photo 22 – Ecofish perform precautionary fish salvage at Vans Creek (June 18, 2015).
