Upper Lillooet Hydro Project

Weekly Environmental Monitoring Report #70

Reporting Period: August 2 – August 29, 2015

Upper Lillooet River Hydroelectric Facility (Water File No. 2002561, Water licence No. C130613), Boulder Creek Hydroelectric Facility (Water File No. 2003049, Water licence No. C129969) & Transmission Line (TX Line)

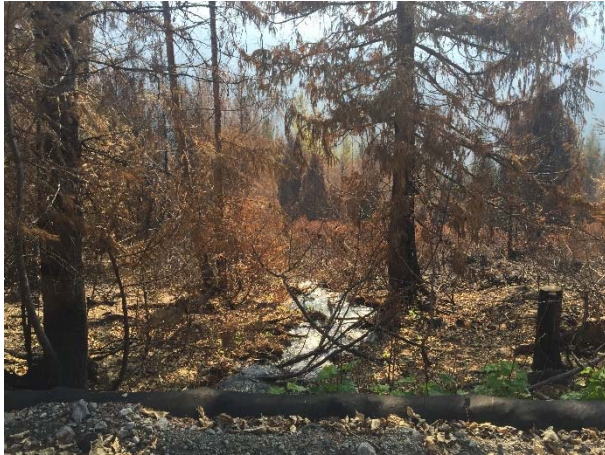
- Clearing danger trees within the stream 9A RVMA crossing along the magazine access road was performed under IEM supervision on August 12, 2015. The feller buncher was able to reach all danger trees from outside of the 15m buffer and by reaching in from the access road. No environmental concerns were noted.

Photo 1 – Stream 9A RVMA downstream of the magazine access road crossing following the removal of danger trees. (August 12, 2015).

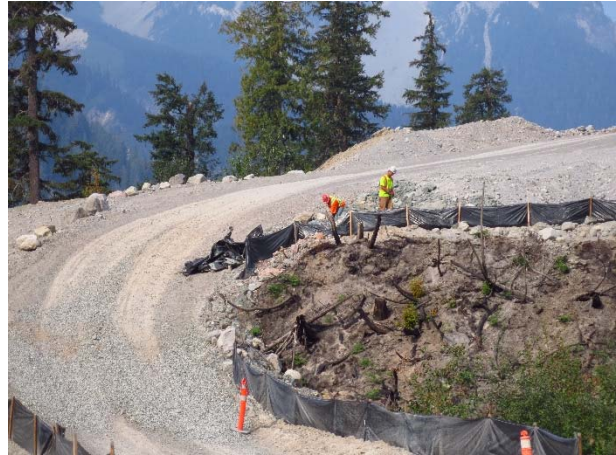
- Silt fences damaged by the wildfire were replaced at the stream 9A, ASTR03, and ASTR04 watercourse crossings during this reporting period (Photo 2).

Photo 2 – Replacement of silt fencing protection at the ASTR03 road culvert crossing. (August 27, 2015).

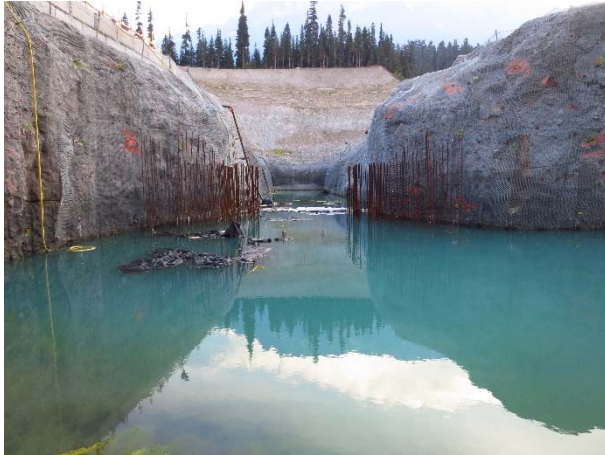
- Site reactivation activities at the intake and upstream tunnel portal resumed on August 27, 2015 with the commencement of dewatering of the flooded tunnel excavation and intake structure (Photo 3, Photo 4, Photo 5, and Photo 6). All water was directed to the wastewater treatment system initially until water quality was confirmed to meet pH and turbidity BCWQG criteria (Photo 6). Once dewatering was completed, crews began cleaning the concrete forms/rebar of the intake structure and began repairs to the electrical and ventilation systems damaged by the flooding of the tunnel.

Photo 3 – Flooded conditions within the ULRHEF upstream tunnel and intake structure prior to dewatering (August 27, 2015).

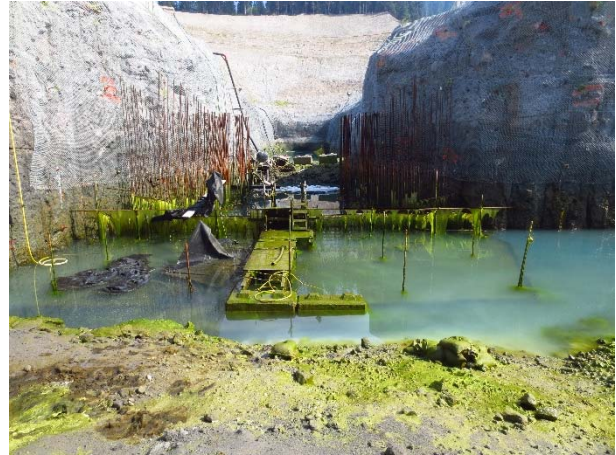
Photo 4 – Conditions of the form work and rebar for the intake structure following dewatering (August 27, 2015).

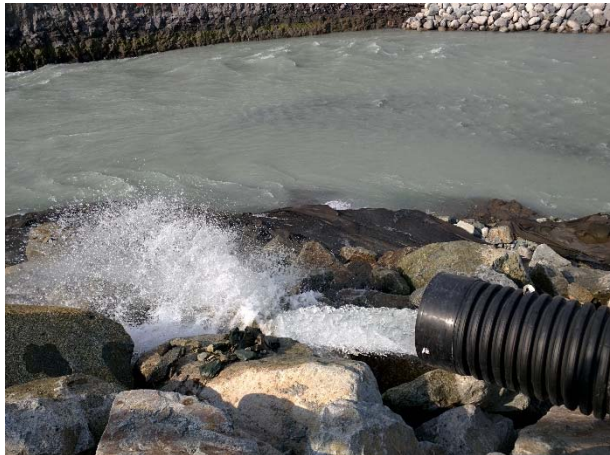
Photo 5 – Clean water discharging to the Lillooet River from the flooded tunnel and intake work area following confirmation that water met BCWQGs (August 27, 2015).

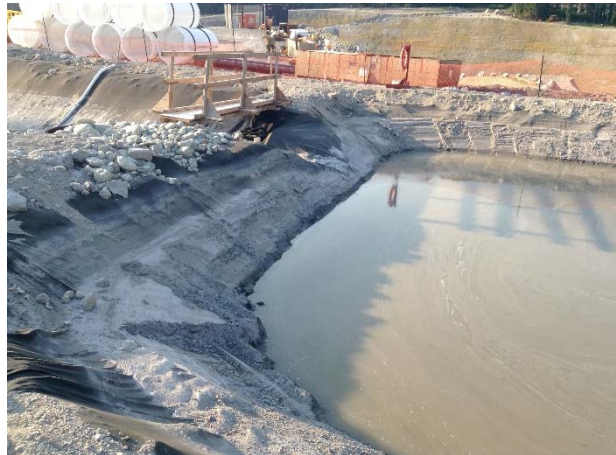
Photo 6 – Discharge of the initial pulse of sediment laden water was directed to water treatment ponds (August 27, 2015).

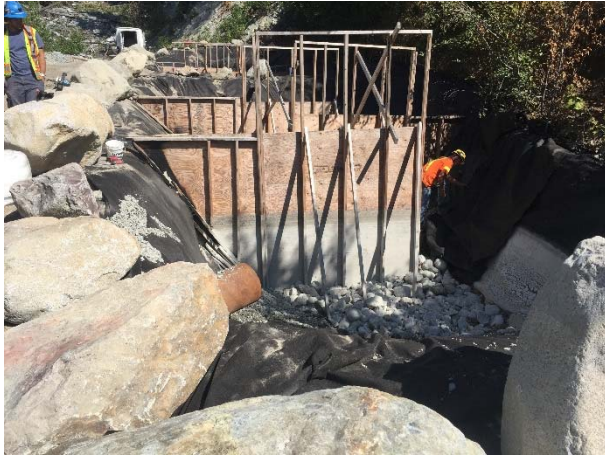
- Prior to starting the dewatering of the flooded downstream tunnel portal, the sediment accumulations within the dewatering infiltration ponds were removed, the oil/water separator was maintained and the baffles were repaired (Photo 7 & Photo 8). On August 28, CE buried the dewatering pipes and moved the oil/water to create more space at the tunnel entrance (Photo 9 & Photo 10).

- Dewatering to the downstream portal infiltration ponds resumed on August 12, 2015 following an IEM inspection of the repairs to the ponds and maintenance of the oil/water separator. The water infiltrated to ground in the second cell of the infiltration ponds with

Photo 7 – Repairs underway in the downstream infiltration ponds (August 12, 2015).

- Prior to commissioning the newly constructed infiltration ponds built to be used for dewatering of the ULRHEF downstream portal, the IEM recommends that CE review the gradient and elevations of the ponds and the integrity of the berms separating the cells. Water velocity through the ponds should be minimized to the extent possible to improve suspended particulate settling ability and to promote infiltration.

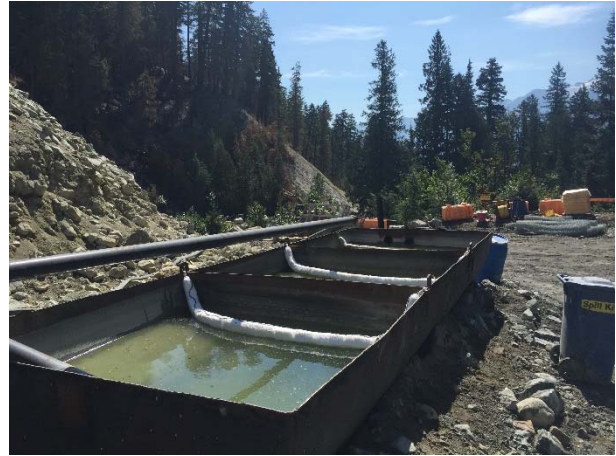
Photo 8 – Replacement of the oil absorbent booms in the oil/water separator (August 12, 2015).

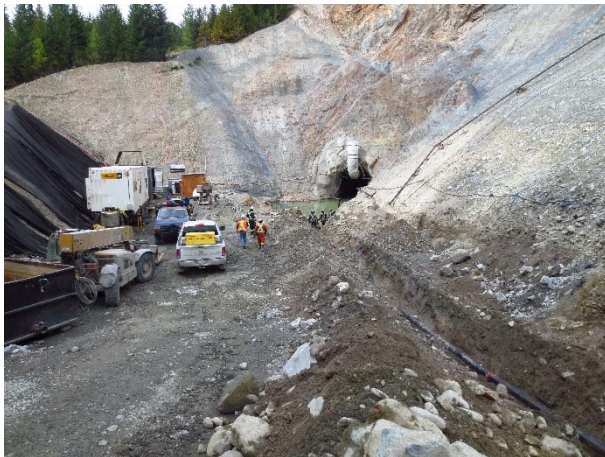
Photo 9 – Burying the dewatering pipes at the ULRHEF downstream tunnel portal (August 28, 2015).

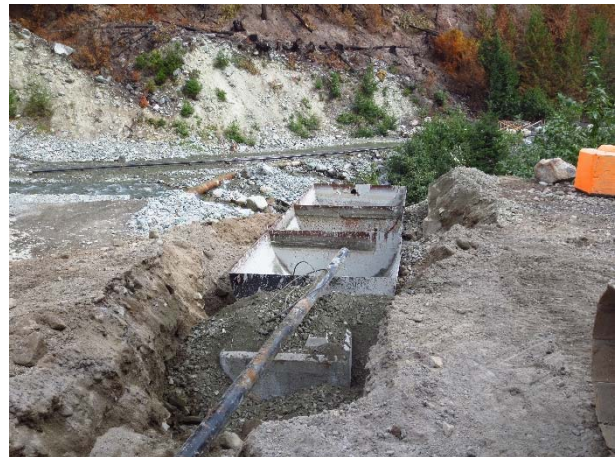
- On August 28, 2015 CE crews began making changes to the location of the dewatering system components to gain more work space at the entrance to the downstream tunnel portal.

Photo 10 – The oil/water separator was moved to create more space at the downstream tunnel portal entrance (August 28, 2015).

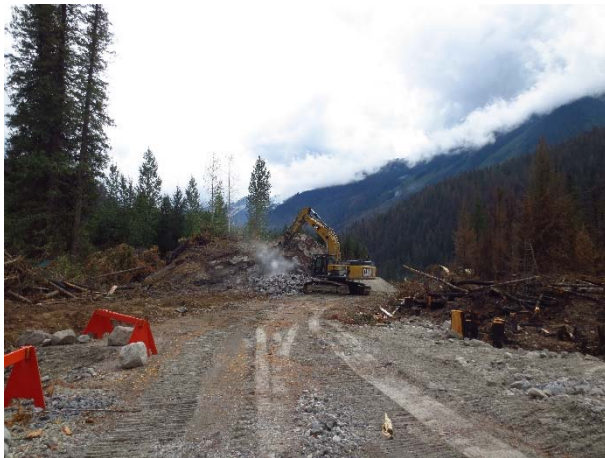
Photo 11 – Breaking up the large rock at 3+900 of the penstock alignment (August 28, 2015).

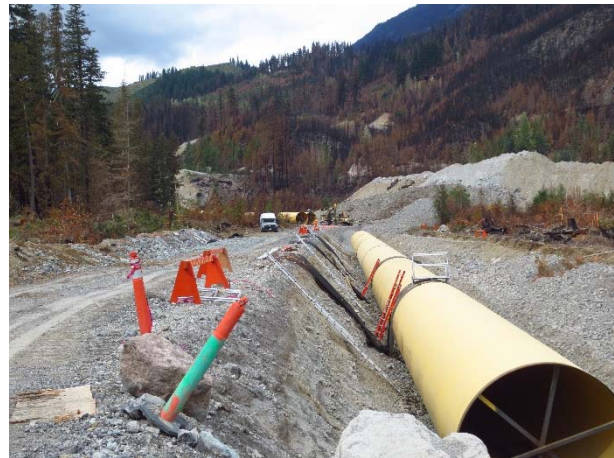
Photo 12 – Penstock installation currently on hold. (August 28, 2015).

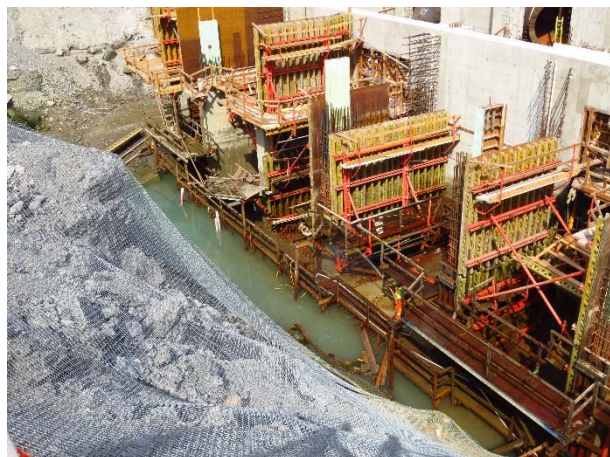
- o On August 26, the IEM was onsite to inspect the ULRHEF powerhouse and verify WQ within the dewatering sump confirming that water was suitable for discharge to the surrounding environment as per the Surface Water Quality Protection Plan.

Photo 13 – Dewatering of the ULRHEF powerhouse (August 26, 2015).

- The ULRHEF powerhouse sump water should be monitored regularly. Alkaline or turbid water should be pumped to the remaining settling ponds for treatment.

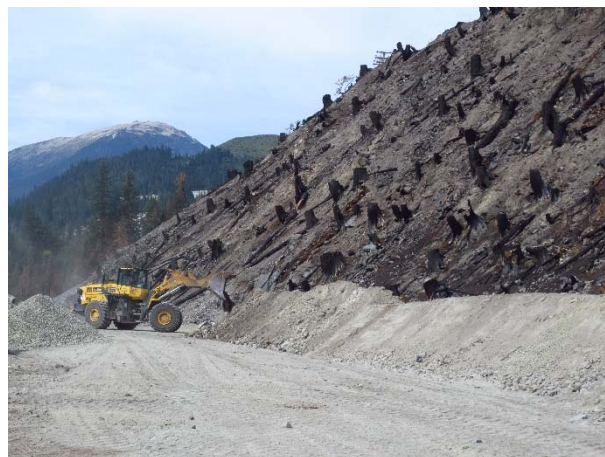
Photo 14 – Construction of a berm to protect the ULRHEF powerhouse access road from landslide and falling material risks (August 26, 2015).

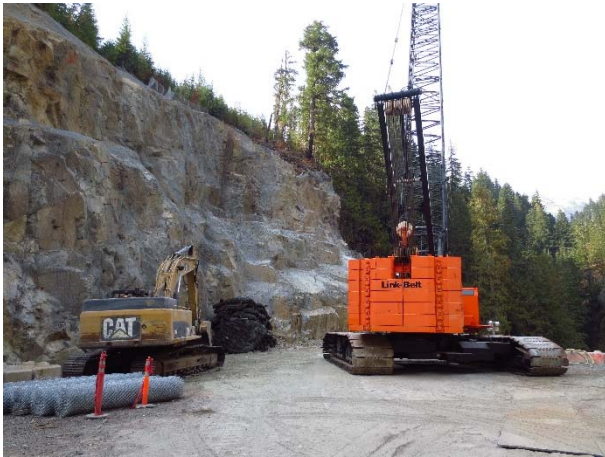
- Works at the BDRHEF intake are currently on hold until road repairs and slope stabilization along the access road is completed (Photo 15).

Photo 15 – Works on hold at the BDRHEF intake (August 26, 2015).

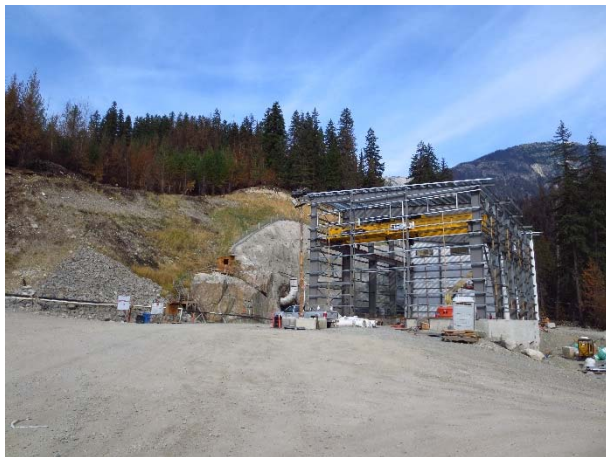
Photo 16 – Works remain on hold at the BDRHEF powerhouse (August 26, 2015).

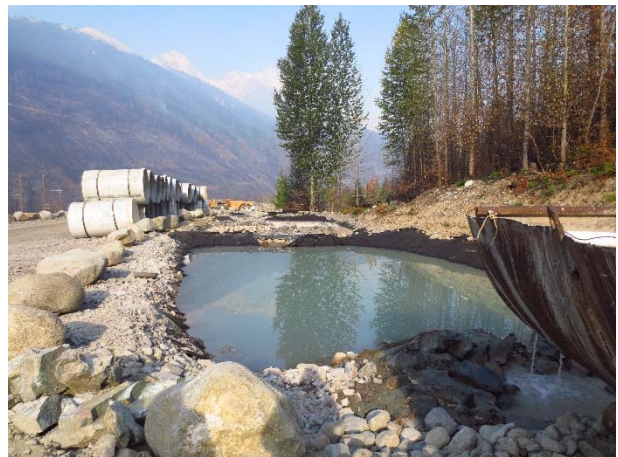
- Erection of the superstructure remained on hold (Photo 16).
- The pumping of tunnel seepage water and water from the flooded powerhouse foundation was directed to the oil/water separator and settling ponds (Photo 17).

- All water emanating from the tunnel and from the flooded foundations of the powerhouse were pumped to the treatment system, which has yet to discharge from the fourth cell.

Photo 17 – Conditions within the BDRHEF powerhouse setting ponds. (August 27, 2015).

- All wastewater related to the BDRHEF tunnelling works should continue to be contained and conveyed to the downstream portal settling ponds for treatment. Regular inspections of the treatment ponds should be performed to ensure the necessary maintenance activities outlined in the work plan are performed.

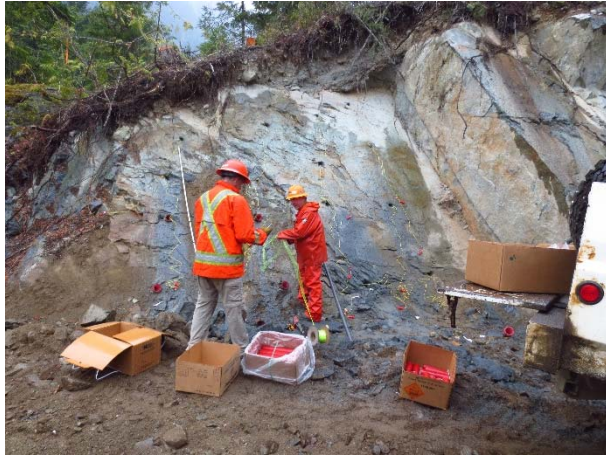
- Road construction in Segments 11 (Branch A road) and 14.
- Widening of the Ryan River bridge approach in Segment 11 involving drilling and blasting on August 28, 2015 (Photo 18).

- Instream acoustic monitoring (via hydrophone) was completed by the IEM during blasting at the Ryan River bridge approach (Photo 1 and 2). The instream acoustic pressure measured within the Ryan River during the blast did not exceed the 15 kPa set trigger level and therefore maintained compliance with the 30 kPa maximum threshold outlined in the CEMP. No water quality concerns or impacts to fish were observed as a result of the single blast event.

Photo 18 – Blast preparations at the Ryan River bridge approach. A hydrophone and seismograph was installed to monitor in-stream acoustic pressure during the blast (August 28, 2015).

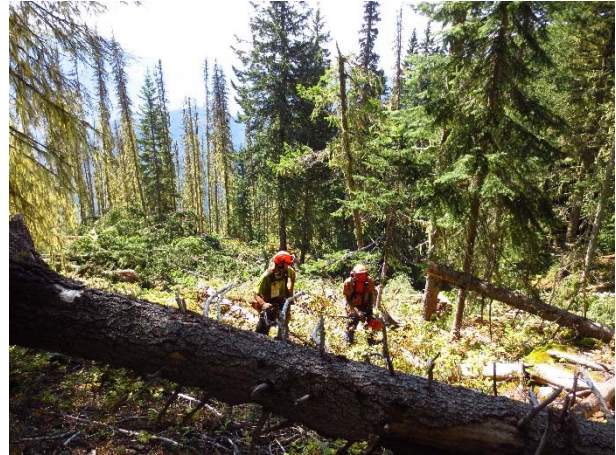
Photo 19 – Hand falling in the class 2 grizzly bear summer forage habitat polygon near structure 376 during the approved project work window (August 17, 2015)
